Why was damage extensive in bridges Types of Damage built in recent years? Pre Mid-1990s Typical Chile Bridges Damage resulted from insufficient integrity of pre-cast concrete girder Diaphragm Pre-tension bridges due to absence of diaphragms PC girders Cap beam •Lack of constraint to rotation of deck in skewed bridges After the Mid 1990s influenced by Spanish practice •Damage of piers and foundations in bridges built in the early days •....

Bridges based on recent practice suffered more damage than bridges based on pre mid-1990s practice

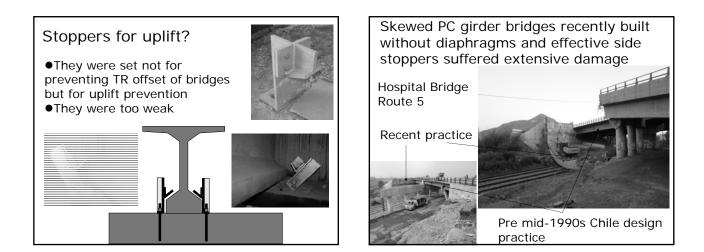
Lack of constraint to rotation of skewed bridges Skewed bridges tend to rotation under seismic excitation Watanabe, G. and Kawashima, K., Paper No. 789, 13th WCEE, 2004

Skewed bridges which lacked diaphragms and effective side stoppers suffered extensive damage
