(1) Seismic Damage of Urban Infrastructures in Past Earthquakes

Kazuhiko Kawashima
Department of Civil Engineering
Tokyo Institute of Technology

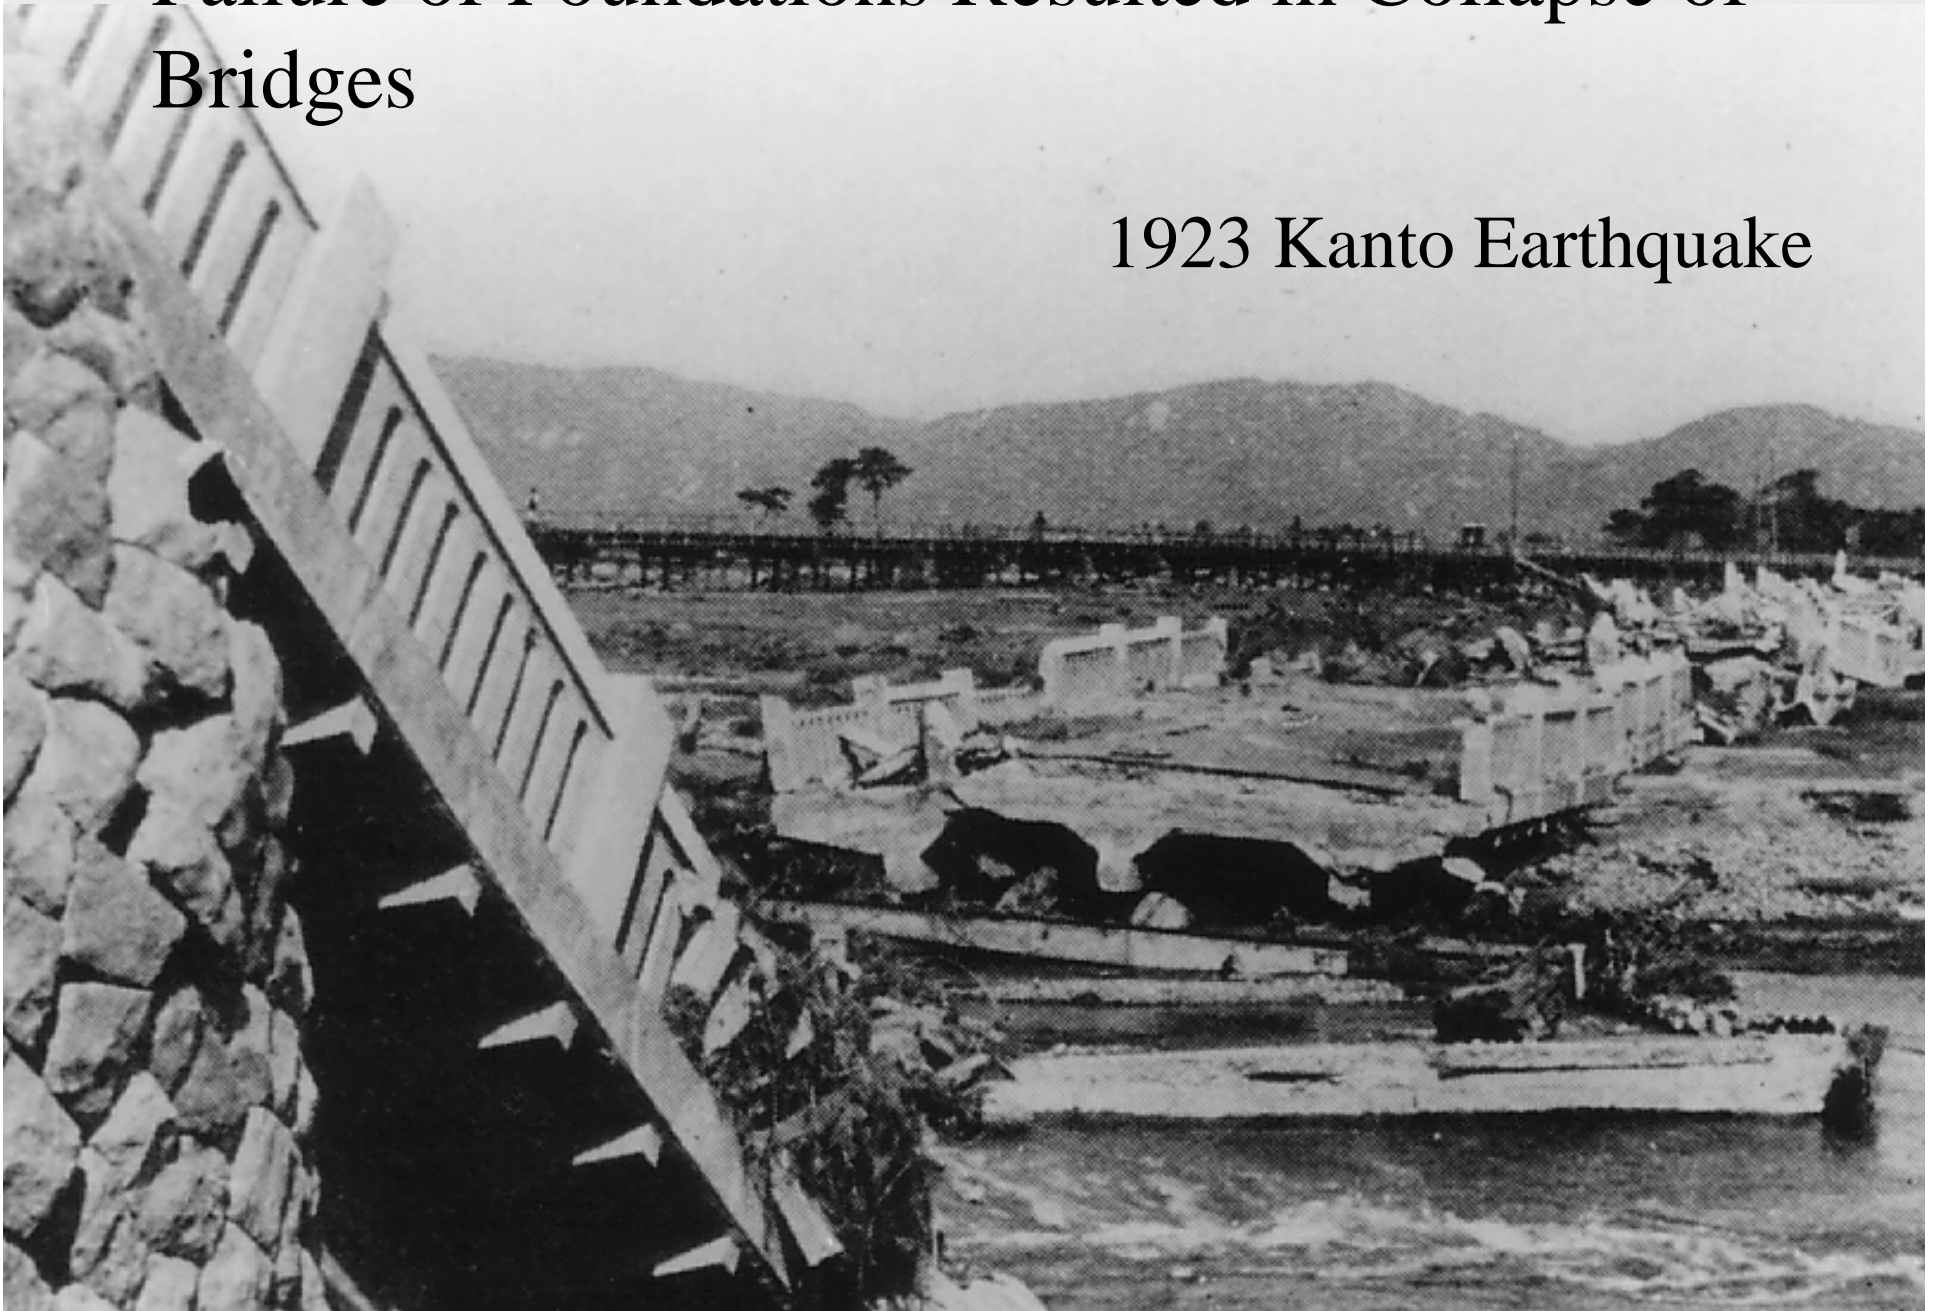
Failure of Foundations Resulted in Collapse of Bridges

1923 Kanto Earthquake

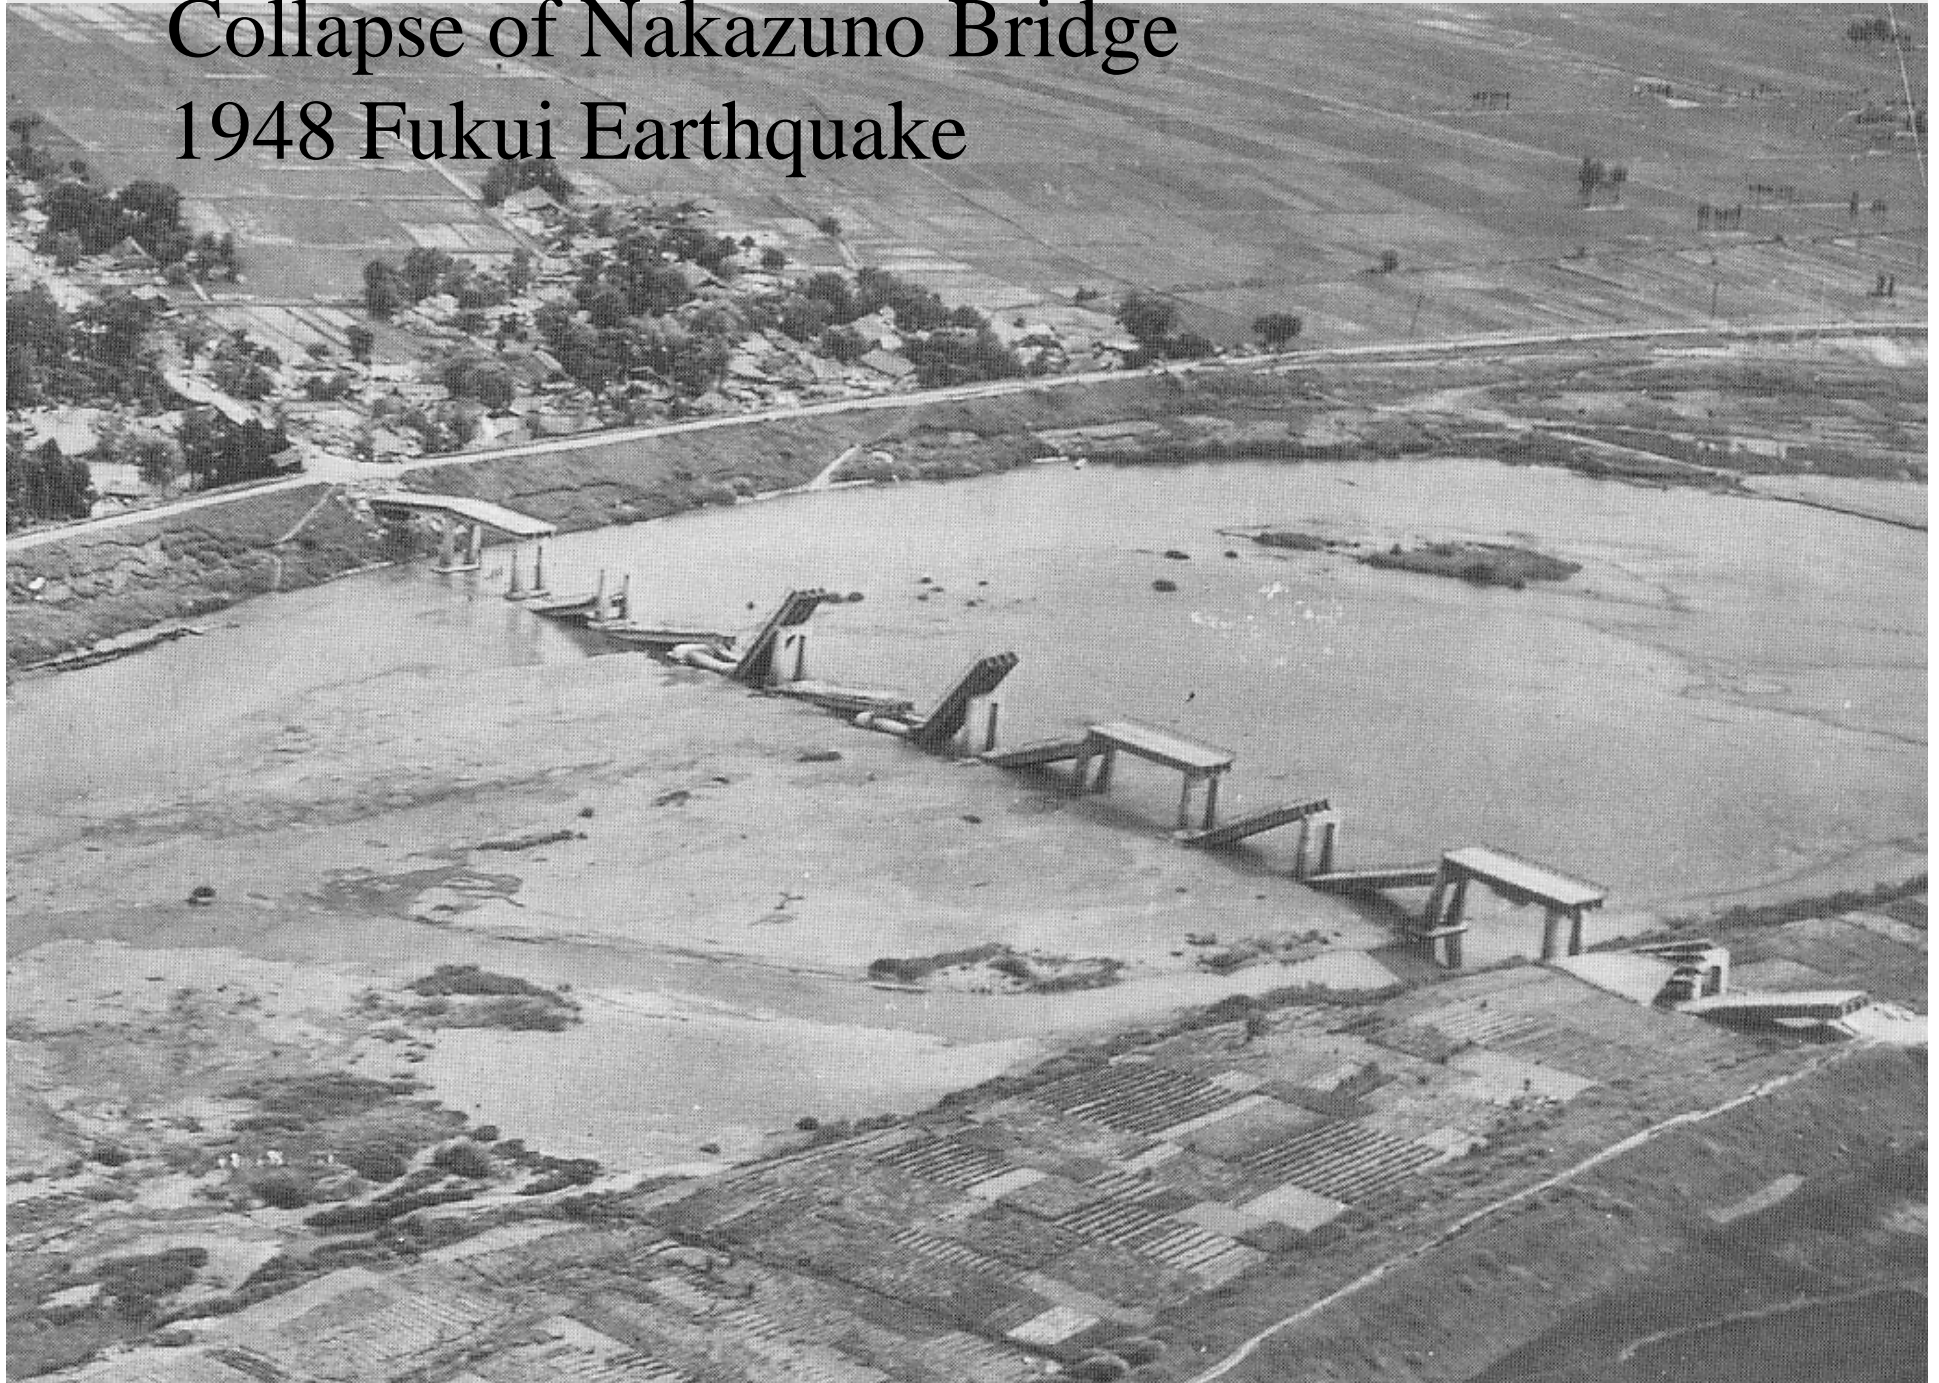
Collapse of Nakazuno Bridge

1948 Fukui Earthquake

Failure of Foundations Resulted in Collapse of the Bridge

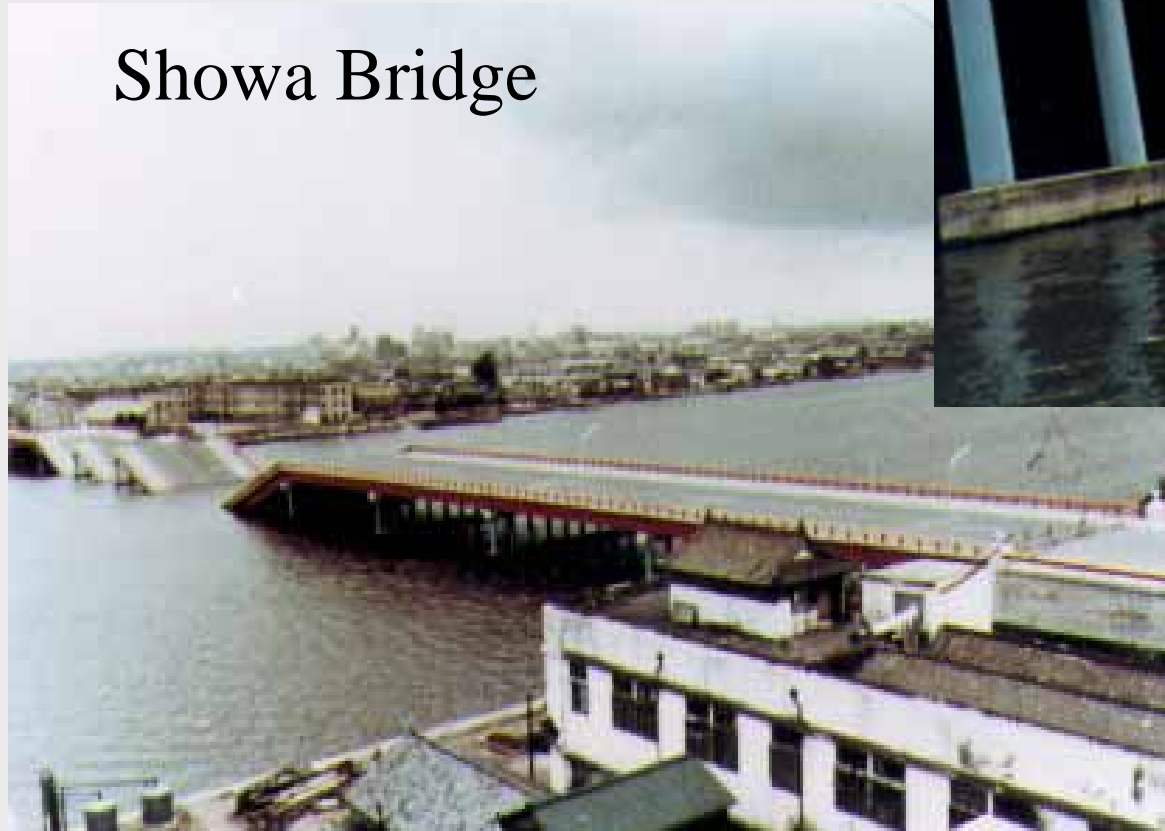
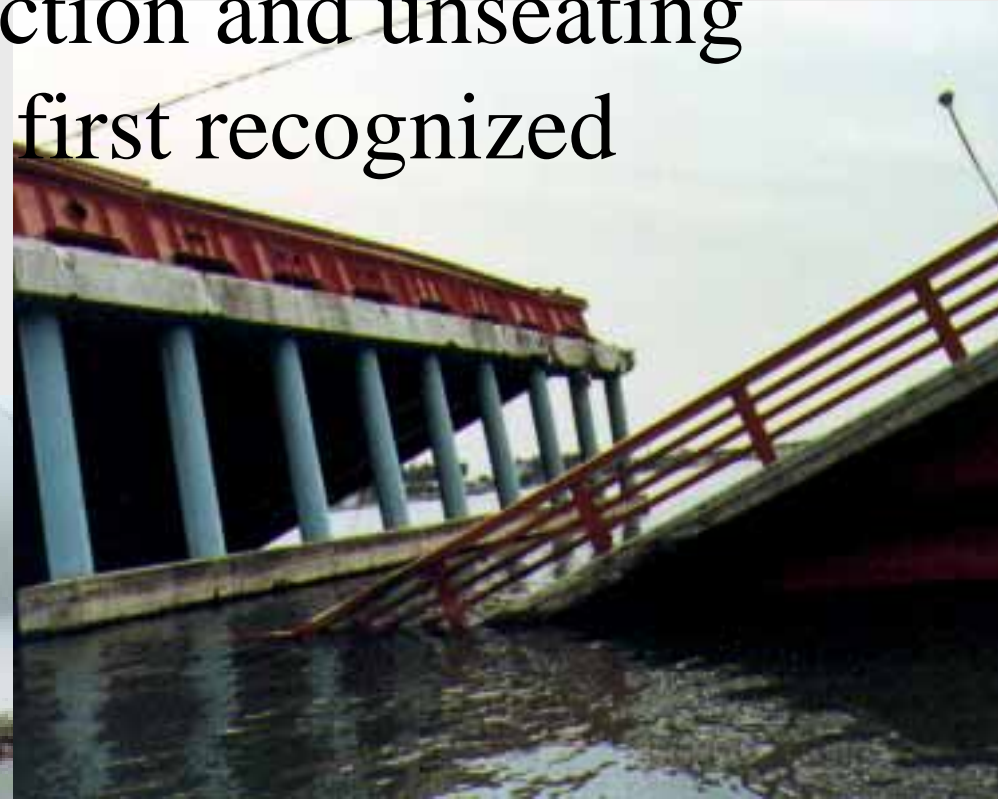
Showa Bridge

1964 Niigata Earthquake

Soil Liquefaction

This damage resulted in the first development of unseating prevention devices

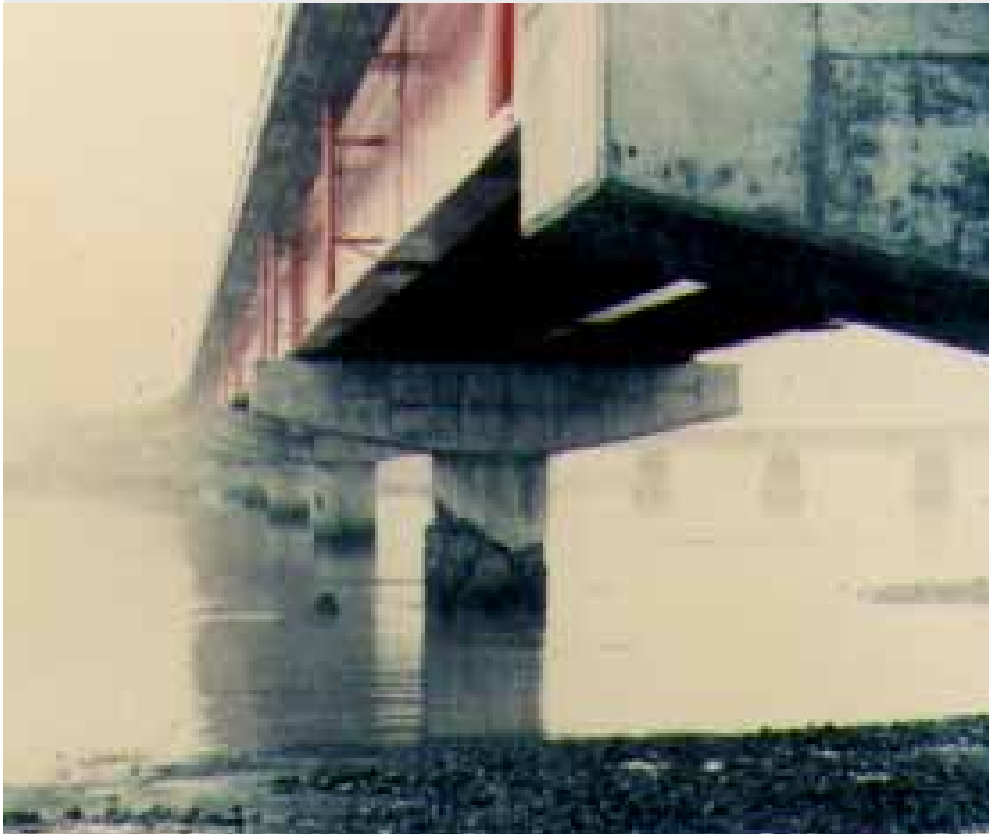
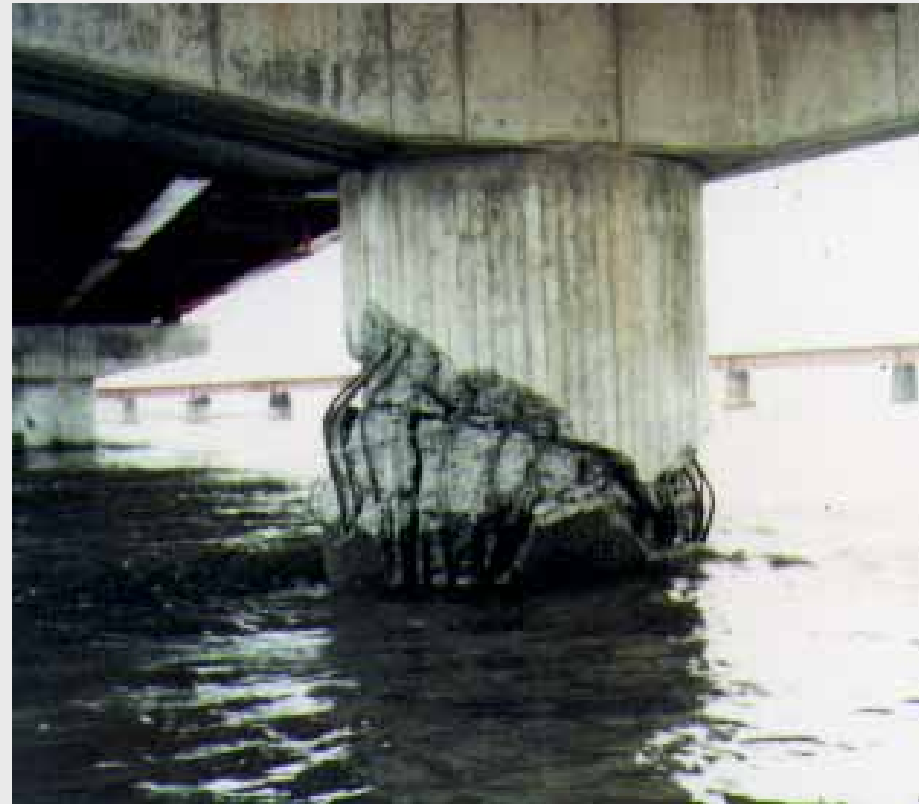
1982 Urakawa-oki Earthquake

Shear failure of RC Columns

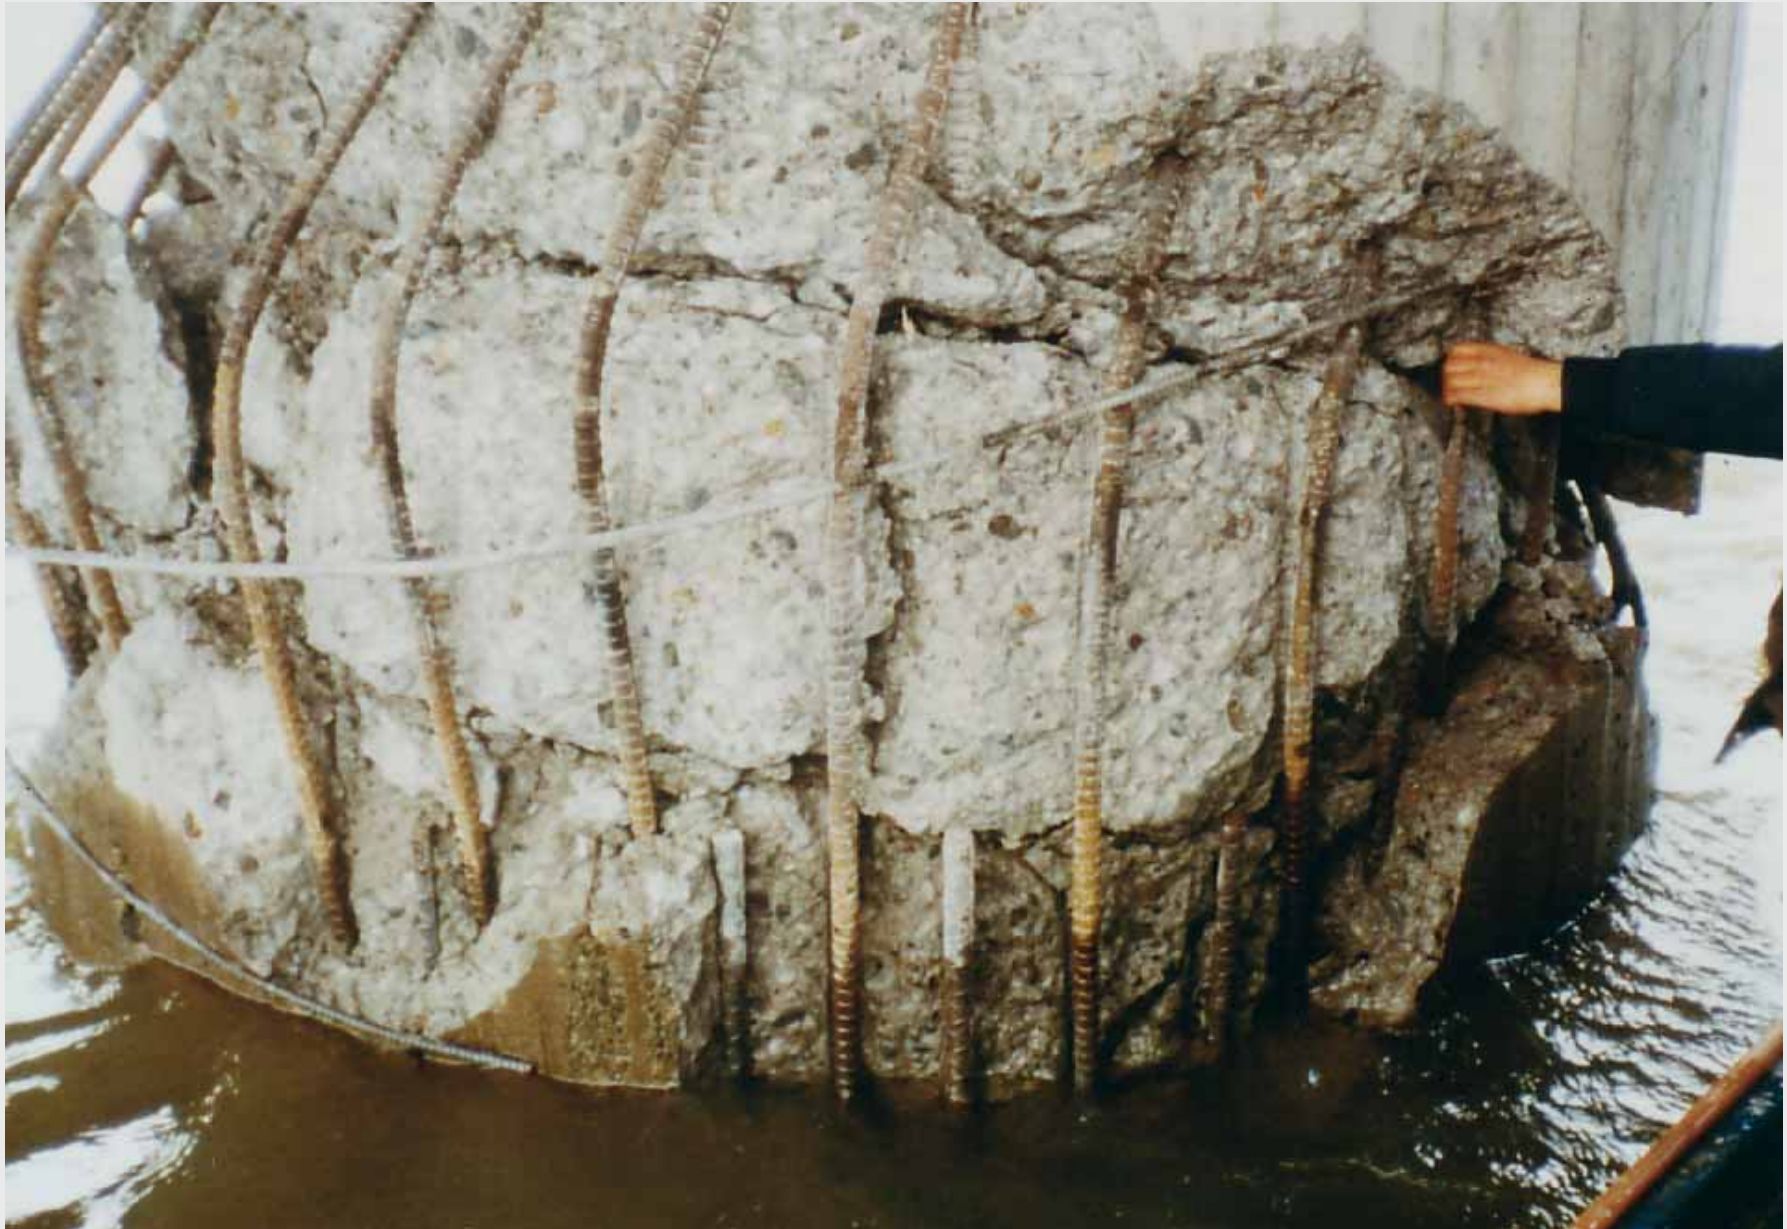
Shizunai Bridge

Premature Shear Failure of RC Piers

Premature Shear Failure of Reinforced Concrete Piers Resulting from Insufficient Development Length

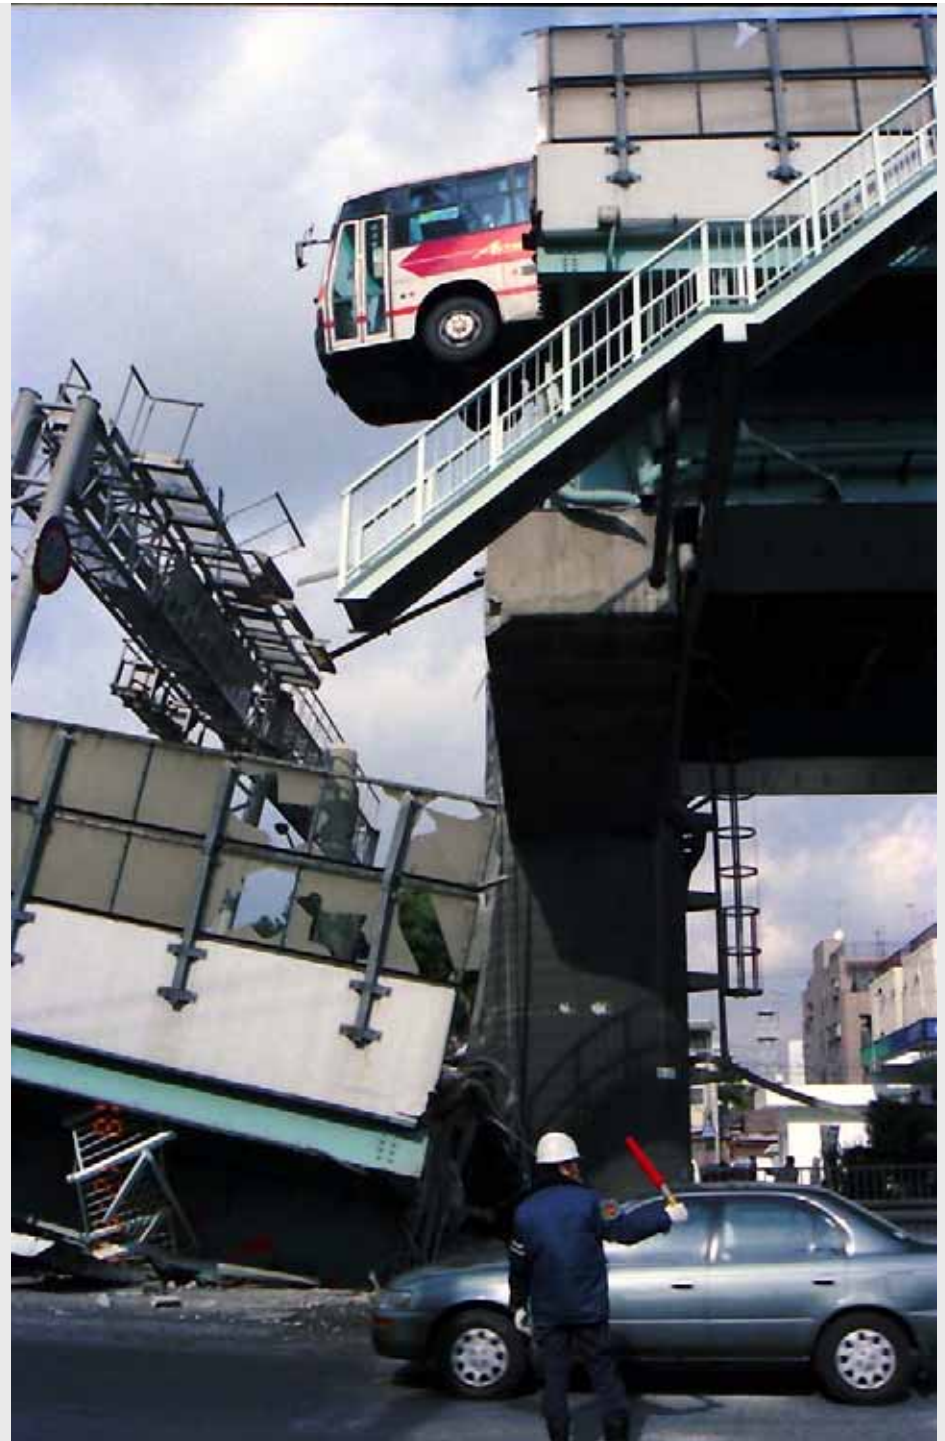
The most extensive damage occurred at a 18-span viaduct. This bridge collapsed due to failure of RC columns resulted from the premature shear failure.

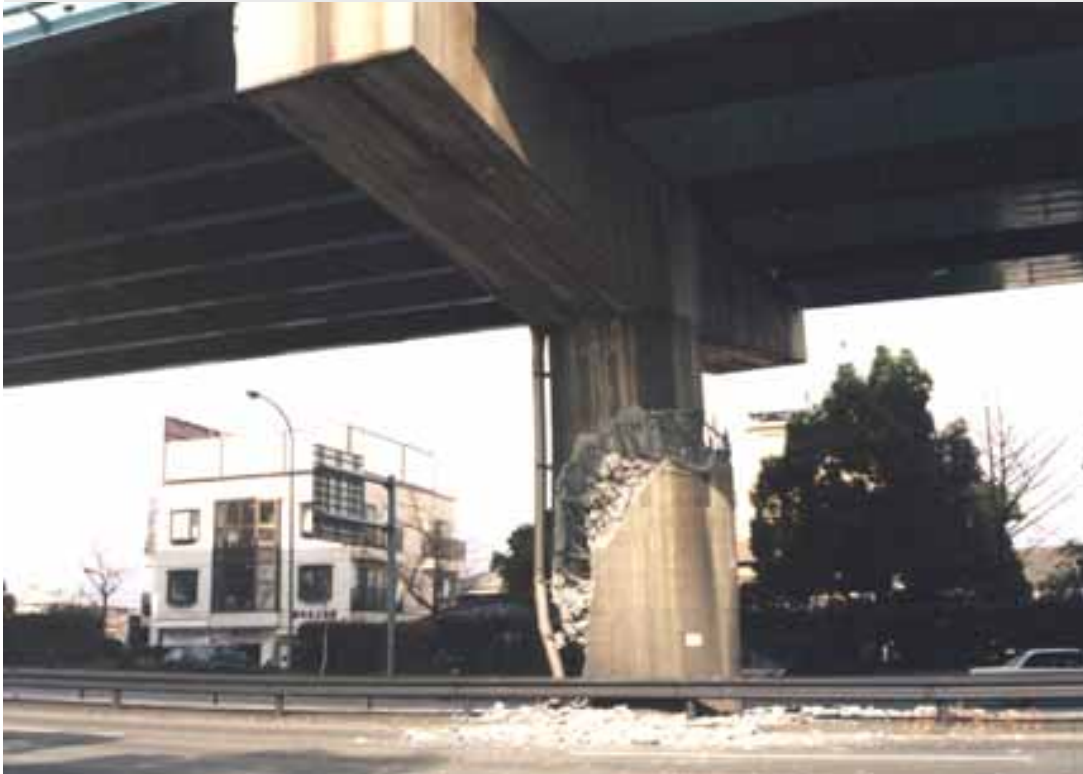
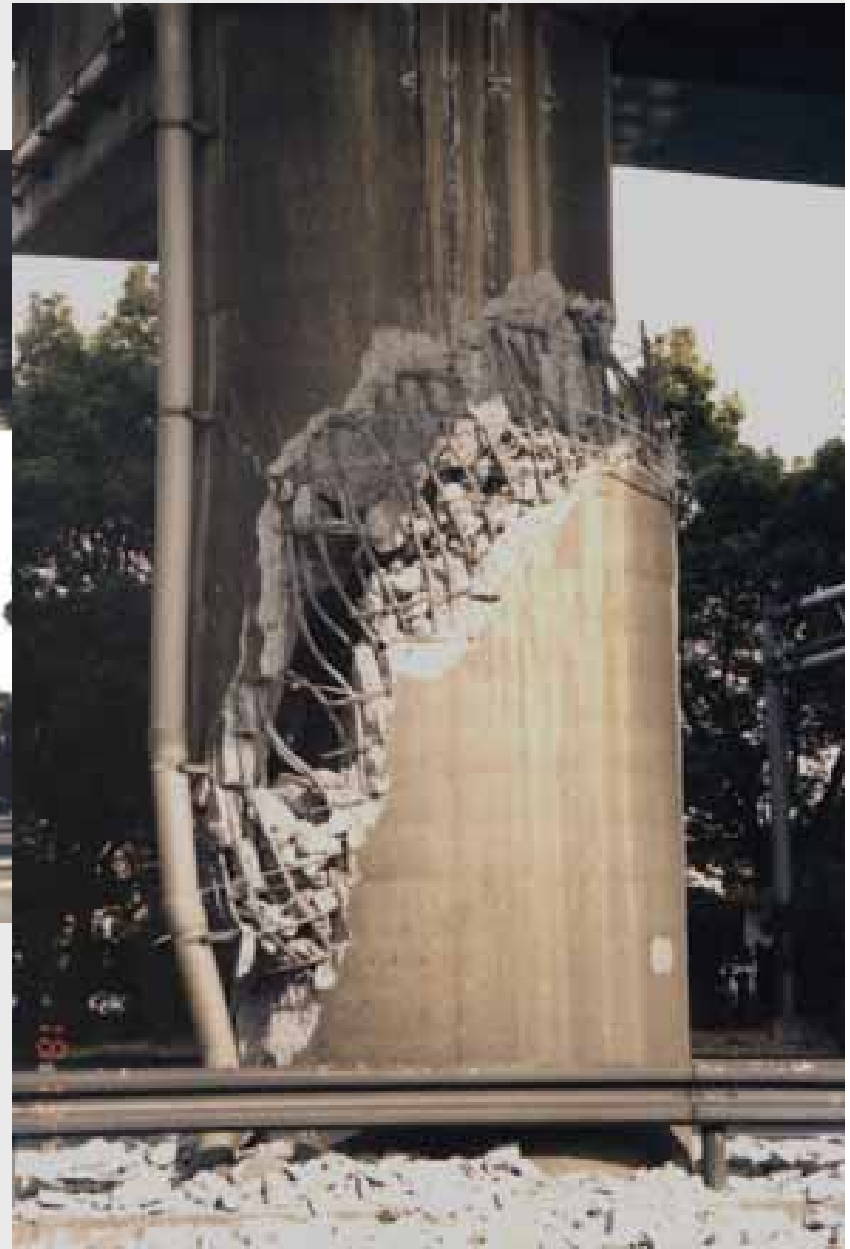
Shear Failure

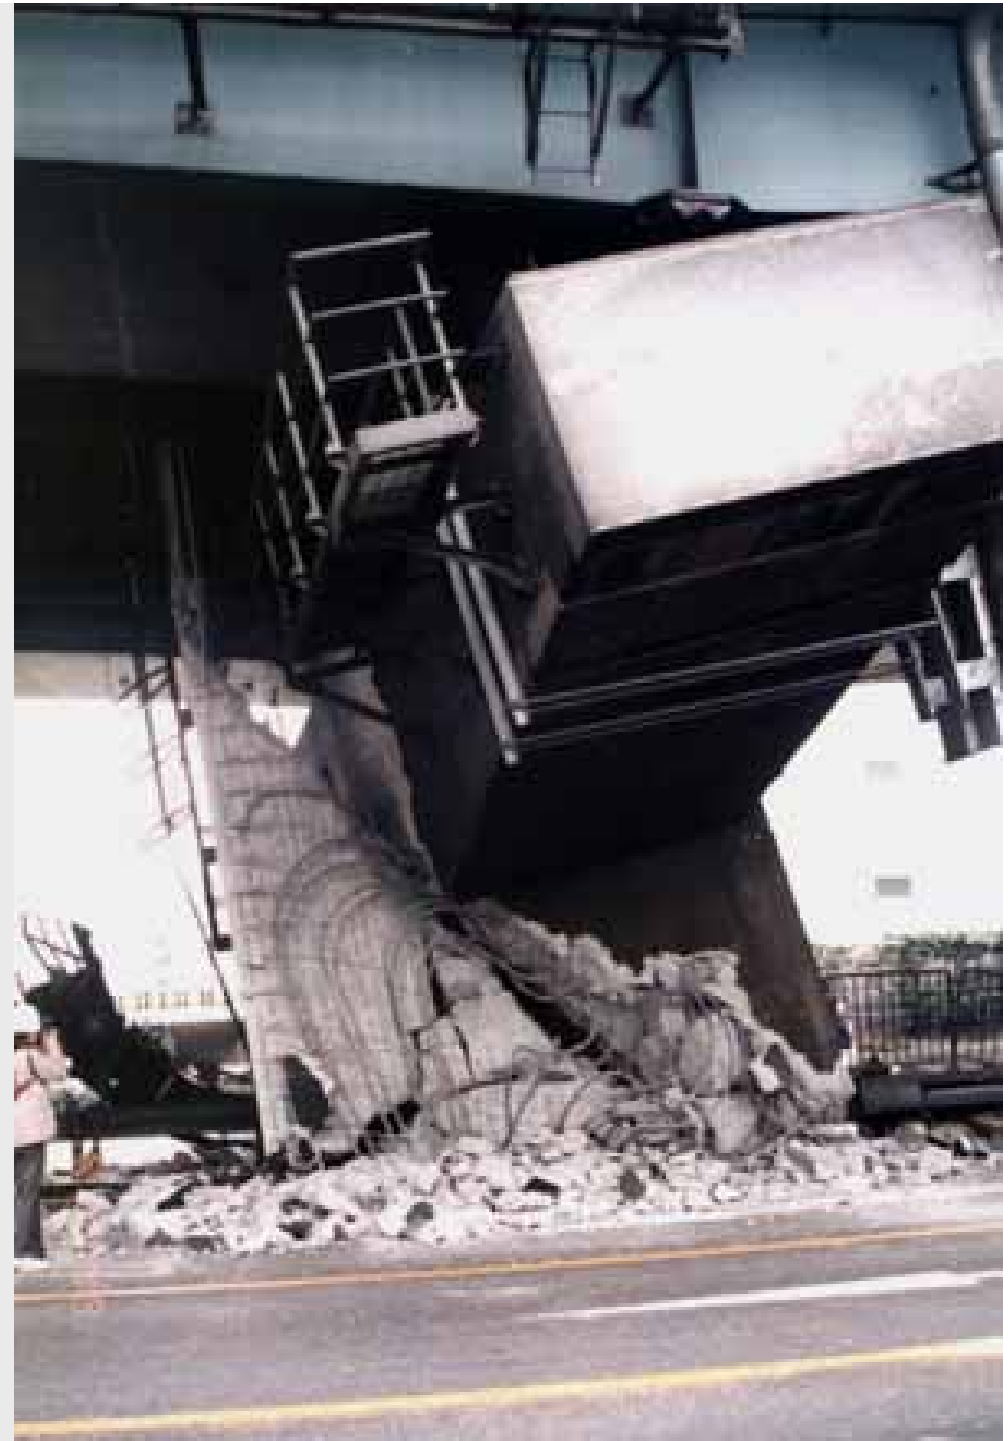
Shear Failure

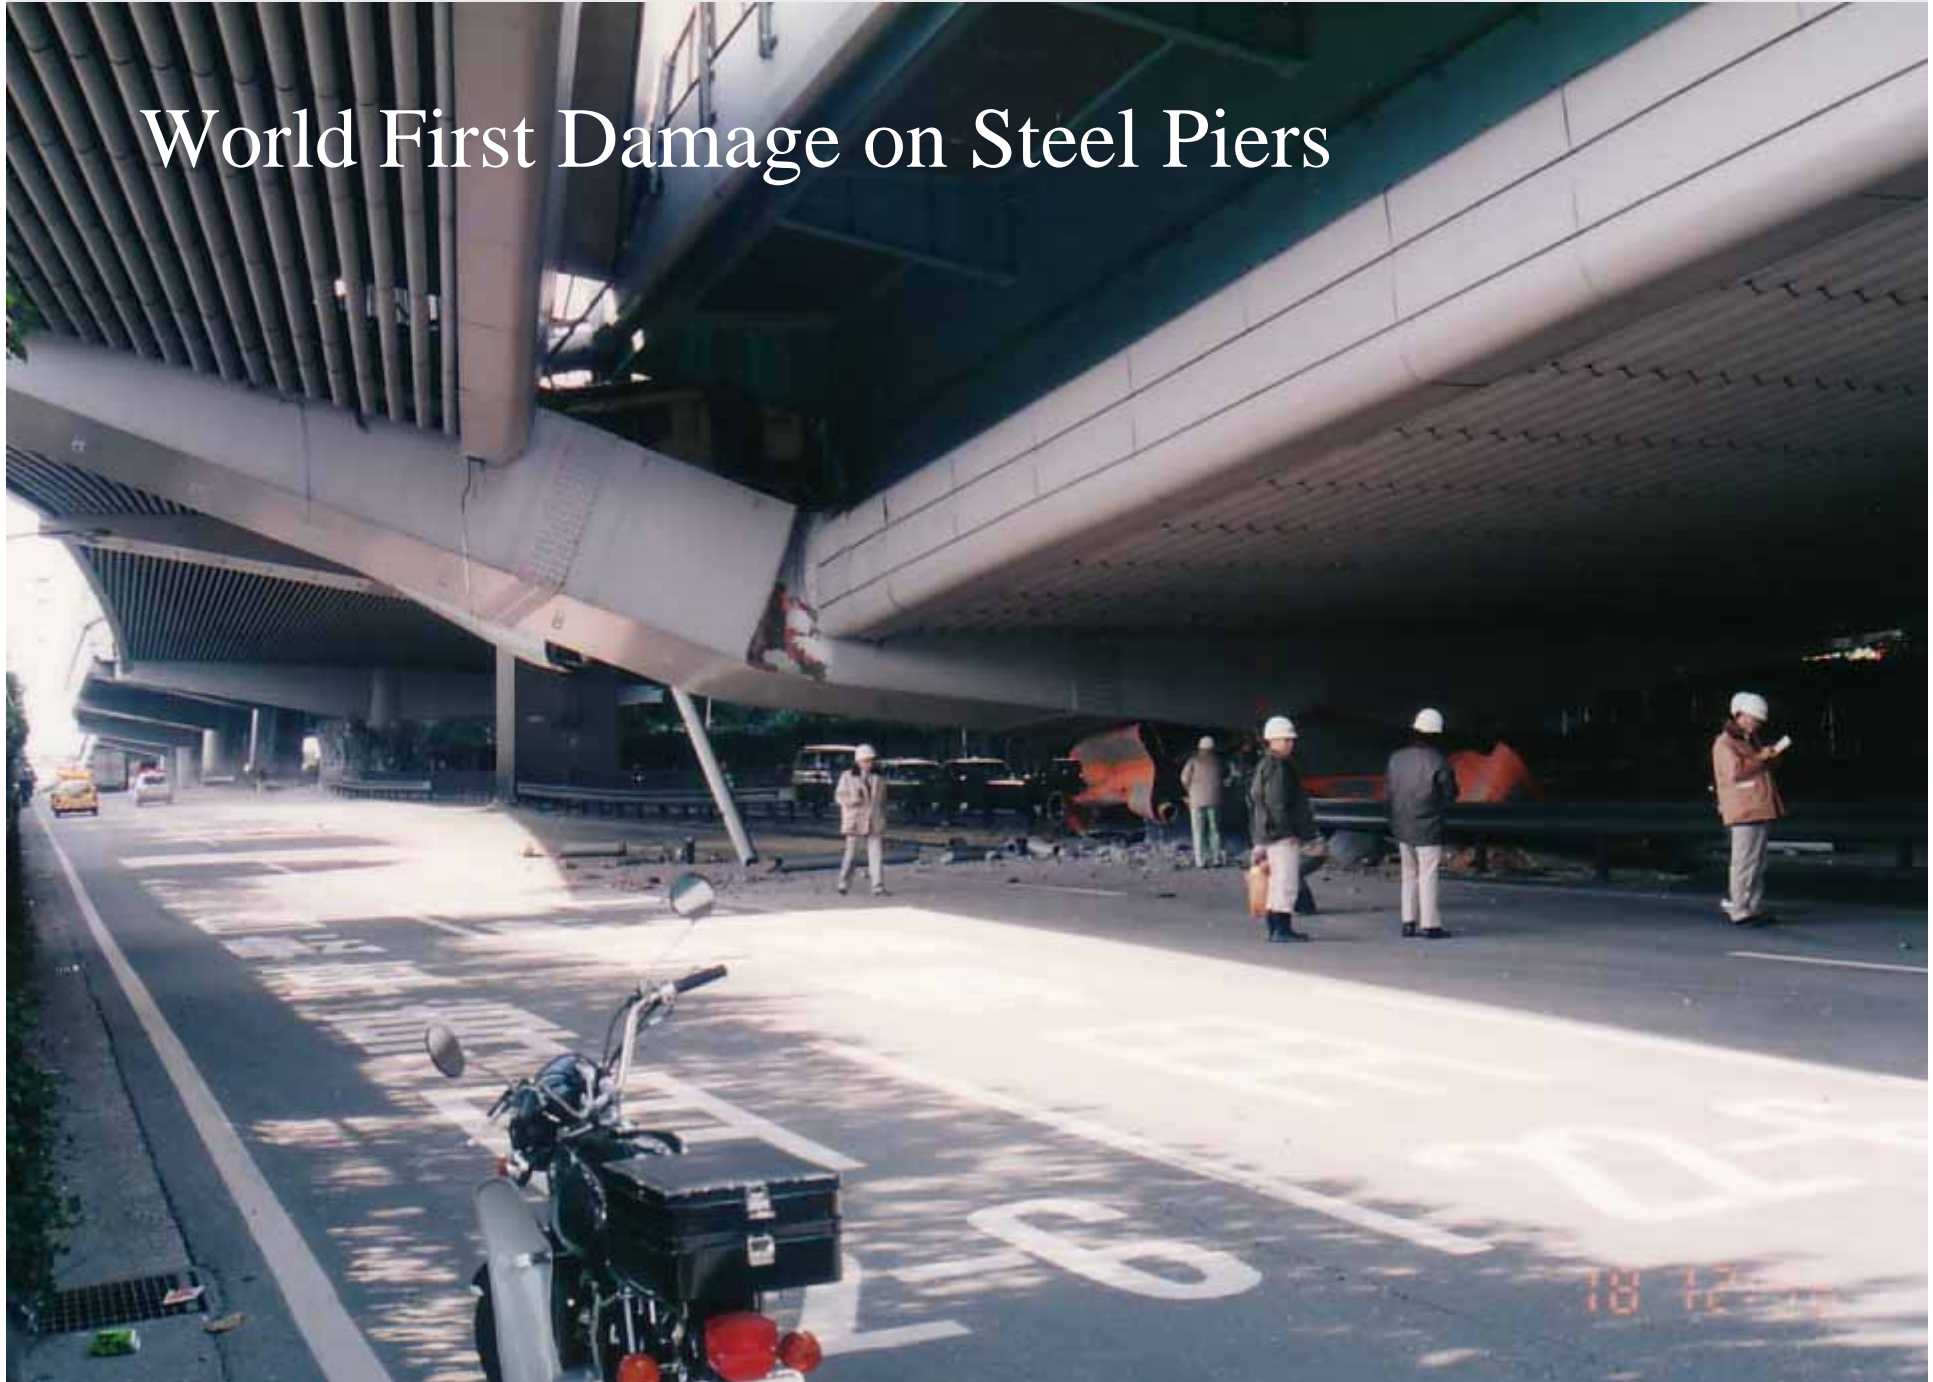
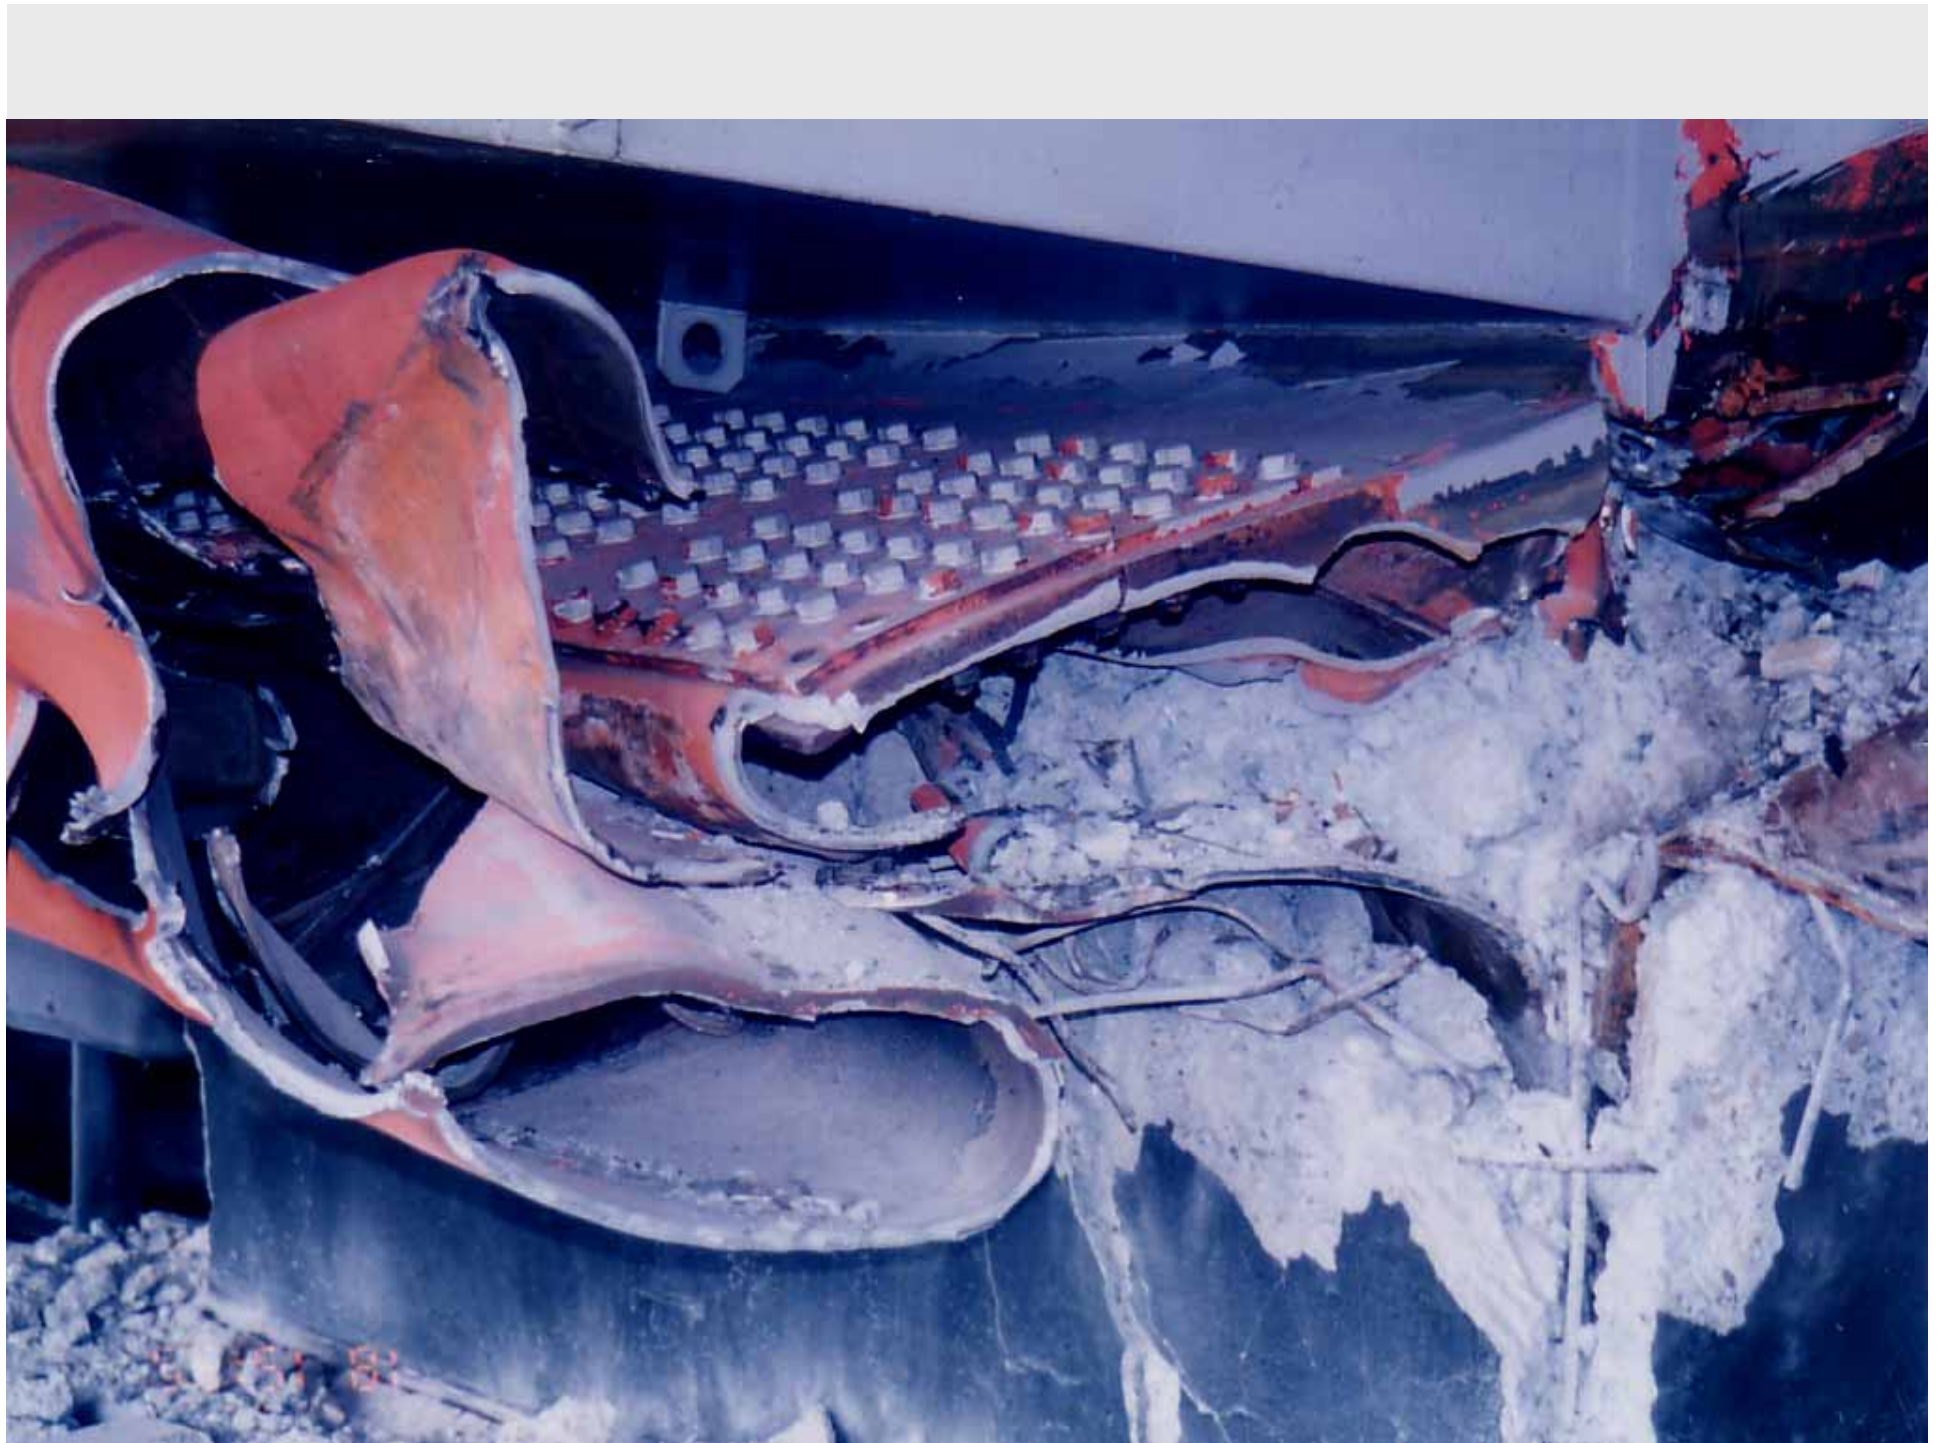
Failure of Steel Piers

World First Damage on Steel Piers

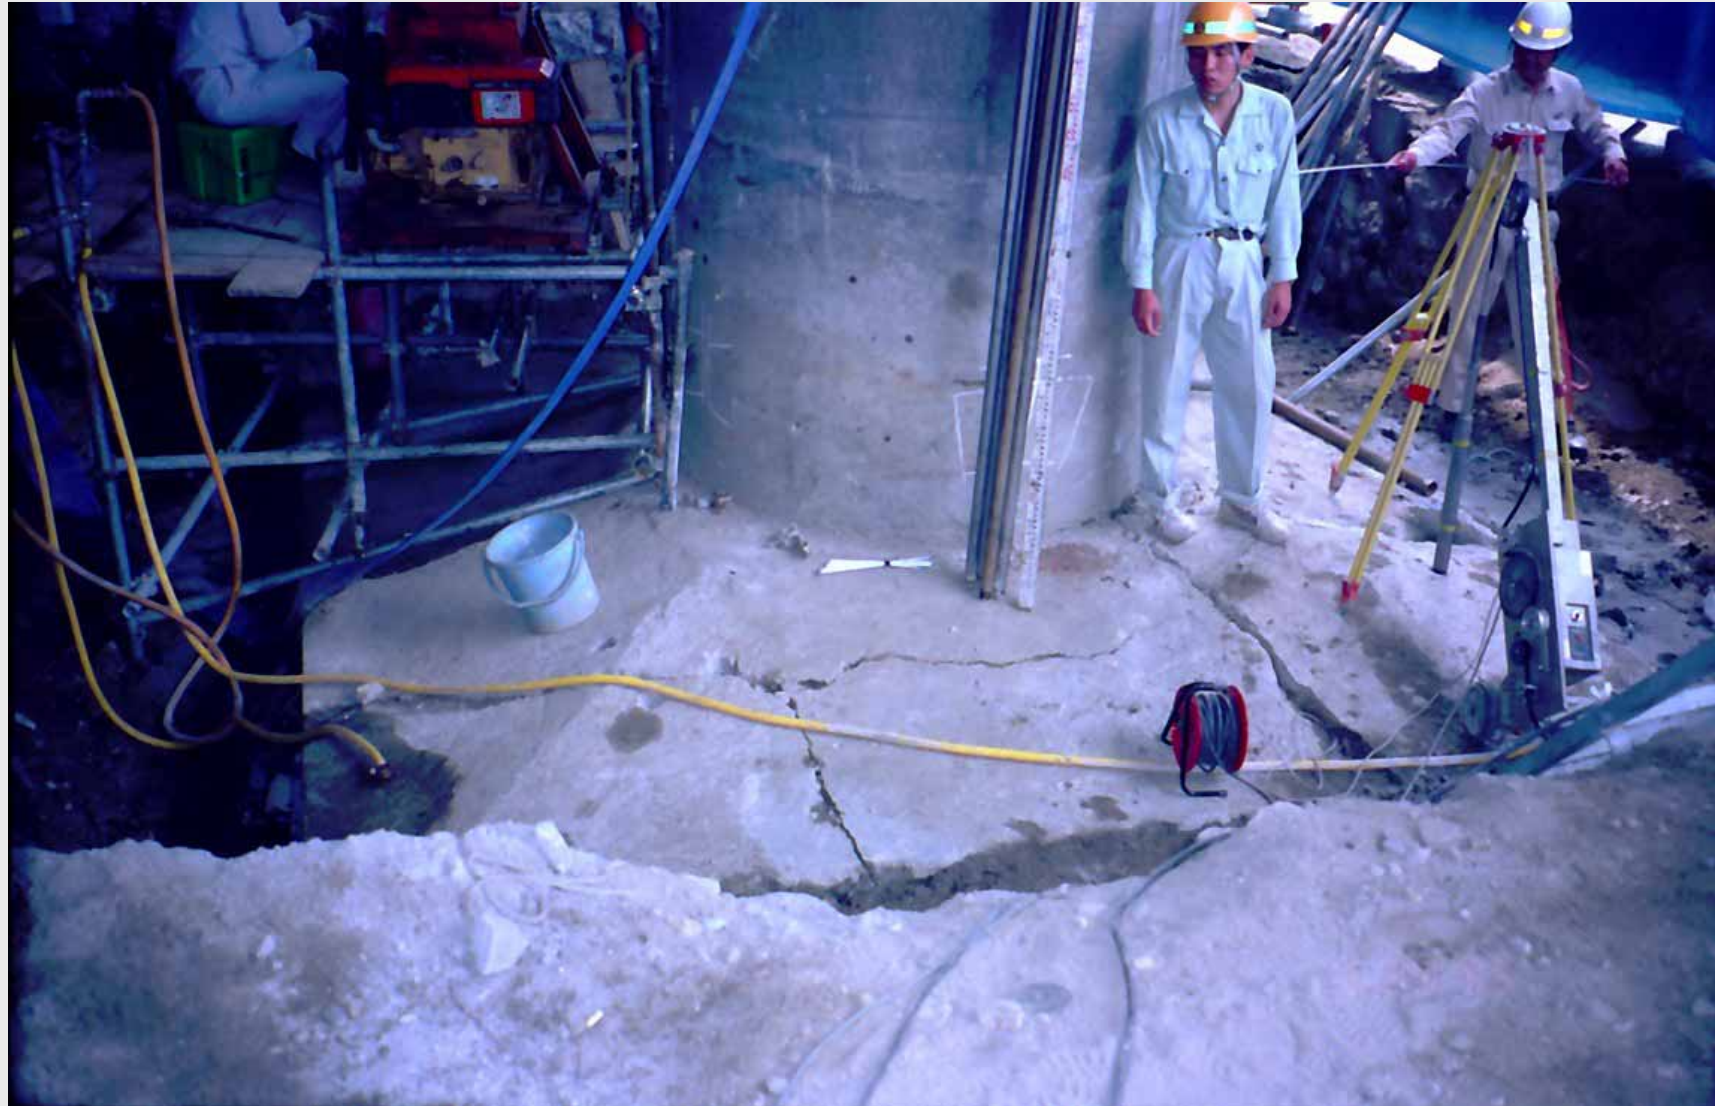
Damage of Foundations

Damage of foundations was less, but none
