(1) Seismic Damage of Urban Infrastructures in Past Earthquakes

Kazuhiko Kawashima
Department of Civil Engineering
Tokyo Institute of Technology

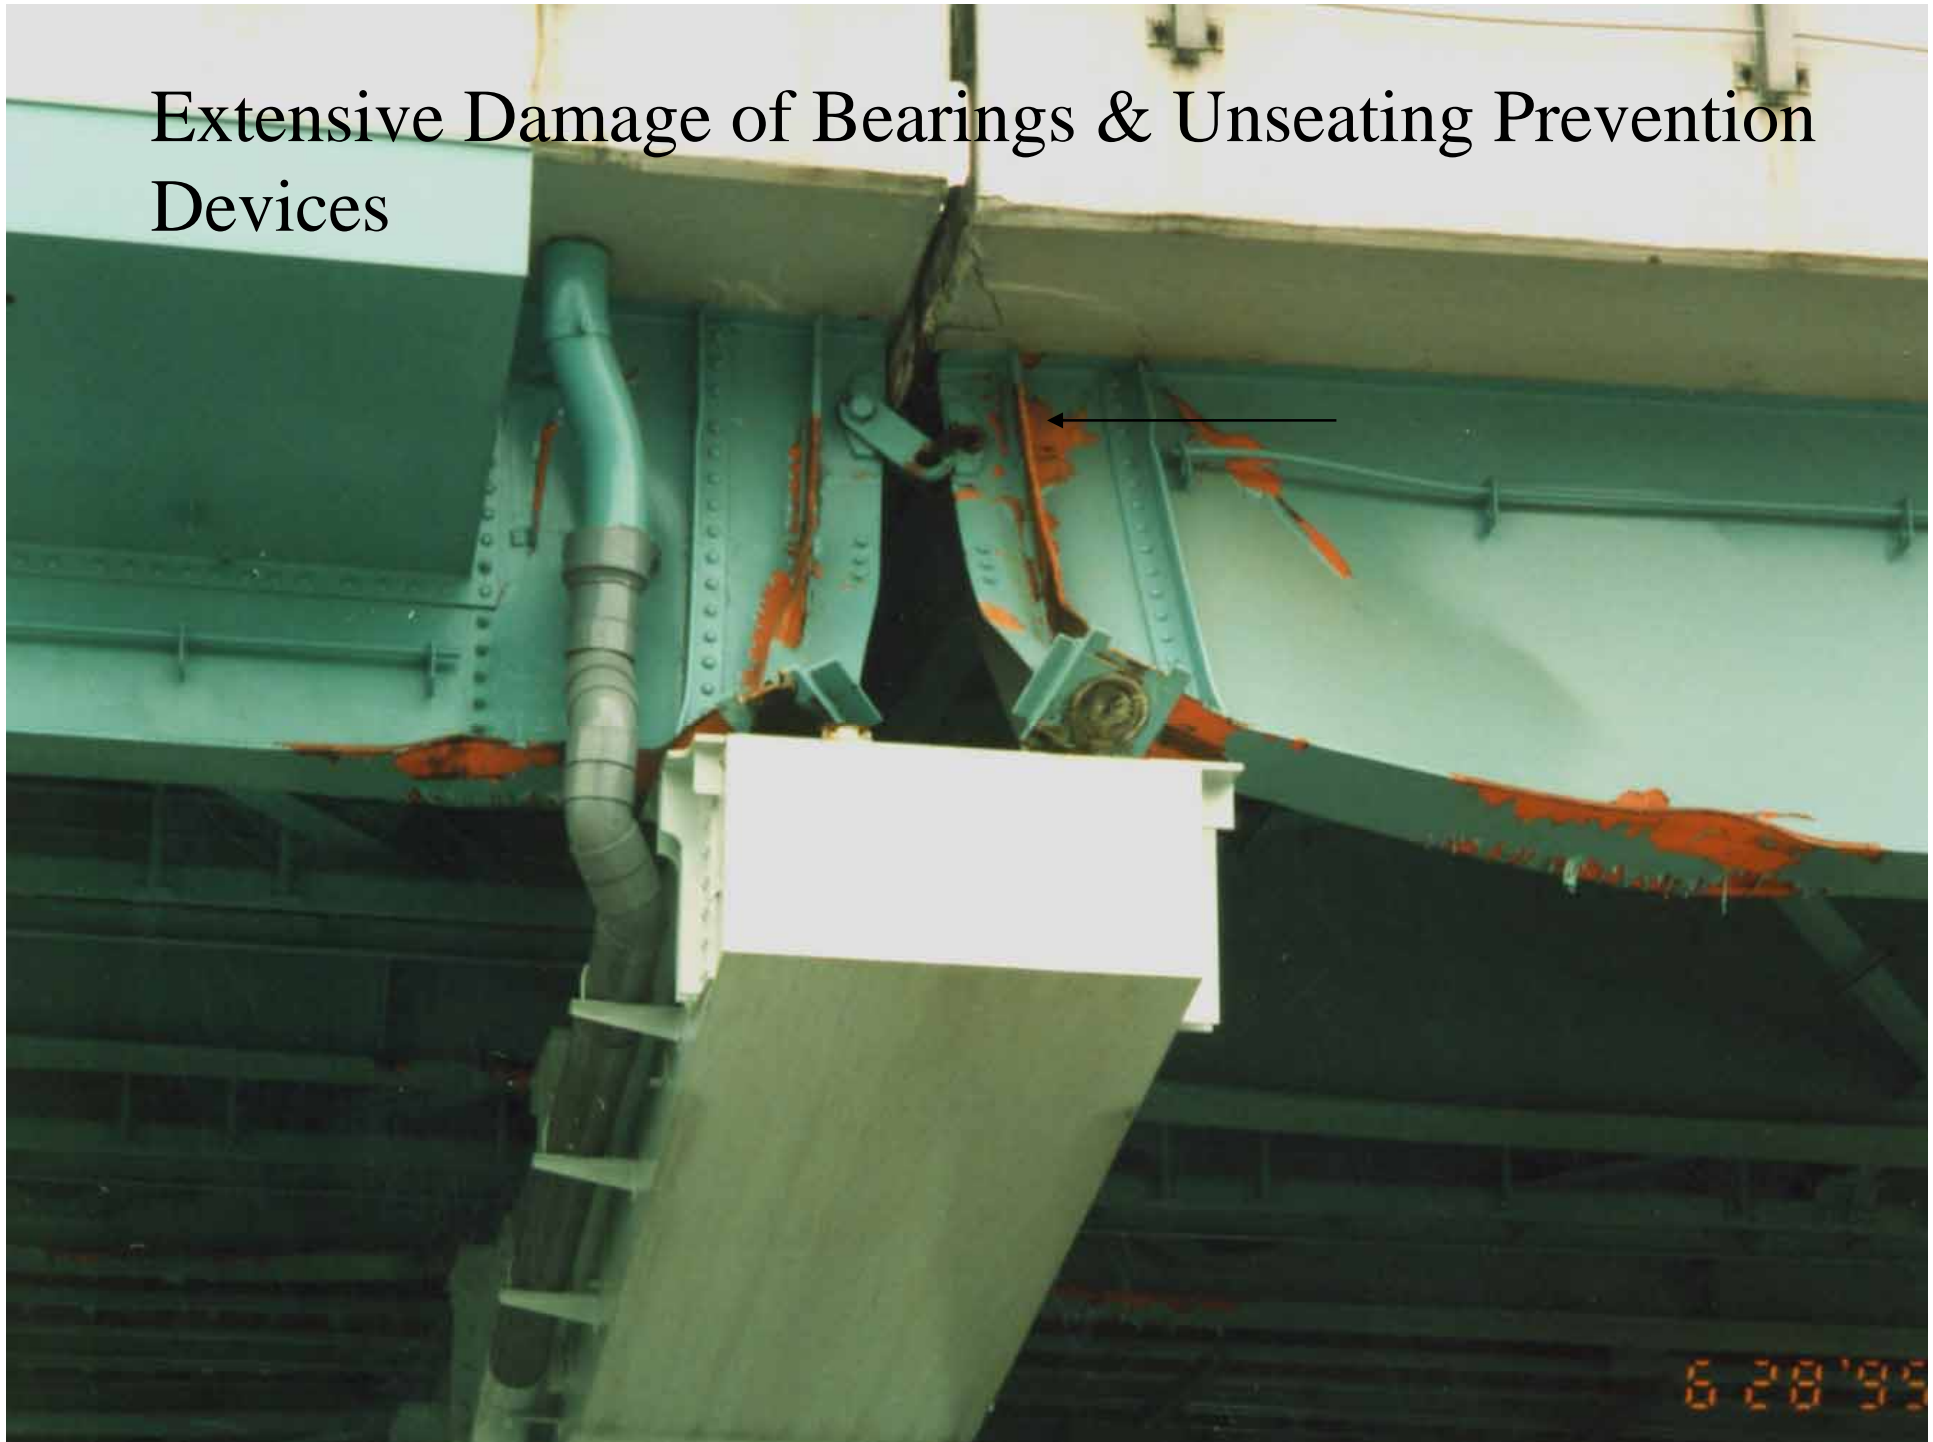
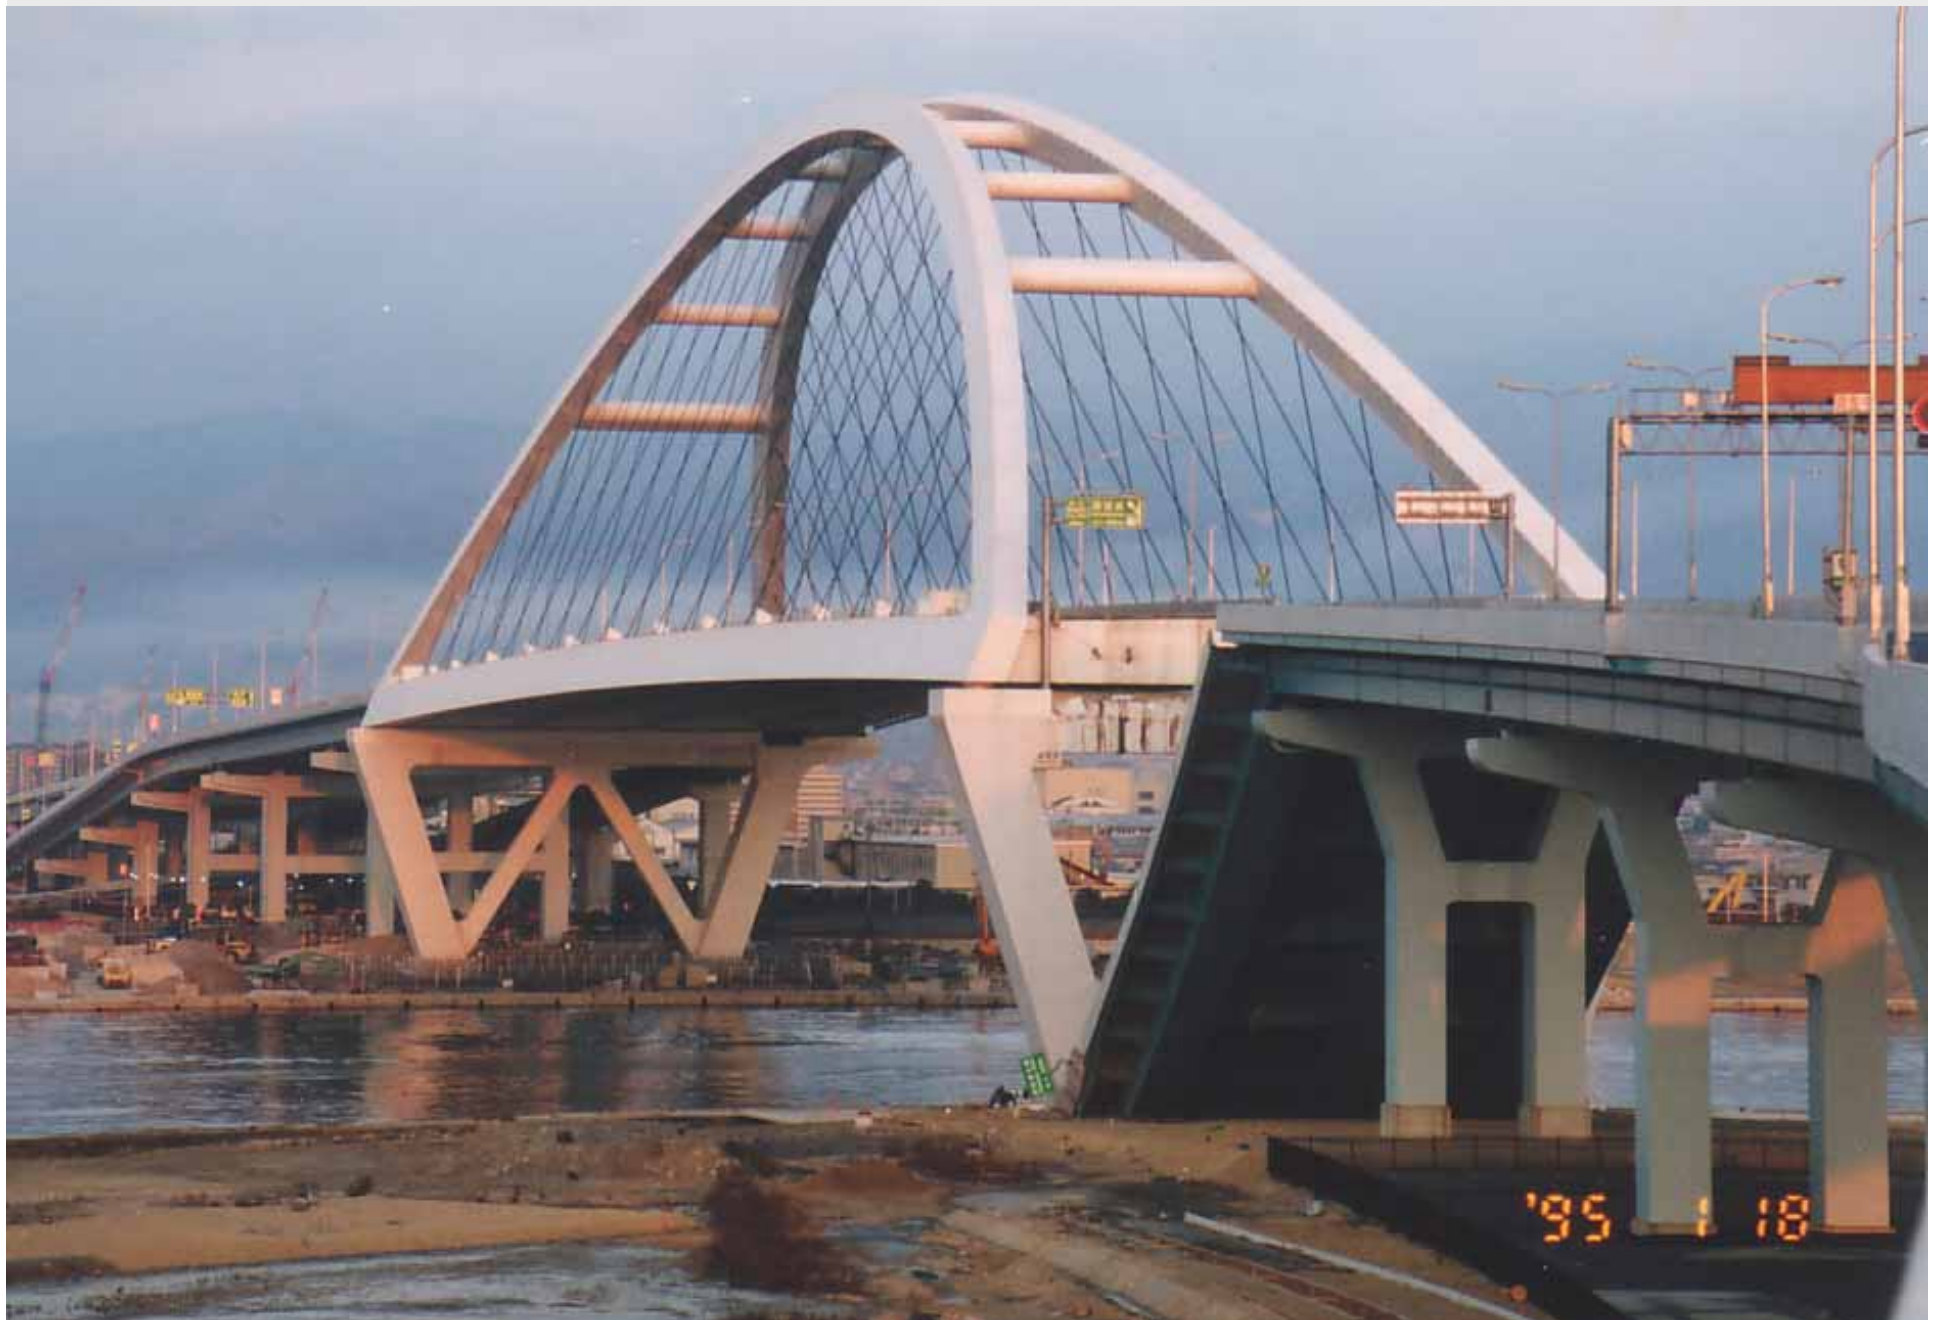
Extensive Damage of Bearings & Unseating Prevention Devices

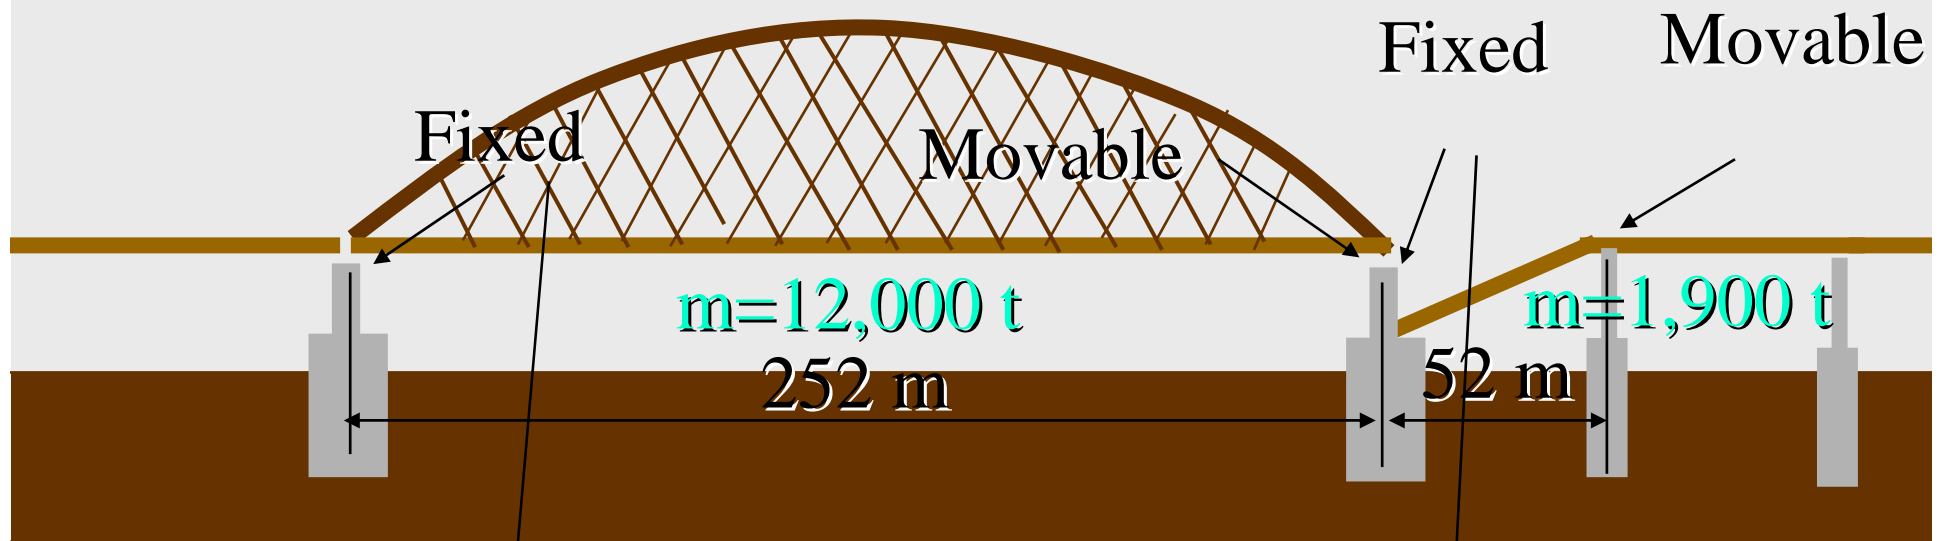
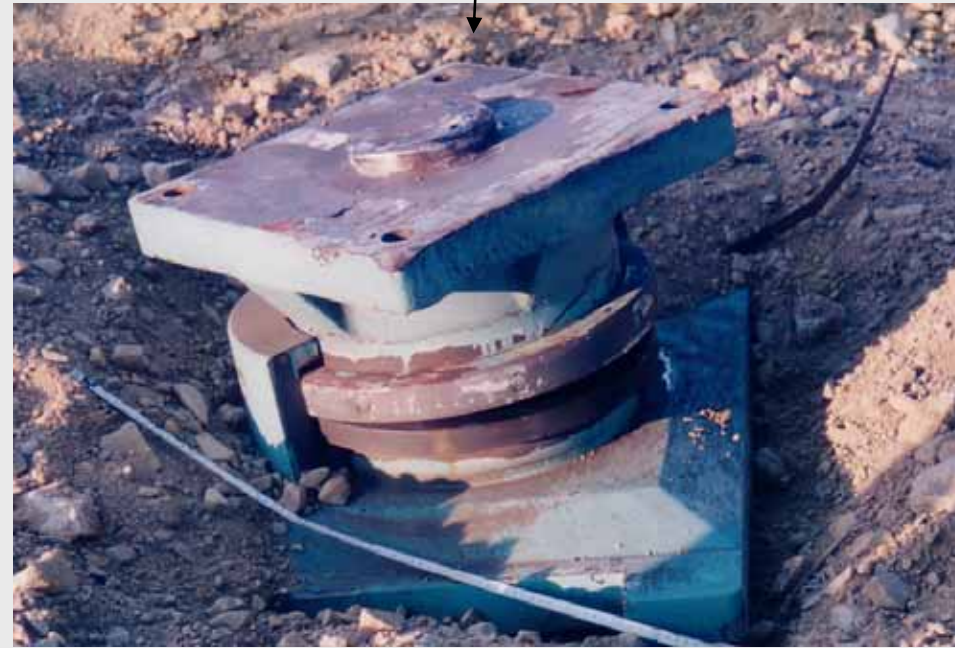
Collapse of an Approaching Span

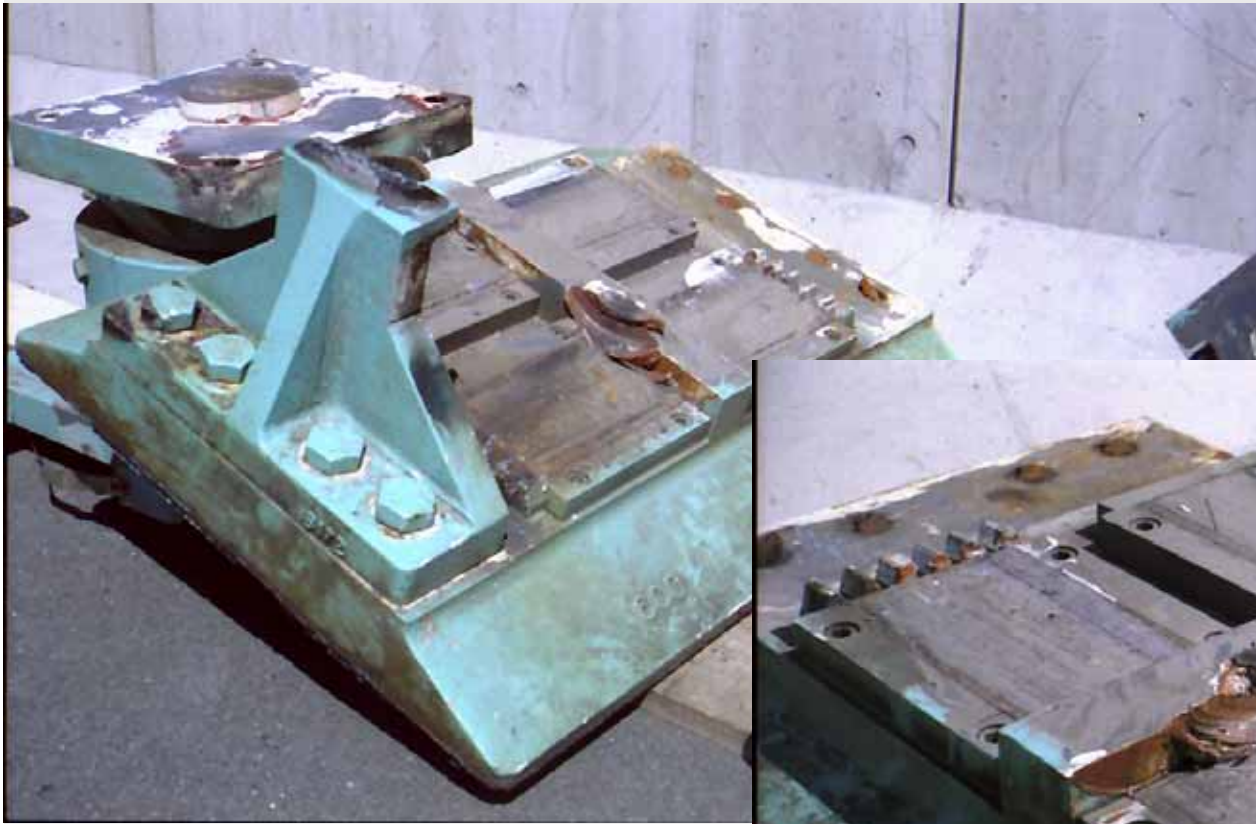
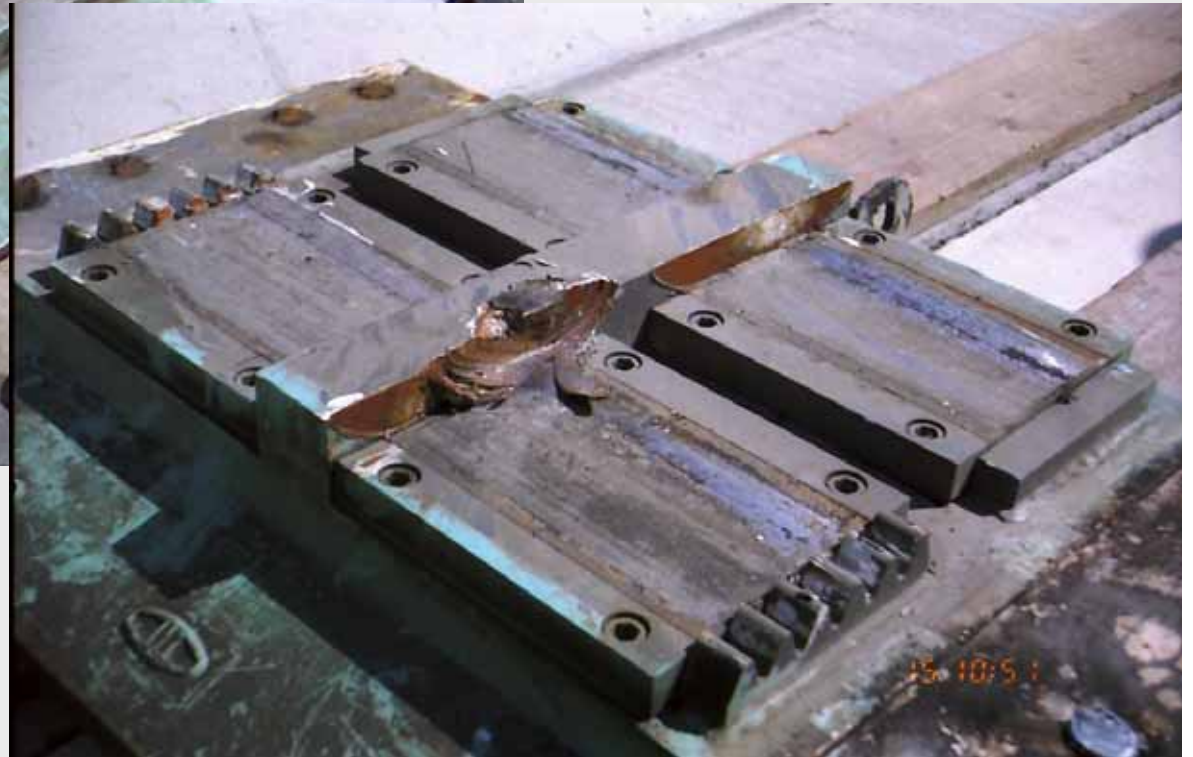
Vulnerable Steel Pin & Roller Bearings

- It was recommended in the 1995 & 1996 codes that elastomeric bearings including LRB and HDR should be used.
- Steel bearings have the following deficiencies:
 - ✓ Insufficient strength and weak for shock
 - ✓ Structures with insufficient lateral and vertical capacity
 - ✓ Insufficient length of movement
- As a consequence, about 98% of the total bearing was steel bearing before 1995, but 90% is now elastomeric bearings.

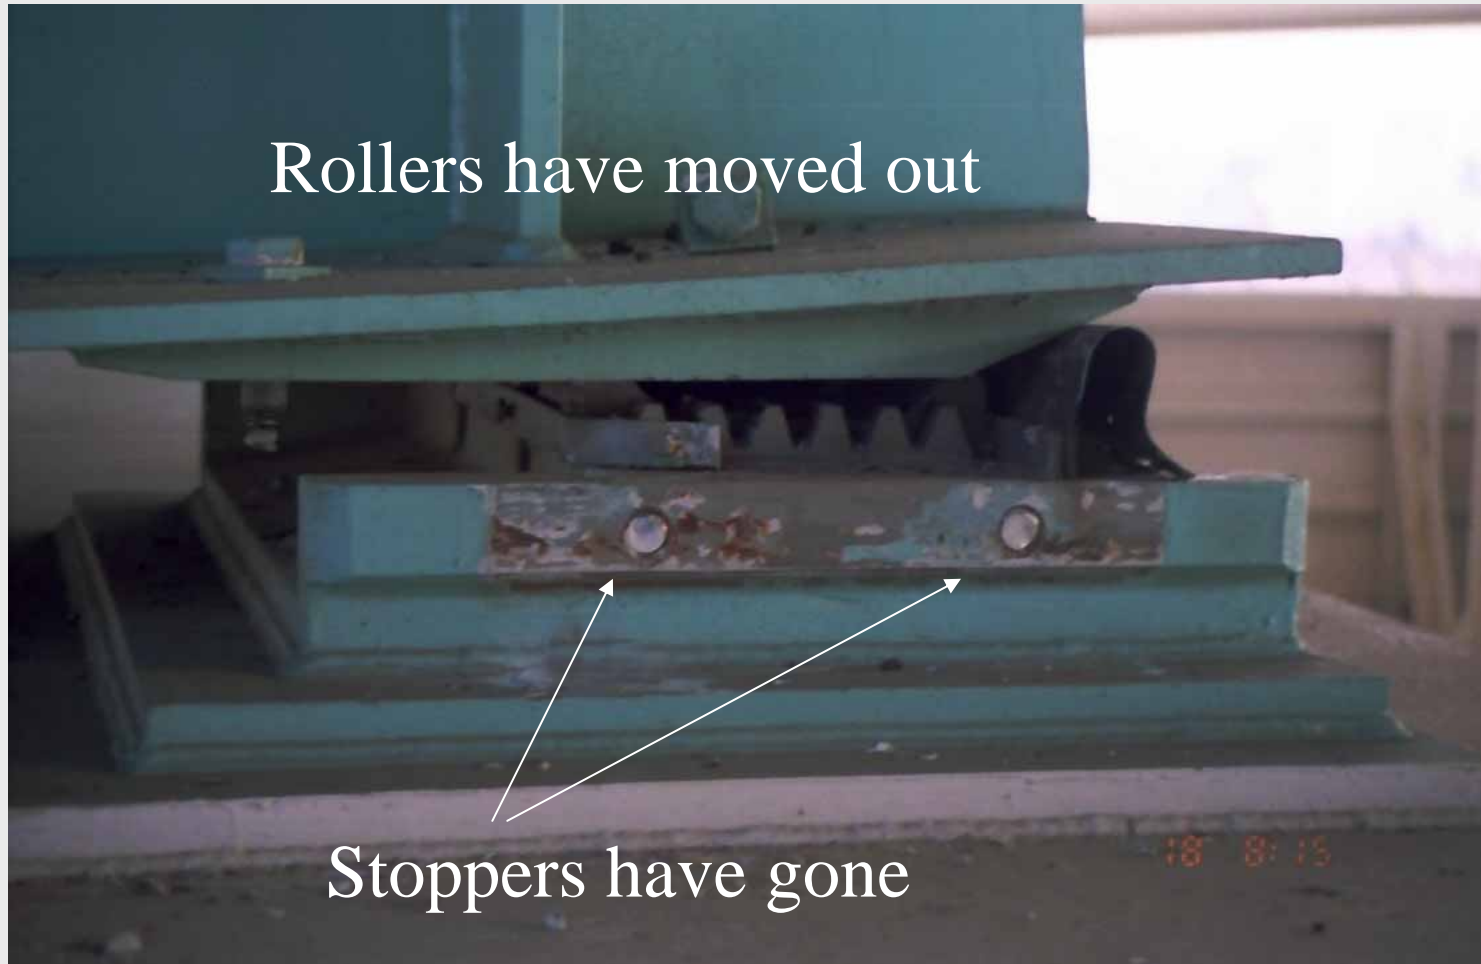
Vulnerable Steel Roller Bearings

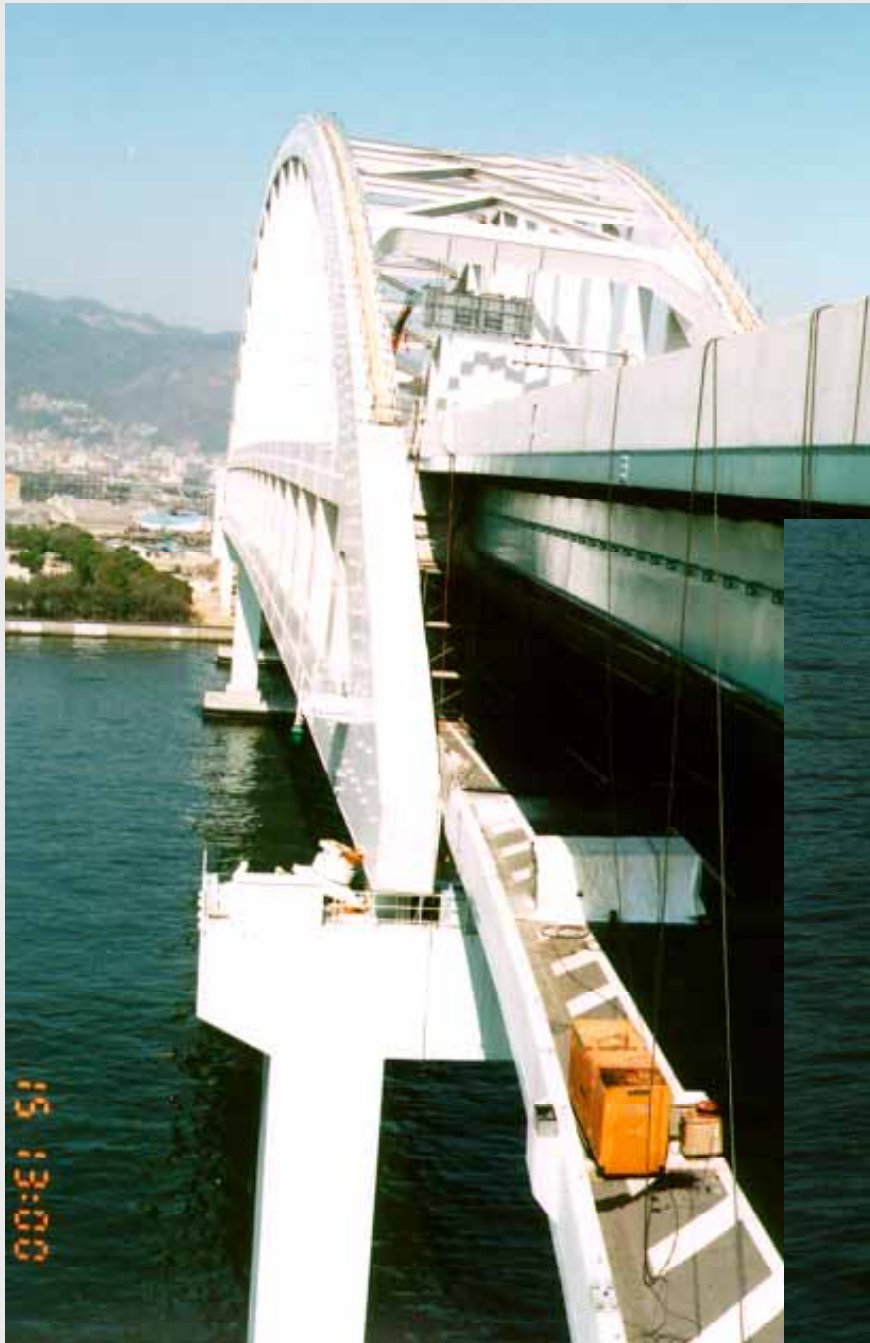
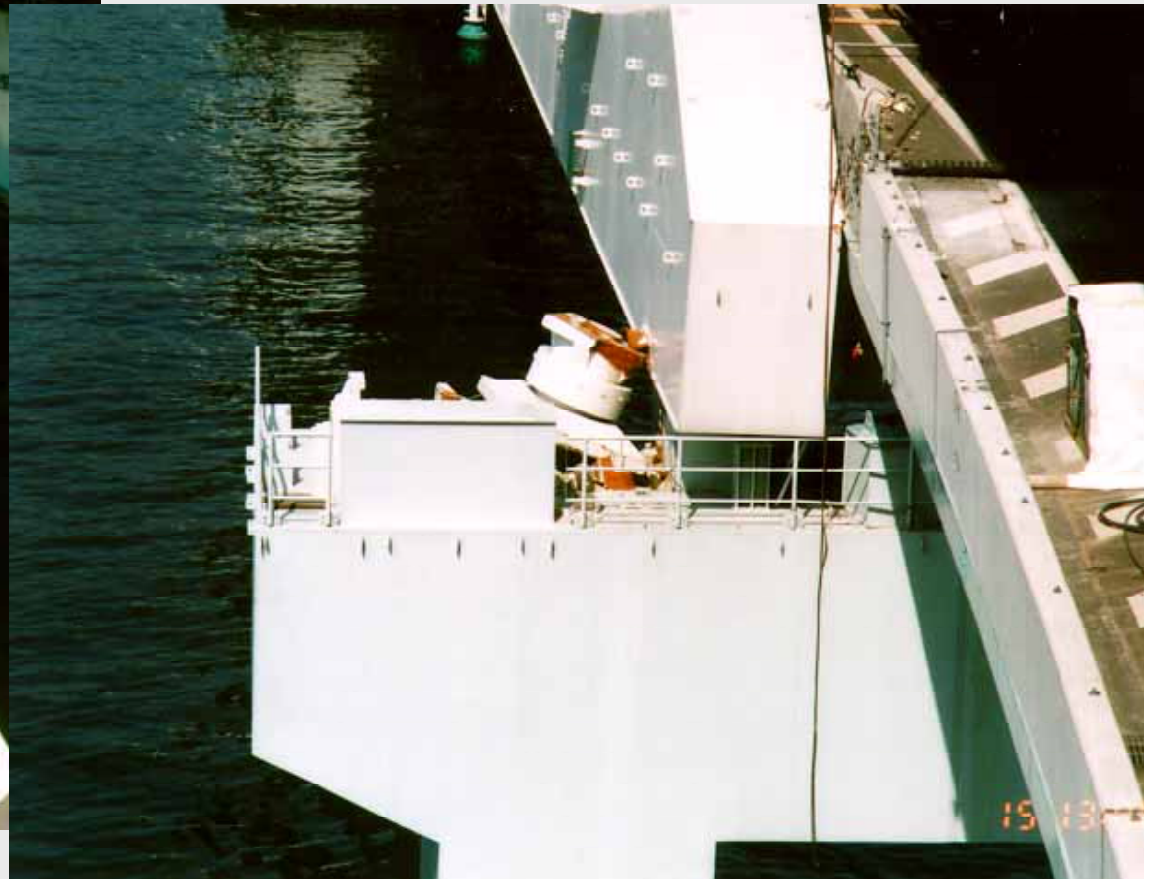
Failure of Steel Bearings

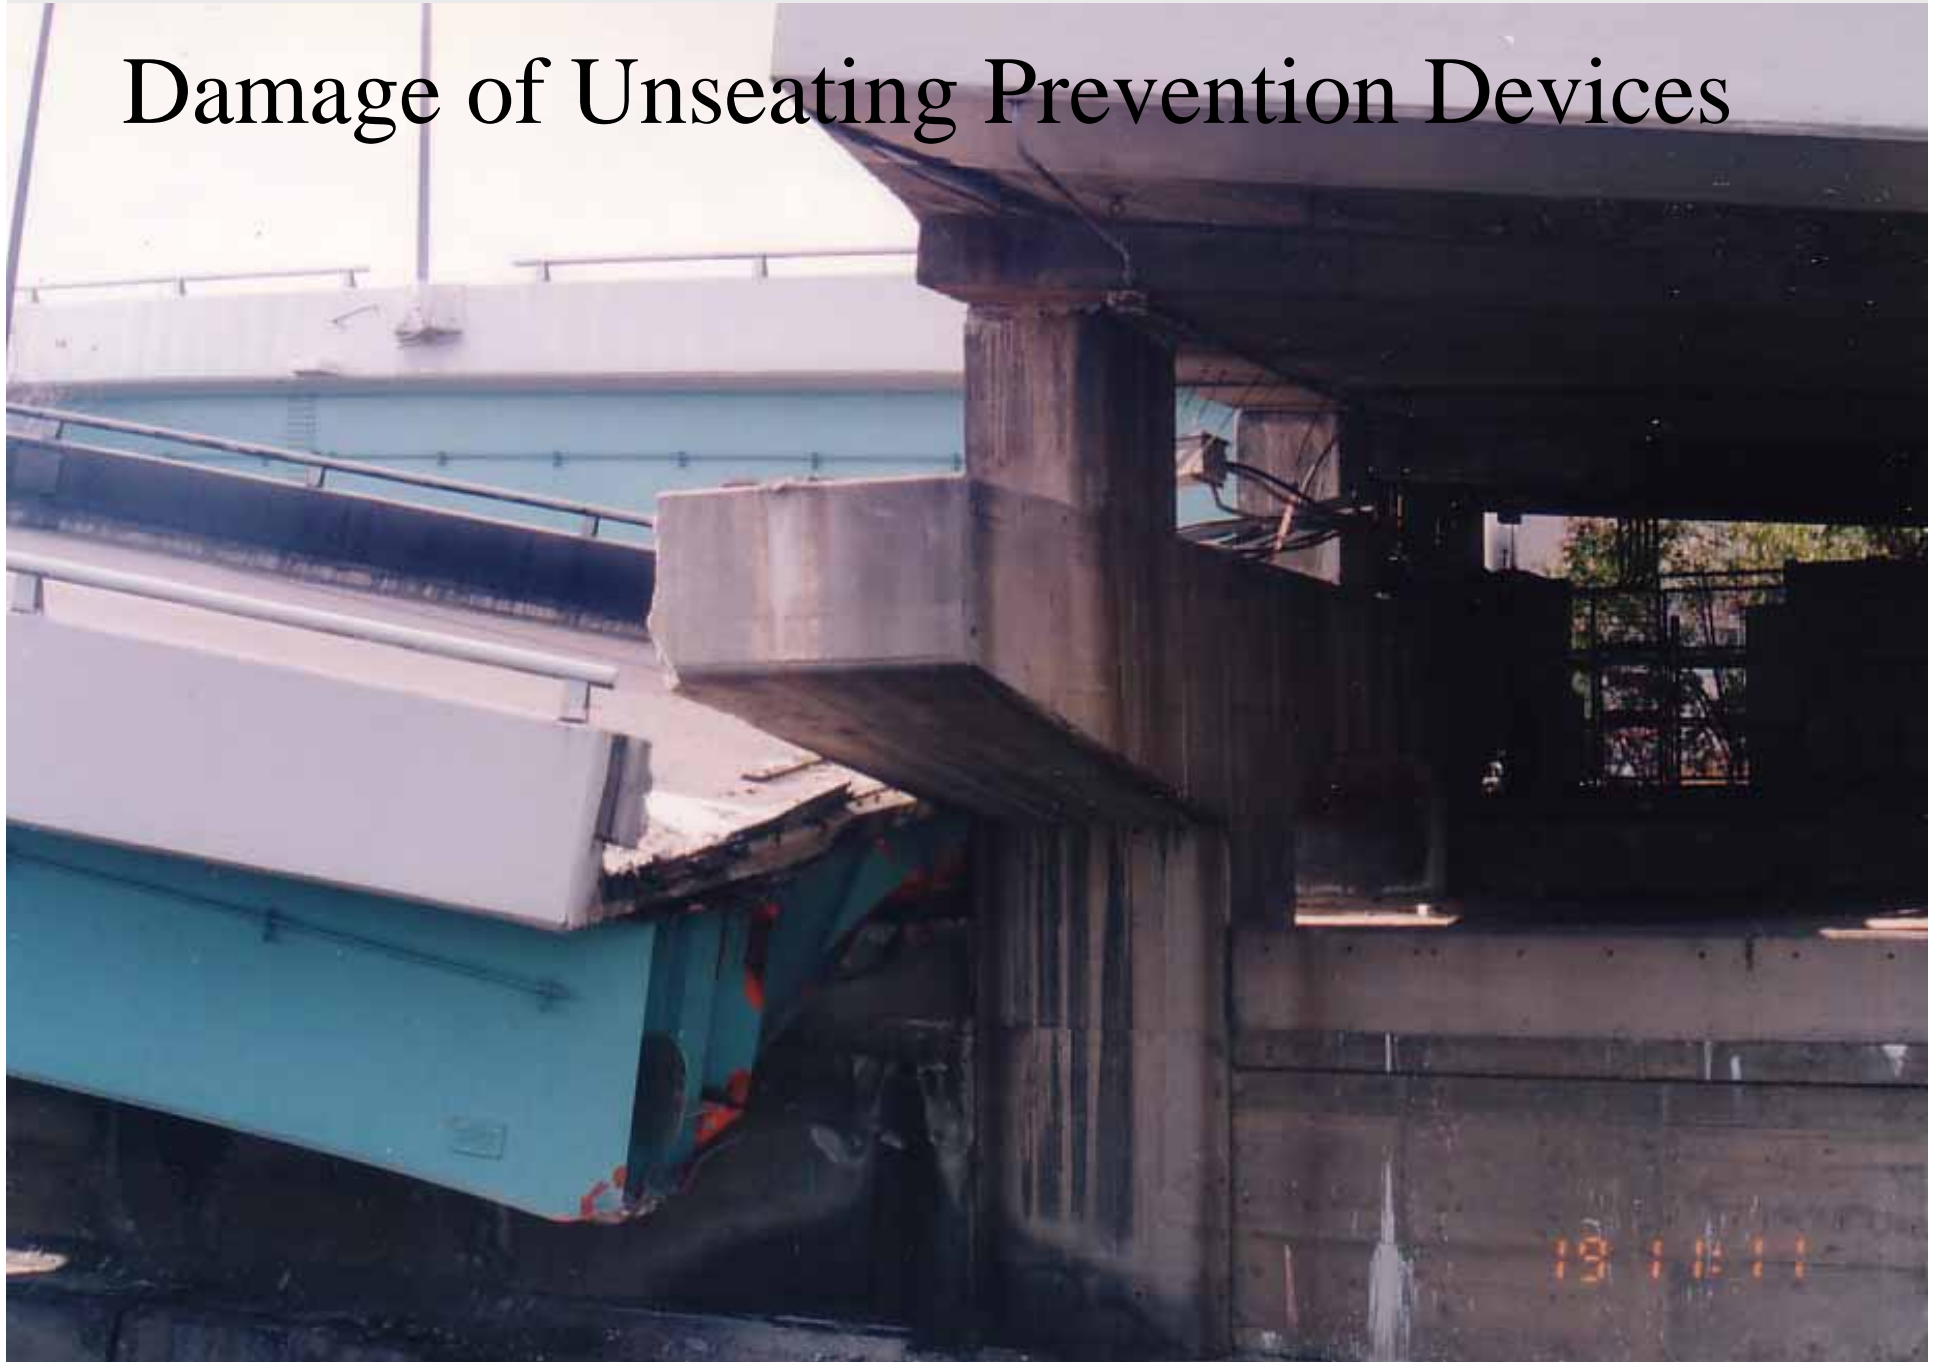
Damage of Unseating Prevention Devices

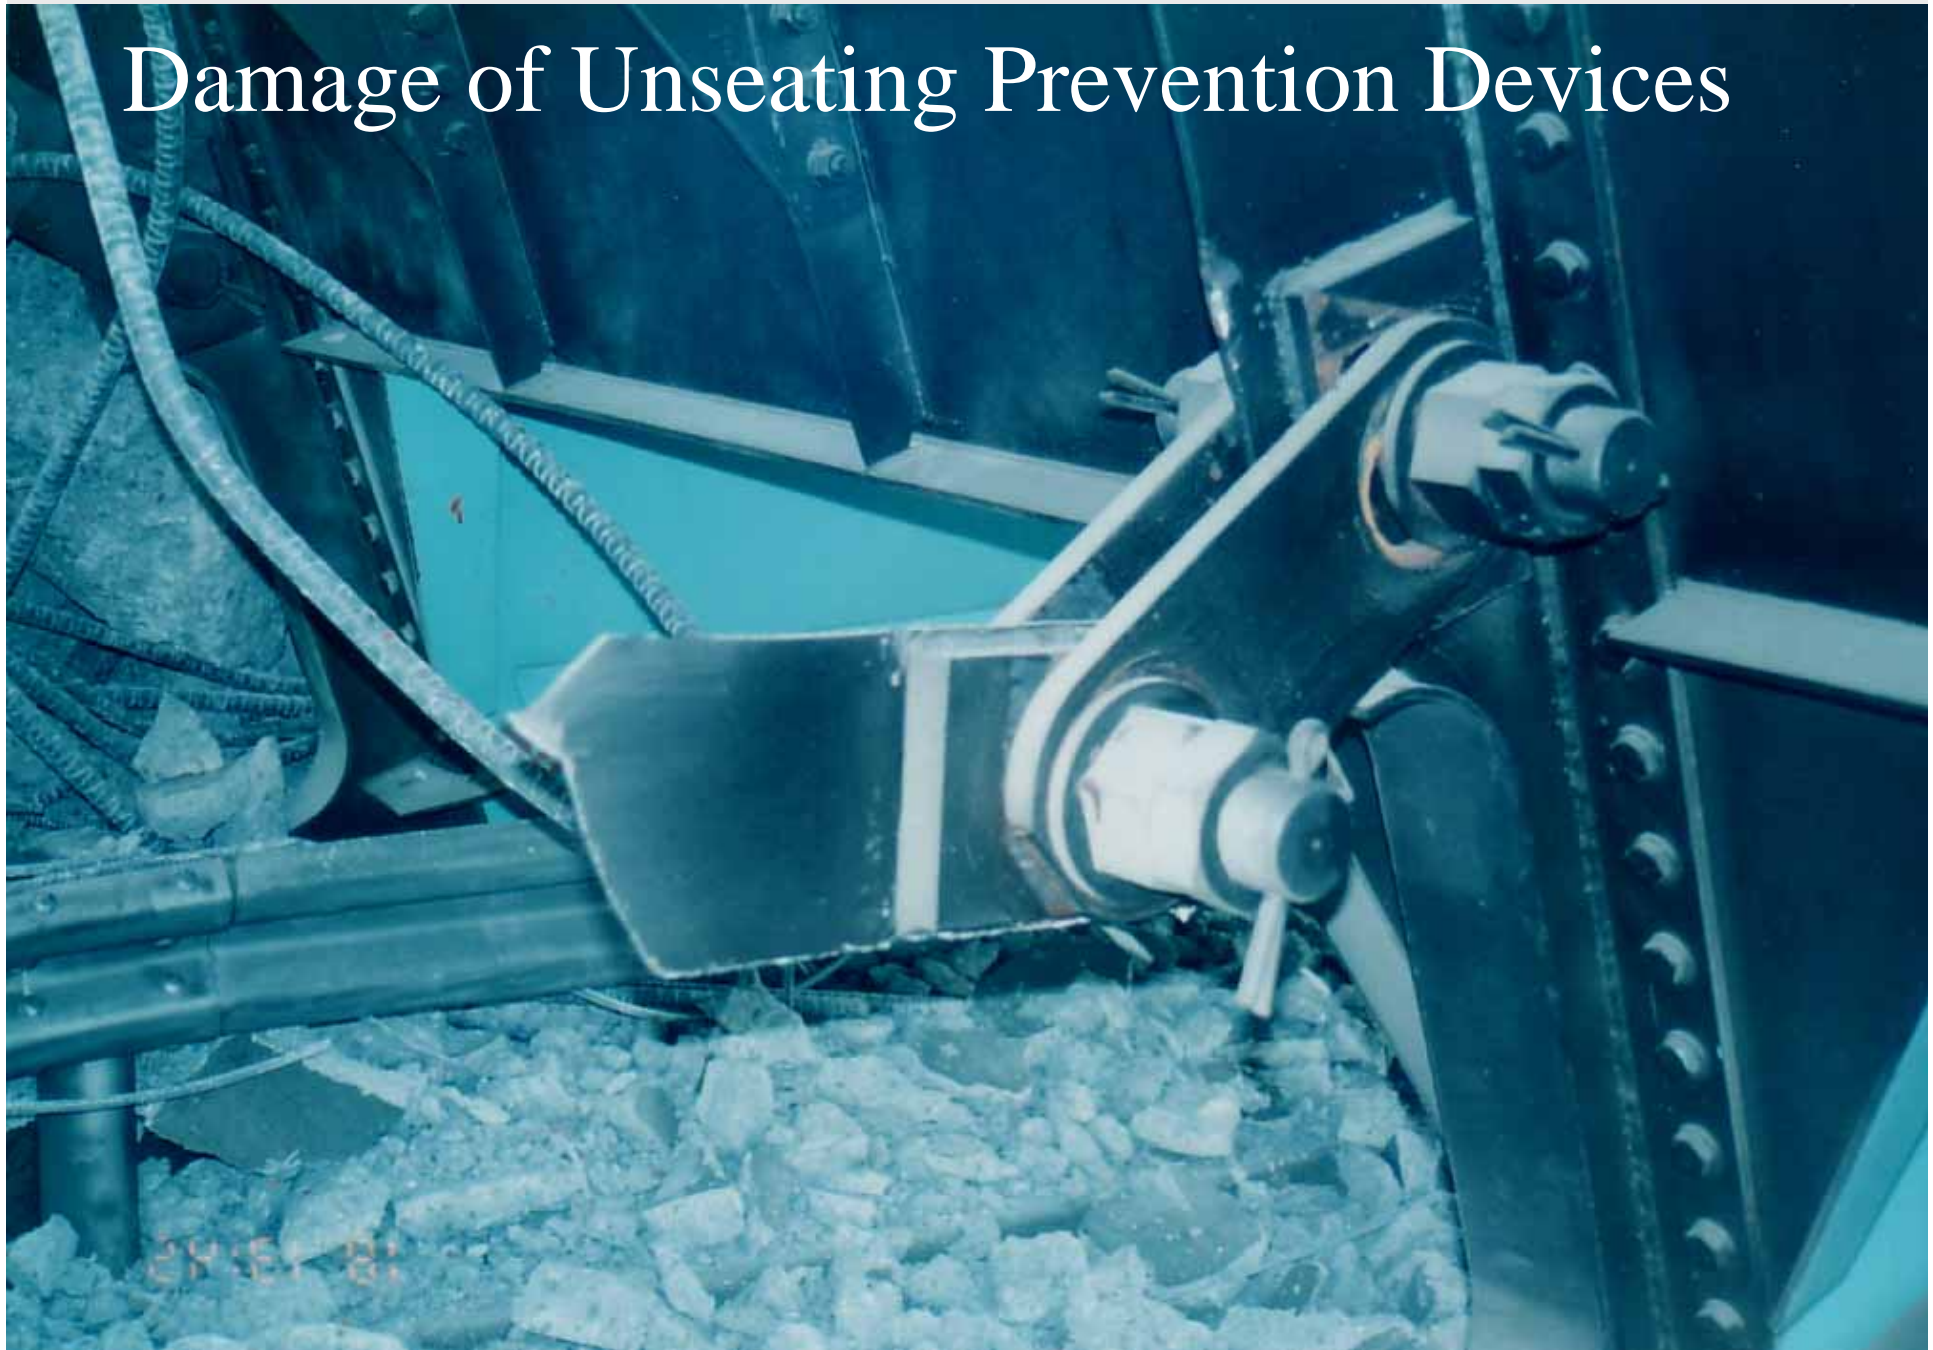
Damage of Unseating Prevention Devices

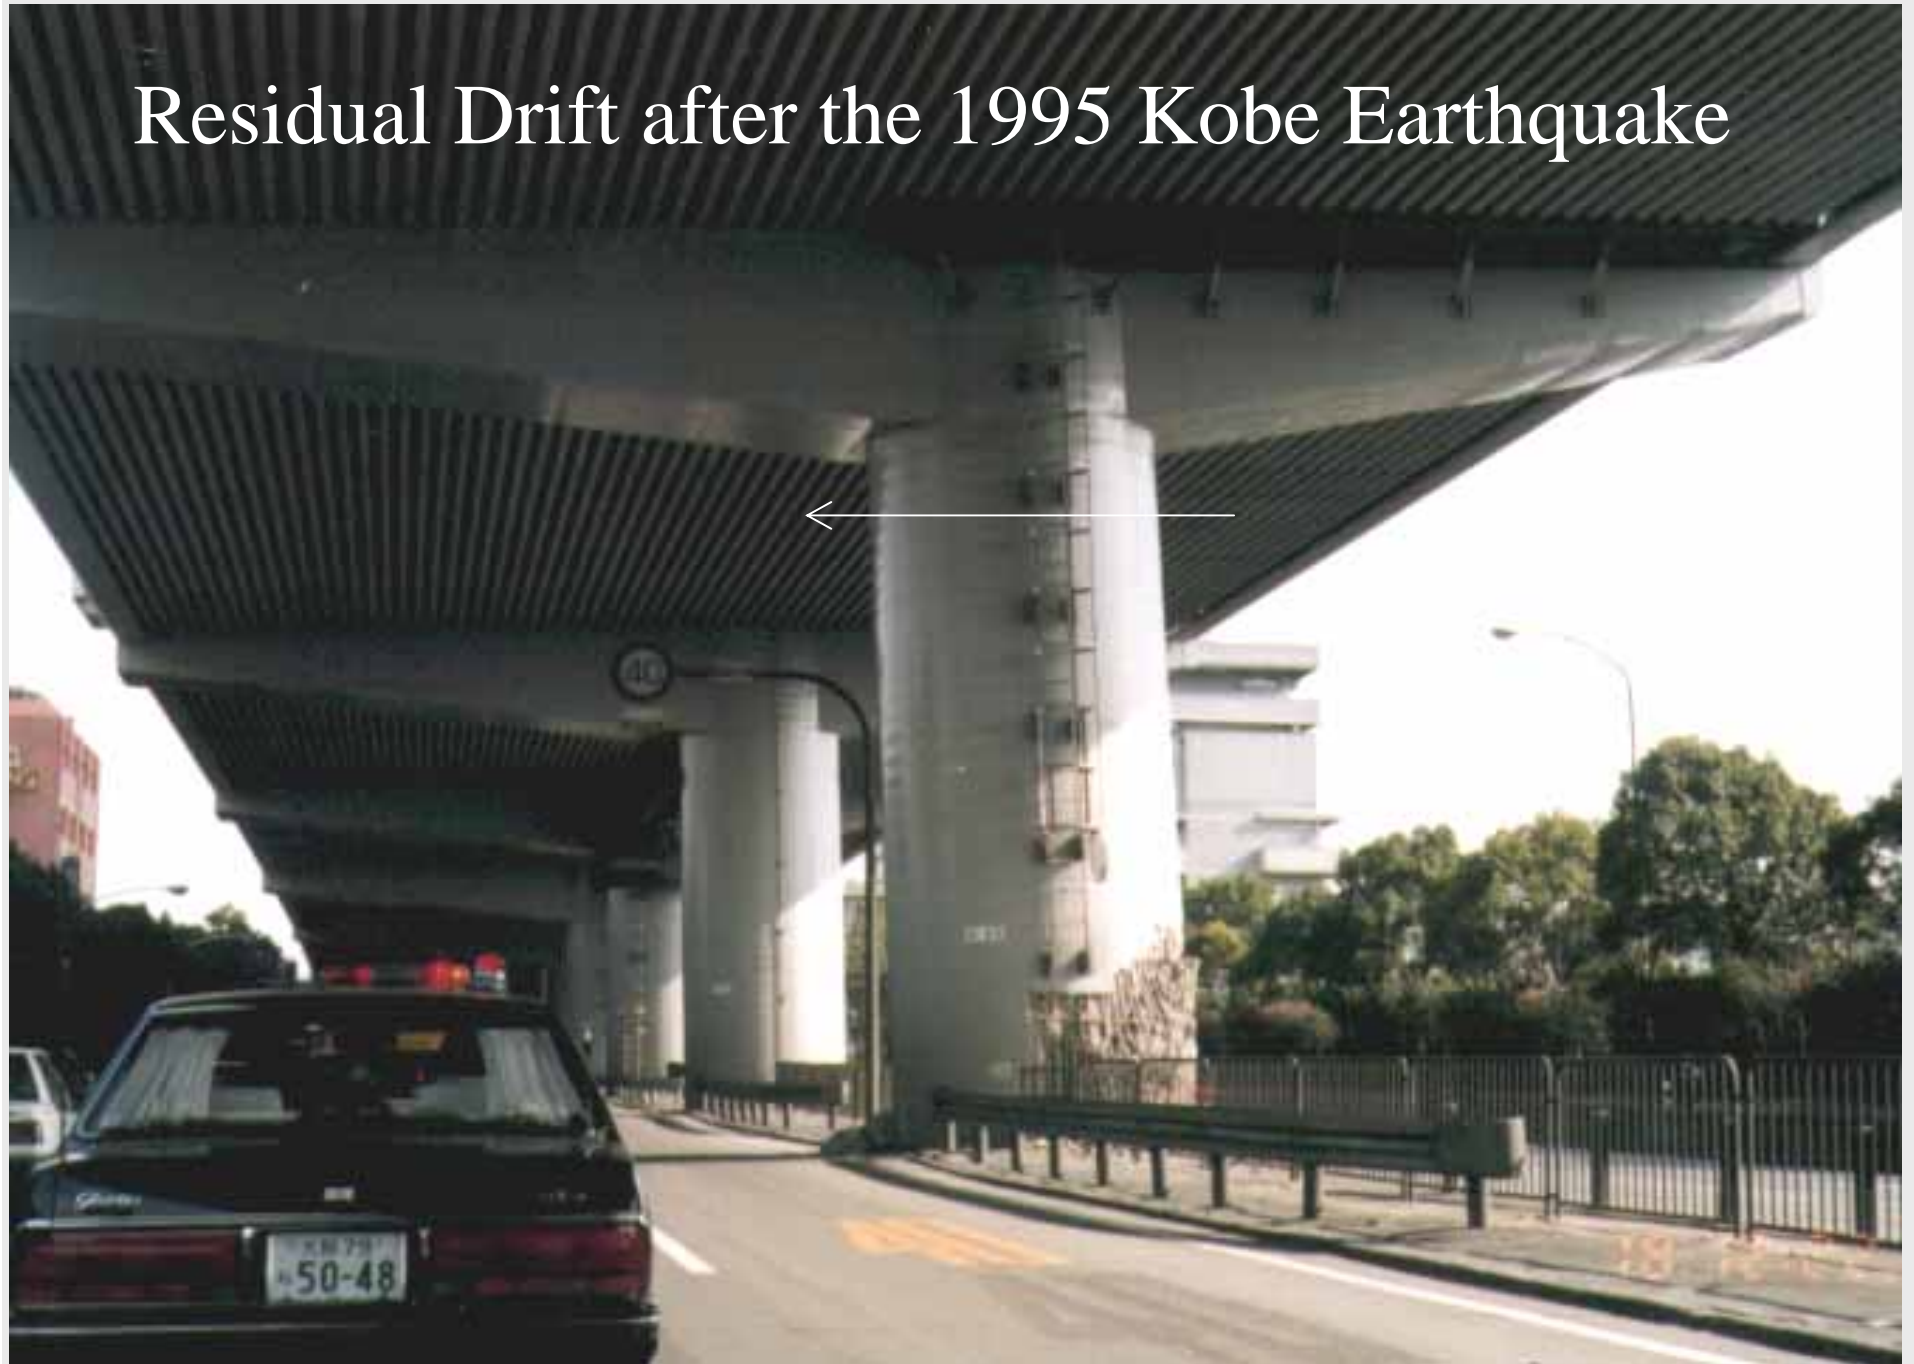
Residual Drift after the 1995 Kobe Earthquake

- A new provision was introduced for limiting residual tilt of columns after the 1995 Kobe earthquake. This was the first provision for the residual tilt.
- Residual displacement response spectra were used to formulate the provision as:

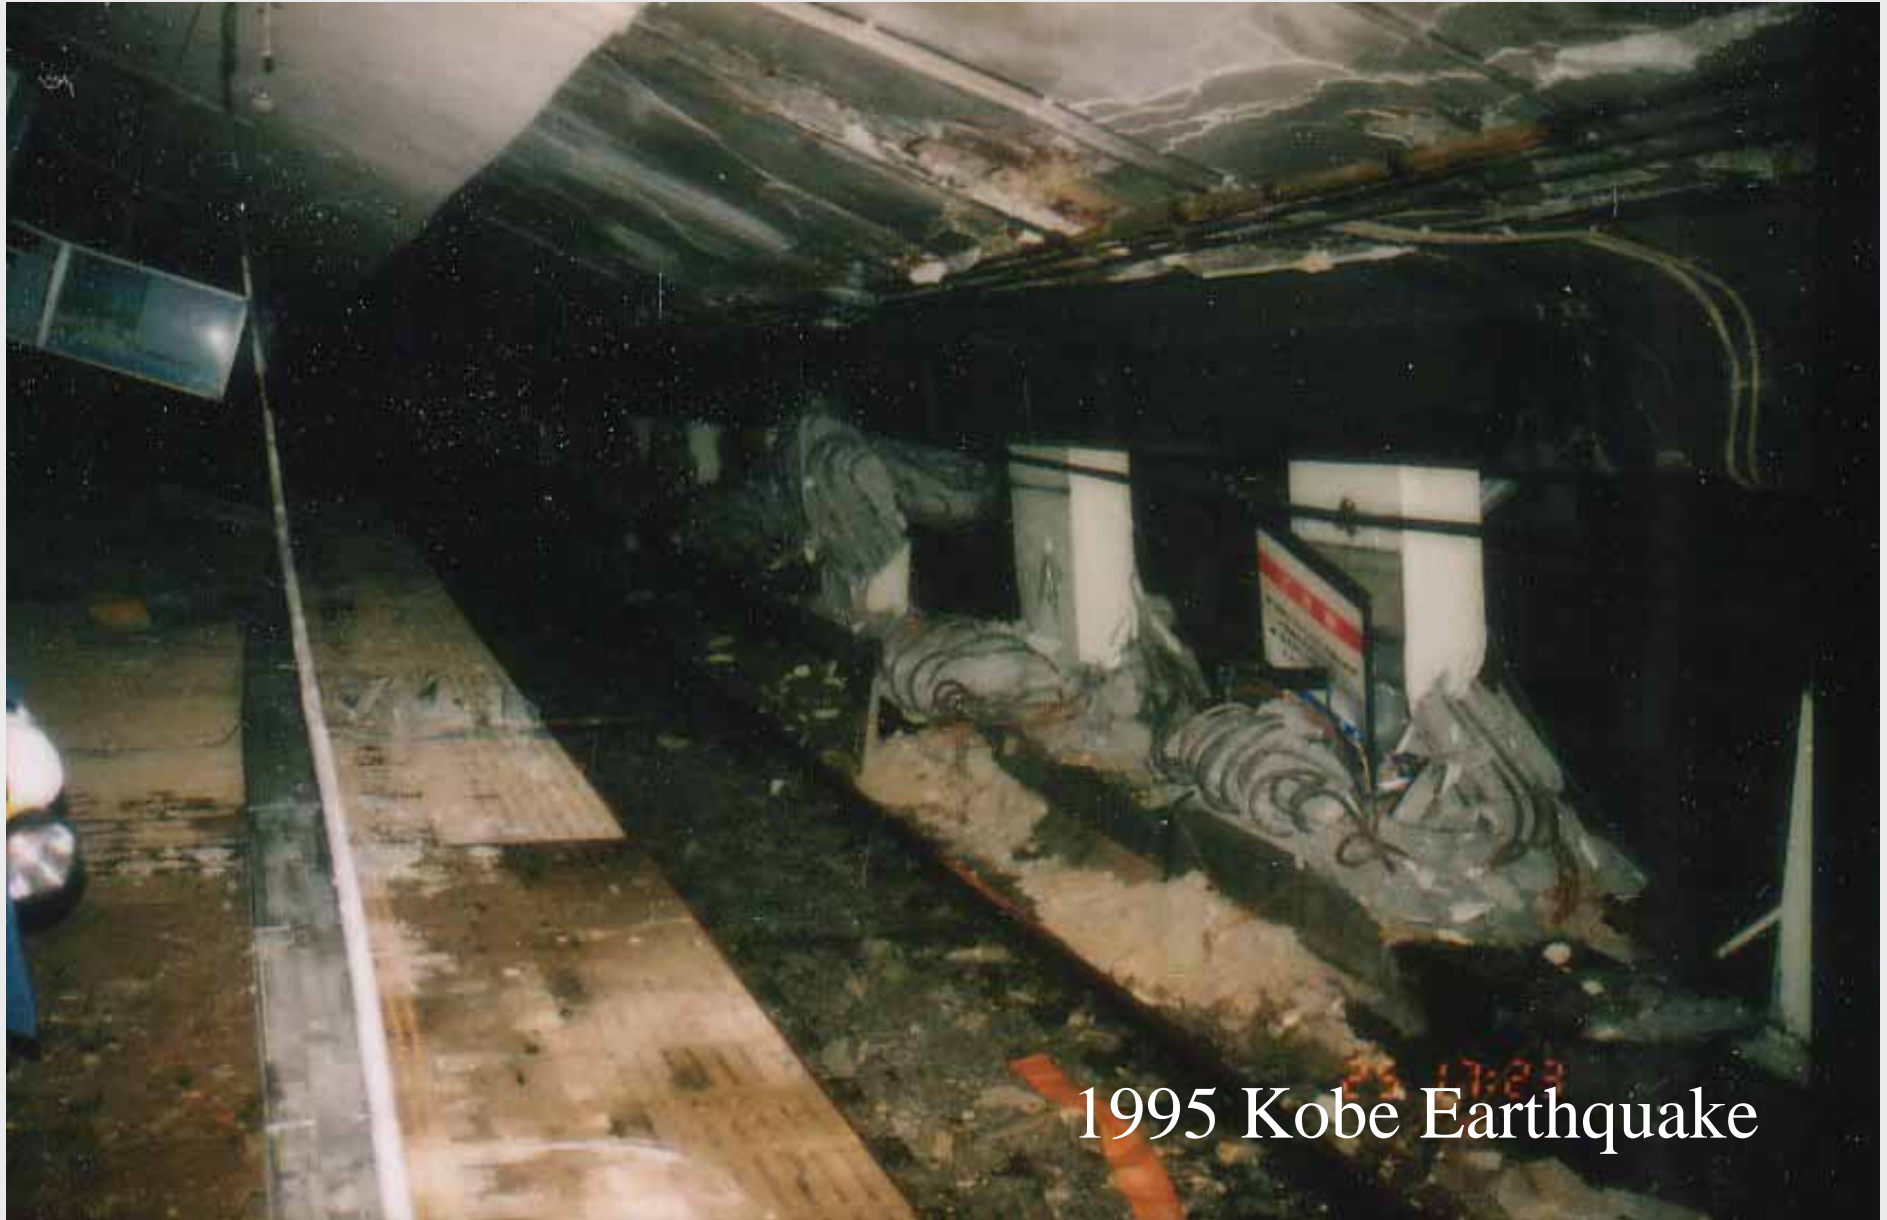
Failure of Subway Station
