(1) Seismic Damage of Urban Infrastructures in Past Earthquakes

Kazuhiko Kawashima
Department of Civil Engineering
Tokyo Institute of Technology

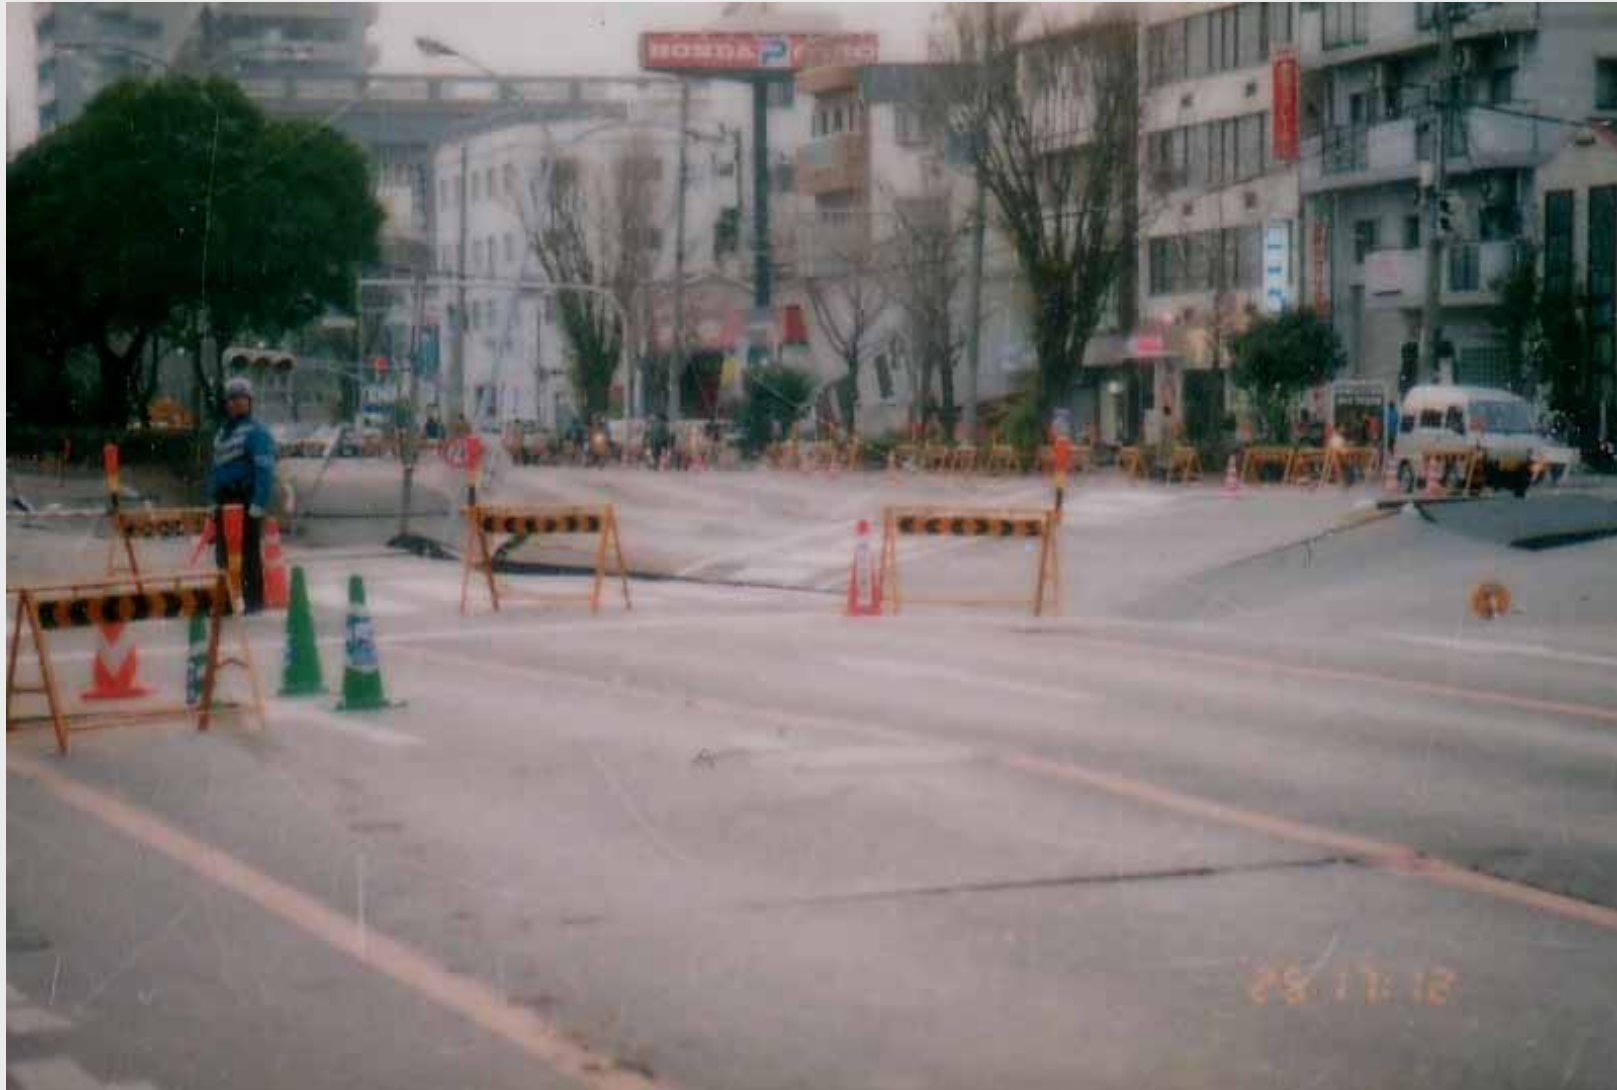
Settlement of Road Surface

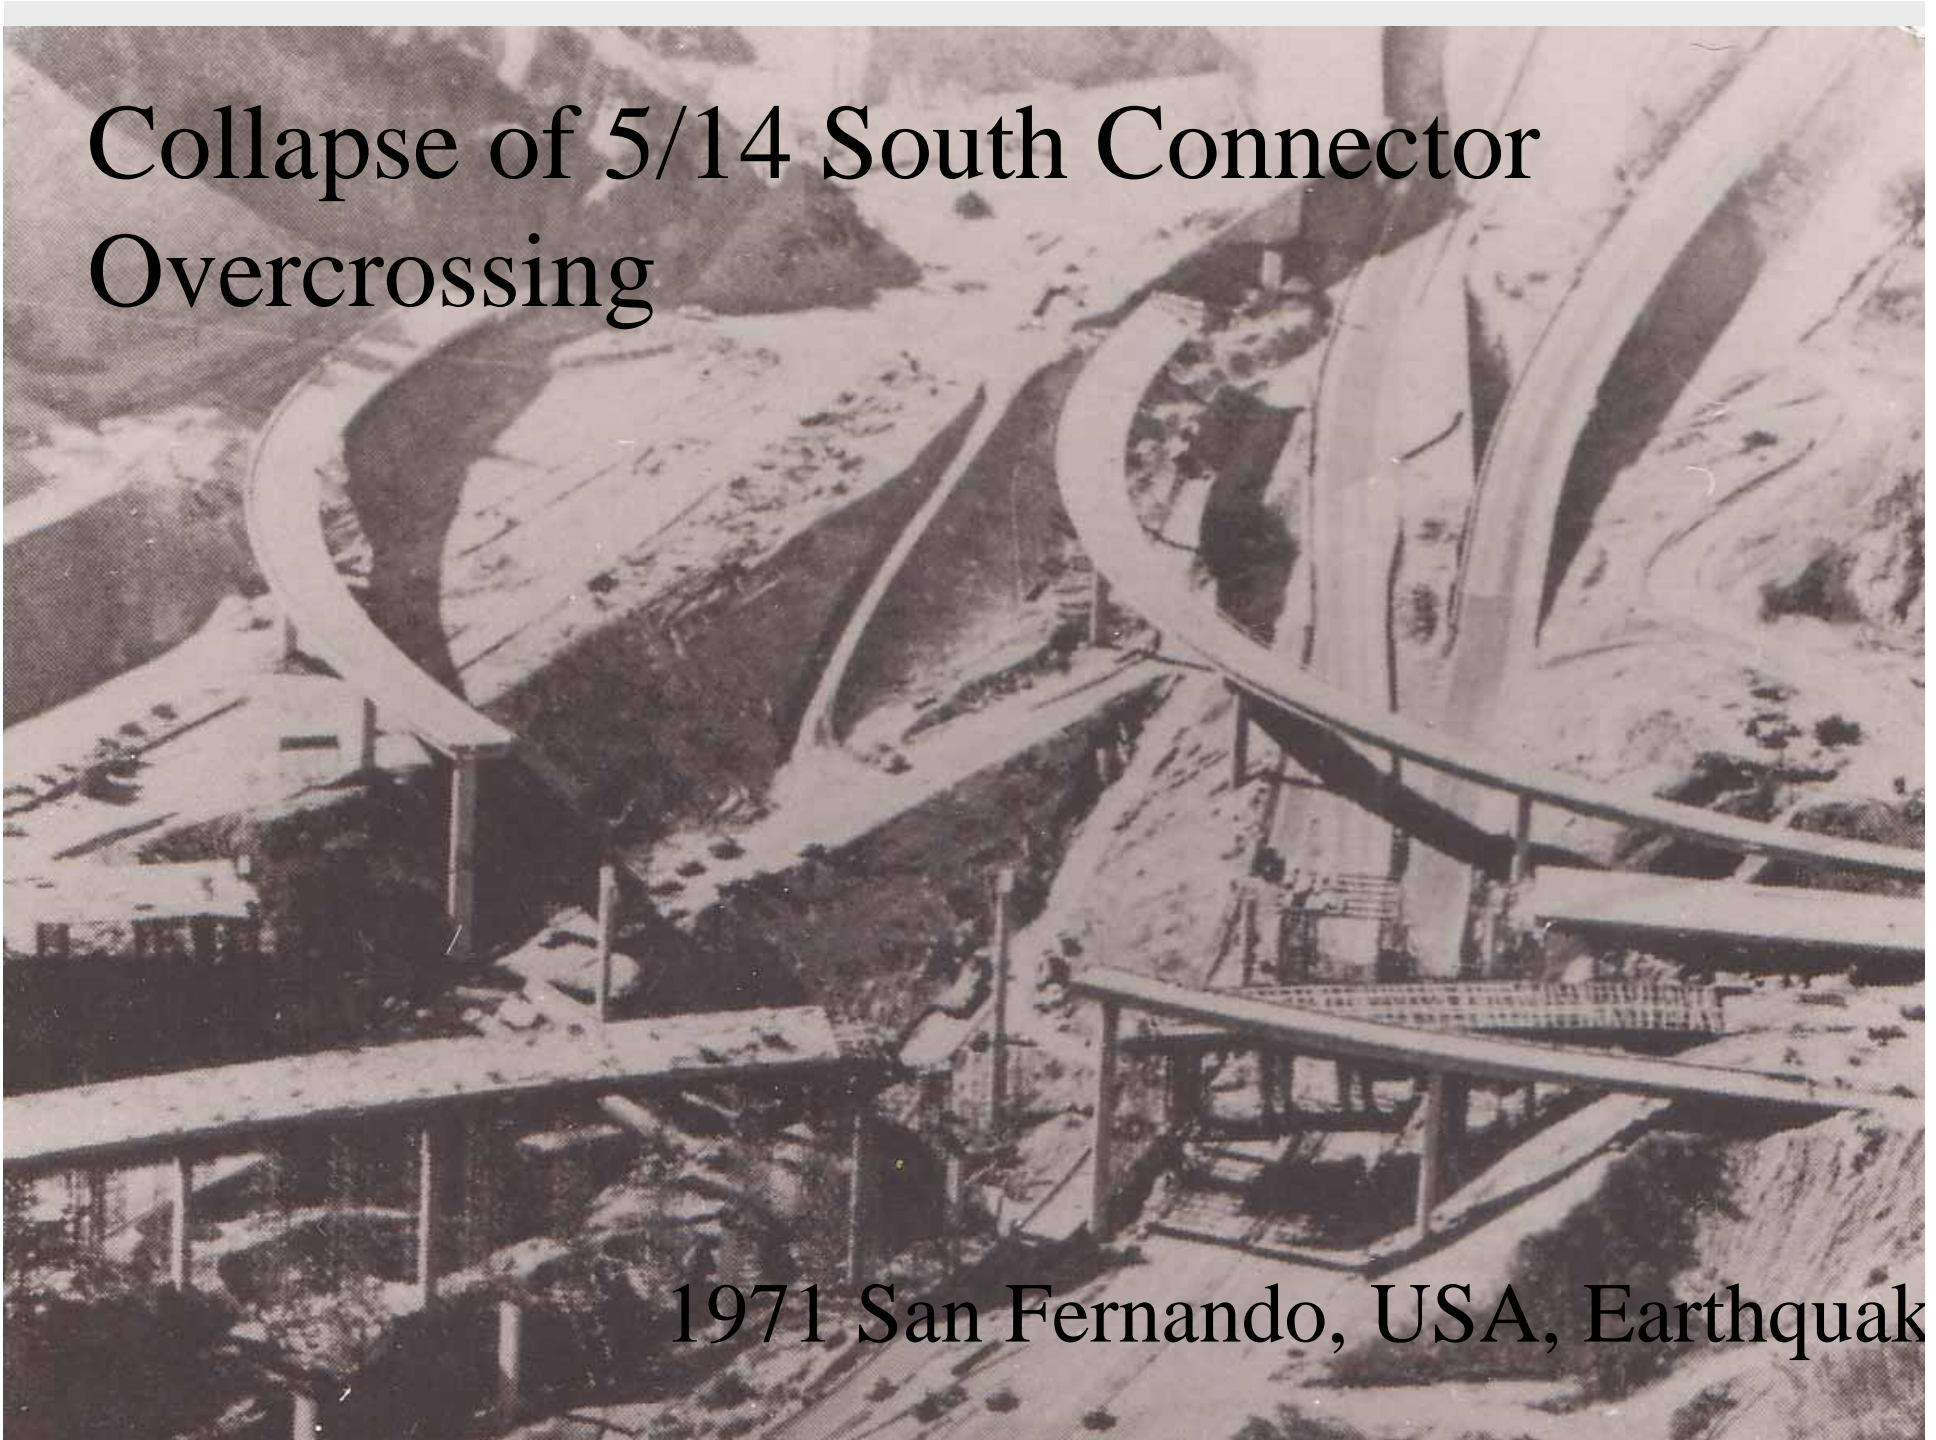
Collapse of 5/14 South Connector Overcrossing

1971 San Fernando, USA, Earthquake

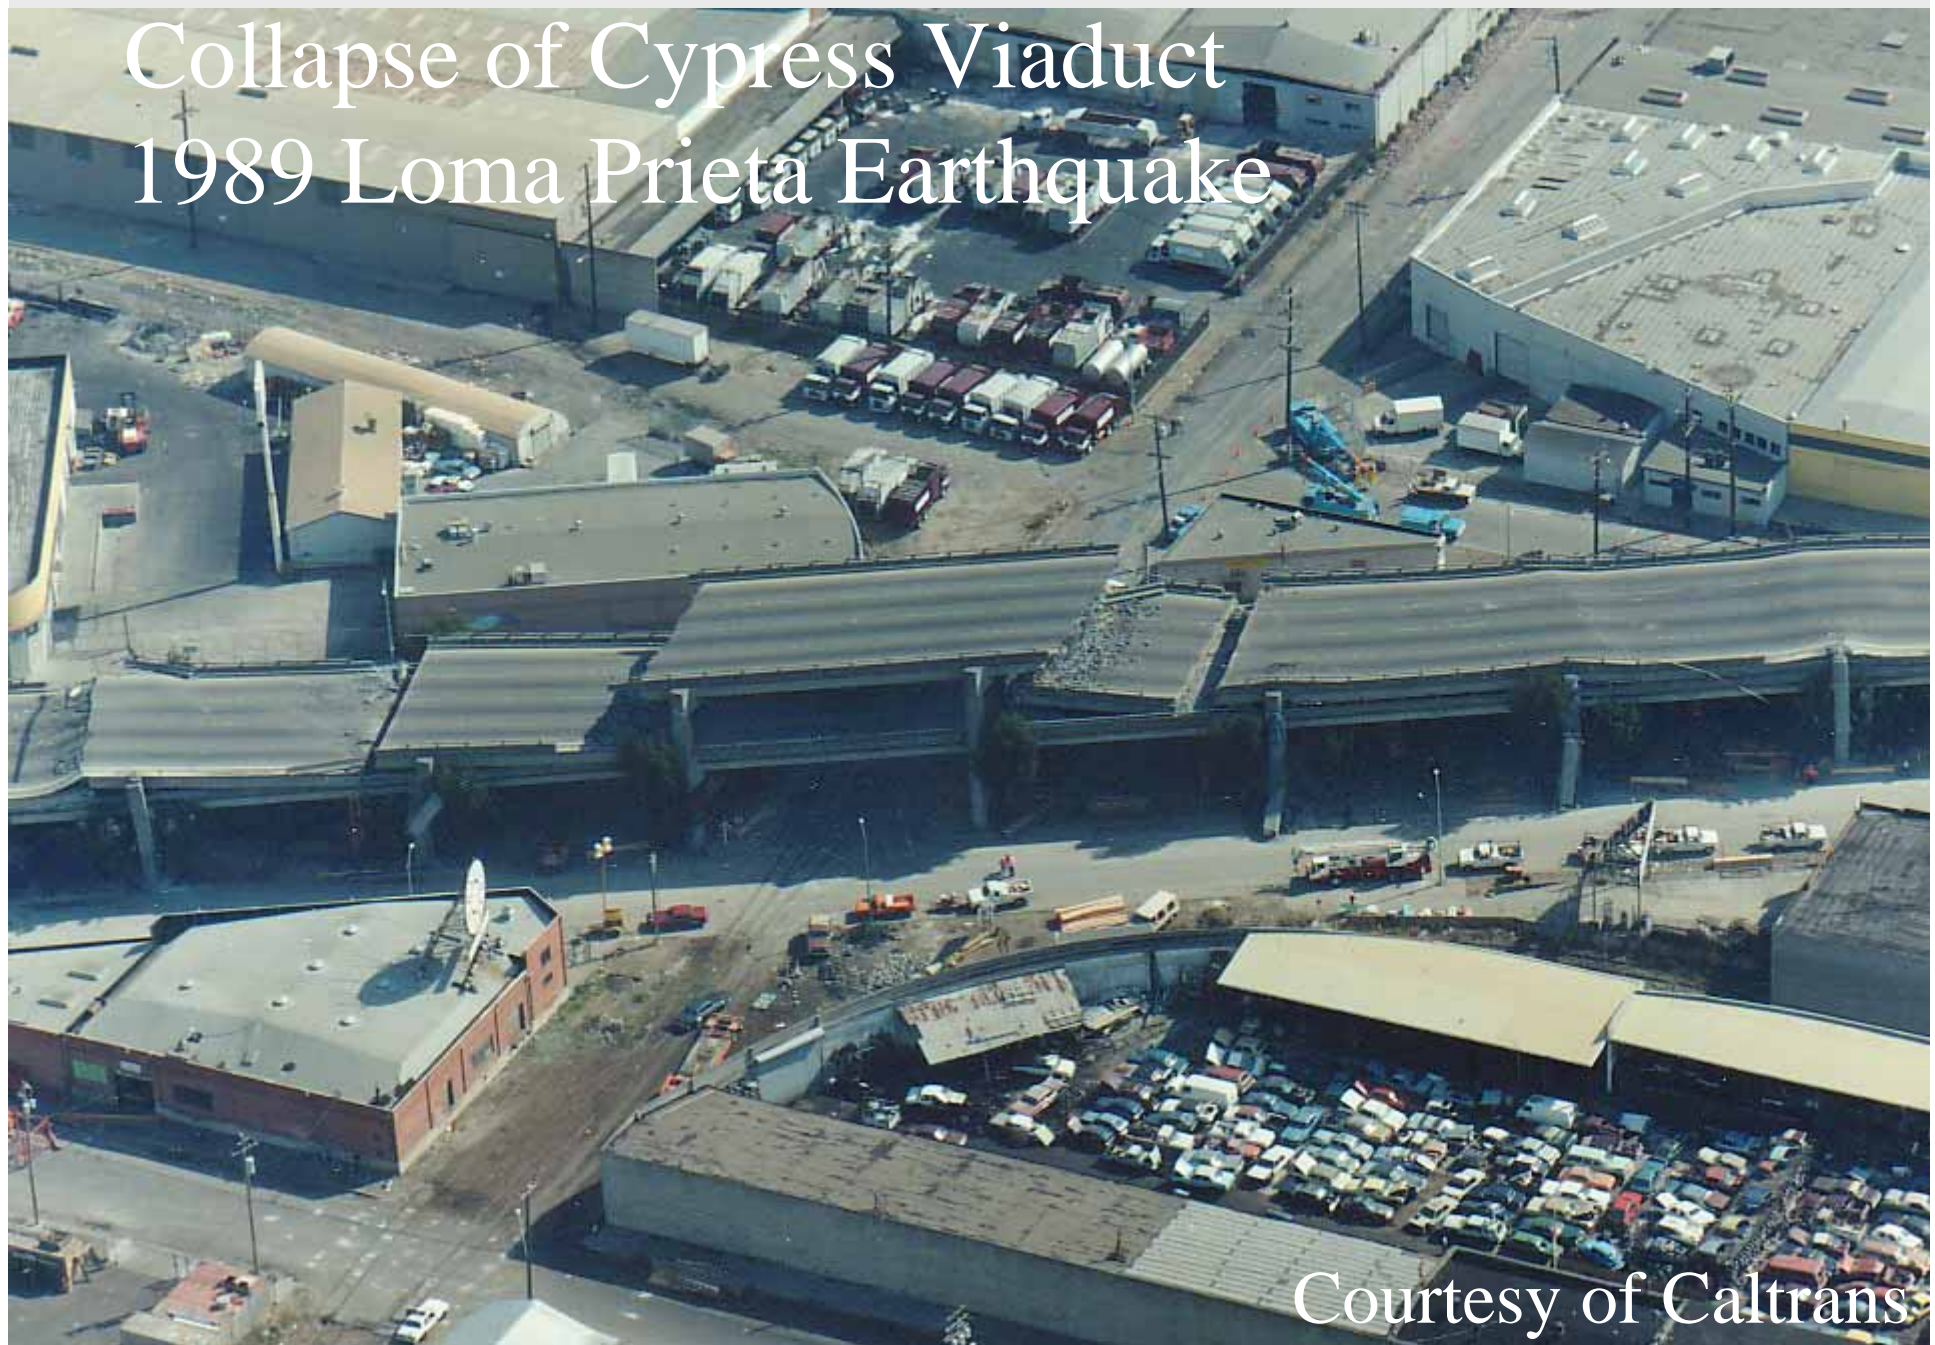
Collapse of Cypress Viaduct 1989 Loma Prieta Earthquake

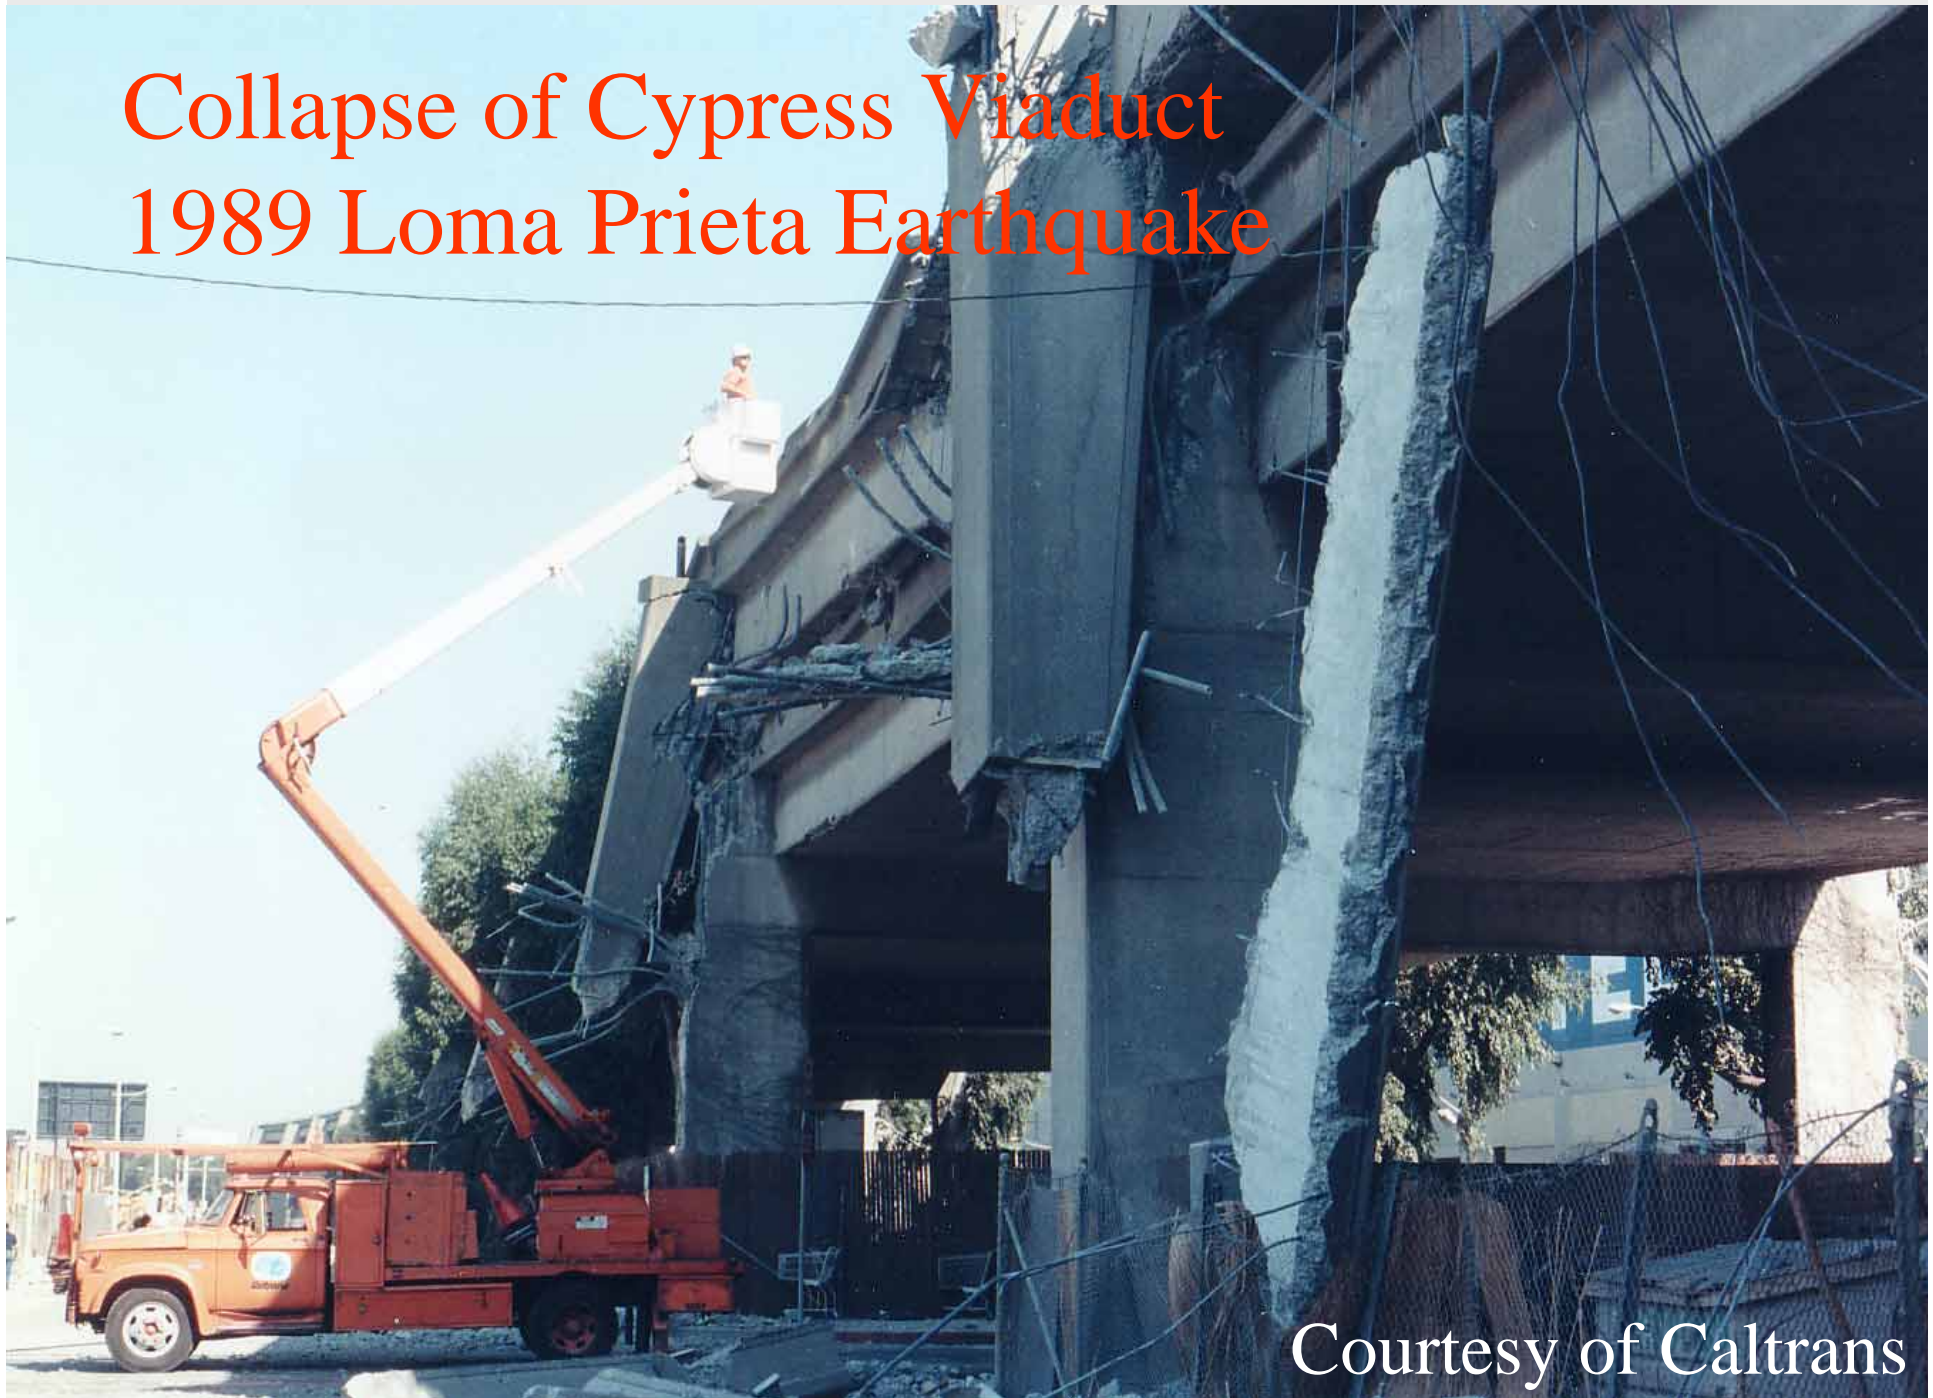
Collapse of Cypress Viaduct 1989 Loma Prieta Earthquake

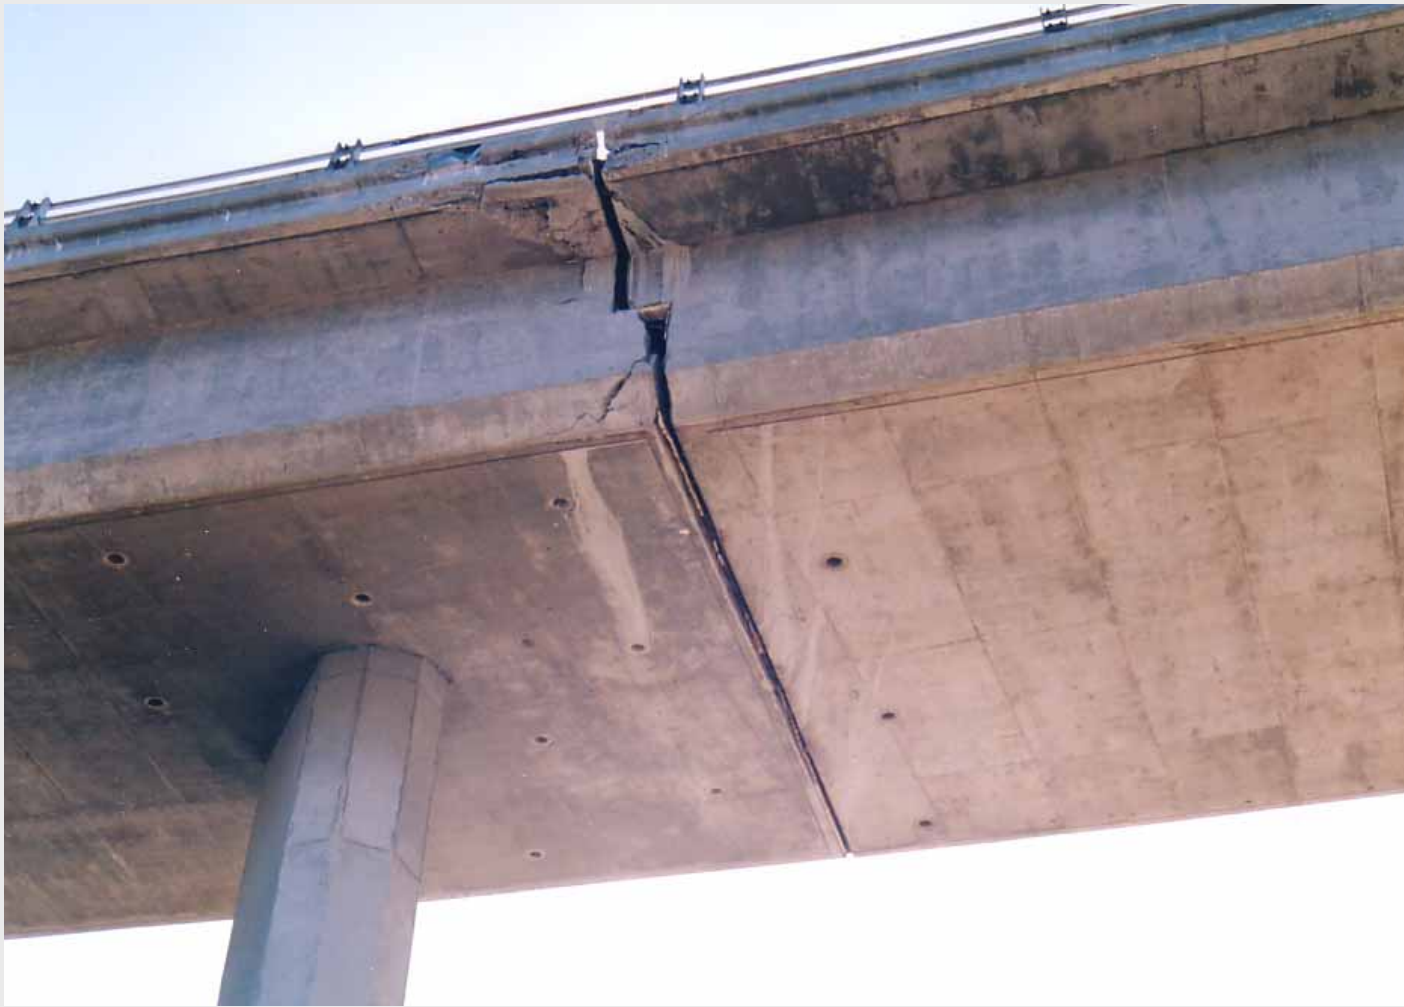
Pounding of Decks at Intermediate Hinge
