2.3 Seismic Damage of Bridges in USA

2.4 Damage of Bridges Due to Fault Displacement

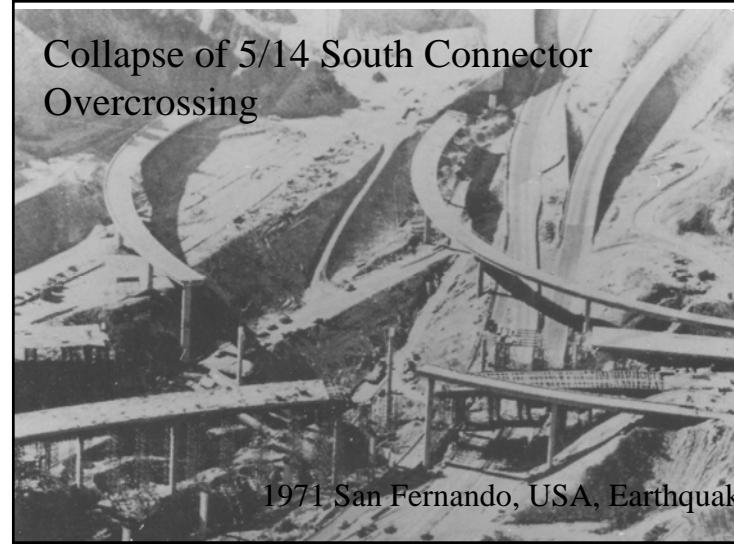
Collapse of 5/14 South Connector
Overcrossing

1971 San Fernando, USA, Earthquake

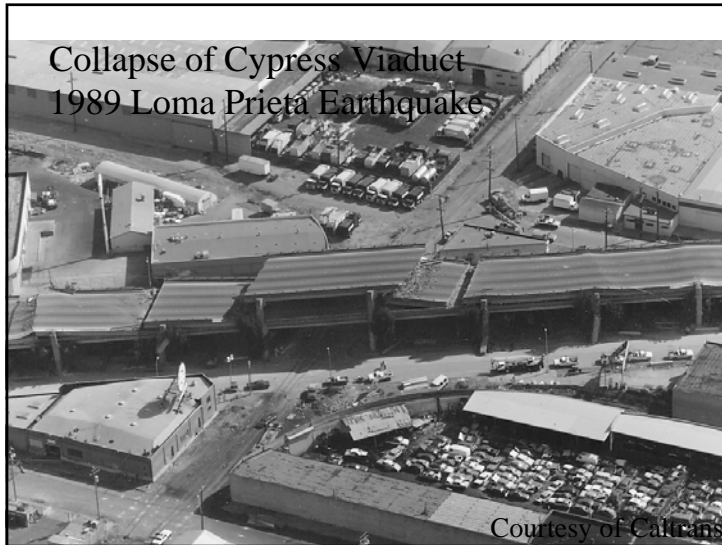
Collapse of Cypress Viaduct
1989 Loma Prieta Earthquake

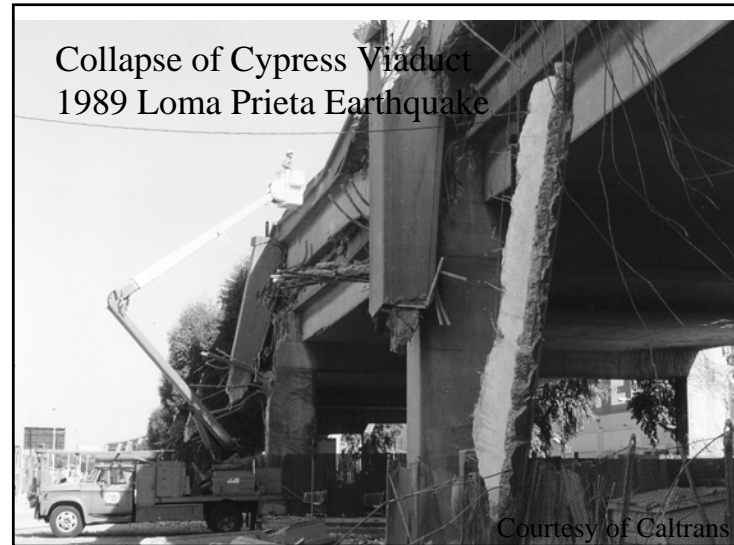
Collapse of Cypress Viaduct
1989 Loma Prieta Earthquake

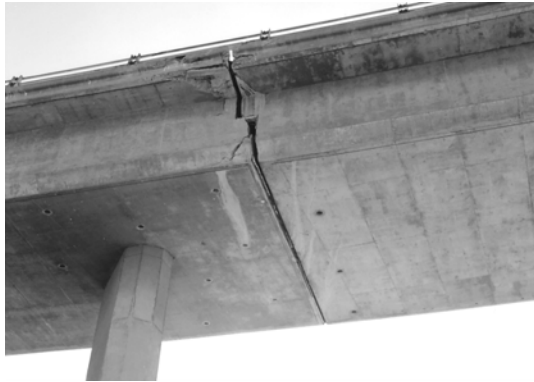
Pounding of Decks at Intermediate Hinge

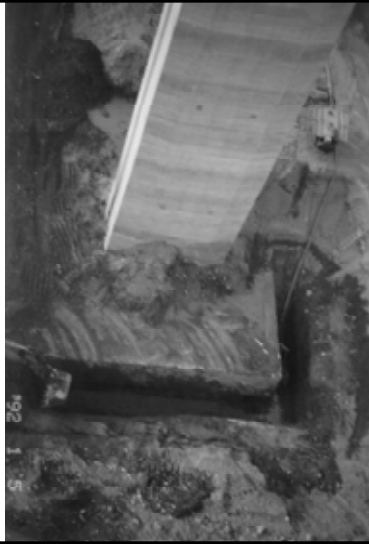
Pile Foundation
Damaged by
Fault Displacement

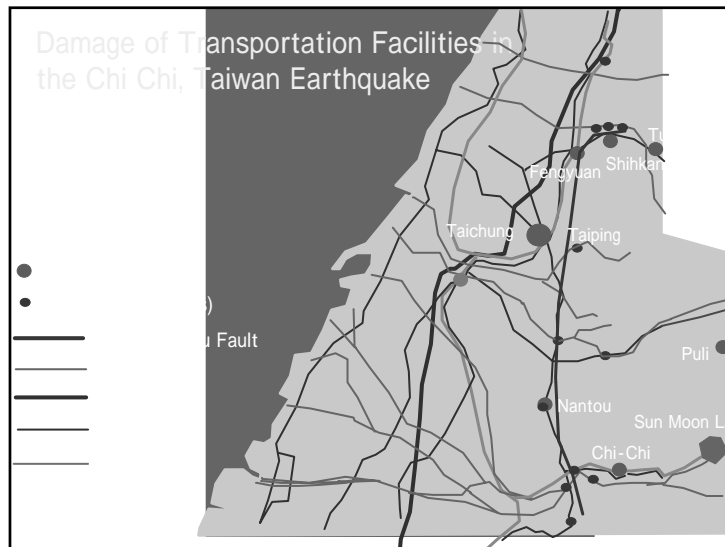
Damage of Transportation Facilities in
the Chi Chi, Taiwan Earthquake
