Bridge engineering learned from failures -fatigue and fracture control-

C. Miki Tokyo Institute of Technology, Tokyo, Japan

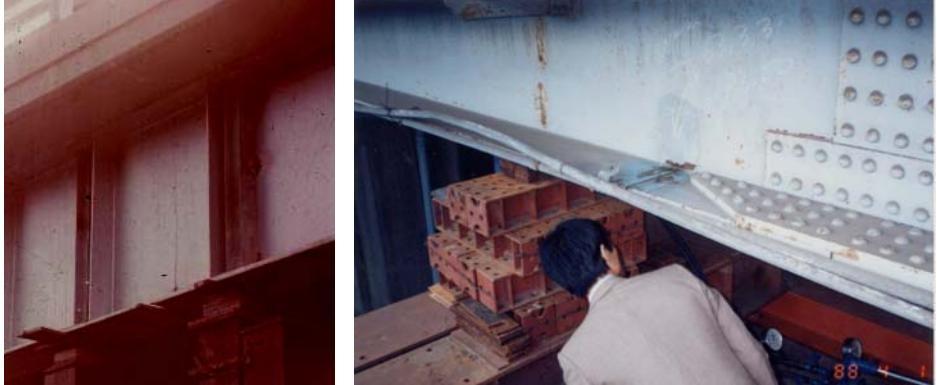
Figure 1(a) is a case in U.S.A.. this bridge is two spans continuous girder(45.7 + 45.7m), constructed in 1949. This cracking accident was found in 1981. Fatigue cracks initiated from the roots of plate butt welds and penetrated through the bottom flange and resulted brittle fracture in web plate. The groove is X with full penetration, but, the wide zone of incomplete penetration

was remained in the center part of joints. The area of incomplete penetration is about one half of section.

(a) In the USA (1949) (b) In Tokyo, Japan (1973) Figure 1. Cracked Girder: Fatigue crack initiated from insufficient penetration

Figure 1(b) is the case in a simply supported composite girder bridge of 30.3m span in Tokyo, Japan. This bridge was constructed in 1973 and fatigue cracks were found in 1988. Fatigue cracks cut the whole section of bottom flange and arrested in fillet welds between the flange plate and the web plate due to large plastic deformation of weld metal zone (Figure 2(b). The observation of fracture surface revealed multiple fatigue cracks initiated along the root of incomplete penetration welds in the plate butt welds of bottom flange (Figure2(c)). The zone of incomplete penetration occupied about 60% of width and 60% of thickness of butt weld. The groove of butt welds in the design plan is K shape with full penetration, of course.

It is close to impossible to predict the occurrences of fatigue damage caused by such kinds of defects in groove welds with full penetration, because these are failures of substantial quality control of factory. However, after a single case has occurred, it will be possible to take measures such as intensive inspection of joints made in the same factory around the same time using the same welding details. In the case of Figure 1(b), as a result of NDI to butt welds in the same bridge, weld defects of incomplete penetration were discovered in 45 joints from 388 joints.

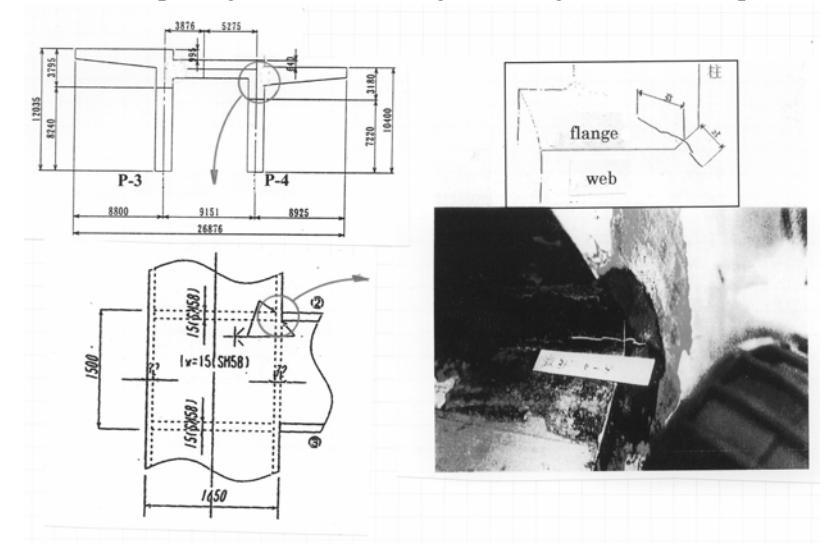
Figure 2 shows fatigue cracks in the bridge rigid bent in the route 3 of Tokyo Metropolitan Expressway. Fatigue cracks appeared on the surface of welded joint between the flanges of beam and column. The observation of the wall surface of stop holes, wide incomplete zones were remained in the welded joint and fatigue cracks initiated from the roots of partially pene-trated welds. The shape of groove in the design drawing is K with full penetration.

Figure 2. Fatigue Cracks in Rigid Frame Bridge Bent (Metropolitan Expressway, Rt.3, Ikejiri)

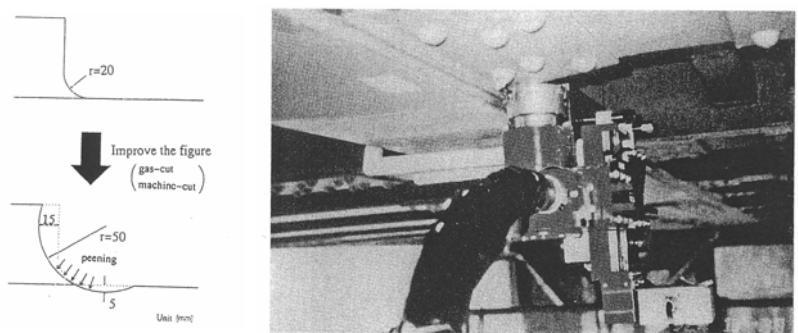
Figure 4. Cutting works by applying the newly developed tool

As a preventive measure, improving the fatigue strength of gusset end detail was studied. Figure 4 shows one of the methods being proposed to gusset plate on flange edge, in which a specially developed circular cutting device as shown in Figure 4 is used to shape the radius of the gusset end large and the fatigue strength is increased by reducing local stress concentration at this location which becomes the initiation point of fatigue cracking.

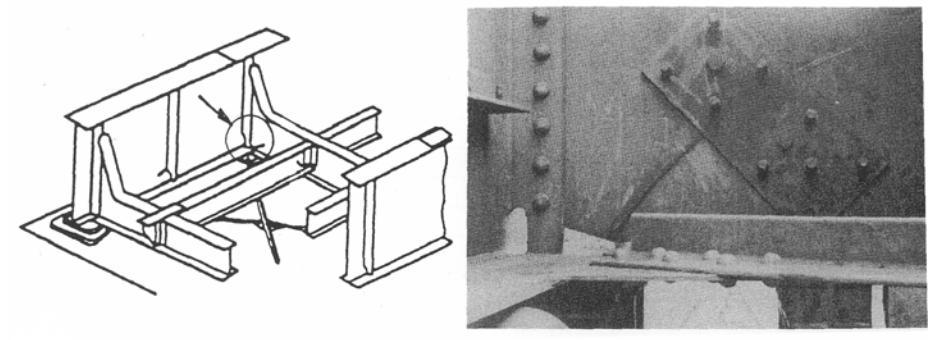
Figure 5 shows a through-type plate girder railway bridge in which fatigue cracking occurred when the flanges of floor beams were provided with cut-outs to facilitate joining at connections attaching floor beams to main girders (Miki. 1995, Miki et al. 1989). In the design, floor beams are provided simple support by main girders and thus only shear force, reactions of cross beams, are transmitted at the joints, and there is no problem if cut-outs are made in flanges. However, since floor beams are fixed to main girders in the actual structure, fixed-end restraints moments are produced. As a result, fairly large direct stress components will occur in the flanges. Because of the large decrease in cross section and change in configuration due to cut-outs of the flanges, large stress concentrations occur at these locations.

Figure 5. Through-type plate girder railway bridge, Fatigue cracks initiated at the connections between main girders

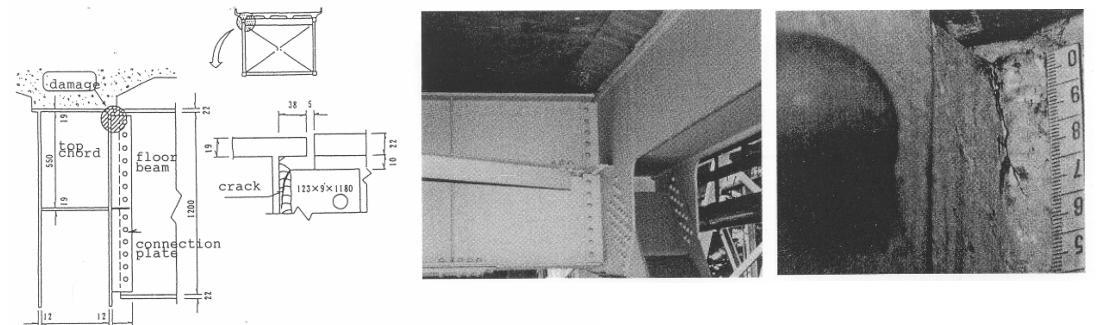
Figure 6 shows fatigue cracking which occurred at the connection between floor beams and panel points of trusses in a deck-type truss girder highway bridge. This damage is due to the occurrence of restraint moment at the end of floor beam. Because, the relatively thin connection plate was connected only with the web plate by single splicing bolted joint, extremely high

stresses were originated at the top end of welded joint between the connection plate and the web of top chord.

Figure 6. Fatigue crack at the connection between floor beam and truss panel point

As the reinforcing measure the top flange of a floor beam and the flange of the upper chord member of a truss should be joined using a connection plate. In order to adjust the gap and difference of level between the flange of top chord, thick plates of 40mm are adopted as connection plates. In order to secure enough space for welding works, concrete at the top surface of the truss was blasted off by water jet.

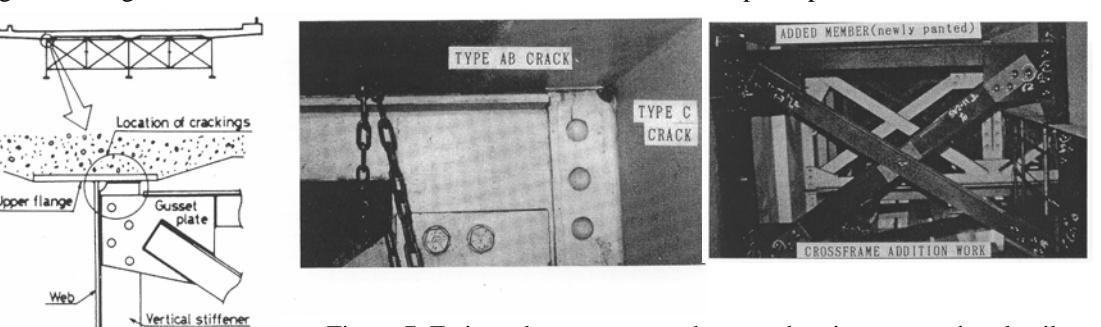
Figure 7 shows fatigue cracking which occurred at welds between a vertical stiffener used attaching cross bracing of a plate girder bridge and an upper flange and web. Such fatigue is due to fairly large forces being produced at the various members of the cross bracing from the difference in deflection between main girders caused by vehicle loads and the forcible deformation of the upper flanges of plate girders by deflection of the concrete deck in a direction perpendicular to the bridge axis.

Figure 7. Fatigue damage case at the cross bracing connection details

Various methods are employed for repair of this damage considering degree of damage and ease of execution. For the smallest cracks, in case there is no problem about size with fillet welds, re-welding the crack is done by TIG dressing. In case of small size of fillet weld with the possibility of crack occurrence from the root, after one to three passes of fillet welding on top of the crack, the toe is finished by TIG or grinding. When the crack is large, it is removed by

gouging after which re-welding is performed by full-penetration welding, with toe finishing done by TIG or grinding. The results of follow-up investigations indicated that most of the repaired spots remained sound, but fatigue cracks have occurred again where stresses produced were large and where cracks had been large.

Improving the deformation behavior of the structure as a whole is also done by installing cross bracings and stringers. In this case, the plate thickness of vertical stiffeners for attaching new cross bracings is changed from the about 10 mm used in the past to about 16 mm, while their widths were made as large as possible. Further, to lower stresses at damaged parts, horizontal members of old cross bracings were removed.

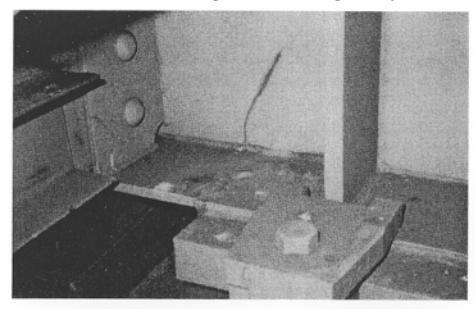
Figure 8(a) shows fatigue cracking which occurred in a plate girder bridge where a sole plate was attached to the underside of a bottom flange by fillet welds(Tateishi et al. 1994). For sole plates, when rotating function is lost, very high stresses occur at the front surface of the sole plate.

Figure 8 (a). Fatigue Crack at Sole Plate End

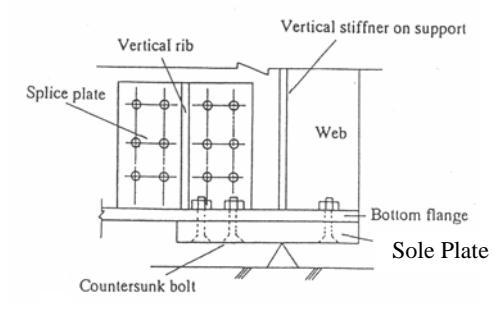
Figure 8 (b). Retrofitting method for sole plate detail

An example of repair is shown in Figure 8(b). The sole plate was changed to a longer one. Joining with the bottom flange was done using high-strength bolts. Cracks which had penetrated into the web, holes were drilled at the tips along with which splicing was done using high-strength bolts. The holes at the tips of cracks were also stopped with high-strength bolts. When cracks of webs are large, welding may also be done.

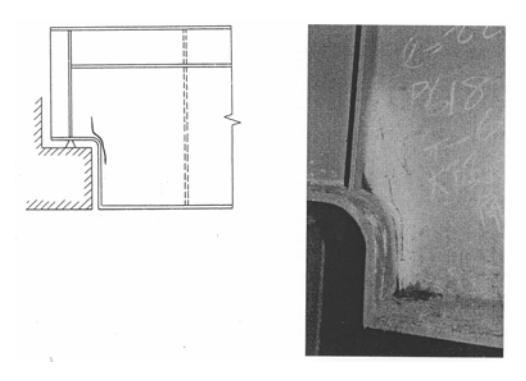
Figure 9 shows fatigue cracking which occurred where a cut-out had been made at the end of a girder of a plate girder bridge. Regard to this part, bending stress is extremely small according to the beam theory, but since a cut-out is provided, a high stress component is produced in the normal-line direction at the corner of the curved part. This stress component becomes higher the smaller the curvature ratio of the curve. When the bearings of supports loss the functions of rotating and sliding, the stress raising at the corner of cut out web becomes more severe. Since the flange and the web are joined by fillet welding, when looked at locally, this fillet weld is supposed to transmit load. Fatigue cracks often are initiated from the roots of welds because of this. This means fatigue cracks appeared on the surface after it grew long.

Figure 9. Fatigue Crack at Cut-out Girder Ends

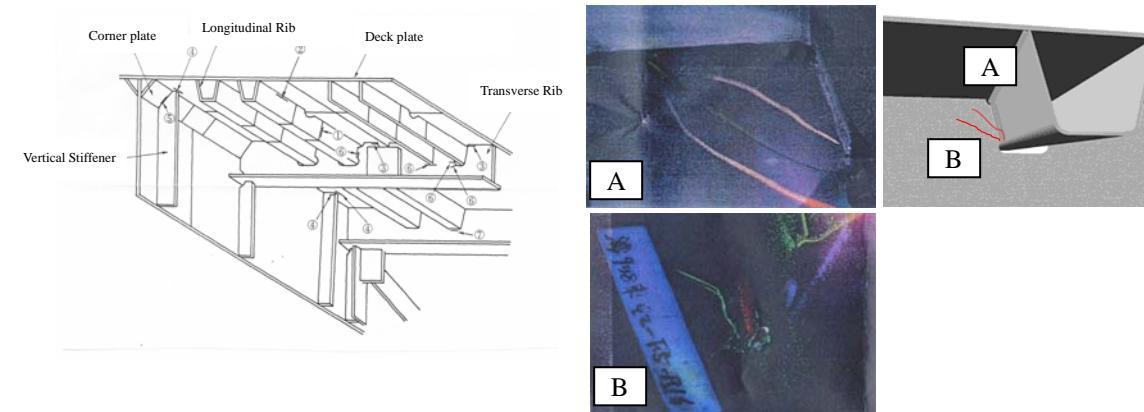
Figure 10 shows the fatigue cracks in one box section girder bridge in the Metropolitan Expressway. Fatigue cracks have developed at various joint details, including welded joints of trough ribs used backing strips, scallops at the intersections of the longitudinal and transverse ribs and welds between trough ribs and deck plate.

The detailed studies through FEM analysis and field measurements indicated the main reason of fatigue damage in the longitudinal ribs and deck plates is the local deformation of deck plates between two webs of trough ribs as punching shear behavior of plate. In order to prevent the occurrence of these fatigue cracks, the increase of the thickness of deck plates is essential and the width of trough rib must be less than the width of truck tires, approximately less than 400mm. As the retrofitting method, the reforming to the composite steel bridge deck by applying steel fiber reinforced concrete has been studied.

Figure 10. Fatigue cracks in orthotoropic steel decks

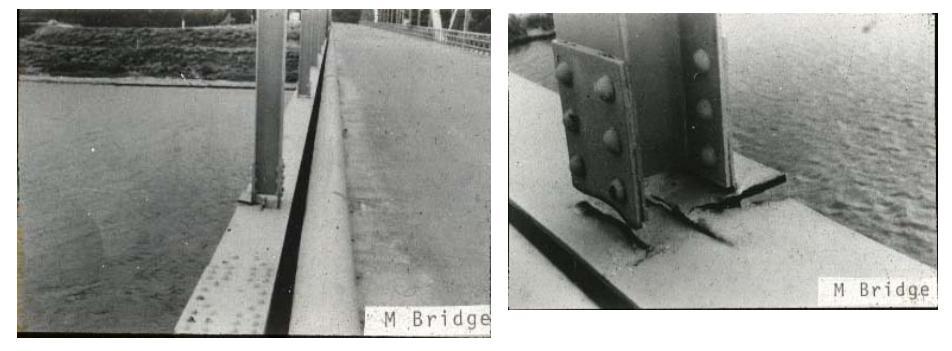
Figure 11. Fatigue damage caused by vibration due to wind.

When winds applied on bridge members of dull sections such as H-shape, box section and circular section, vortexes are originated in the back steam of wind, and these vortexes induce vibrations on bridge members, called Karman vortex shedding. These unexpected vibrations cause fatigue damage in bridge members. Figure 11 shows a case in an arch type bridge, fatigue cracks cut the connection plates between the main girder and the vertical suspension members. Fatigue cracks propagated into the flange of main girder. Similar fatigue damage in vertical members occurred in several arch type bridges in Japan. Various Types of retrofitting works have been tried. In order to suppress the occurrence of vortexes, the surfaces of members changed to rough by winding spiral wires with members which provides easy separation of air stream. The change of natural frequency of members is also one effective countermeasure. Vertical members were connected by applying wires. The details of connections were improved to be high fatigue resistance.

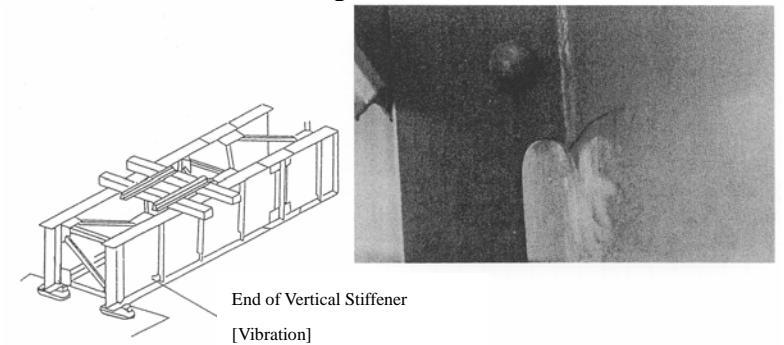
When a train travels at high speed, there may be a case of vibration of a kind unforeseen occurring in a bridge. Figure 12 shows examples of fatigue damage due to vibaration in bridge structures of the Shinkansen Line of Japan. Since start of operation in 1964, speeds have been increased and from about the time that 200 km/h was exceeded, vibrations of bottom flanges of stringers in plate girder bridges and truss girder bridges in directions perpendicular to bridge axes began to appear prominently when crossed by trains. Also, vibrations in out-of-plane directions occurred in diaphragms of box-section girder bridges. Fatigue cracks have occurred in vertical stiffeners and ribs restraining such vibrations.

Figure 12. Fatigue damage due to the out of plane vibration of bottom flange of girder in bullet train systems
