### Fatigue Cases and Retrofit Works in Steel Bridges

#### Causes of fatigue damage

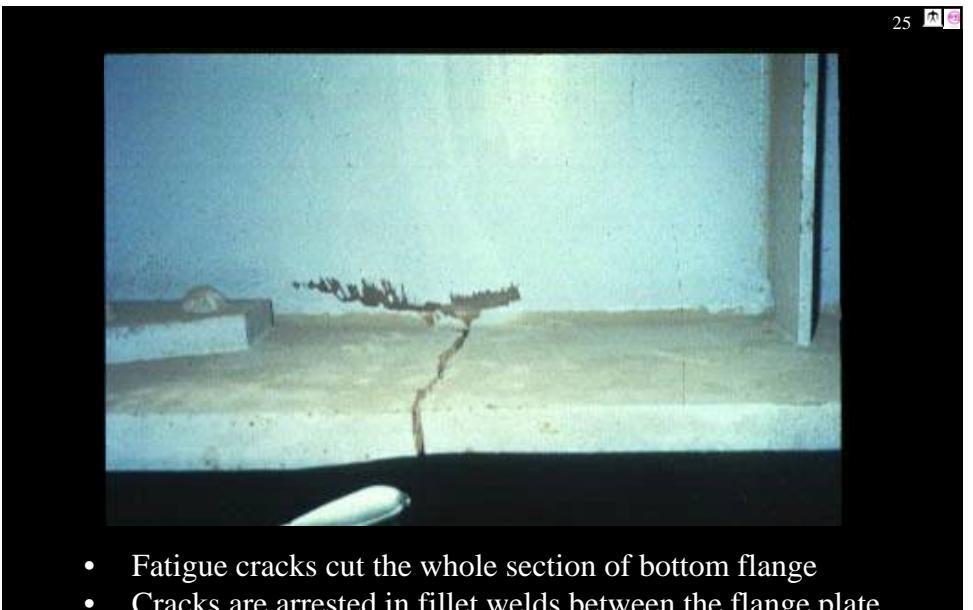
• Cracks are arrested in fillet welds between the flange plate and the web plate due to large plastic deformation of weld metal.

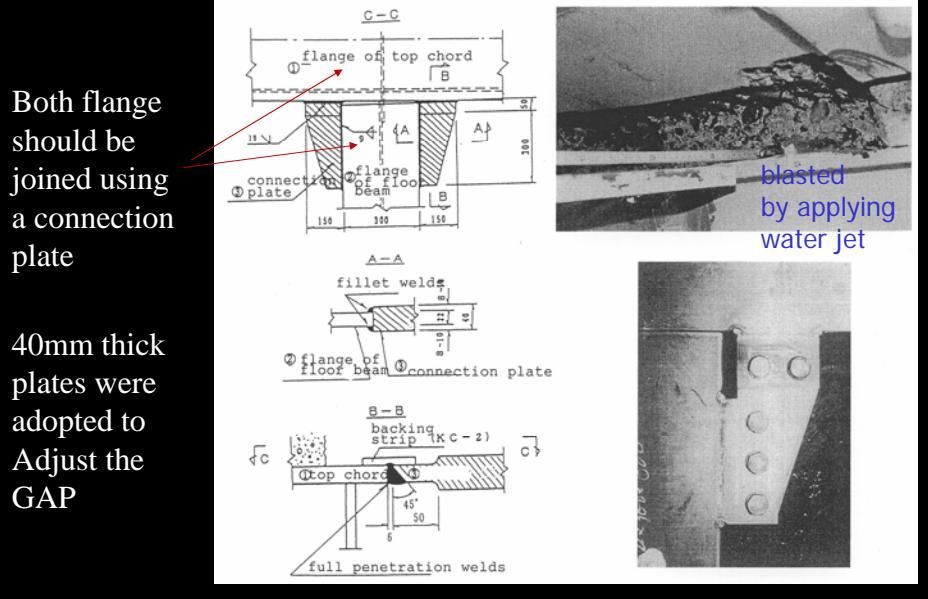
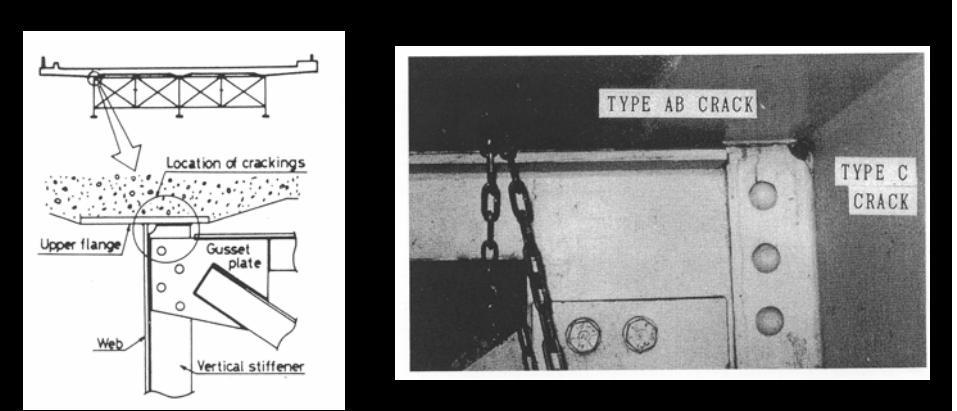
#### 3-3 Fatigue cracks at the cross bracing connection details

large forces are produced in cross bracing from

- Difference in deflection between main girders caused by vehicle loads
- forced deformation of the upper flanges of plate girders by deflection of the concrete deck in a direction perpendicular to the bridge axis.

- 1. For small cracks : re-welding the crack is done by TIG dressing
- 2. small size fillet weld (possibility of crack from root) : after fillet welding on top of the crack, the toe is finished by TIG or grinding
- 3. When a crack is large : the crack is removed by gouging, fullpenetration welding is performed, with toe finishing done by TIG or grinding.

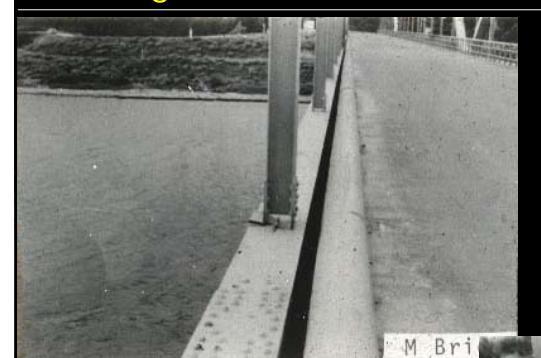
M Bridge

- Karman vortex shedding may cause fatigue damage in bridge members.
- fatigue cracks cut the connection plates between the main girder and the vertical suspension members.

The End of Vertical Member In Ranger Type Bridge

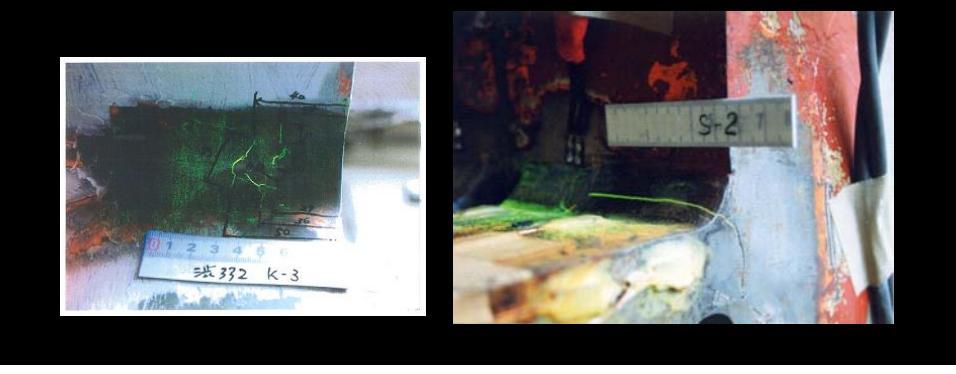
# Fatigue crack in beam-column connection of steel pier

- Cracks come out from inside of weld metal.
- From unwelded zone, Lack of fusion, weld crack, or other weld defects

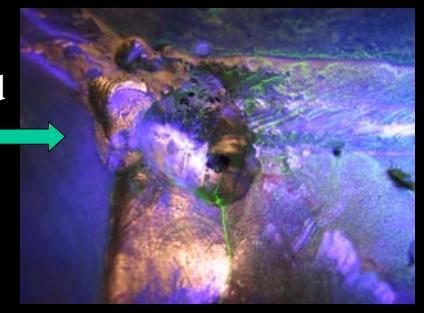
# Cause of fatigue crack

- Intersection of weld line
   →high restraint stress, weld
   flaw (blow hole,slag
   inclusion, weld crack)
- 2. Stress concentration (Geometry, shear lag, bead, notch)
- 3. Inherent Internal Flaw
