3. SEISMIC DAMAGE IN THE PAST EARTHQUAKES

3.1 Loma Prieta and Northridge, USA, Earthquakes

3.2 Pre-Kobe and Kobe, Japan, Earthquakes

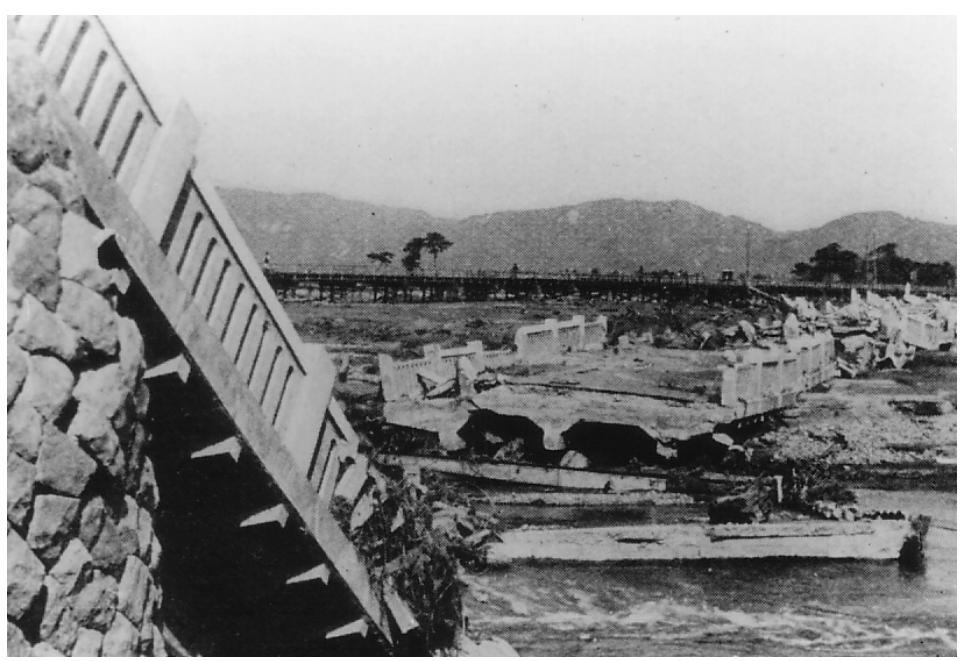
Importance of taking account of the seismic effects in design of engineering structures was first recognized when the destructive damage occurred in 1923 Kanto Earthquake. At those days, bridges were constructed based on the technologies imported from the USA, UK, German and French with no consideration for the effects of seismic disturbances. Photo 3.1 shows a typical damage in the earthquake. The foundations settled, laterally moved and tilted. This resulted in the collapse of an entire bridge system. This was a typical damage when seismic effects were not considered, or when the seismic design, in particular for foundations, was insufficient. This type damage occurred in 1920s-1950s.

Photo 3.1 Collapse of Sakawa-gawa Bridge, 1923 Kanto Earthquake

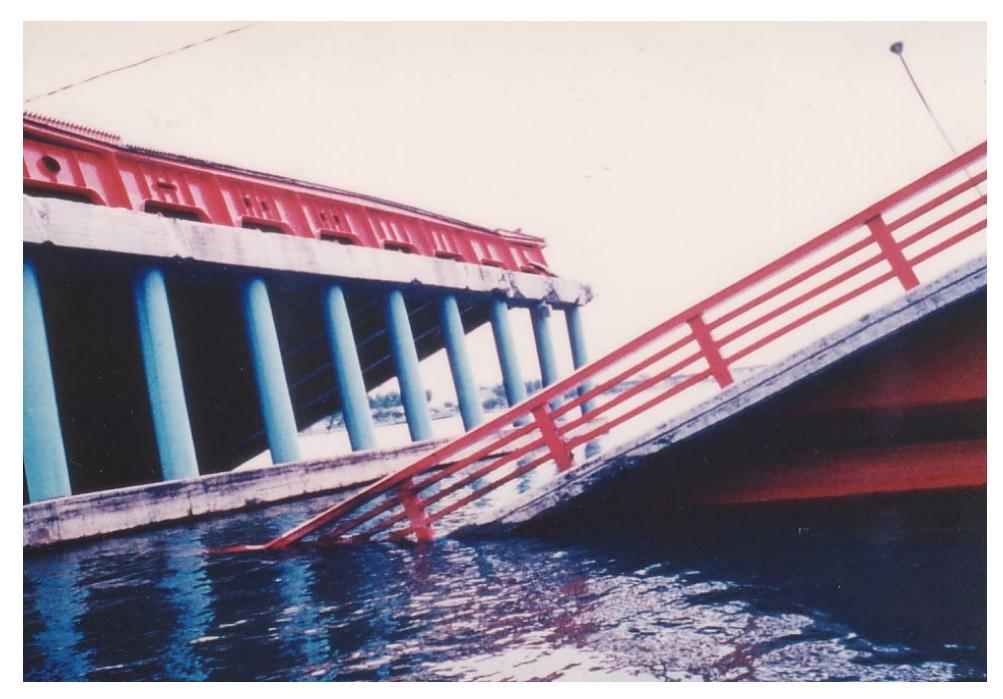
Extensive damage of bridges occurred in the 1964 Niigata Earthquake resulted from soil liquefaction. Showa Bridge supported by flexible bent-piles collapse as shown in Photo 3.2. Soil liquefaction occurred extensively around the bridge. This caused lateral spreading of surface ground as long as 10m along the Shinano River.

Photo 3.2 Collapse of Showa Bridge, 1923 Niigata Earthquake

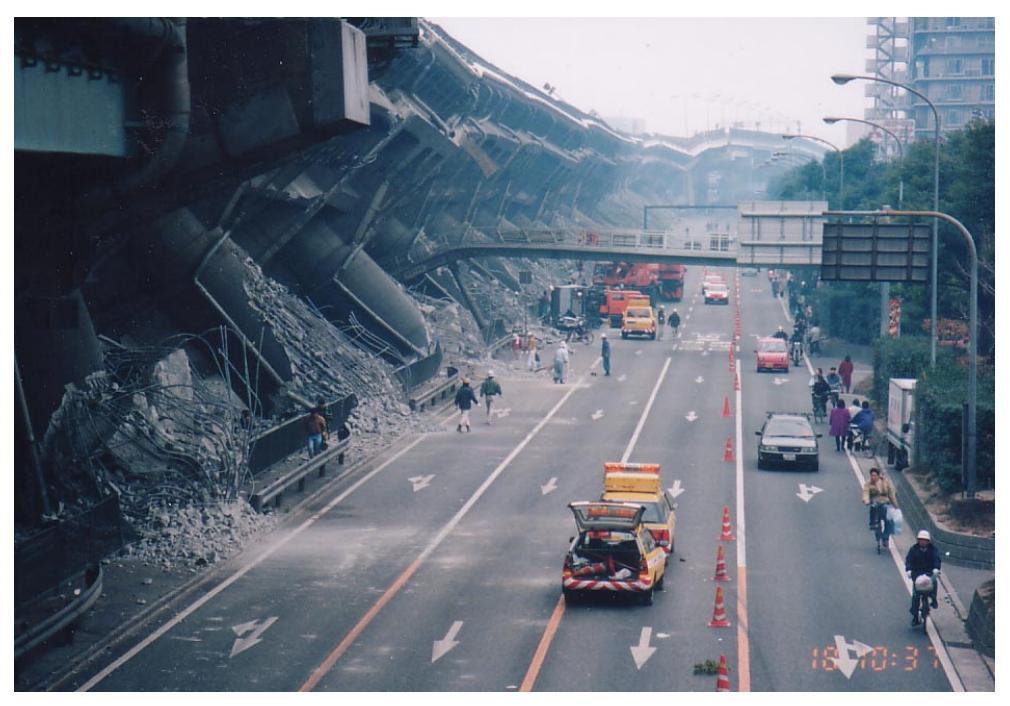
Eighteen spans of Fukae Viaduct, Hanshin Expressway collapsed as shown in Photos 3.3 and 3.4. The viaduct was designed in accordance with the 1964 Design Specifications using 0.2 horizontal and 0.1 vertical seismic coefficients based on the allowable stress design approach. It was completed in 1969. Prestressed concrete decks with 22 m span were simply supported by internal hinges at both ends. The reinforced concrete columns were 9.9-12.4 m tall with a diameter of 3.1-3.3 m. Longitudinal and tie bars were deformed bars with a diameter of 35 mm (SD30, D35) and 16 mm (SD30, D16), respectively. Number of the longitudinal bars was 180 at the bottom of columns, and it reduced 120 at 2.5 m from the bottom by terminating 60 bars.

Photo 3.3 Collapse of Fukae Viaduct, 1995 Kobe Earthquake

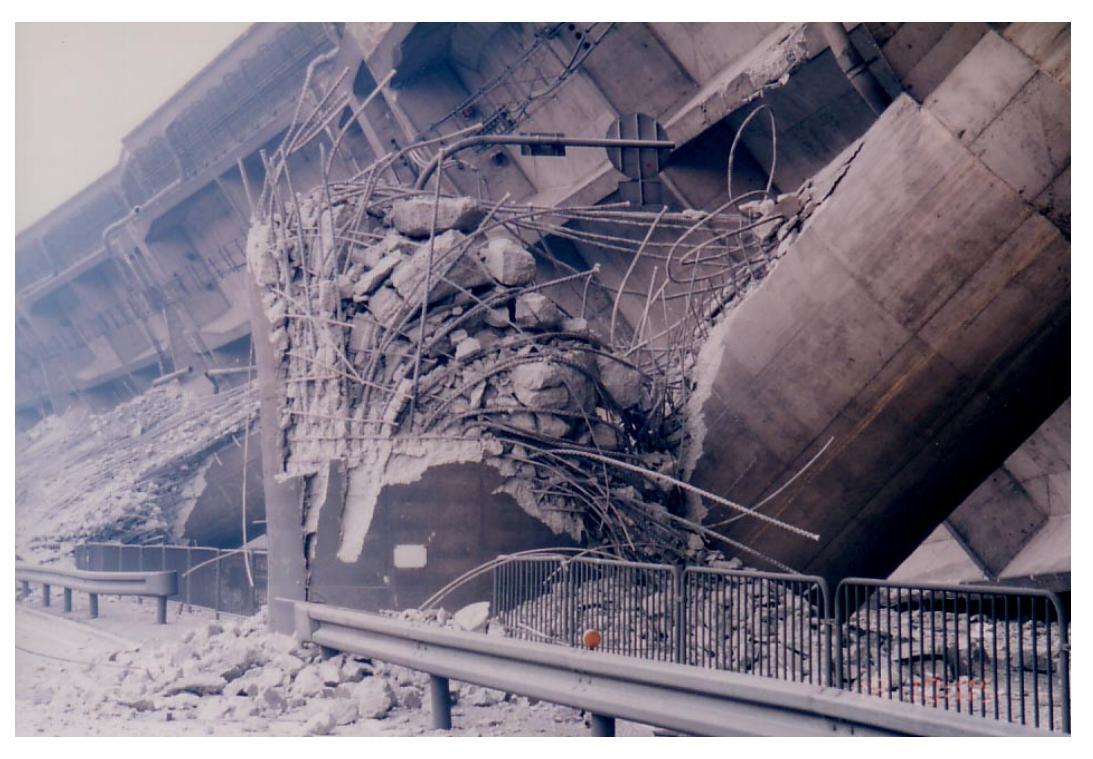
Photo 3.4 Premature Shear Failure of Reinforced Concrete Column, Fukae Viaduct

There were three important problems in the design of this viaduct. First is the overestimated allowable shear stress. The allowable shear stress that is required in the current codes is less than 60 % of the value used in design of this viaduct. Second is the insufficient development length of longitudinal bars terminated at mid-height. Only 20 times bar diameter was the development length. Based on the current requirements, it has to be further extended

an effective width of the column, i.e., 3.1-3.3m. Third is the insufficient amount of tie bars. Tie reinforcement ratio by Eq. (4.?) was only ?.

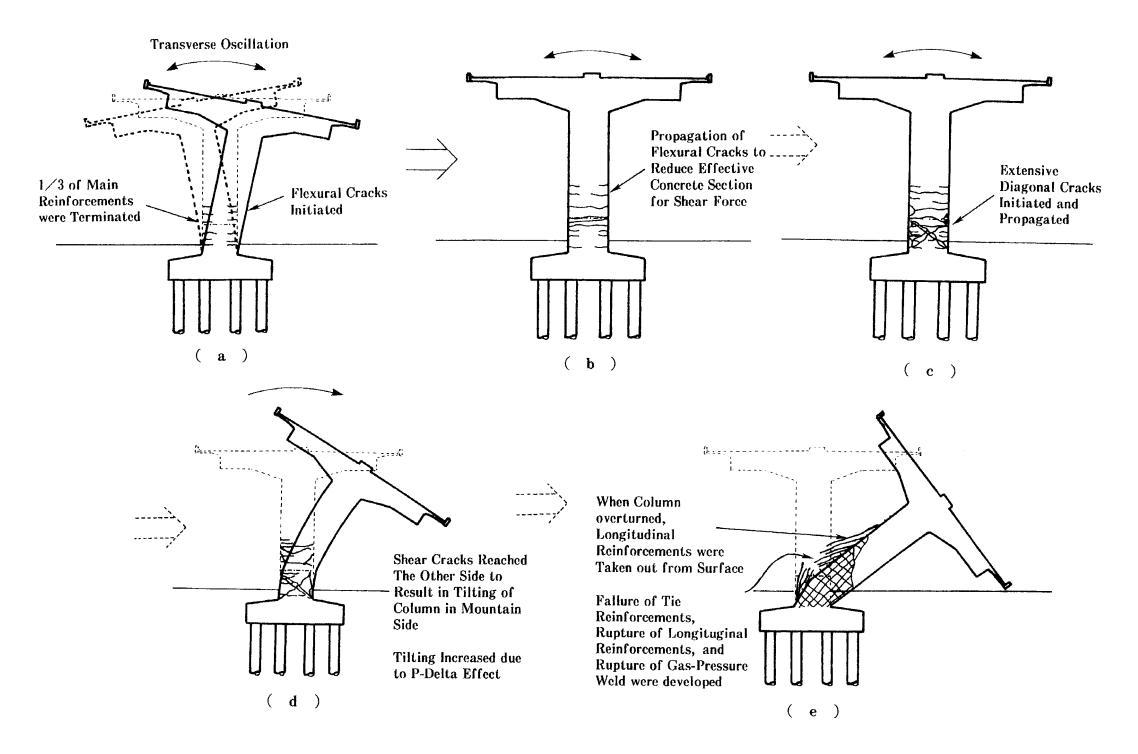
The failure mechanism of the viaduct is as shown in Fig. 3.1. Subjecting to a strong ground motion, the columns suffered extensive flexural and diagonal cracks at 2.5m above the footing where 1/3 longitudinal bars were terminated with insufficient development length. Since the amount of tie bars was insufficient, this caused premature shear failure in the columns.

Fig. 3.1 Failure Mechanism of Fukae Viaduct

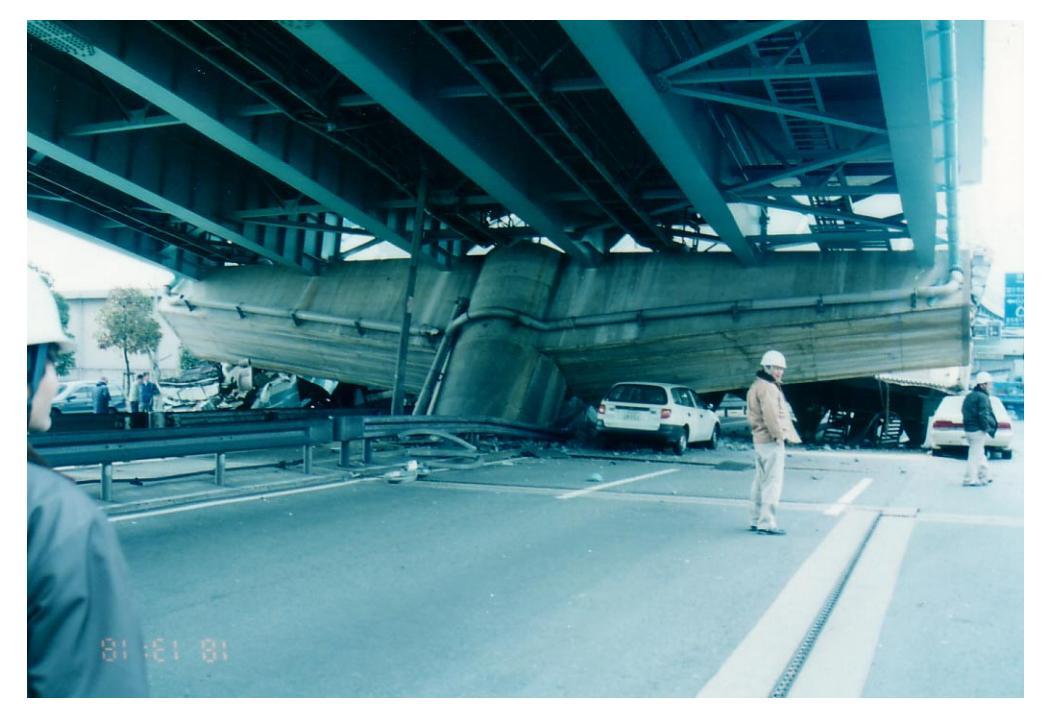
Similar failures occurred extensively. In fact, it was the major reason for causing the destructive damage of bridges in the Kobe Earthquake. For example, two simply supported steel girder bridges collapsed at Takashio, Hanshin Expressway as shown in Photo 3.5. It was completed in 1979 based on the 1971 Guide Specifications using 0.23 horizontal and ± 0.11 vertical seismic coefficients. Tie bars with a diameter of 16mm was provided 300mm interval. Hence the tie reinforcement ratio by Eq. (4.?)was only ? %. The number of longitudinal bars was 150 at the bottom of columns, and it reduced 120 and 60 at 3.3 m and 5.7 m from the bottom, respectively. As was the case of Fukae Viaduct, the insufficient development length of terminated longitudinal bars and the insufficient amount of tie bars resulted in the premature shear failure of columns. Fig. 3.2 shows the estimated failure mechanism.

Photo 3.5 Collapse of Takashio Viaduct, 1995 Kobe Earthquake

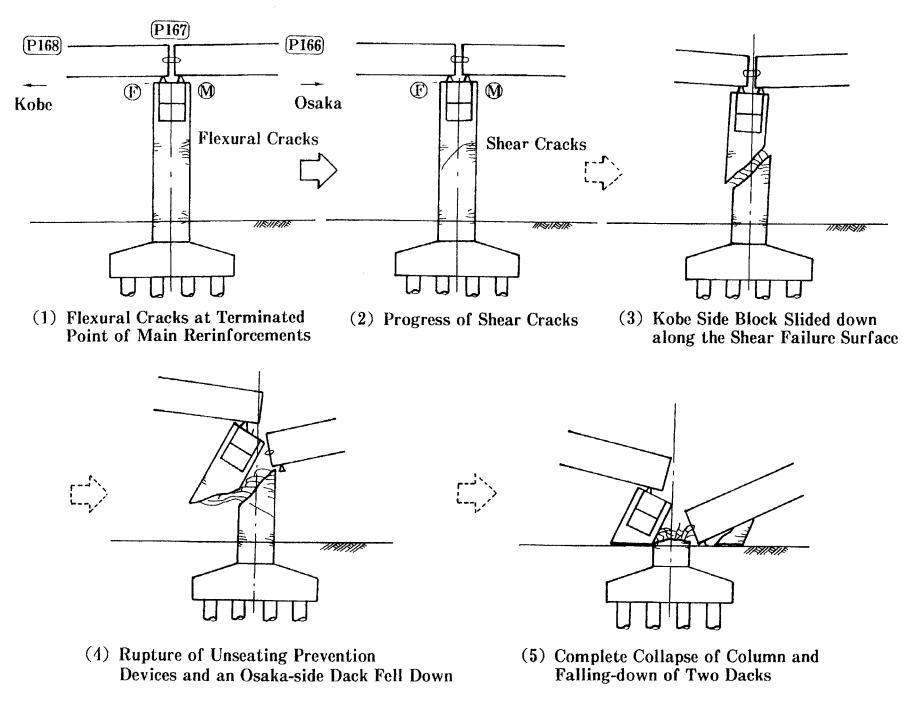
Fig. 3.2 Failure Mechanism of Tateishi Viaduct

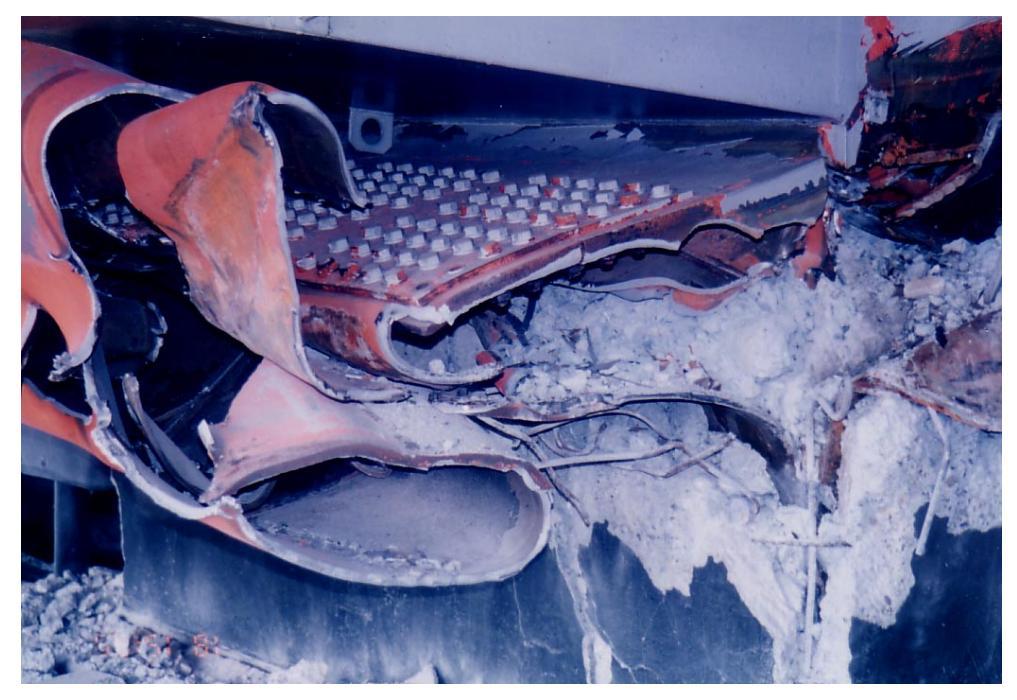
Steel columns collapsed at a number of sites. Photo 3.6 shows collapse of a steel column at the Tateishi Crossing, Hanshin Expressway. The bridge was completed in 1969 based on the allowable stress design approach using 0.2 horizontal and ± 0.1 vertical seismic coefficients. The steel column at the center was first constructed, and two reinforced concrete

The steel column failed as if it was crushed in vertical direction. The lateral beam buckled and settled down about 6m. Weak concrete was filled inside the column from bottom to 2.3 m high for protection to automobile collision. The thickness of flange and web plates varied from 28 mm at the column-lateral beam joint to 18 mm at the bottom. They were stiffened by vertical stiffeners and diaphragms. The buckling strength of the column is 65,000 kN, while the compression due to the dead weight of three decks is only 14,900 kN. Consequently, more than 4.3 g acceleration is required to result in the damage of column by compression. It is obvious that the failure was not resulted from the vertical excitation.

Photo 3.6 Collapse of a Steel Column, Tateishi Viaduct, 1995 Kobe Earthquake

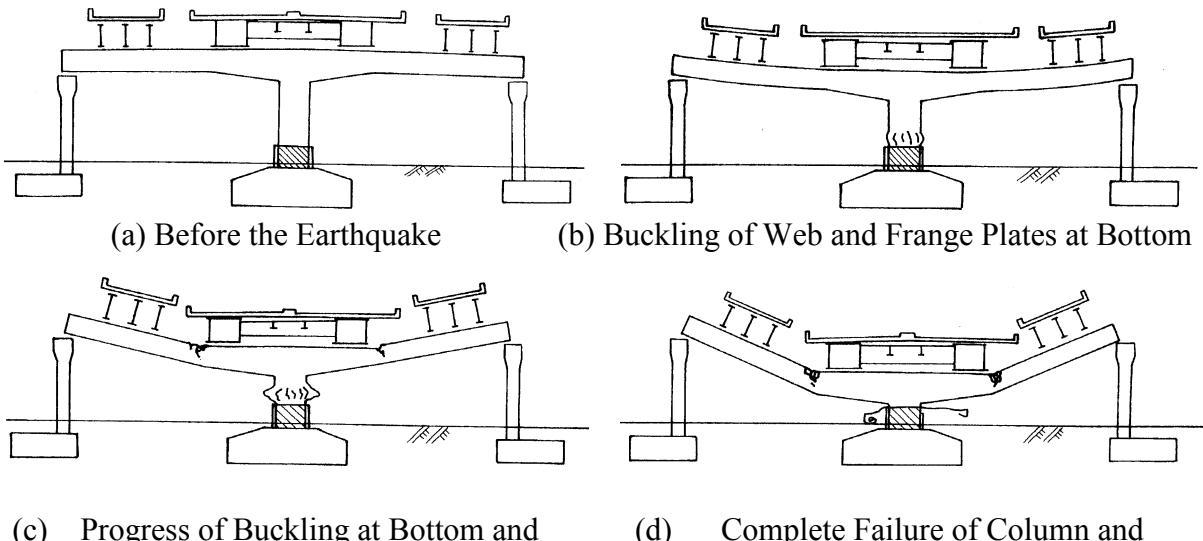
Failure mechanism is shown in Fig. 3.3. Under a strong excitation, local buckling of web and flange plates as well as rupture of welded corner occurred at the bottom of column. This decreased the bearing capacity of the column in both lateral and vertical directions, which progressed the settle down of the column due to dead weight of the decks. This caused buckling to occur at both sides of the center deck, and this further progressed the buckling of the column.

- (c) Progress of Buckling at Bottom and Buckling of Lateral Beam
- d) Complete Failure of Column and Settlement of Lateral Beam

Fig. 3.3 Failure Mechanism of Tateishi Viaduct

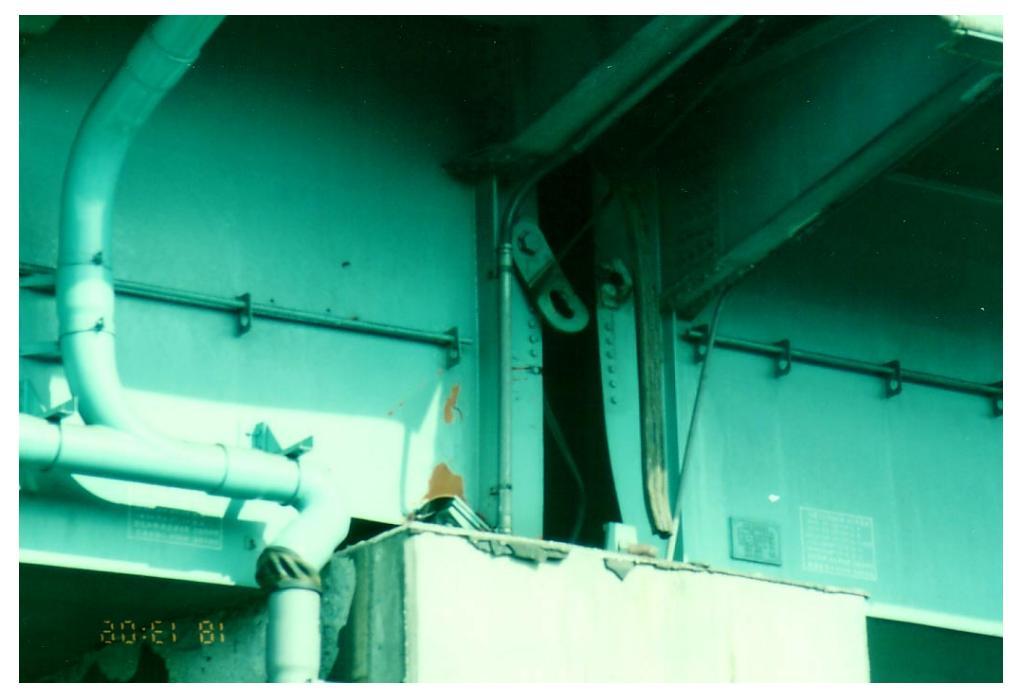
Unseating prevention devices are important to prevent collapse of a bridge system even when destructive damage occurs. They have fail-safety function. However, failure of various types unseating prevention devices occurred. For example, Photos 3.7 and 3.8 show a failure of plate-type unseating prevention device and a cable restrainer, respectively. They were designed using design forces multiplying 0.3-0.4 seismic coefficient by a static reaction force. It was obvious that the design force was too small.

Photo 3.7 Failure of Unseating Prevention Device, Kobe Earthquake

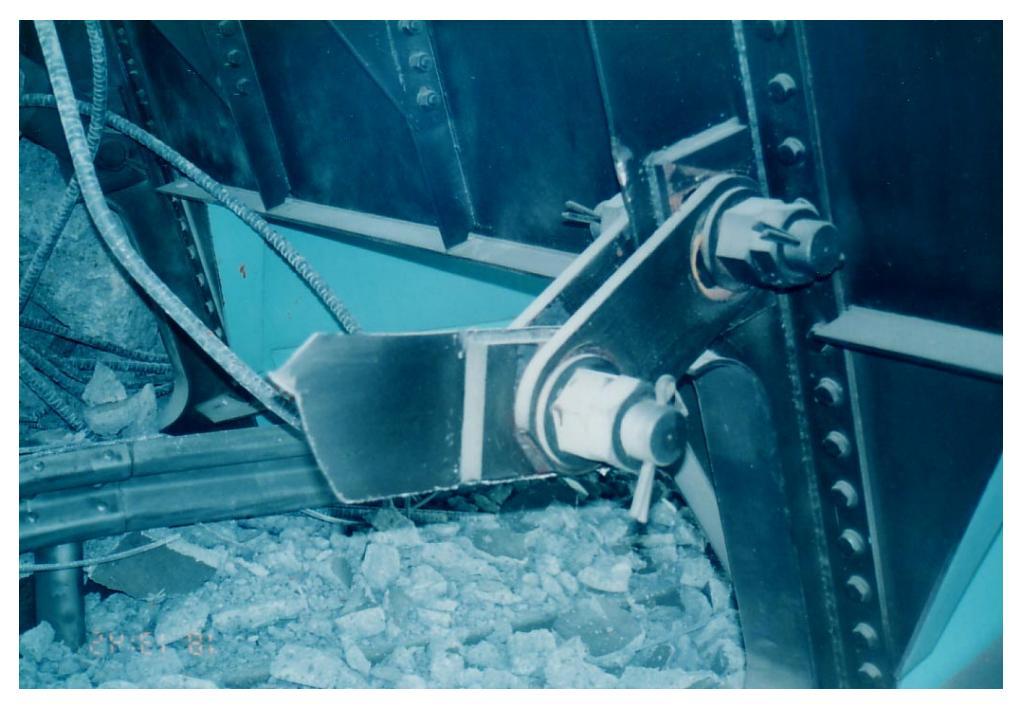
Photo 3.8 Failure of Unseating Prevention Device, Kobe Earthquake

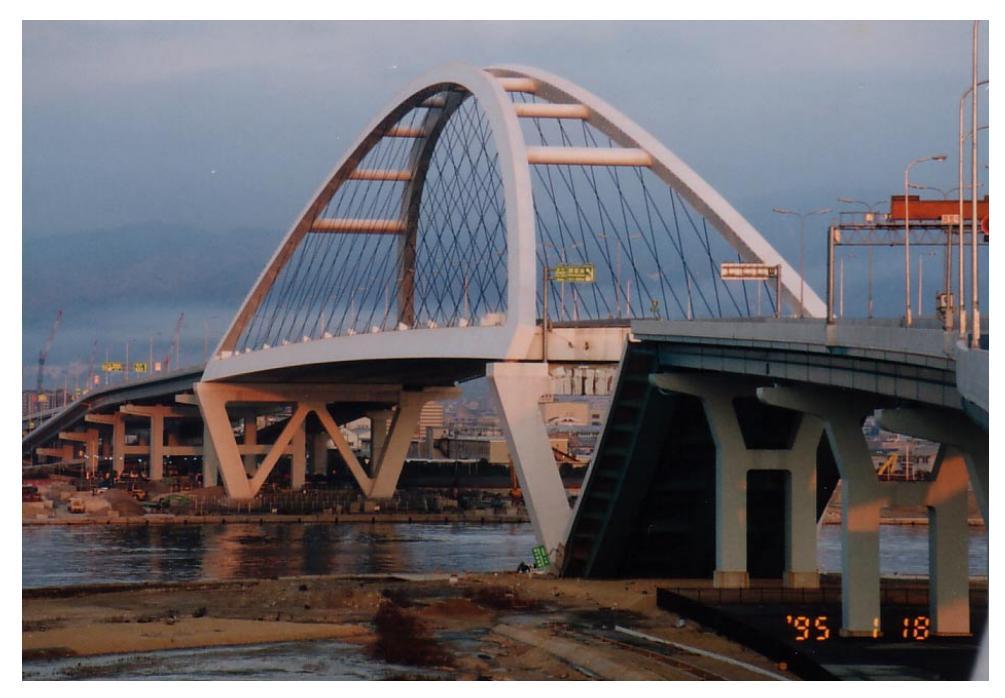
Unseating prevention devices also affect the total response of a bridge system. A good example for this is the collapse of an approach span of the Nishinomiya Bridge system, Hanshin Expressway, as shown in Photo 3.9. The main bridge was a Nielsen Lohse bridge with a mass of 12,000 t, while the approach span was a steel plate girder bridge with a mass of 1,900 t. These two structures were tied together by plate-type restrainers. The damage was initiated by failure of fixed-bearings of the main bridge. This allowed large response displacement of the main bridge to take place, and the main bridge pulled the approach span, which resulted in failure of the fixed-bearings in the approach span. As a consequence the approach span dislodged from its support when the decks moved in the other direction. The unseating prevention devices were not strong enough to support the approach span once it dislodged from the support.

Photo 3.9 Collapse of an Approach Span, Nishinomiya Bridge, 1995 Kobe Earthquake

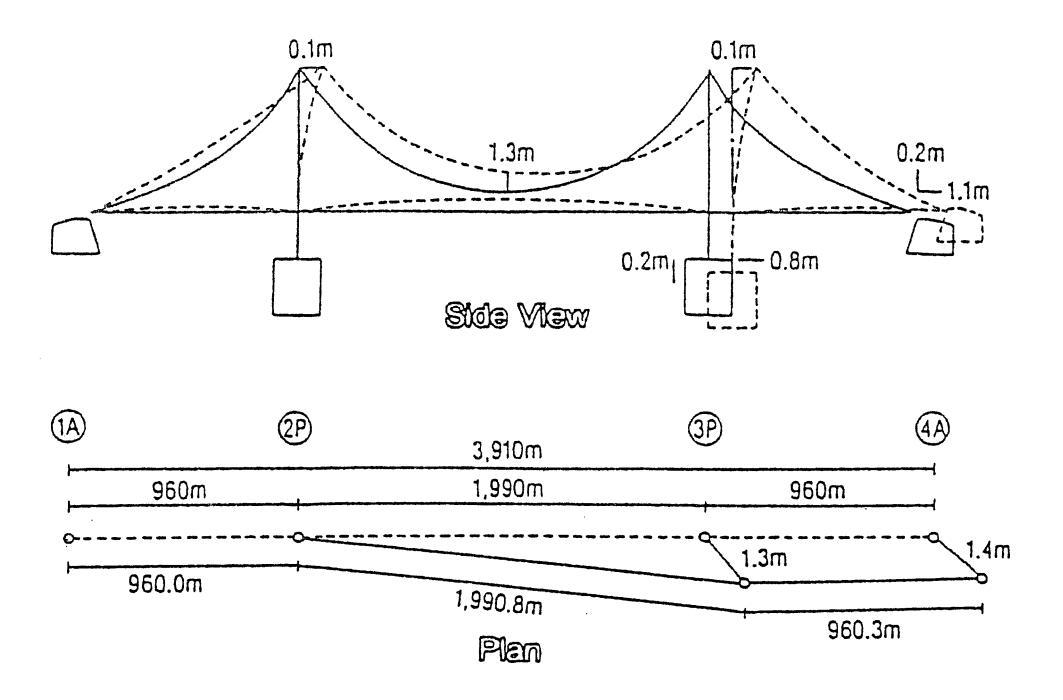
The world-longest Akashi Straight Bridge (refer to Photo 3.10) was under construction when the earthquake occurred. Two abutments and two main towers were already completed, and cables hanged a part of the superstructure. The fault crossed the bridge between two tower foundations (P2 and P3). This resulted in the permanent movements and rotations of the anchorage and tower foundations as shown in Fig. 3.4 (Saeki et al 1997, Yasuda et al 2000). P3 tower foundation and A4 anchorage were dislocated 1.3m and 1.4m, respectively, relative to 1A anchorage and P2 tower foundation. This increased the center-span length from 1990m to 1990.84m, and the total bridge length from 3910m to 3911.09. Survey after the earthquake revealed that there was not any damage in the structures except the permanent movements. The superstructure was erected by slightly changing the length.

Fig. 3.4 Permanent Offset of Foundations, Akashi Straight Bridge, 1995 Kobe Earthquake (Saeki et al, 1997)

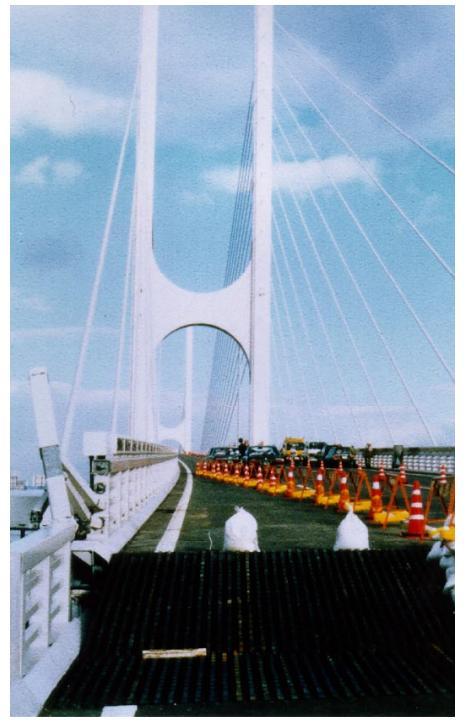
Higashi Kobe Bridge, a cable stayed bridge with 485m center span and two 200m side spans, suffered a controlled damage at dampers and bearings on one of the two end piers. Since reaction force of the deck resulting from the dead load was negative, a pair of steel bearings was provided to pull the deck down at the end pier. Vane-type rotating viscous dampers and window bearings were also provided at the end pier for the distribution of the seismic lateral force of the deck in longitudinal direction and the prevention of excessive transverse response of the deck resulting from high wind, respectively. The steel bearings suffered damage resulting in an about 0.4m uplift of the deck as shown in Photo 3.11. A connection of the rotating viscous damper suffered damage due to excessive longitudinal displacement as shown in Photo 3.12, and the window shoe also suffered some flexural and shear buckling.

Photo 3.11 Uplift of Deck, Higashi-Kobe Bridge, 1995 Kobe Earthquake

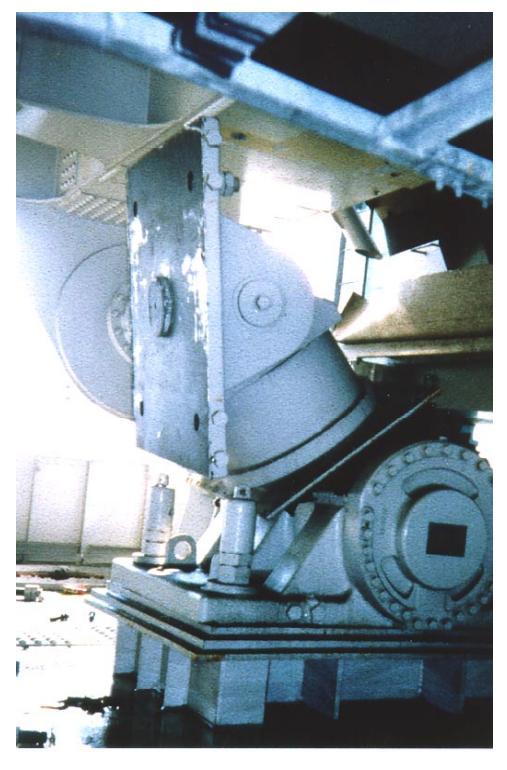
Photo 3.12 Failure of a Conector of Rotating Viscous Damper, Higashi-Kobe Bridge

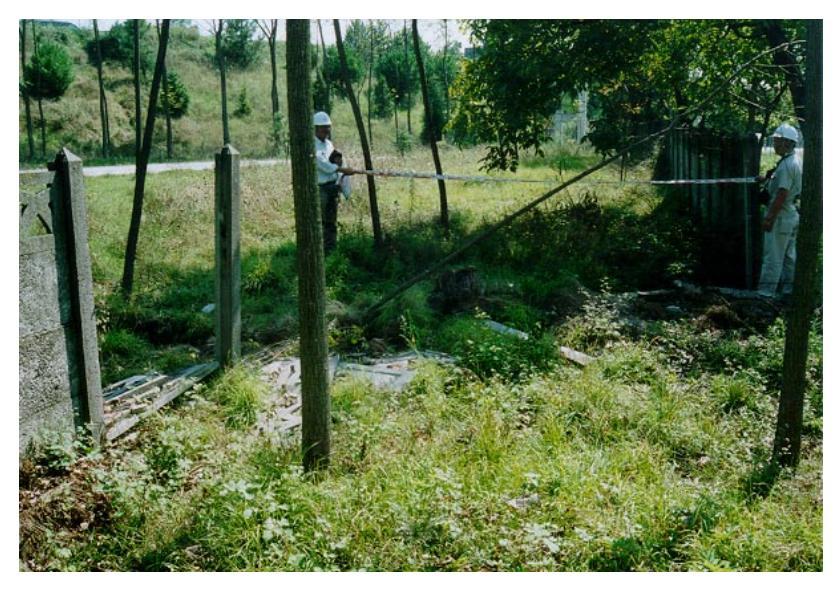
Photo 3.13 4.3m Offset of a Concrete Fence (Arifiye)

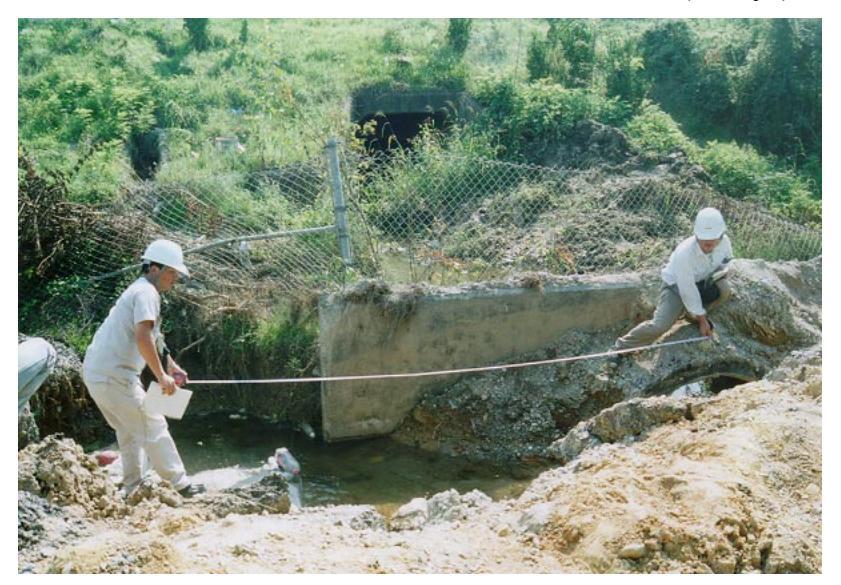
Photo 3.14 3.6m Offset of a Drainage Pipe (Arifiye)

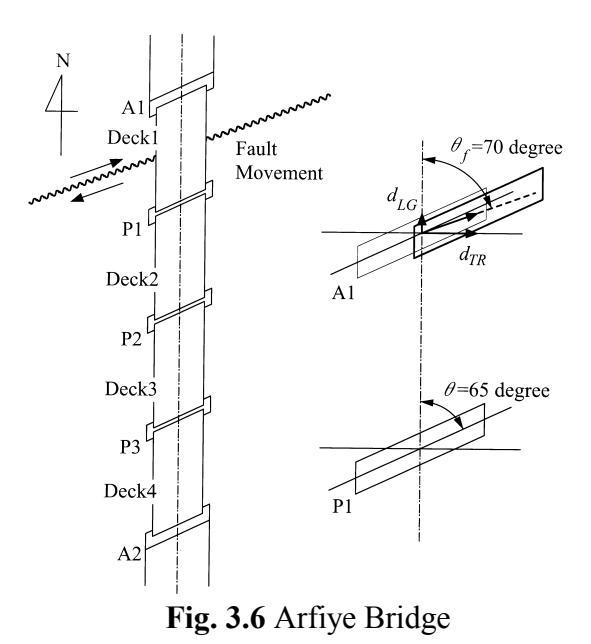
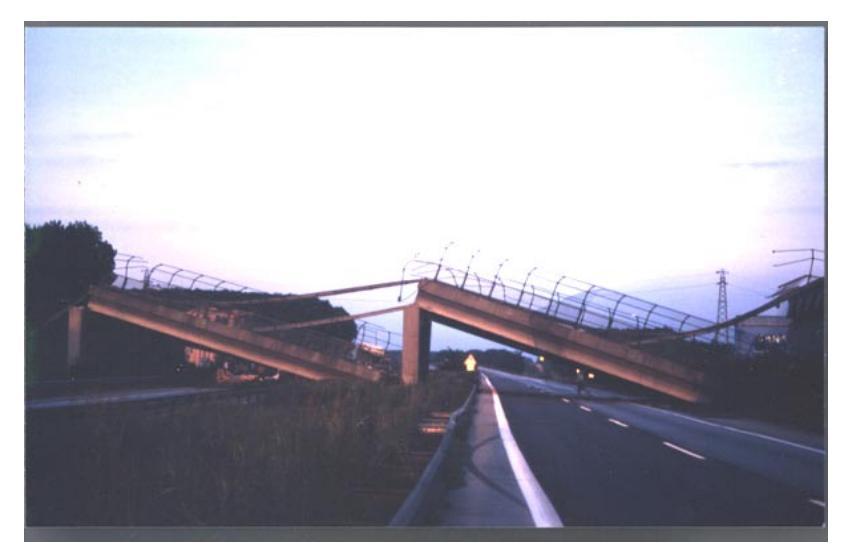
The Arifiye Overpass, a 4 span simply supported prestressed concrete bridge, collapsed as shown in Photo 3.15. It was a skewed bridge with an angle of 65-degree. The fault crossed the bridge between A1 and P1 at an angle θ of 70-degree as shown in Fig. 3.6. The right-lateral strike-slip fault dislocated A1 in northeast direction relative to P1-P3 and A2. Representing D_0 the displacement amplitude along the fault, the relative extension and sway of A1 to P1-P3 in longitudinal and transverse directions, d_{LG} and d_{TR} , are $d_{TR} = D_0 \cdot \sin \theta$ and $d_{LG} = D_0 \cdot \cos \theta$. Assuming $D_0 \approx 4$ m and $\theta \approx 70$ -degree, the relative extension between A1 and P1 in longitudinal direction, d_{LG} , is 1.37m, which is much longer than the seat length of 0.6 m at A1 and 0.45 m at P1. The deck between A1 and P1 dislodged from the supports resulting from such a large relative displacement.

Photo 3.15 Collapse of Arifiye Bridge

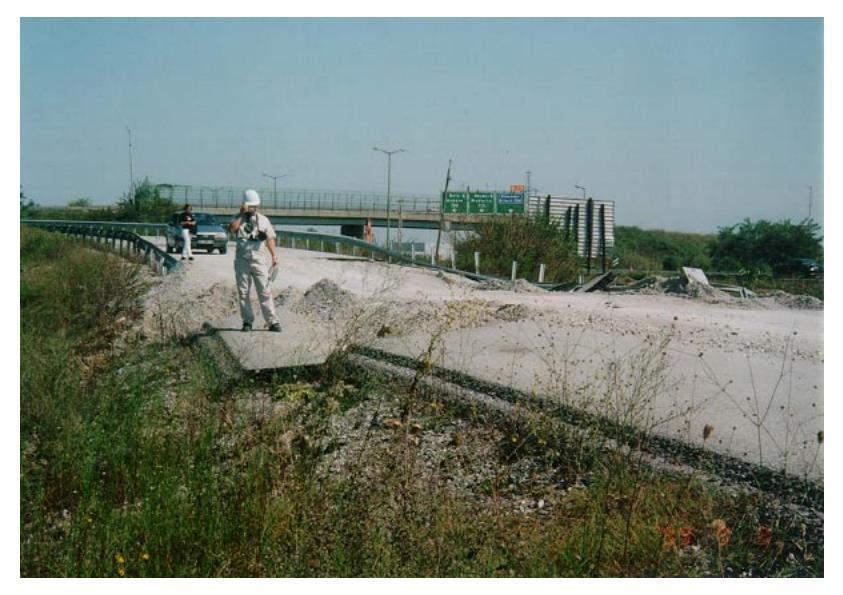
Near the Arifiye Overpass, there were several overpasses similar to the Arifiye Overpass. In general, their seismic performance was satisfactory. For example, the fault crossed a 2 span simply supported prestressed concrete overpass at its abutment as shown in Photo 3.16. However, the damage was limited.

Photo 3.16 Limited Damage of an Overpass where a Fault Crossed at its Abutment

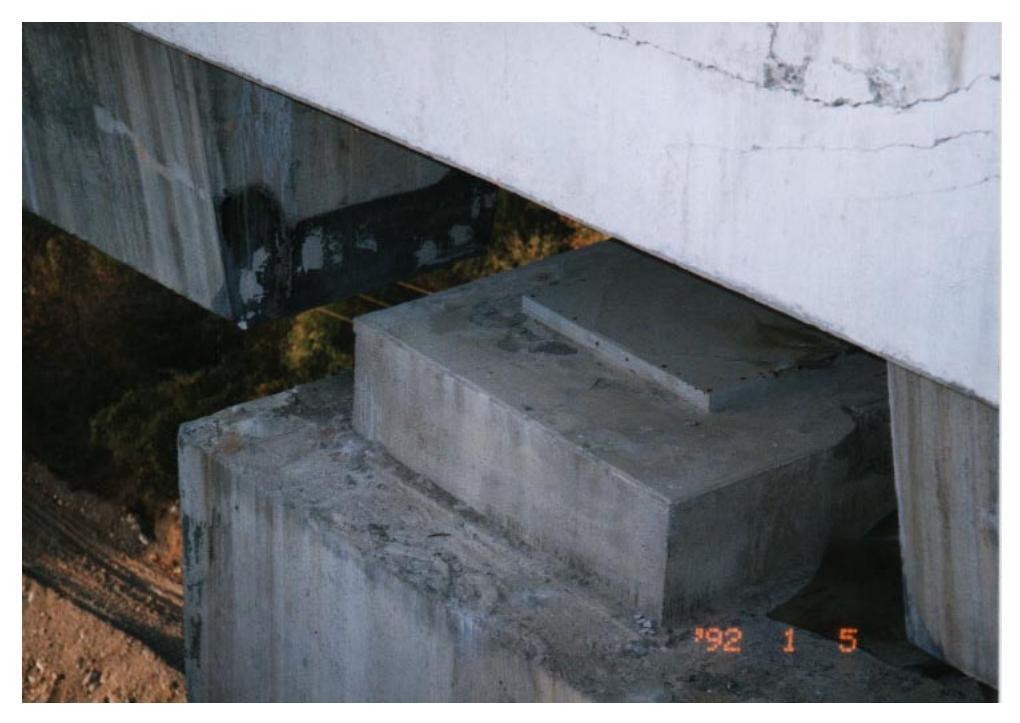
As a result, some pile foundations tilted and rotated. Most decks moved in longitudinal and transversal directions. At several piers, the girders offset from the pedestal, and were hung only by the concrete decks as shown in Photo 3.18. As a result, the concrete decks suffered extensive shear failure. Some decks were about to fall from their supports.

Photo 3.18 Girder Offset from Support, Bolu Viaduct

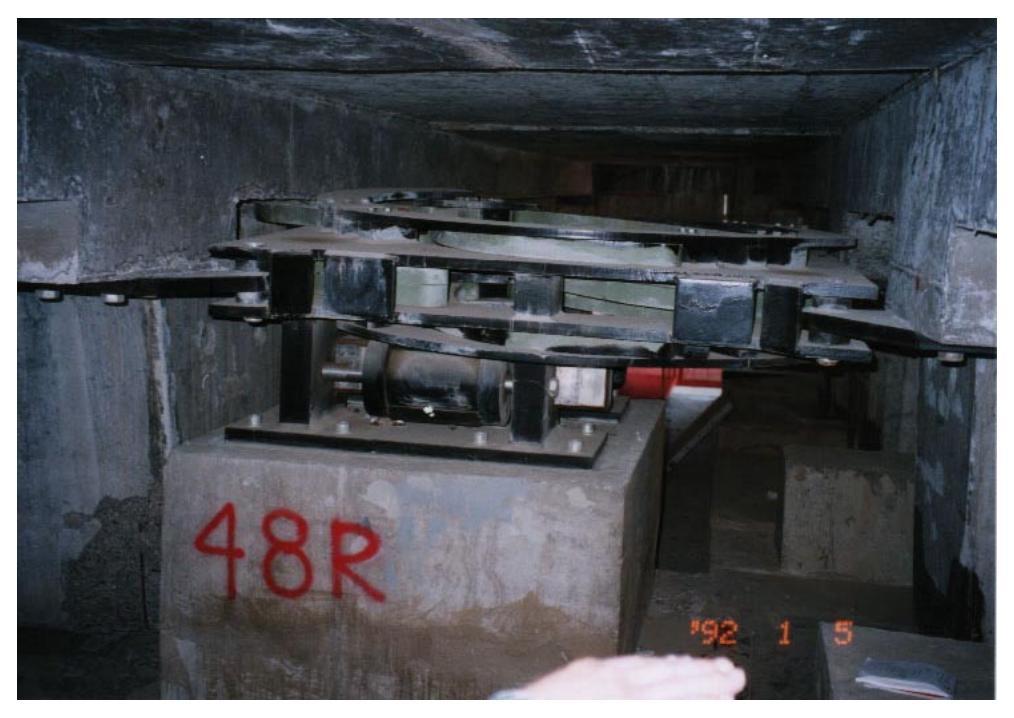
Photo 3.19 shows damage of an energy-dissipating unit and a viscous damper stopper at Pier 48R. The C-shaped energy dissipating elements suffered damage, resulting from an excessive deck movement.

Photo 3.19 Damage of Energy Dissipating Unit and Viscous Damper Stopper, Bolu Viaduct

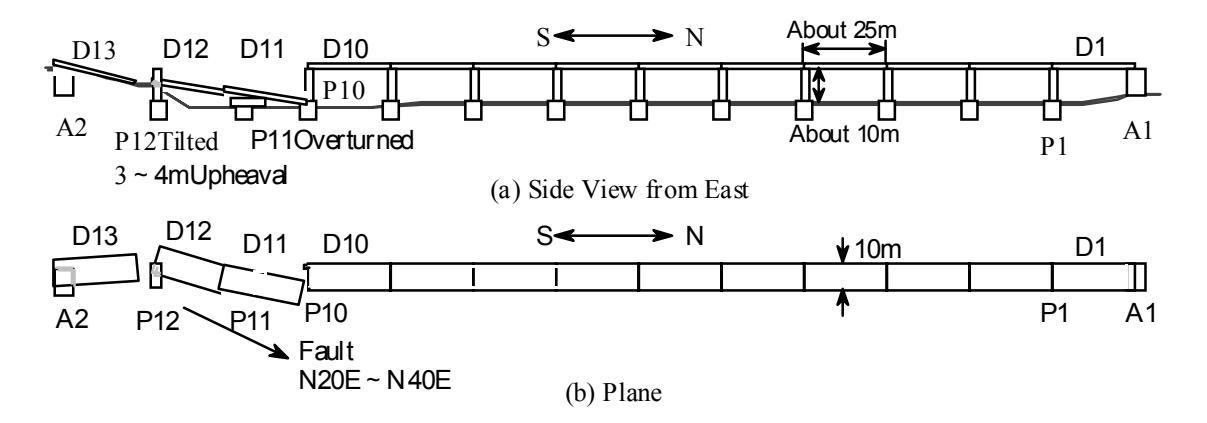
Bei-Fong Bridge was a 13-span simply supported I-beam girder constructed in 1991. The fault crossed the bridge between A2 and P12 at an angle of 42-degree. The south most three spans collapsed as shown in Fig. 3.10 with other spans being free from damage. A2, P12 and P11 were up heaved about 3-4m, and P12 and A2 were laterally displaced about 3.5m and 4m, respectively, in downstream direction (west) as shown in Photo 3.20.

Fig.3.10 Collapse of Bei-Fong Bridge, Chi Chi Earthquake

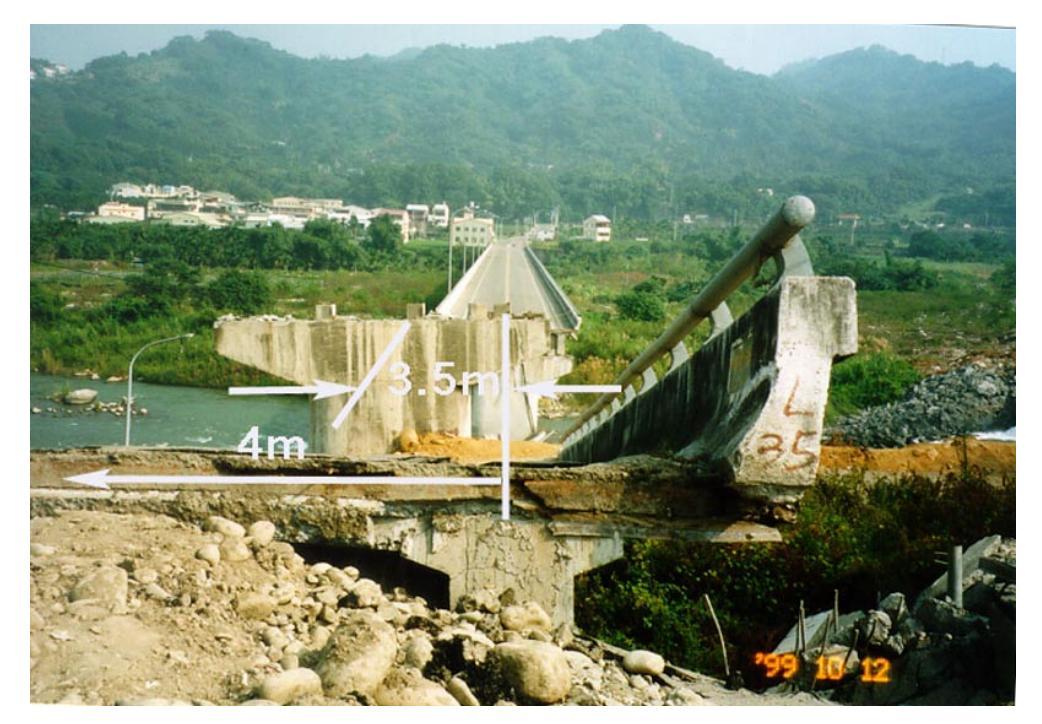
Photo 3.19 Lateral Movement of A2 and P2, Bei-Fong Bridge, Chi Chi Earthquake

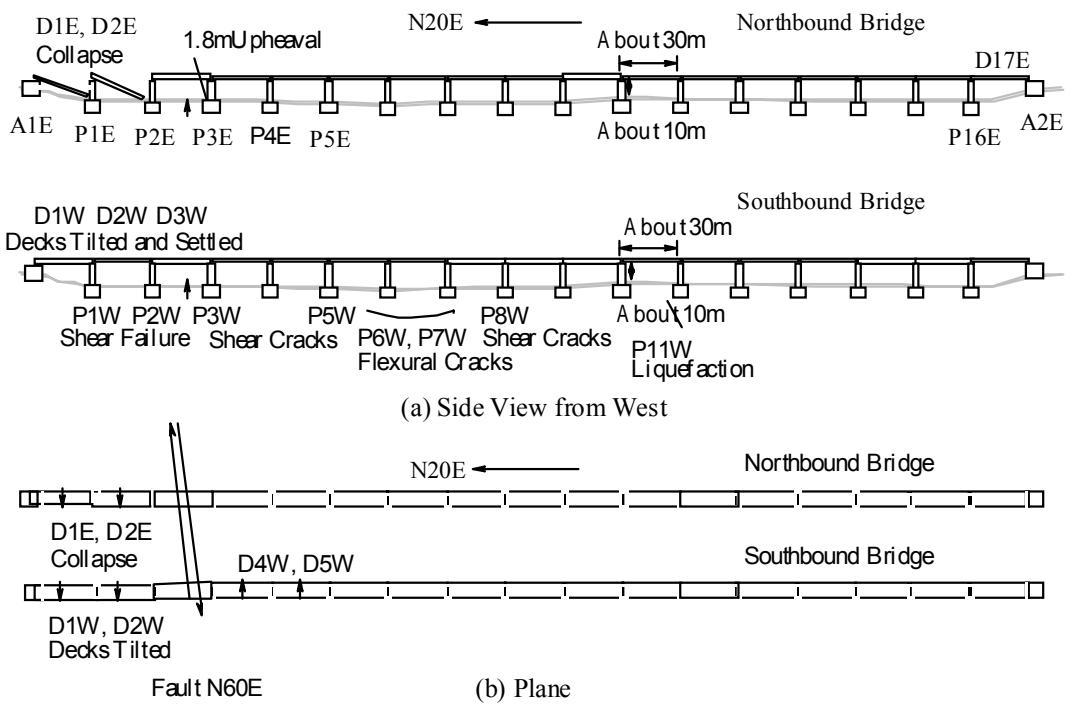
Wu-Shi Bridge consisted of a northbound bridge (upstream, east) and a southbound bridge (downstream, west) as shown in Fig. 3.11. They were 17-span simply supported PC beam girders. The northbound and southbound bridges are identified here by putting "E" and "W", respectively. The southbound bridge was newer than the northbound bridge. As shown in Photo 3.21, the northbound bridge was supported by 8.5m x 3m wall piers, while 5m x 2m rectangular reinforced concrete piers supported the southbound bridge.

Fig. 3.11 Collapse of Wu-Shi Bridge

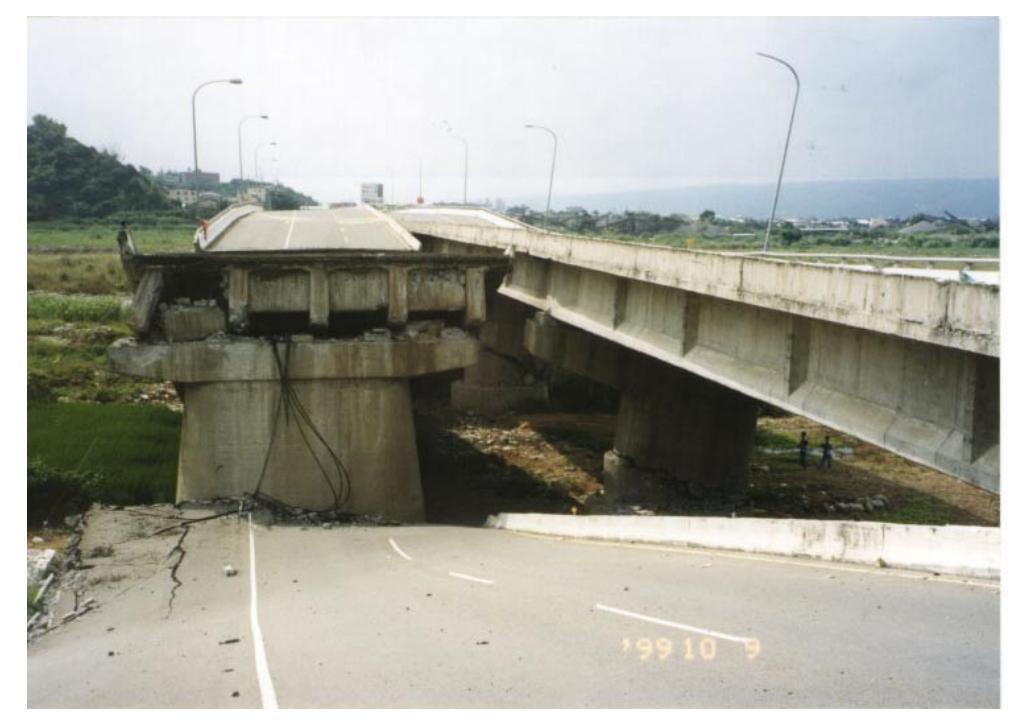
Photo 3.21 Collapse of Wu-Shi Bridge, Chi Chi Earthquake

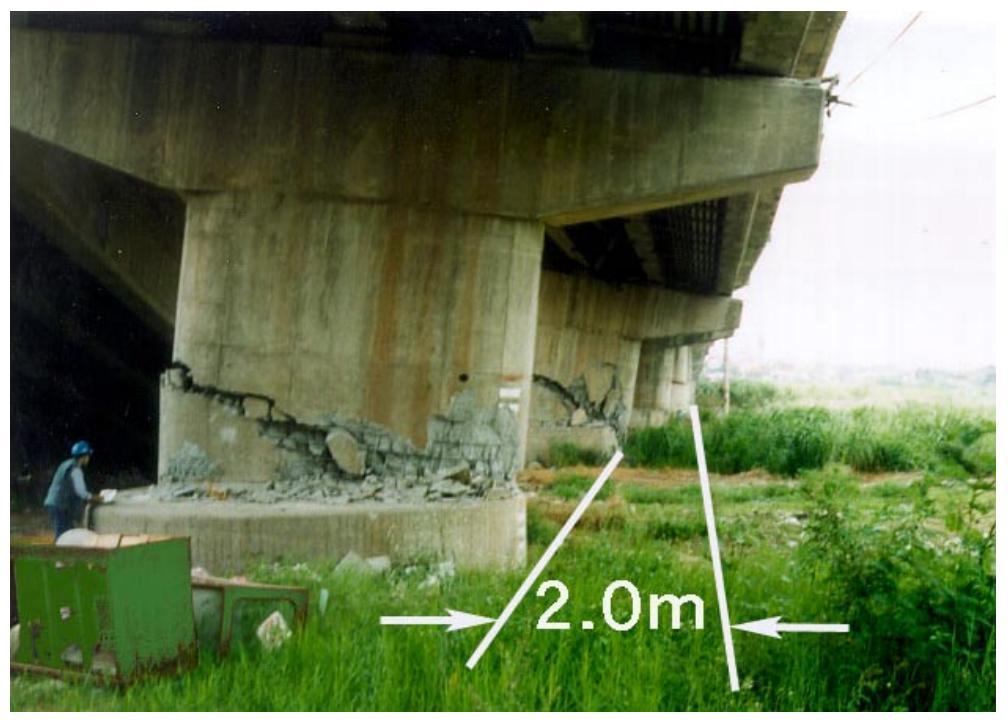
A fault crossed the bridge between P2 (P2E & P2W) and P3 (P3E & P3W) at an angle of about 40-degree N60E). As a result, most piers in the southbound bridge suffered extensive damage. In particular, P1W and P2W failed in shear from east to west as shown in Photo 3.22. The caisson foundation at P3W suffered shear failure from east to west, as shown in Photo 3.23, as a direct result of fault movement.

Photo 3.22 Lateral Movement of P1W and P2W, Wu-Shi Bridge

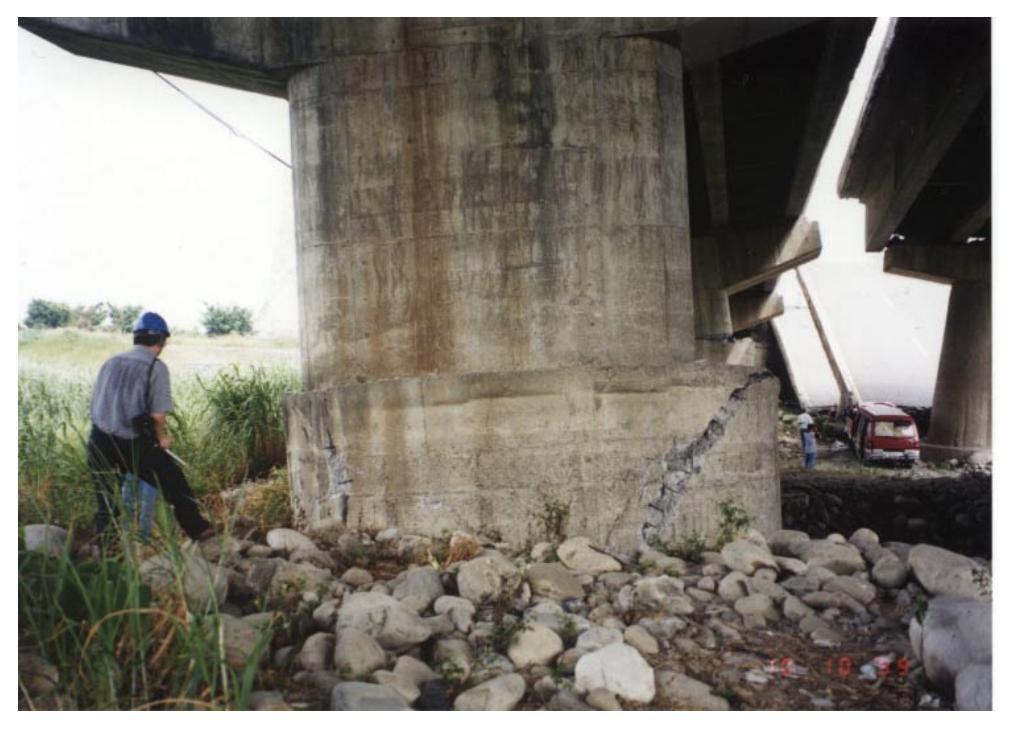
Photo 3.23 Shear Failure of Caisson Foundation Reslting from Fault Movement, Wu-Shi Bridge
