## Response Modification of Urban Infrastructure 都市施設の免震設計

(2) Chapter 2 Seismic Damage of Bridges due to Ground Vibration (Part 1)
 (2)2章 地震動による橋梁の地震被害 (Part 1)

Kazuhiko Kawashima Department of Civil Engineering Tokyo institute of Technology 東京工業大学大学院理工学研究科土木工学専攻 川島一彦

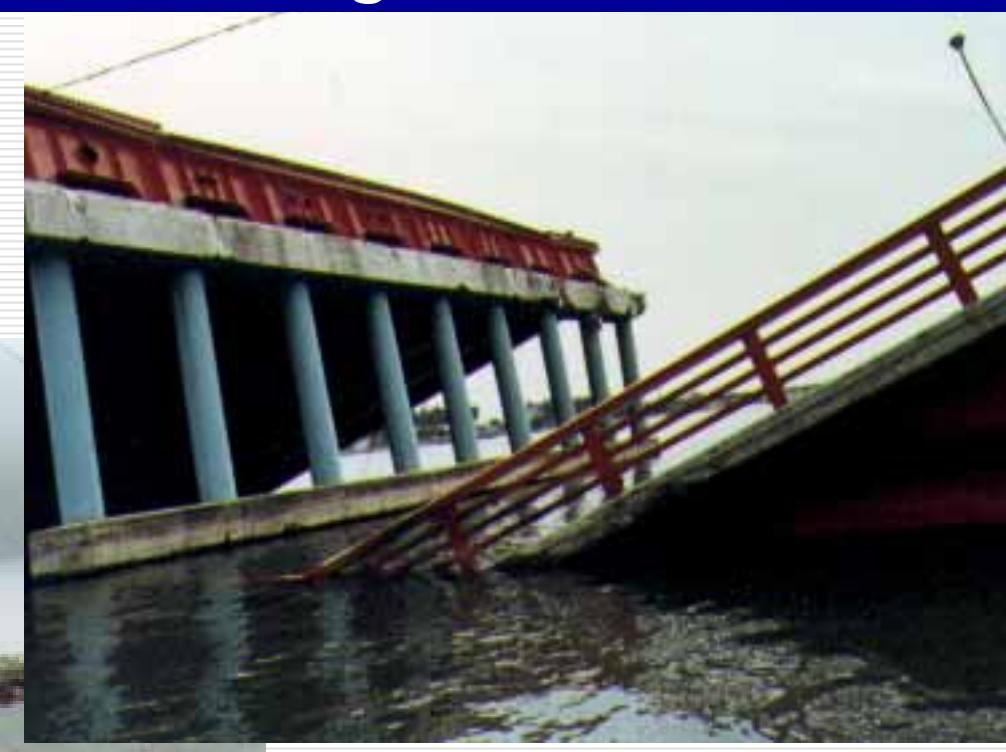
Showa Bridge

#### 1964 Niigata Earthquake

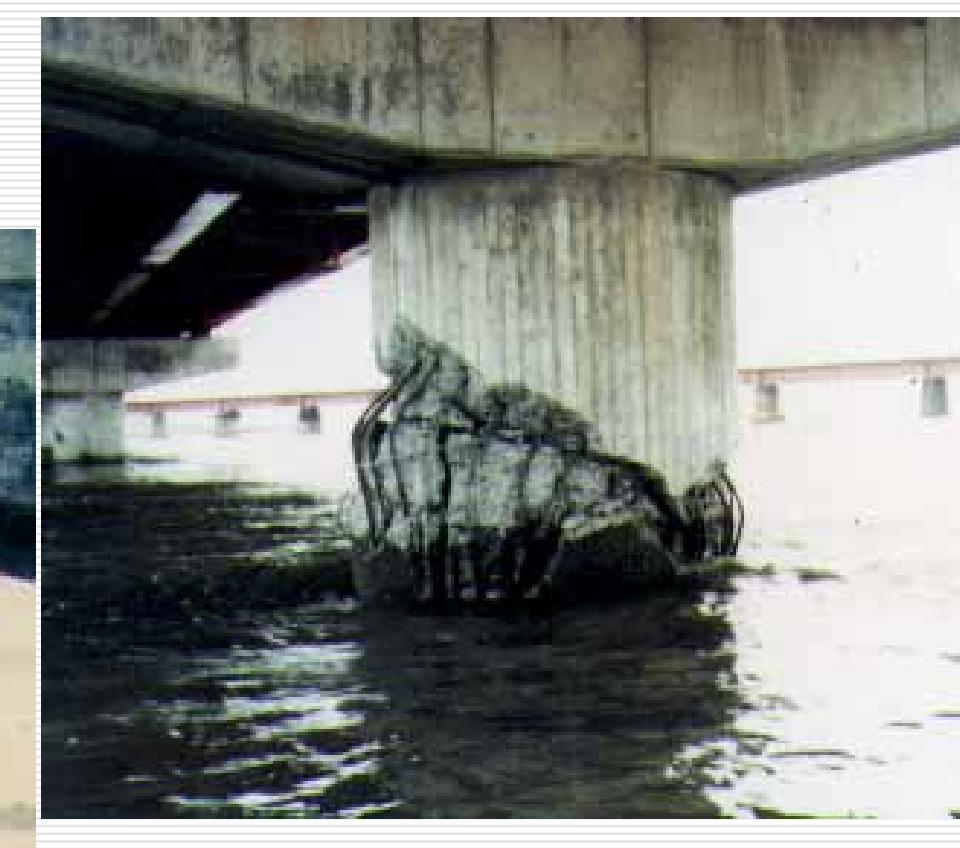
Shizunai Bridge 静内橋

1982 Urakawa-oki Earthquake **浦河沖地震**

Shear failure of RC Columns

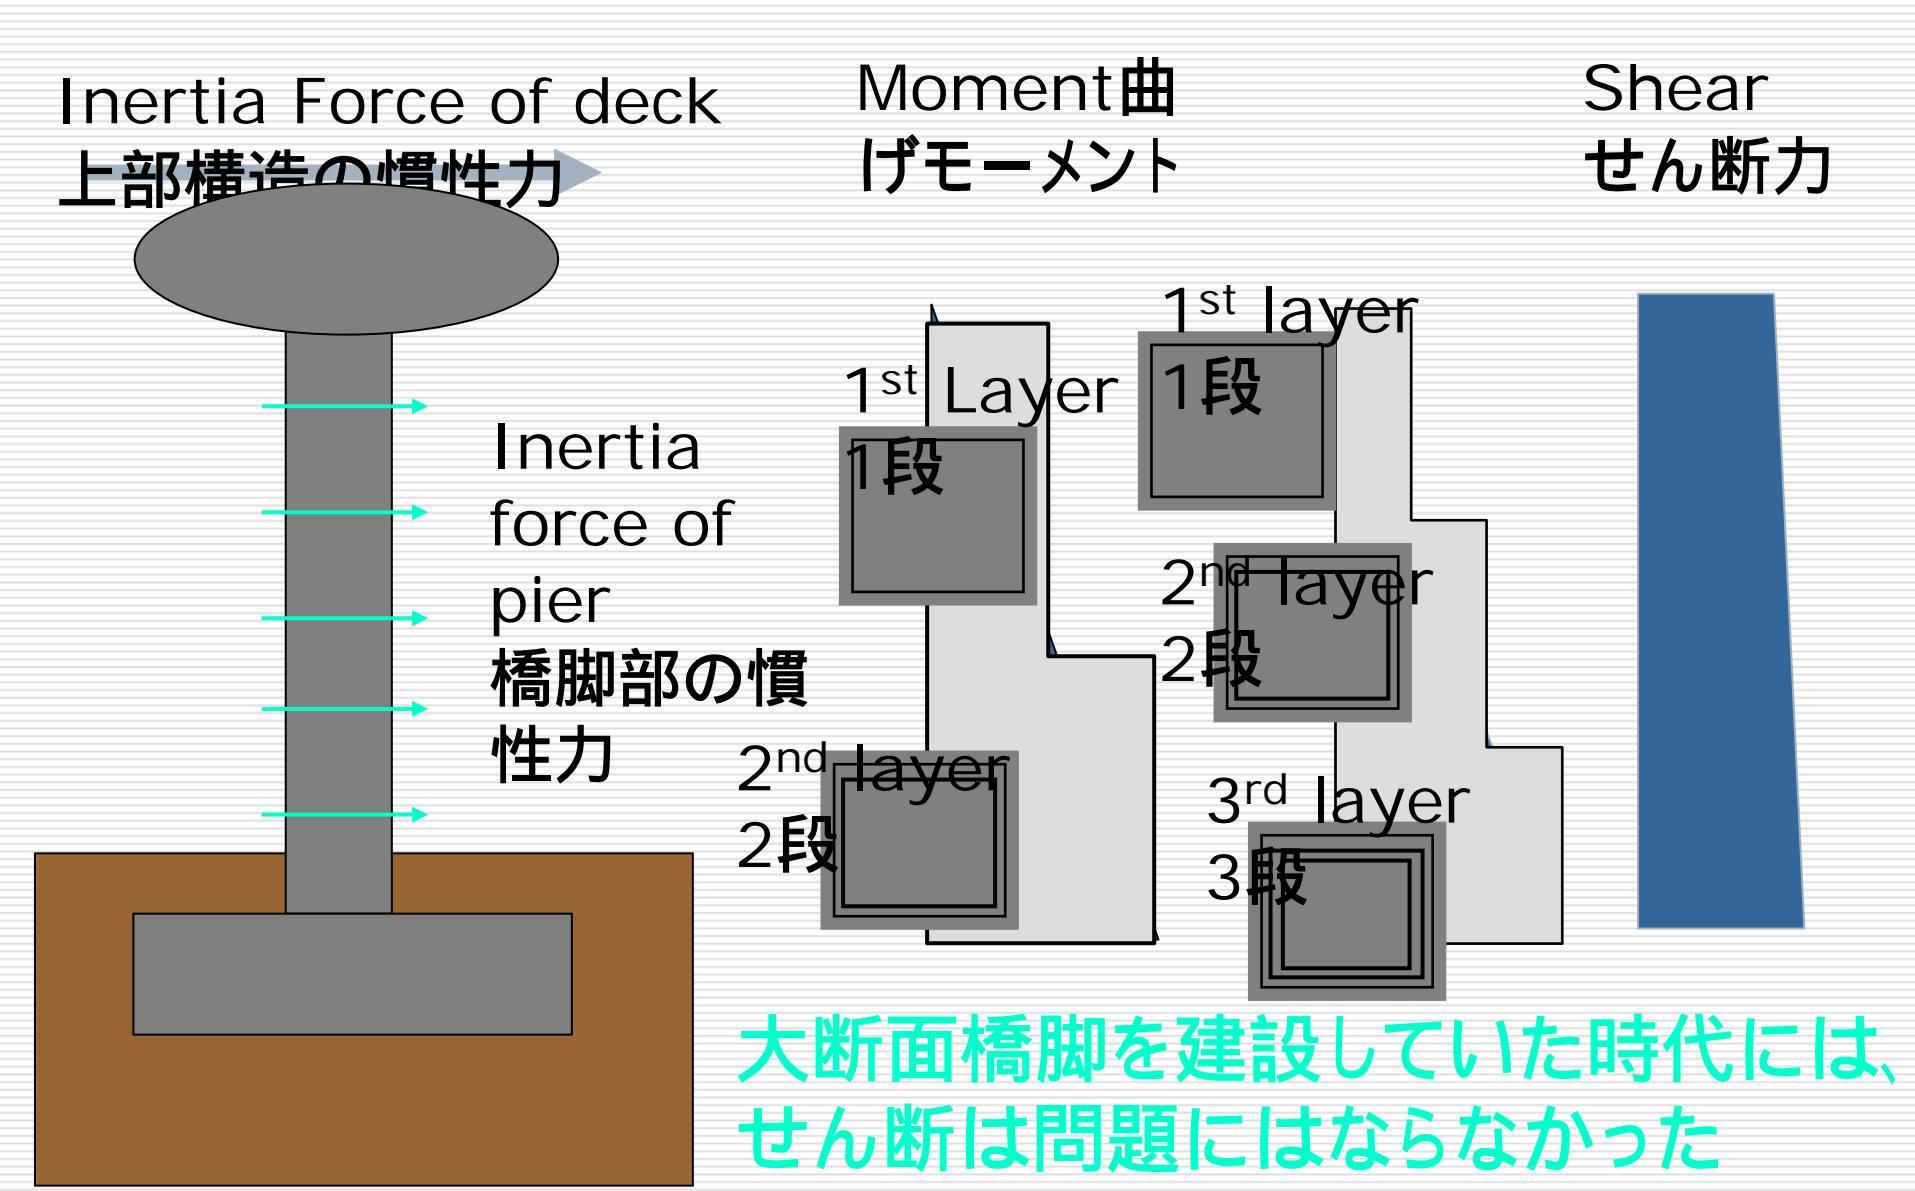
## Premature Shear Failure of RC Piers 橋脚のせん断破壊

## Why is the number of longitudinal bars reduced at the upper part of a pier?

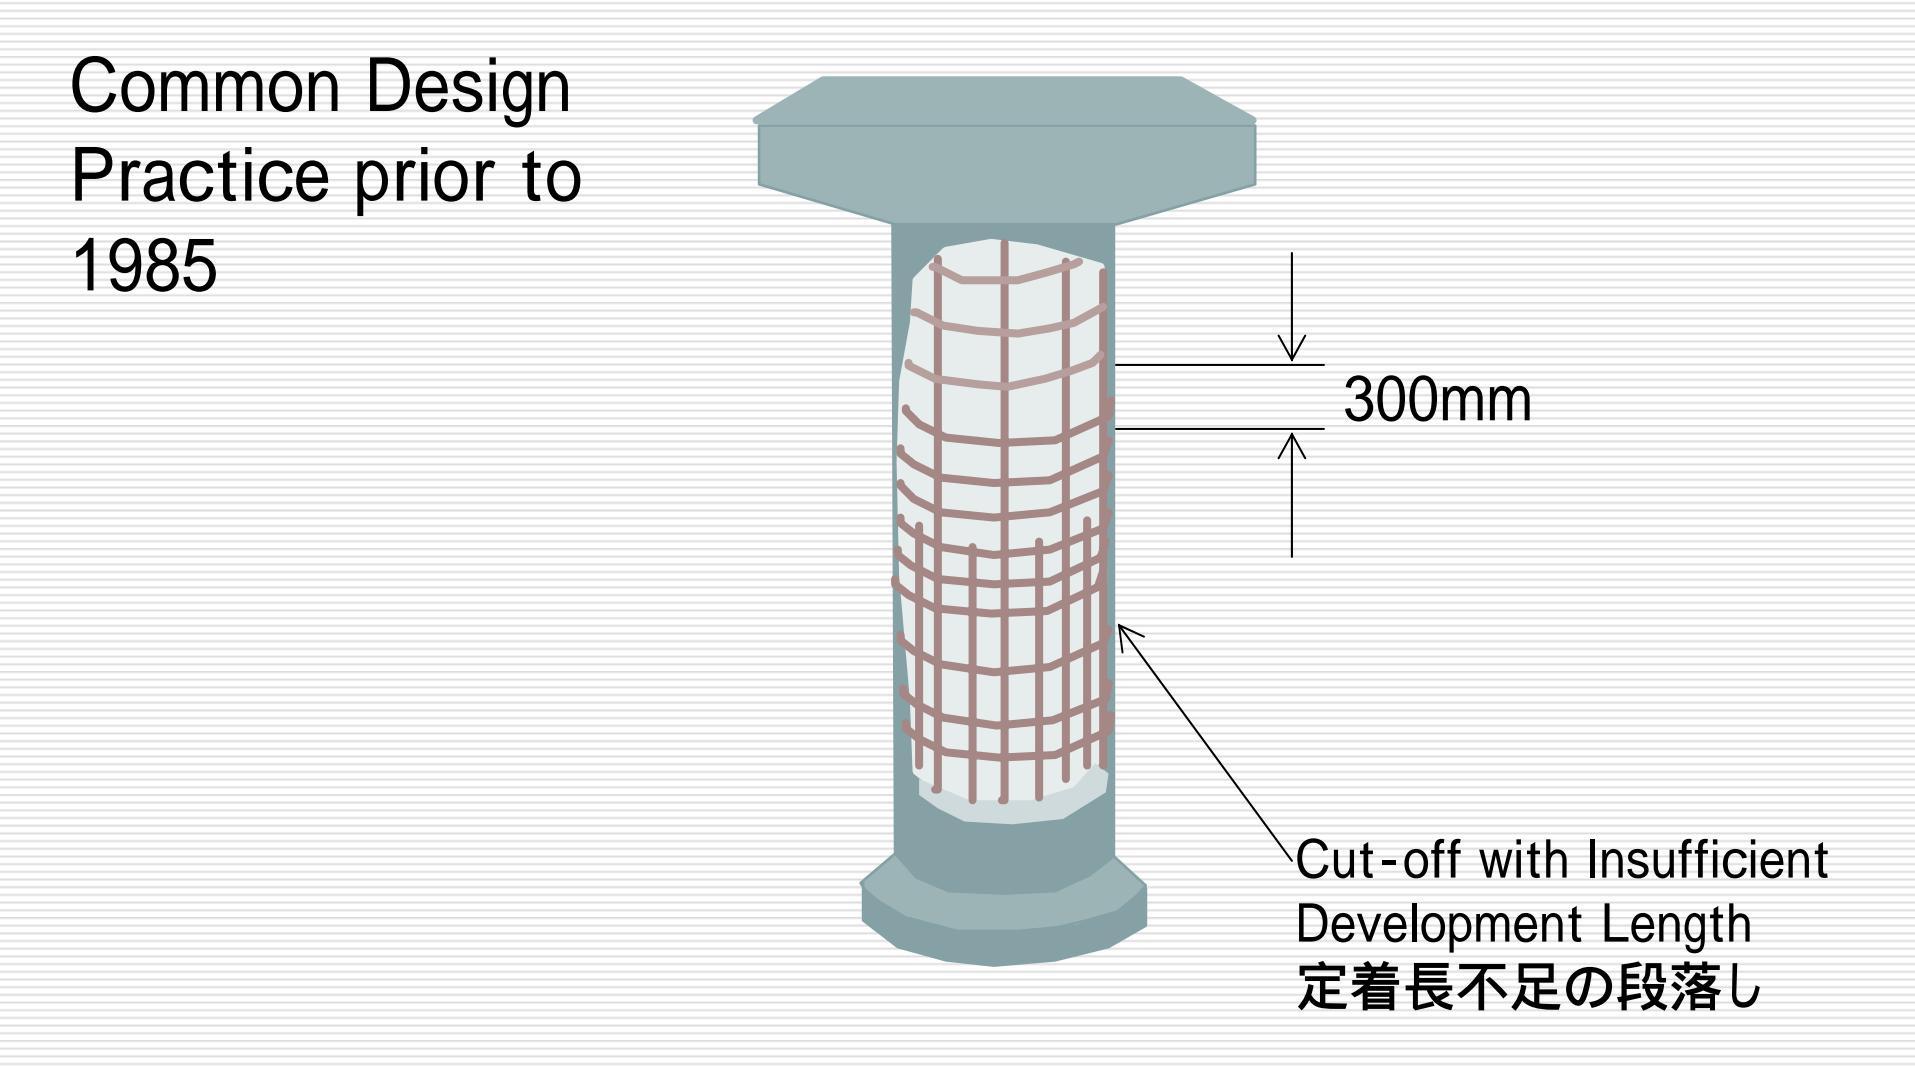
Shear Failure of Reinforced Concrete Piers Resulting from Insufficient Development Length 定着長不足の主鉄筋段落しに起因するせん断破壊

Developed by bending inside **主鉄筋を内側に曲げて定着**  Develop by extending bars with a certain length **主鉄筋をまっすぐ定着する場合**
