Seismic Design of Urban Infrastructures

Chapter 2 Seismic Damage of Bridges in Past Earthquakes

Kazuhiko Kawashima Tokyo Institute of Technology

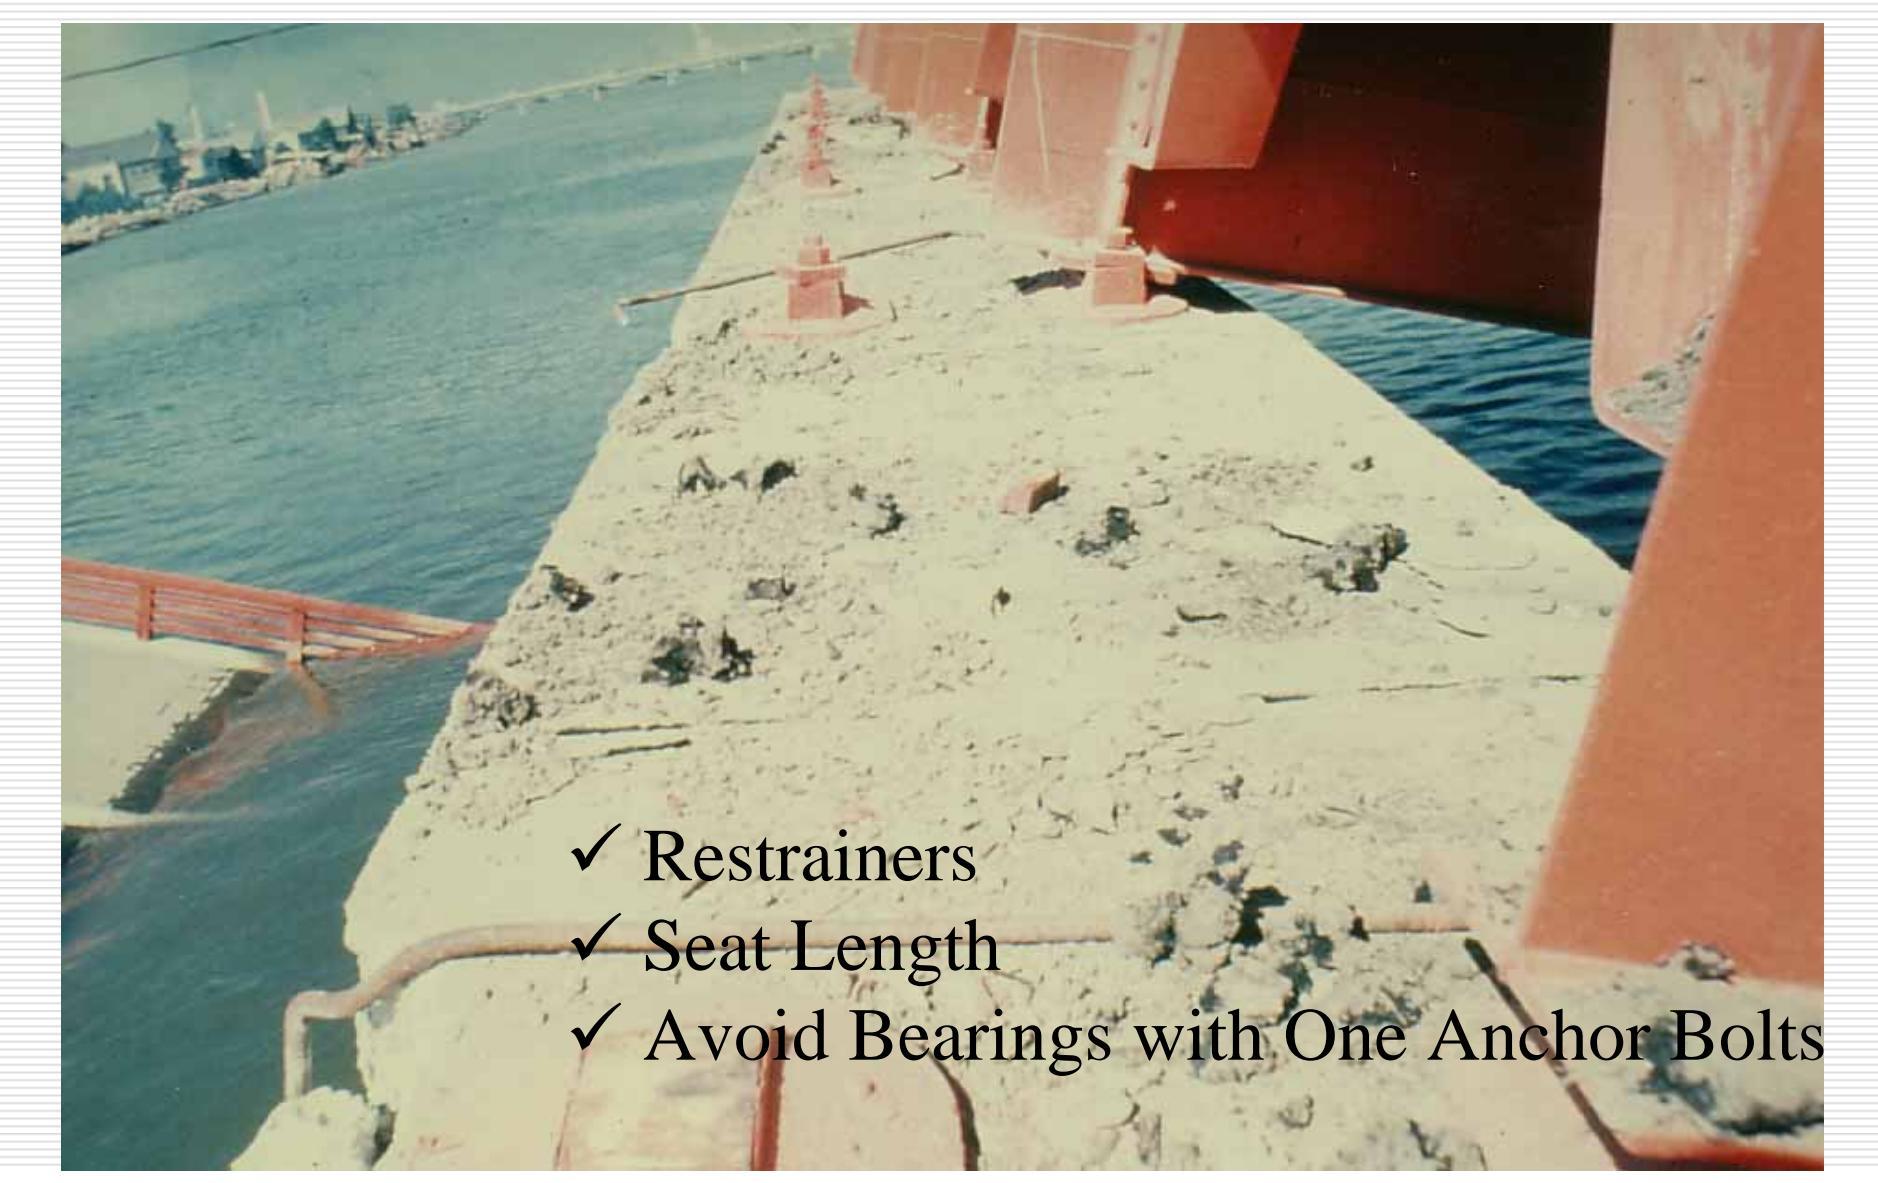
Showa Bridge

This damage resulted in the first development of unseating prevention devices

•Effectiveness of unseating prevention devices was recognized by Japanese engineers who investigated the damage of bridges in 1964 Niigata earthquake.

•They proposed to

\checkmark extend the seat length

✓ provide connection between adjacent decks

\checkmark connect the deck to the substructures

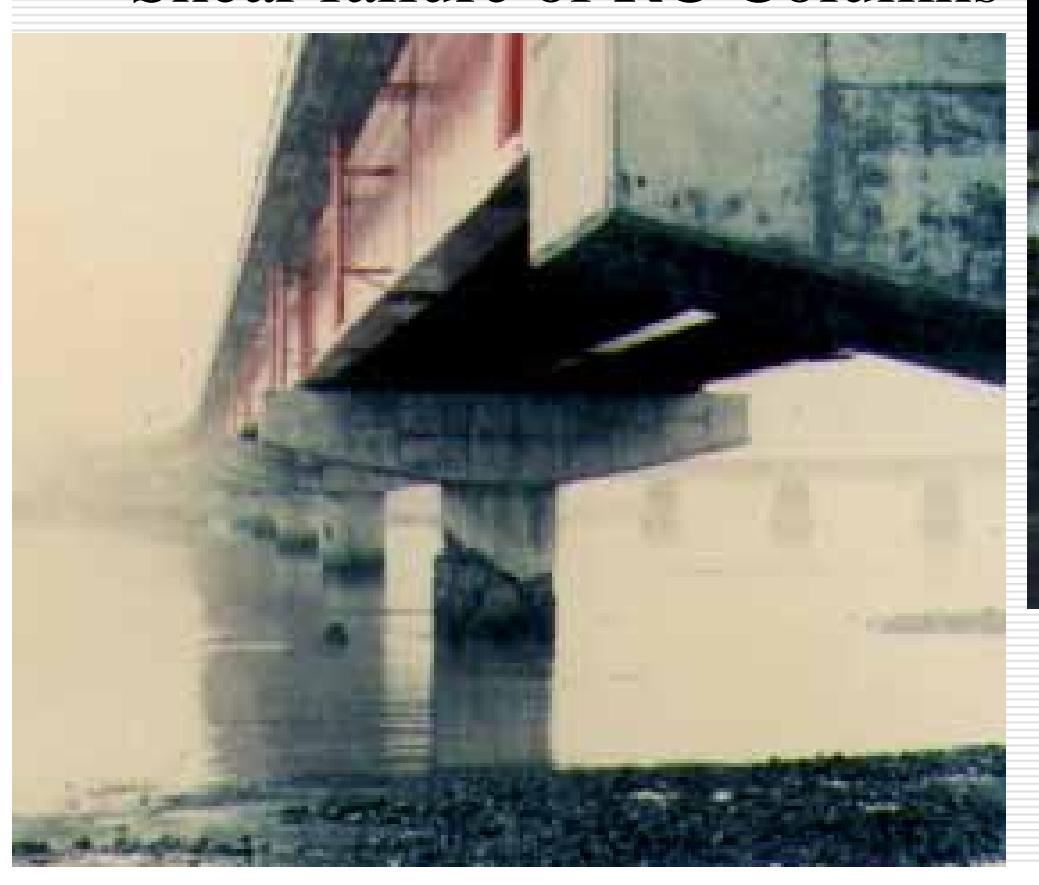
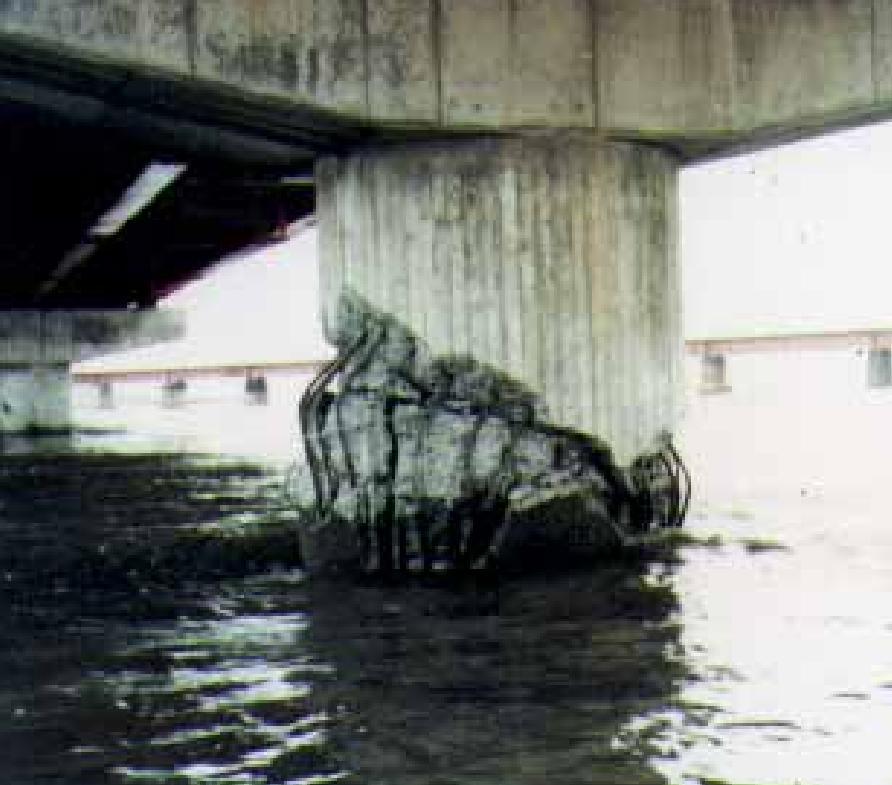
Shizunai Bridge

Shear failure of RC Columns

Premature Shear Failure of RC Piers

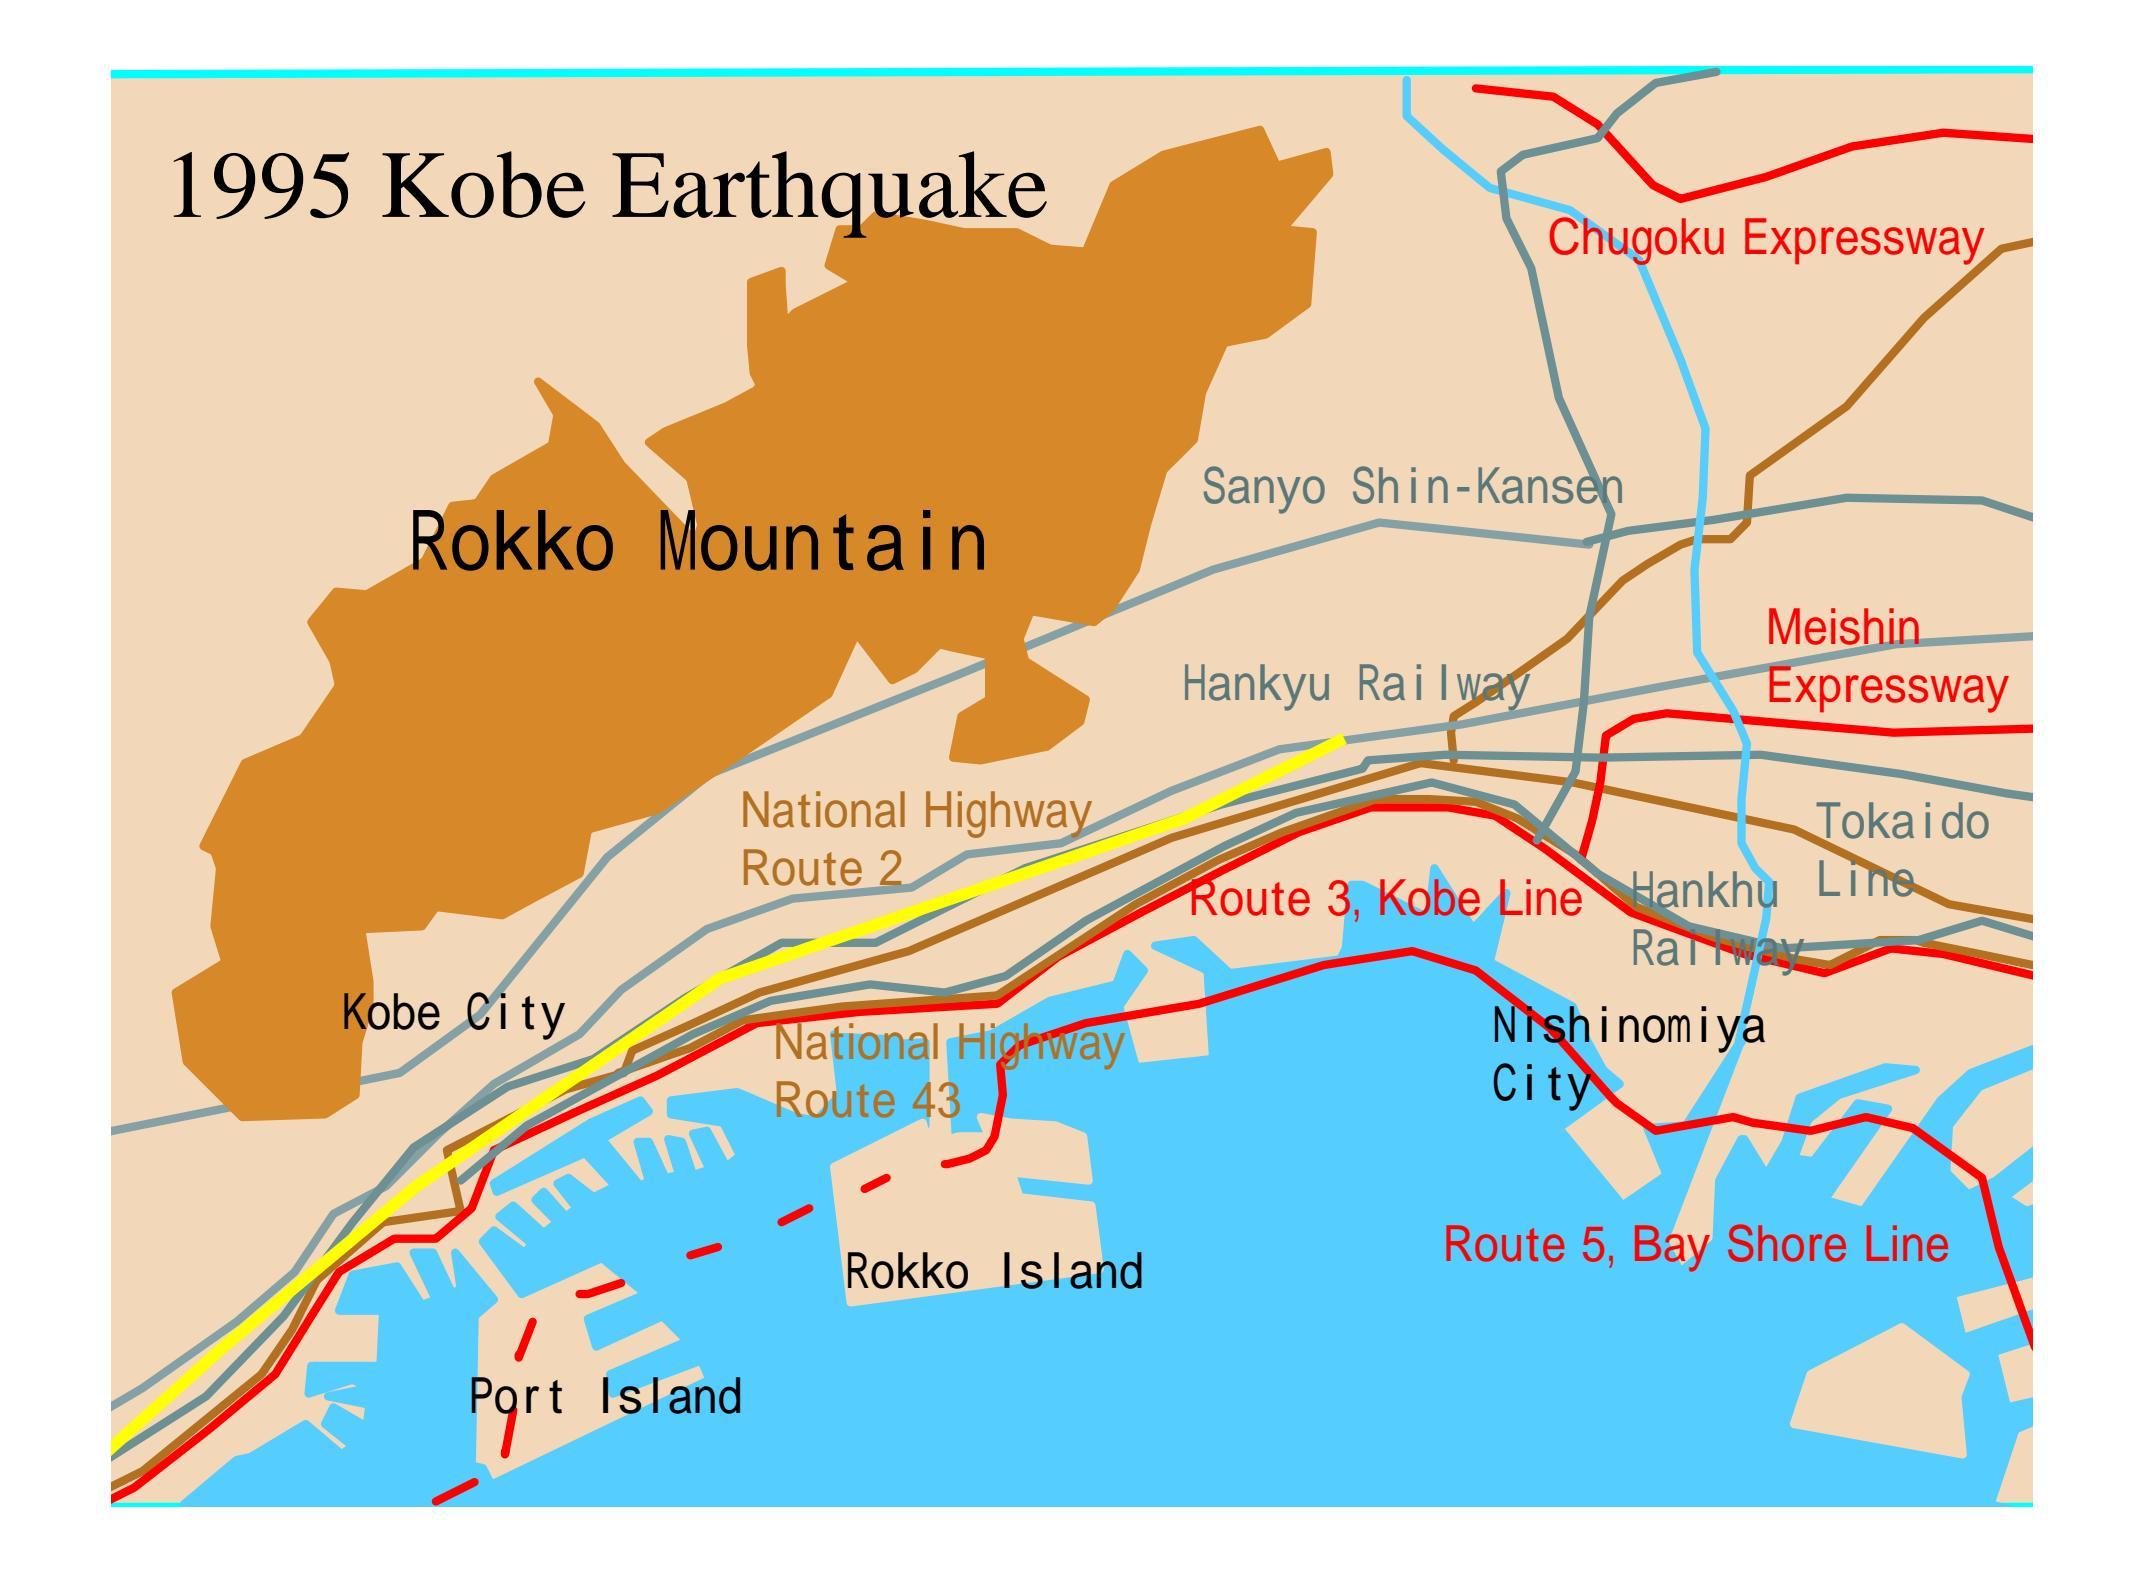
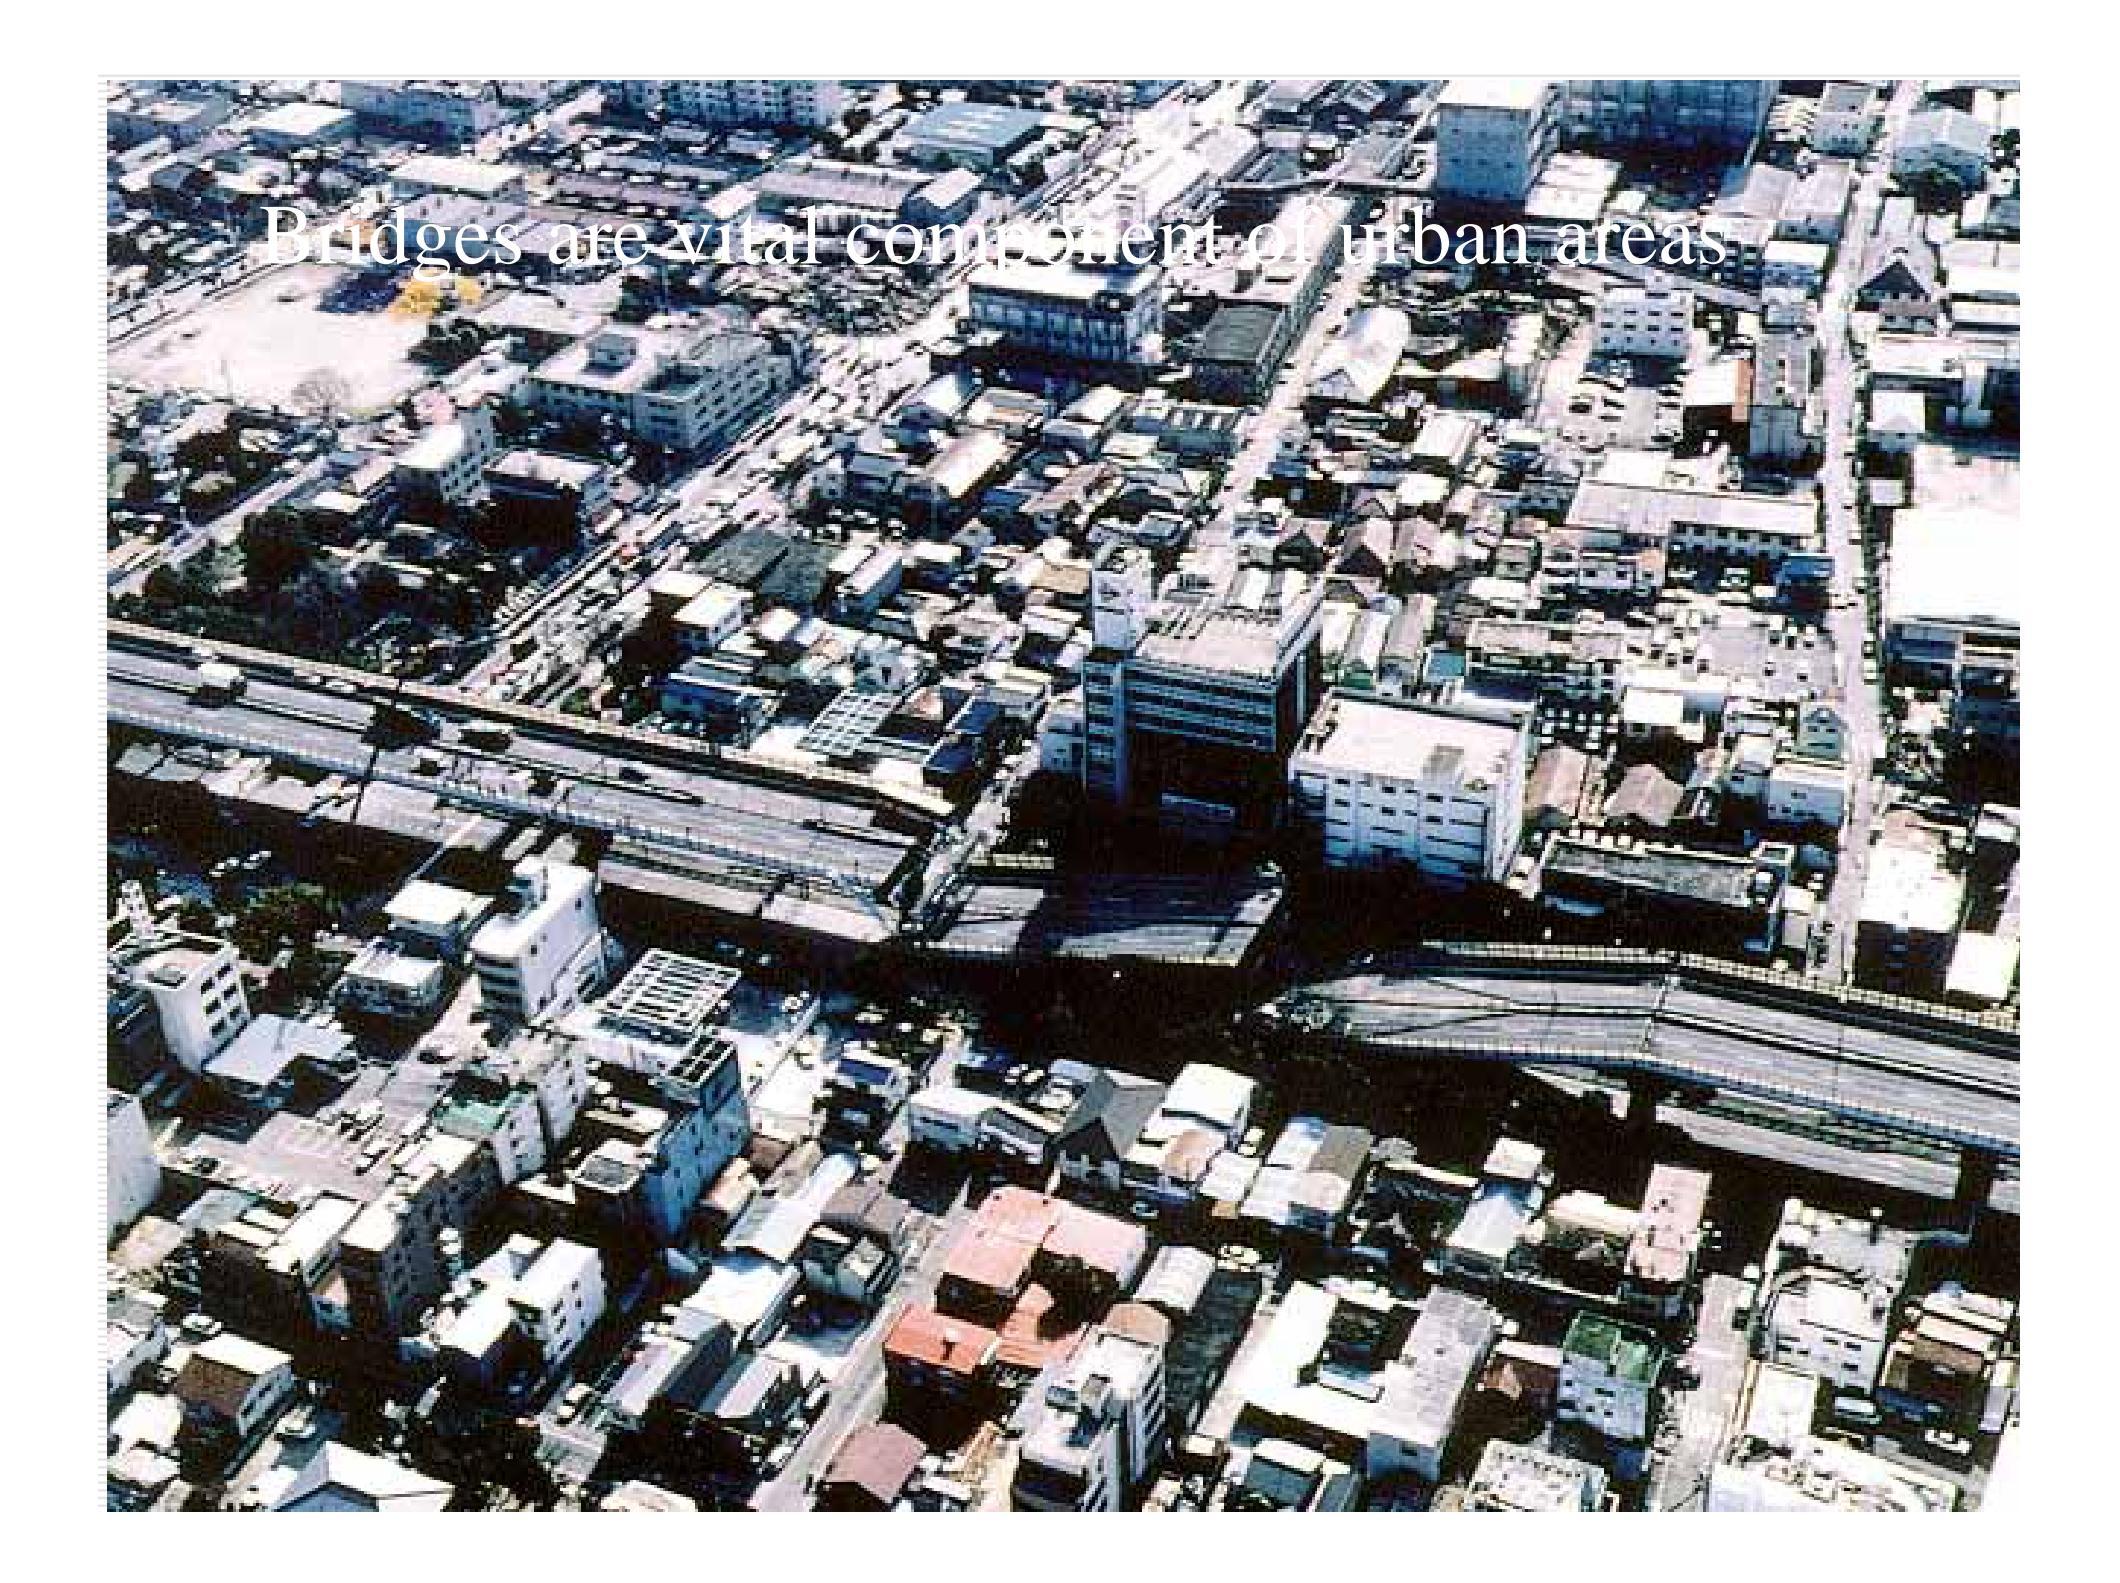
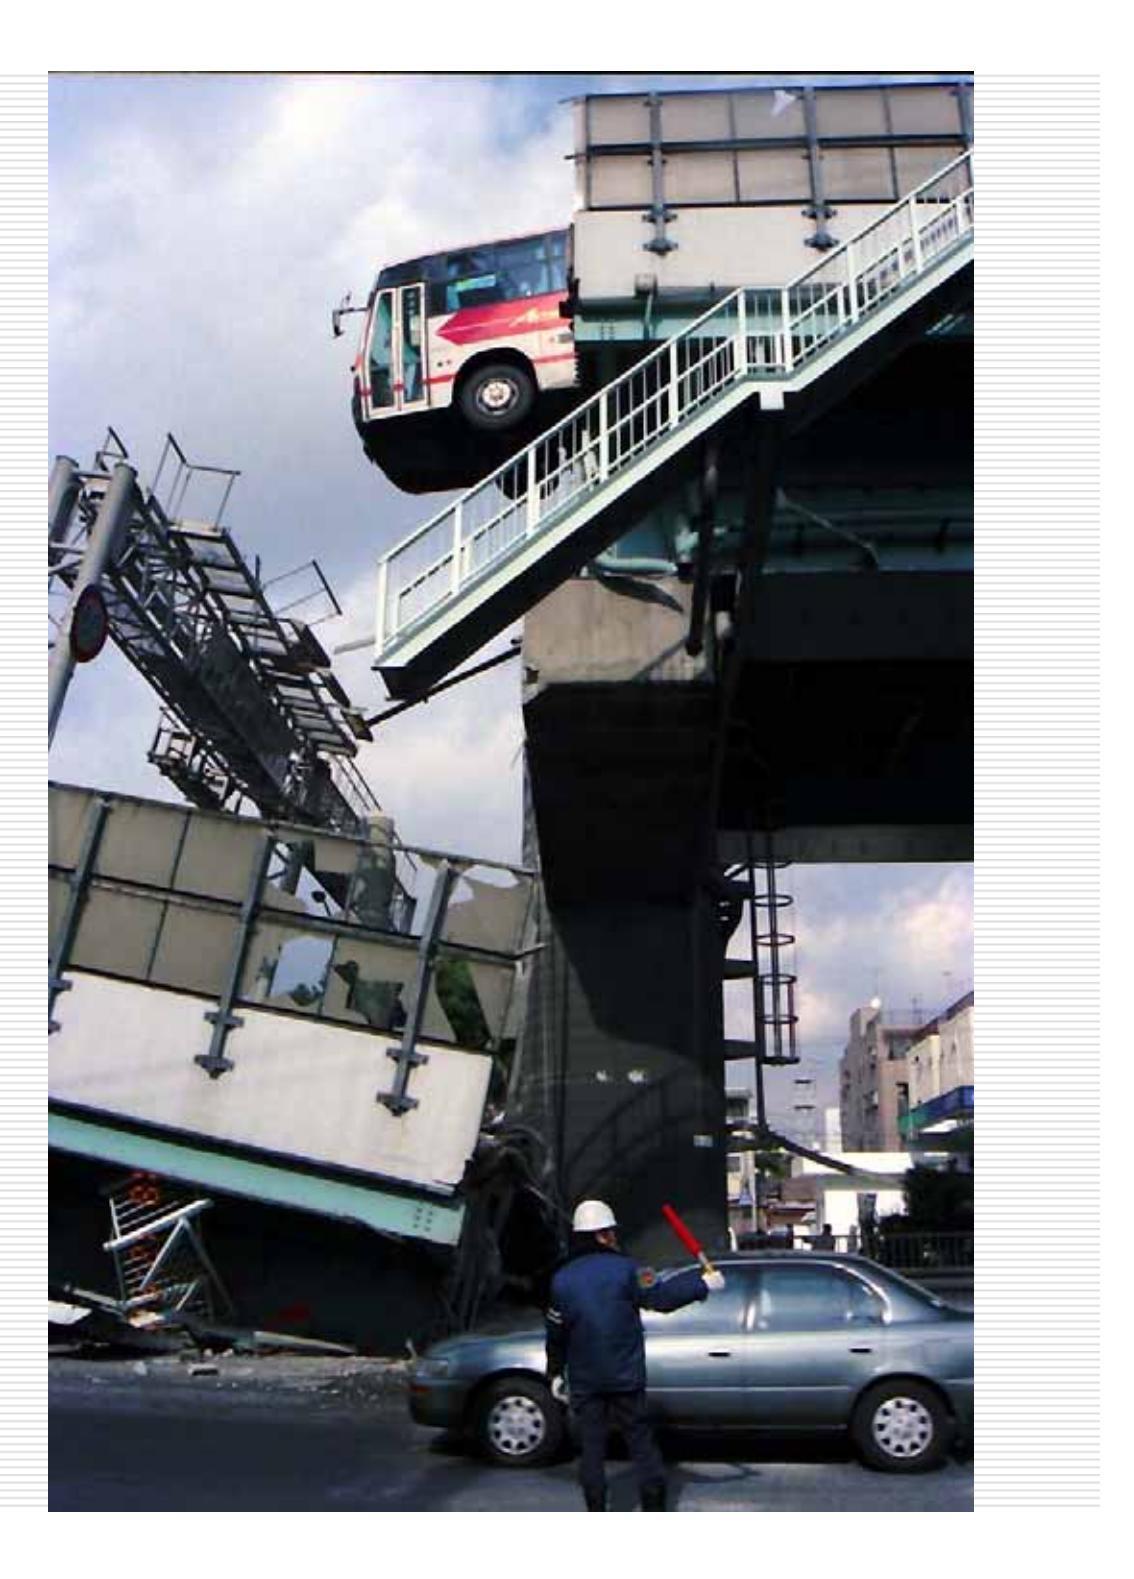
2.2.1 The most extensive damage occurred at a 18-span viaduct. This bridge collapsed due to failure of RC columns resulted from the premature shear failure. Collapse of 18-Span Fuka Hanshin Expressway 1995 Kobe Earthquake

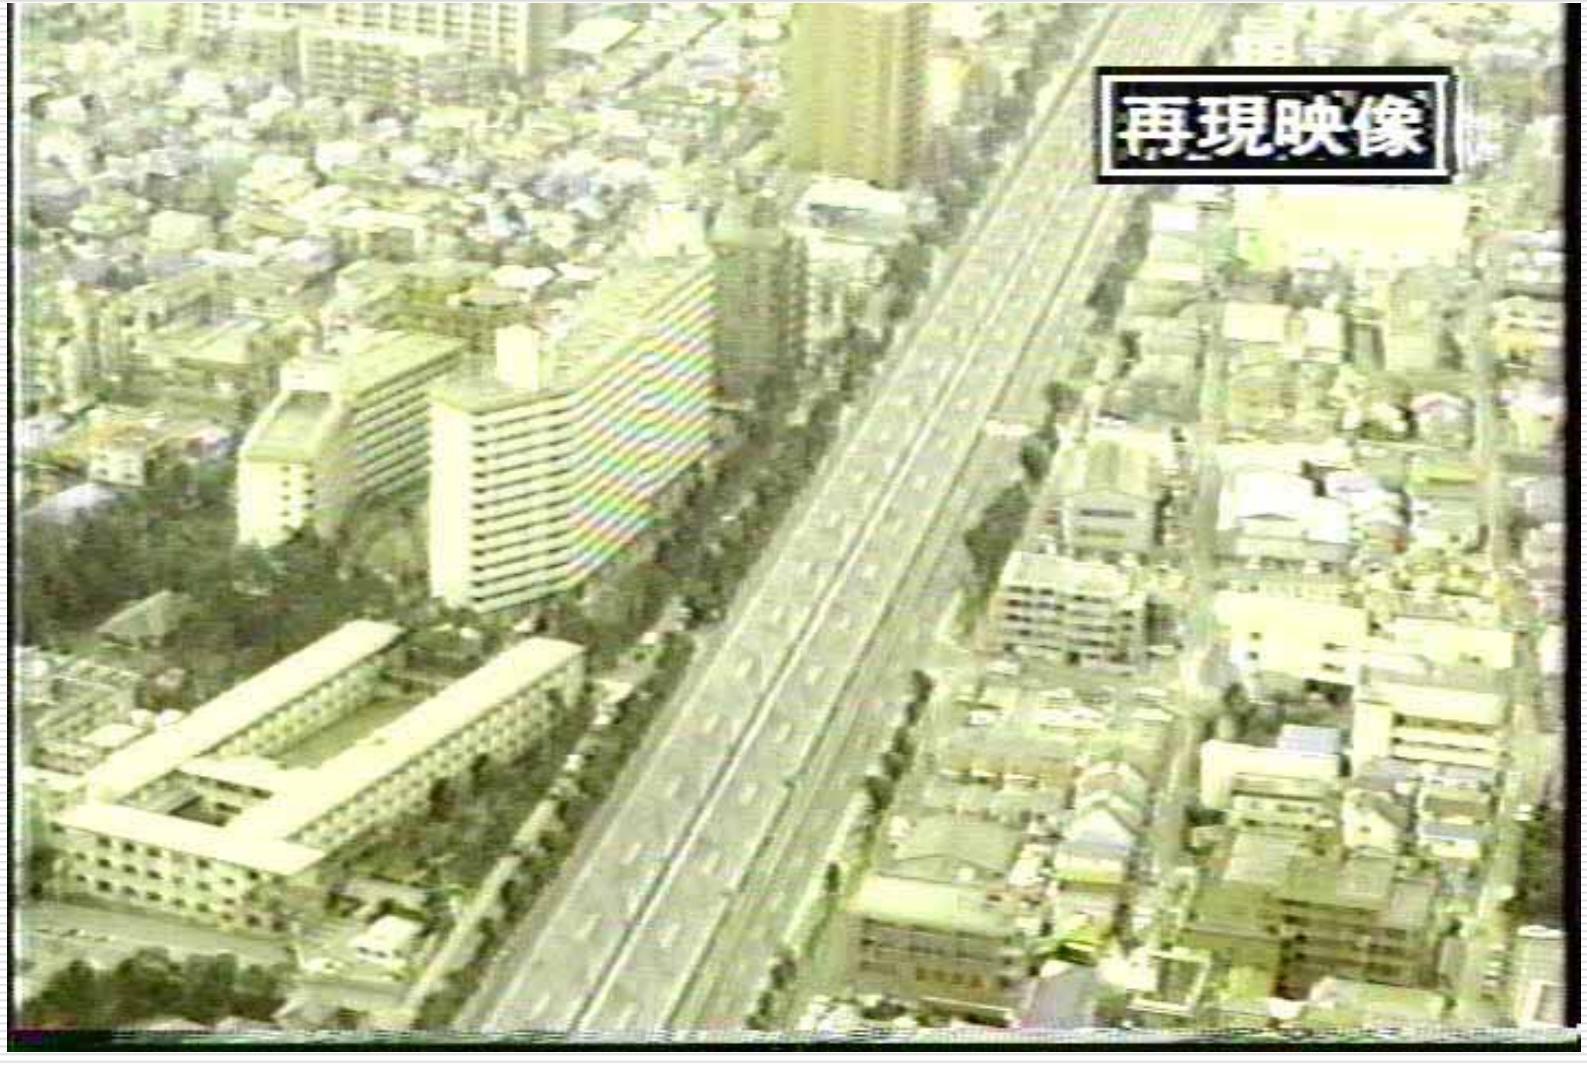
Collapse of a 18-span viaduct in the 1995 Kobe Earthquake

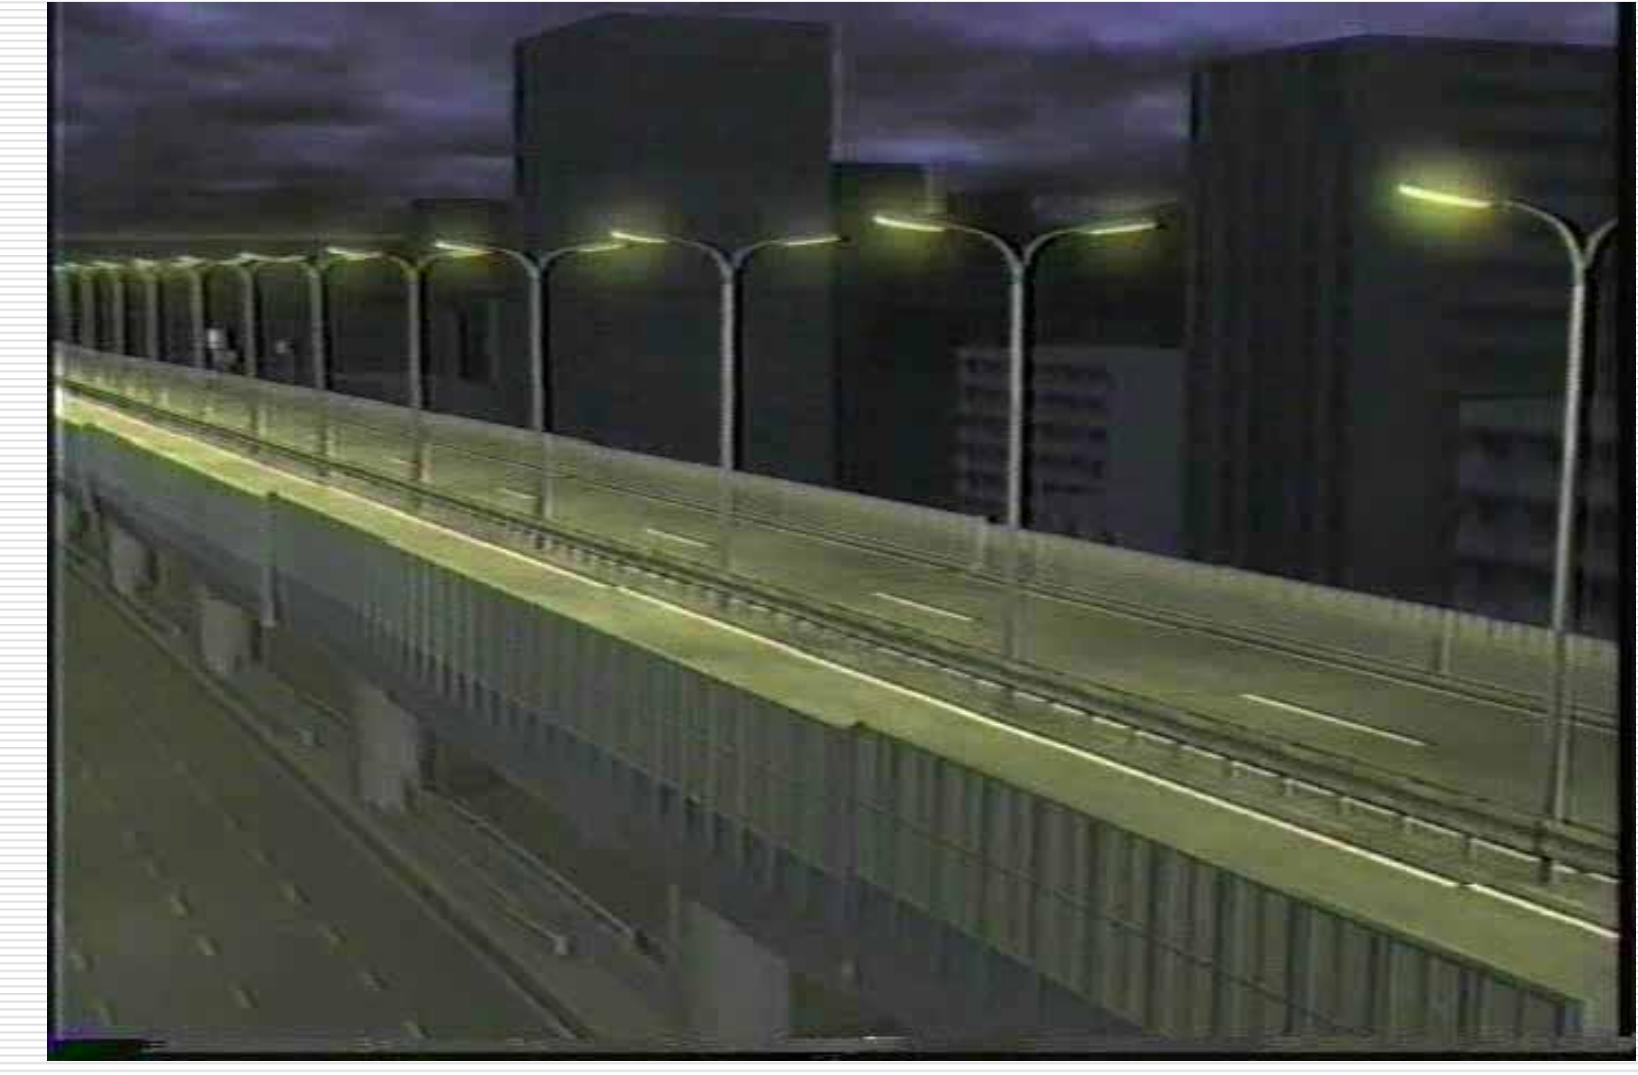
Collapse of a 18-span viaduct in the 1995 Kobe Earthquake

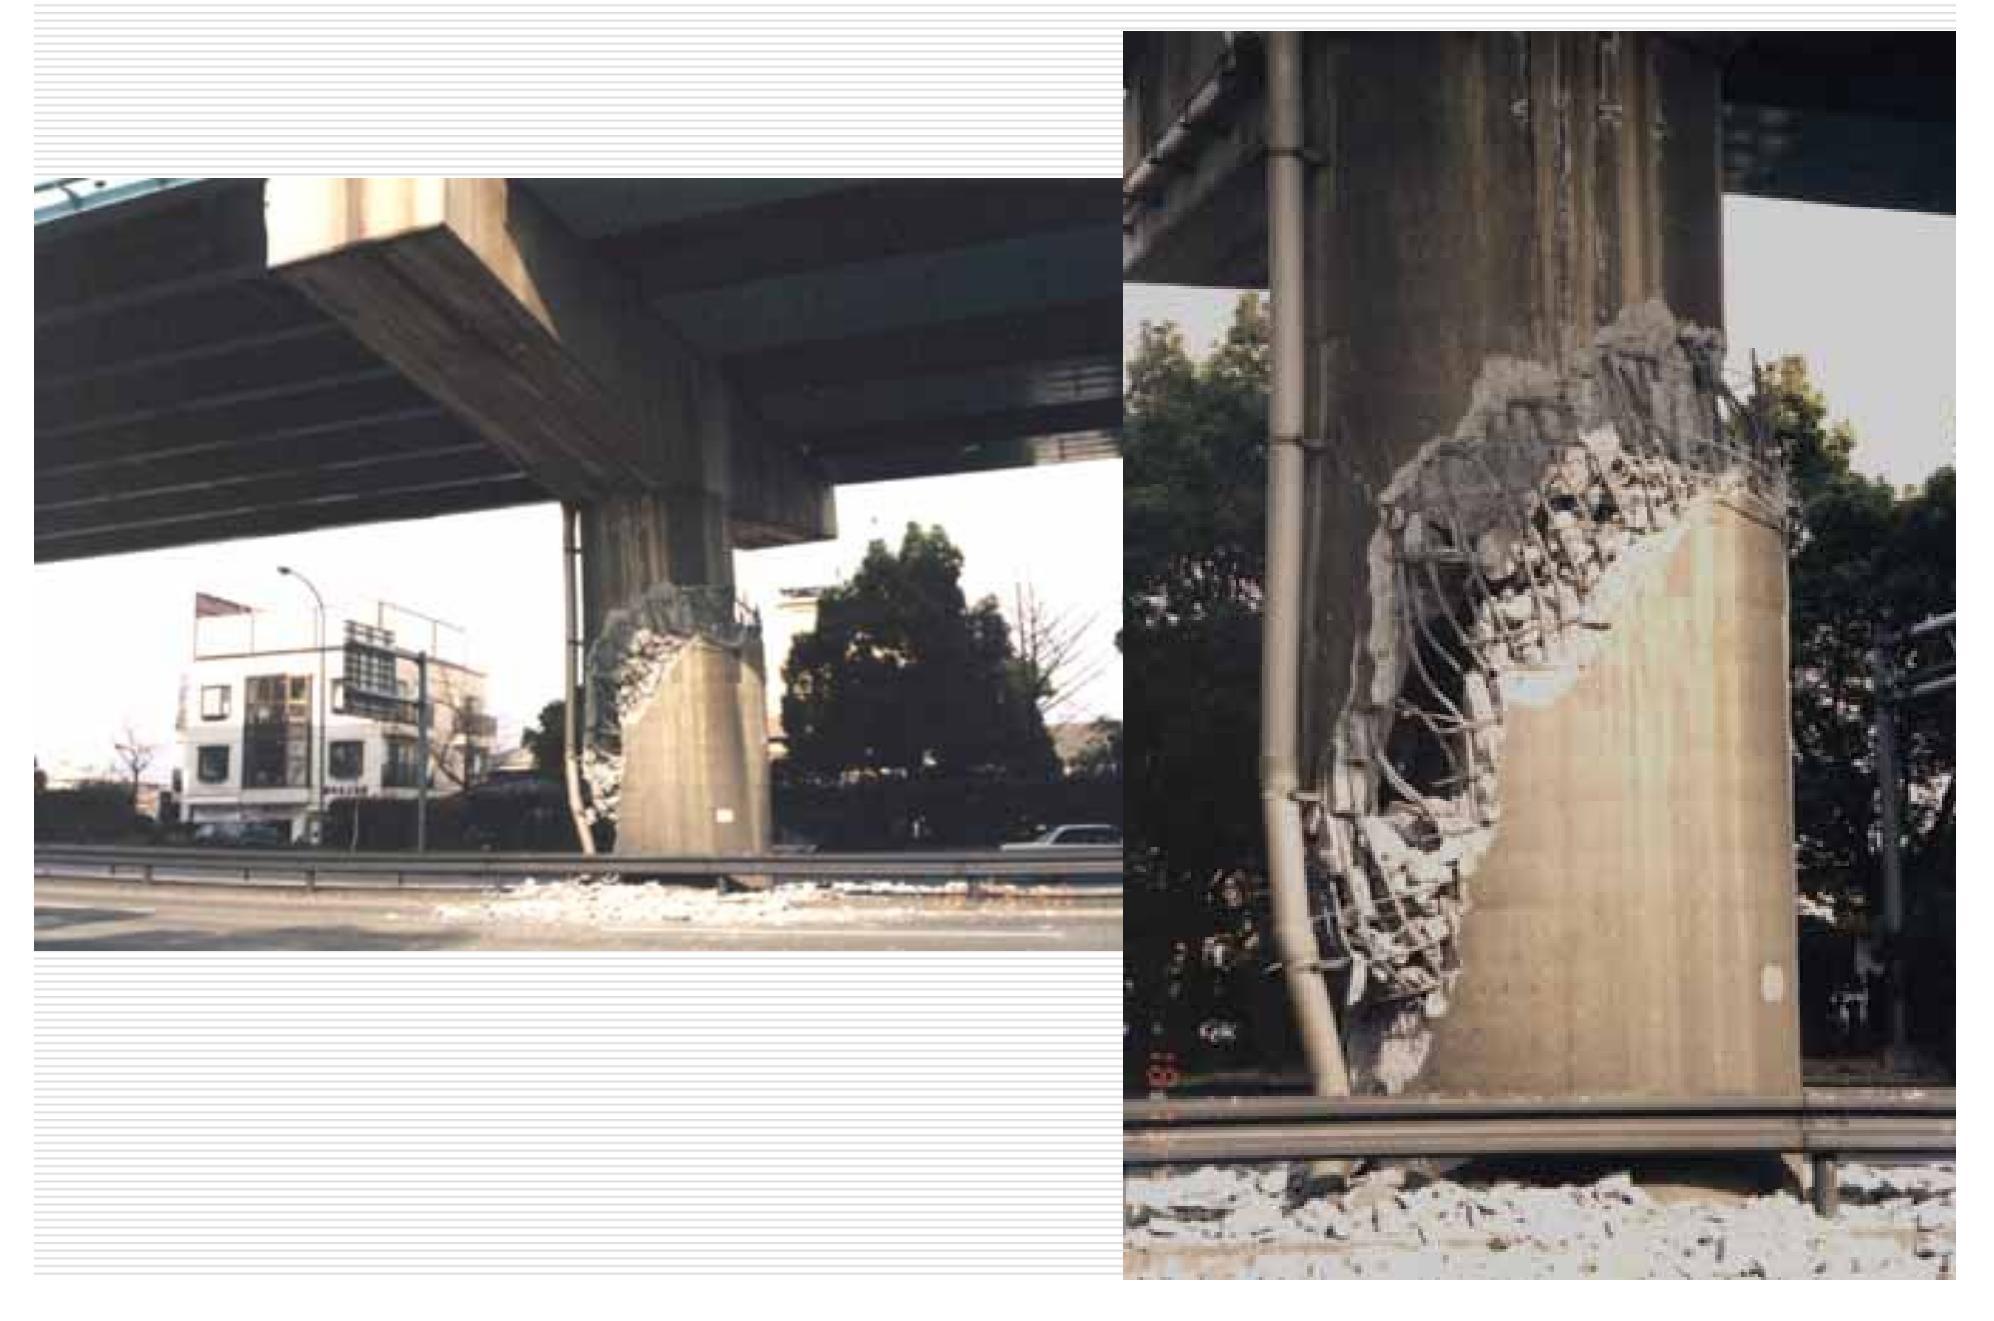
Shear Failure

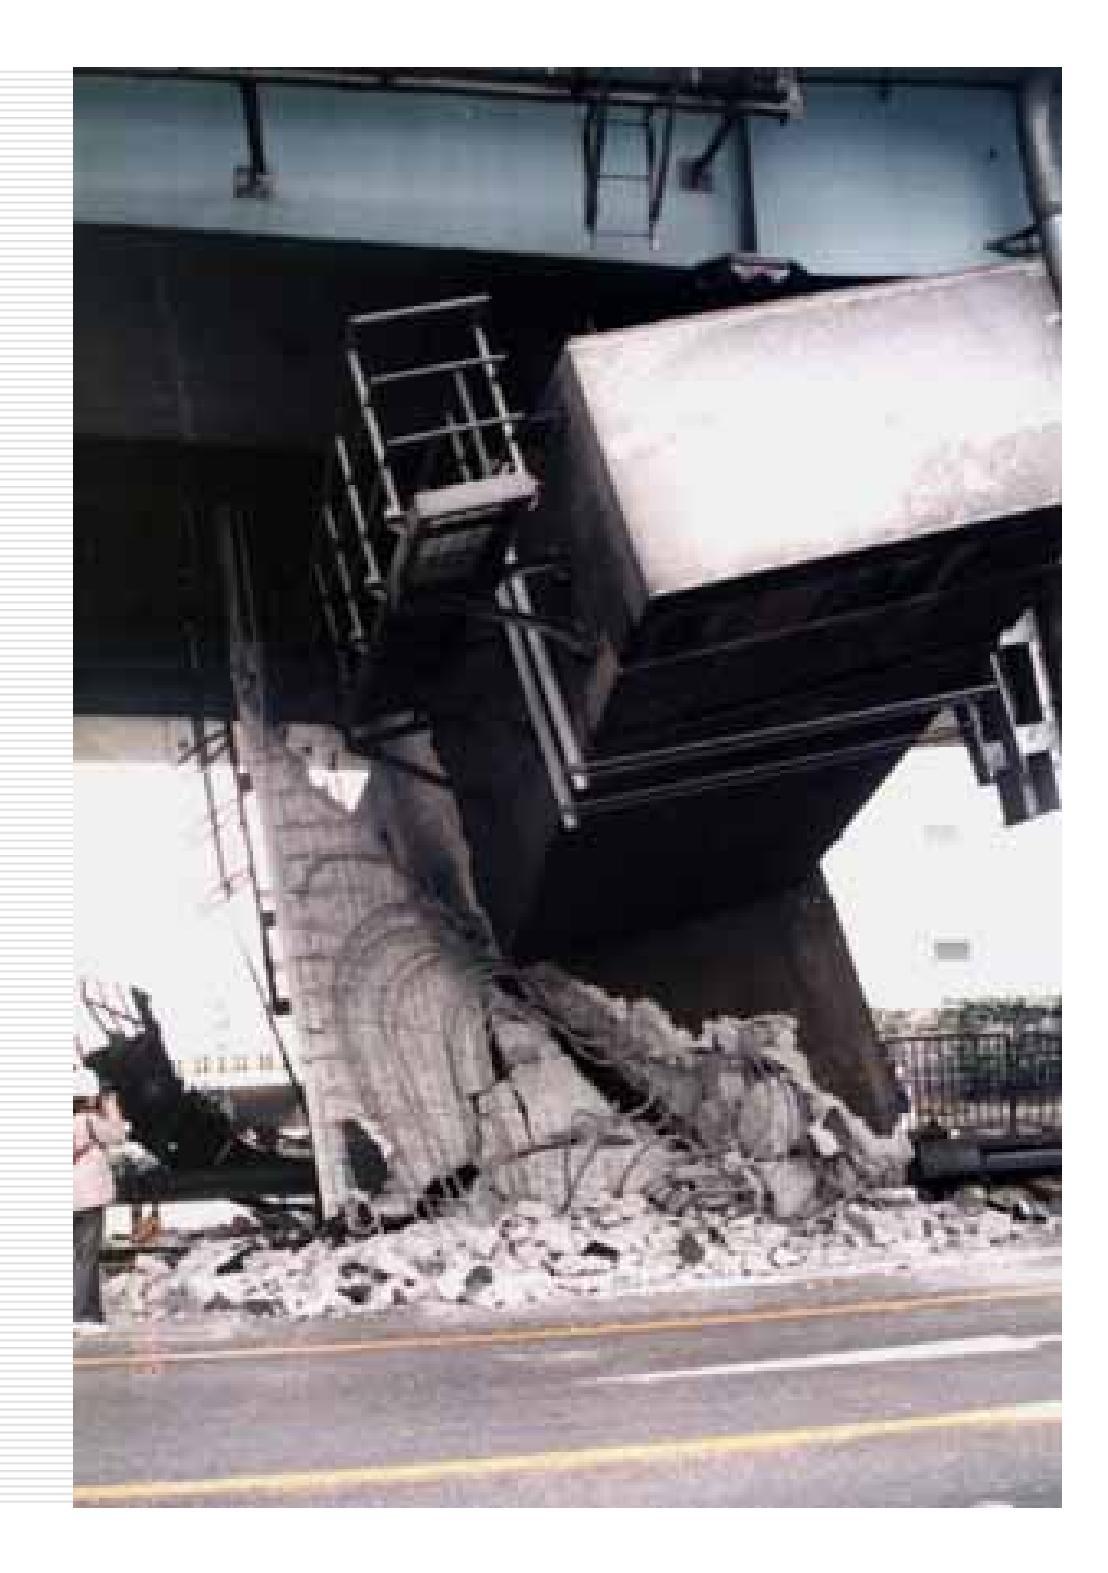
Shear Failure

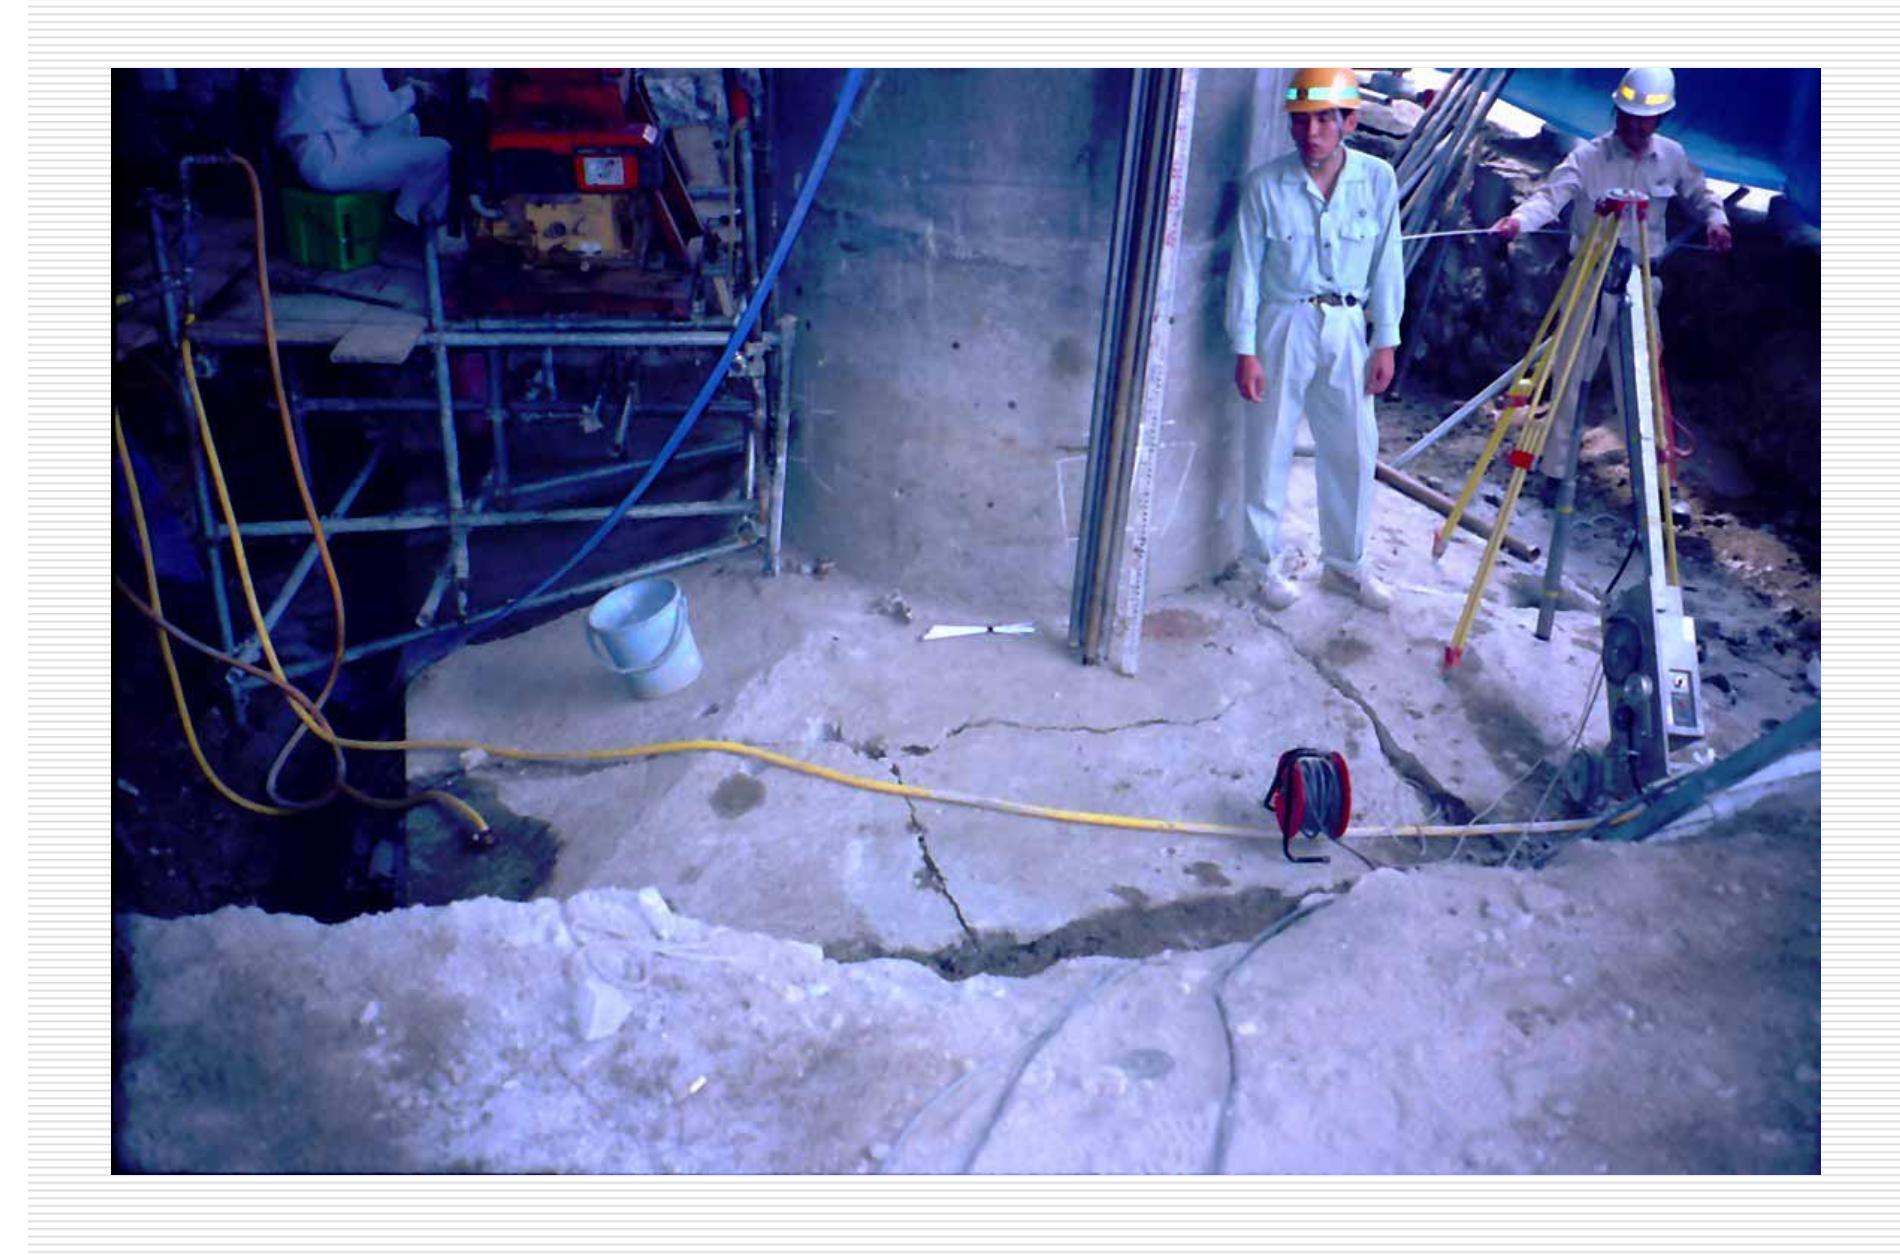
Damage of foundations was less, but none
