Seismic Design of Urban Infrastructures

Chapter 2 Seismic Damage of Bridges in Past Earthquakes

Kazuhiko Kawashima Tokyo Institute of Technology

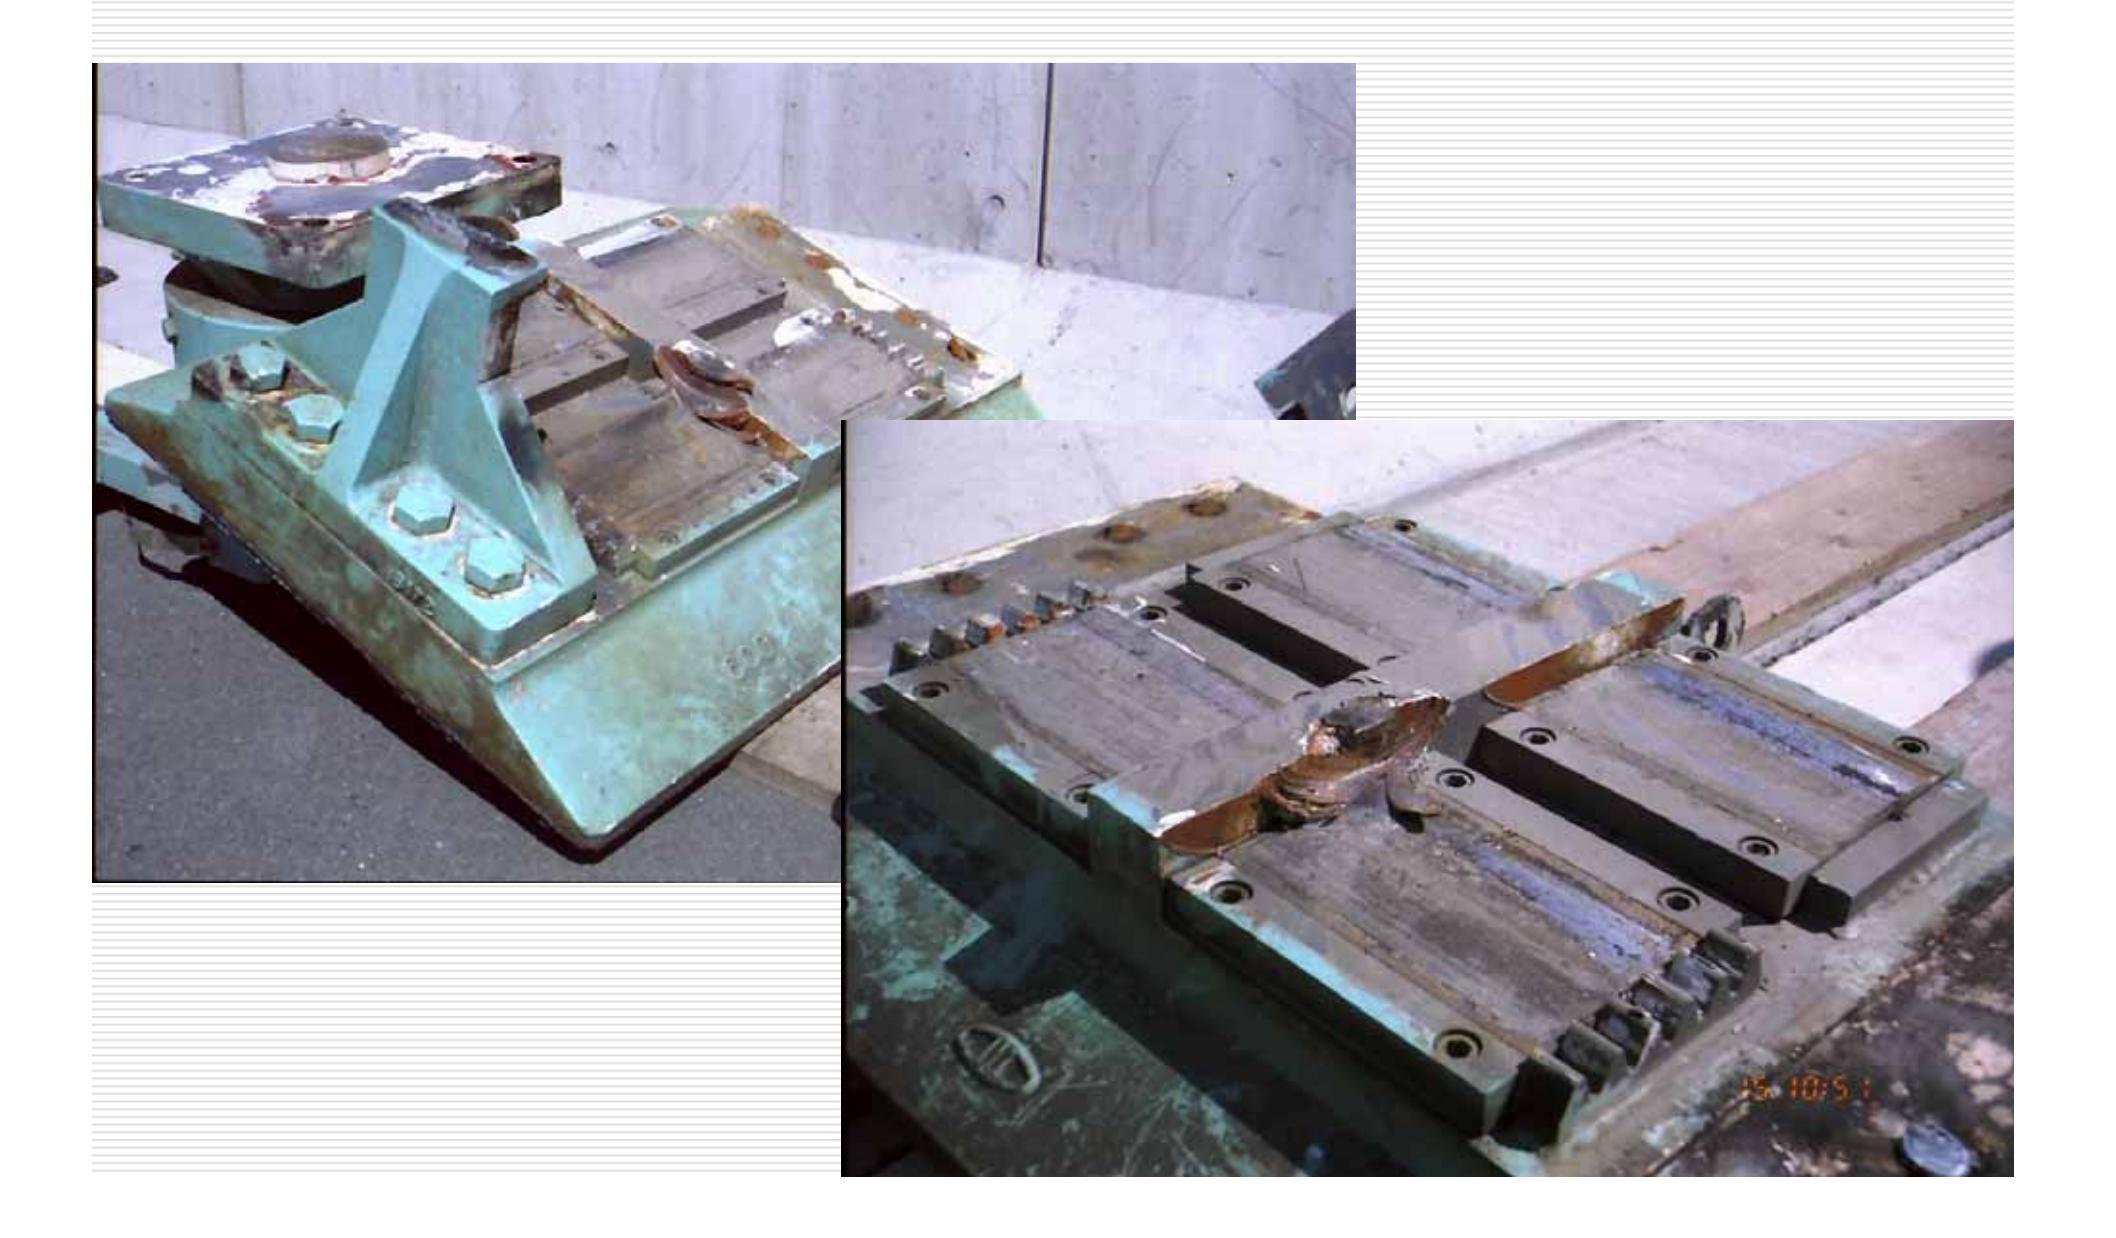
Vulnerable Steel Pin & Roller Bearings

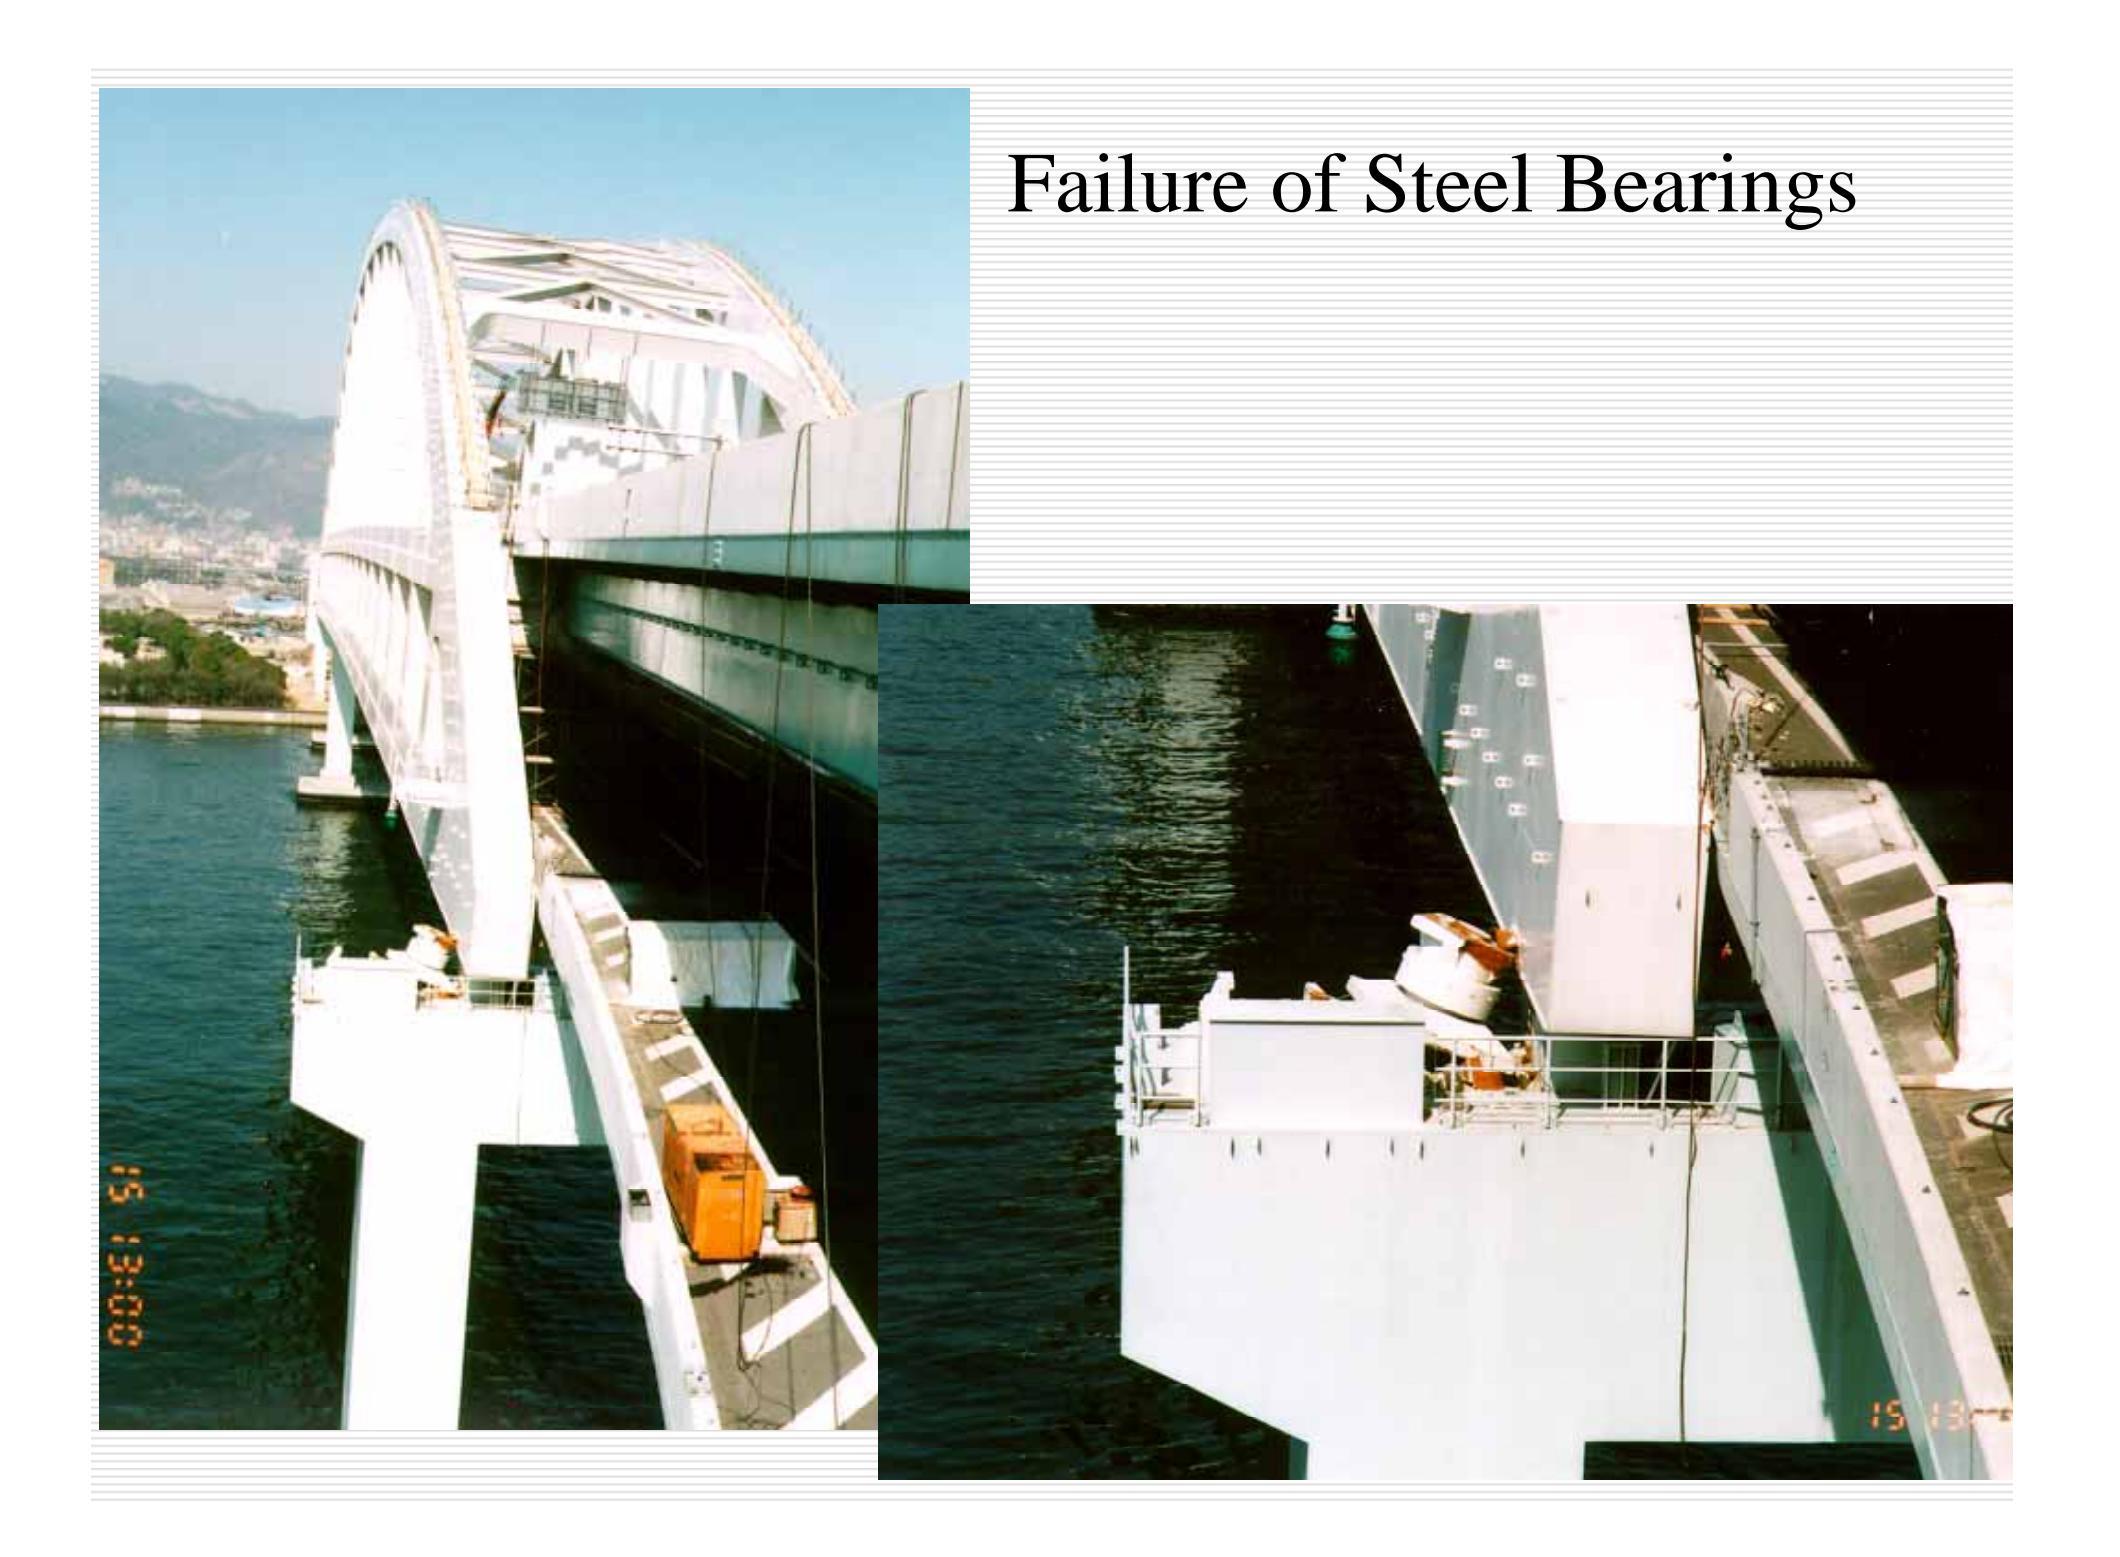
Vulnerable Steel Roller Bearings

Rollers have moved out

Stoppers have gone

- •It was recommended in the 1995 & 1996 codes that elastomeric bearings including LRB and HDR should be used.
- •Steel bearings have the following deficiencies:
 - \checkmark Insufficient strength and weak for shock
 - ✓ Structures with insufficient lateral and vertical capacity
 - ✓ Insufficient lengnth of movement
