2.3 Seismic Damage of Bridges in USA

2.4 Damage of Bridges Due to Fault Displacement

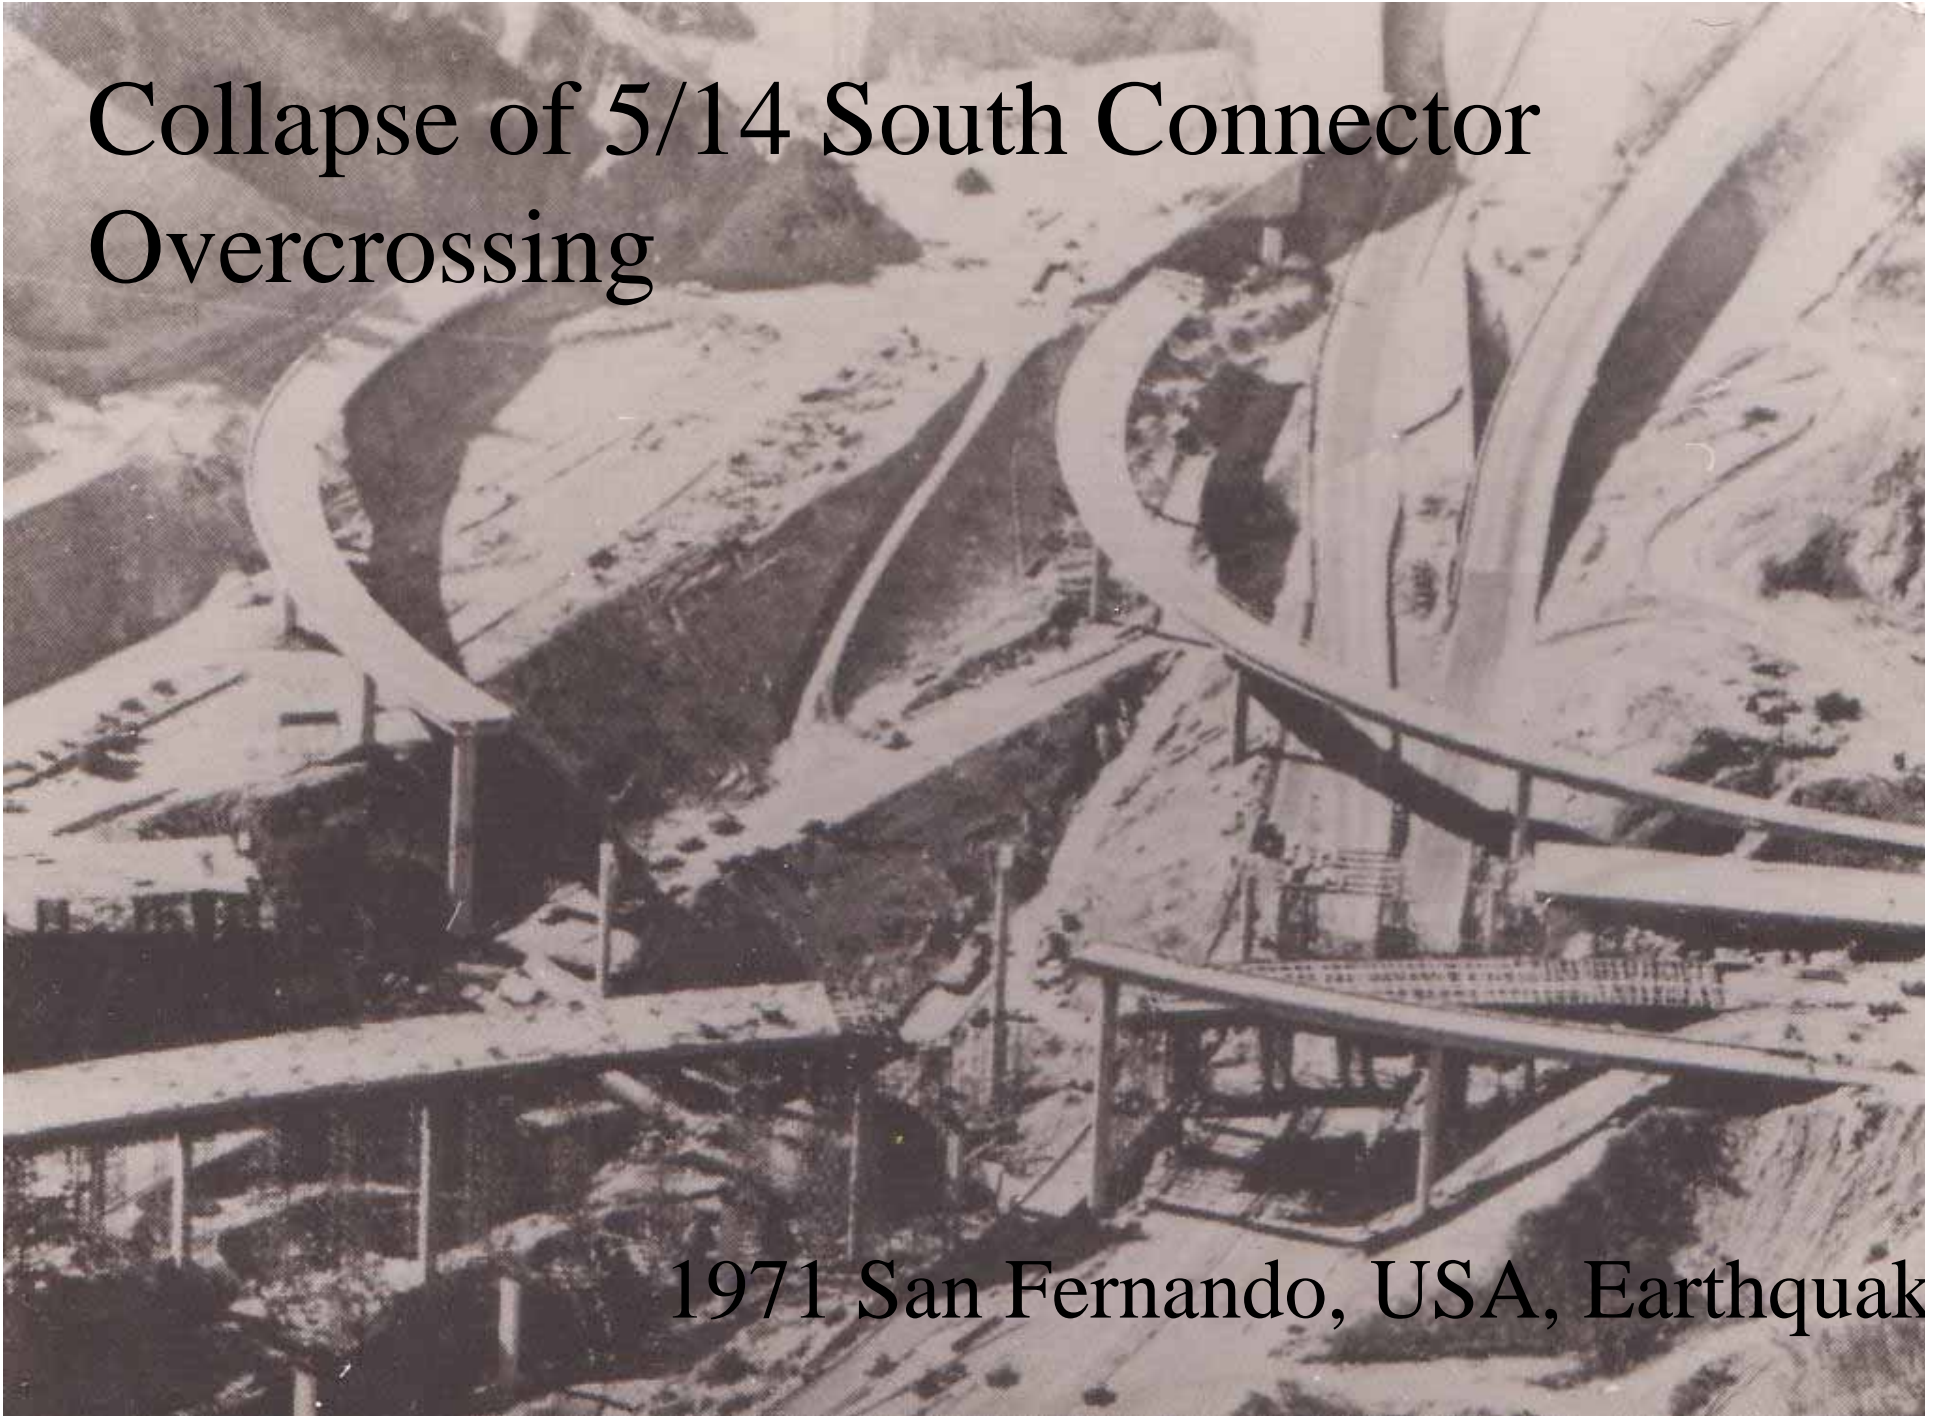
Collapse of 5/14 South Connector Overcrossing

1971 San Fernando, USA, Earthquake

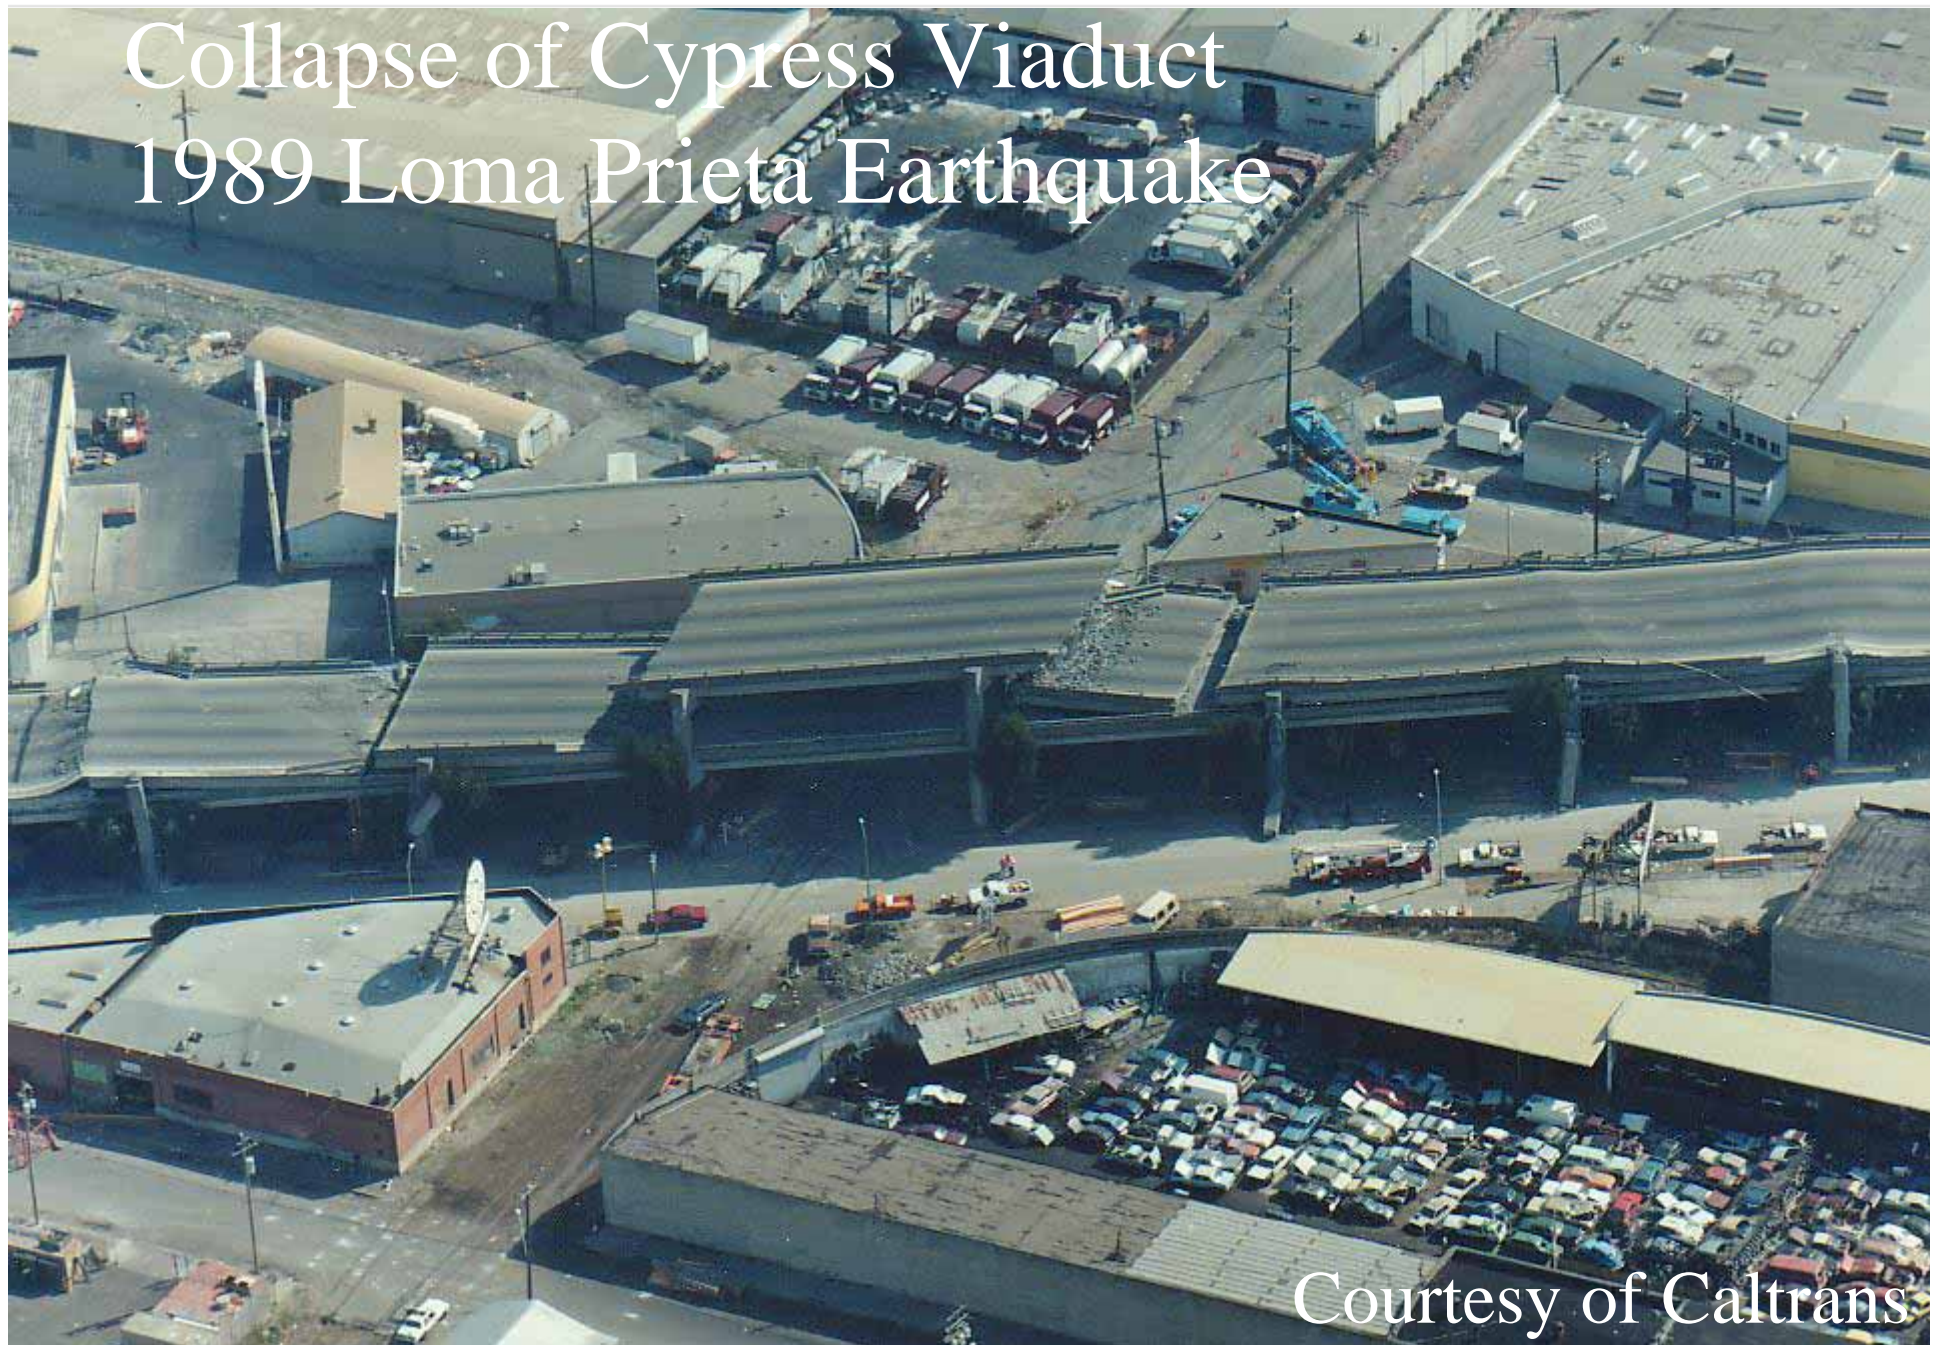
Collapse of Cypress Viaduct 1989 Loma Prieta Earthquake

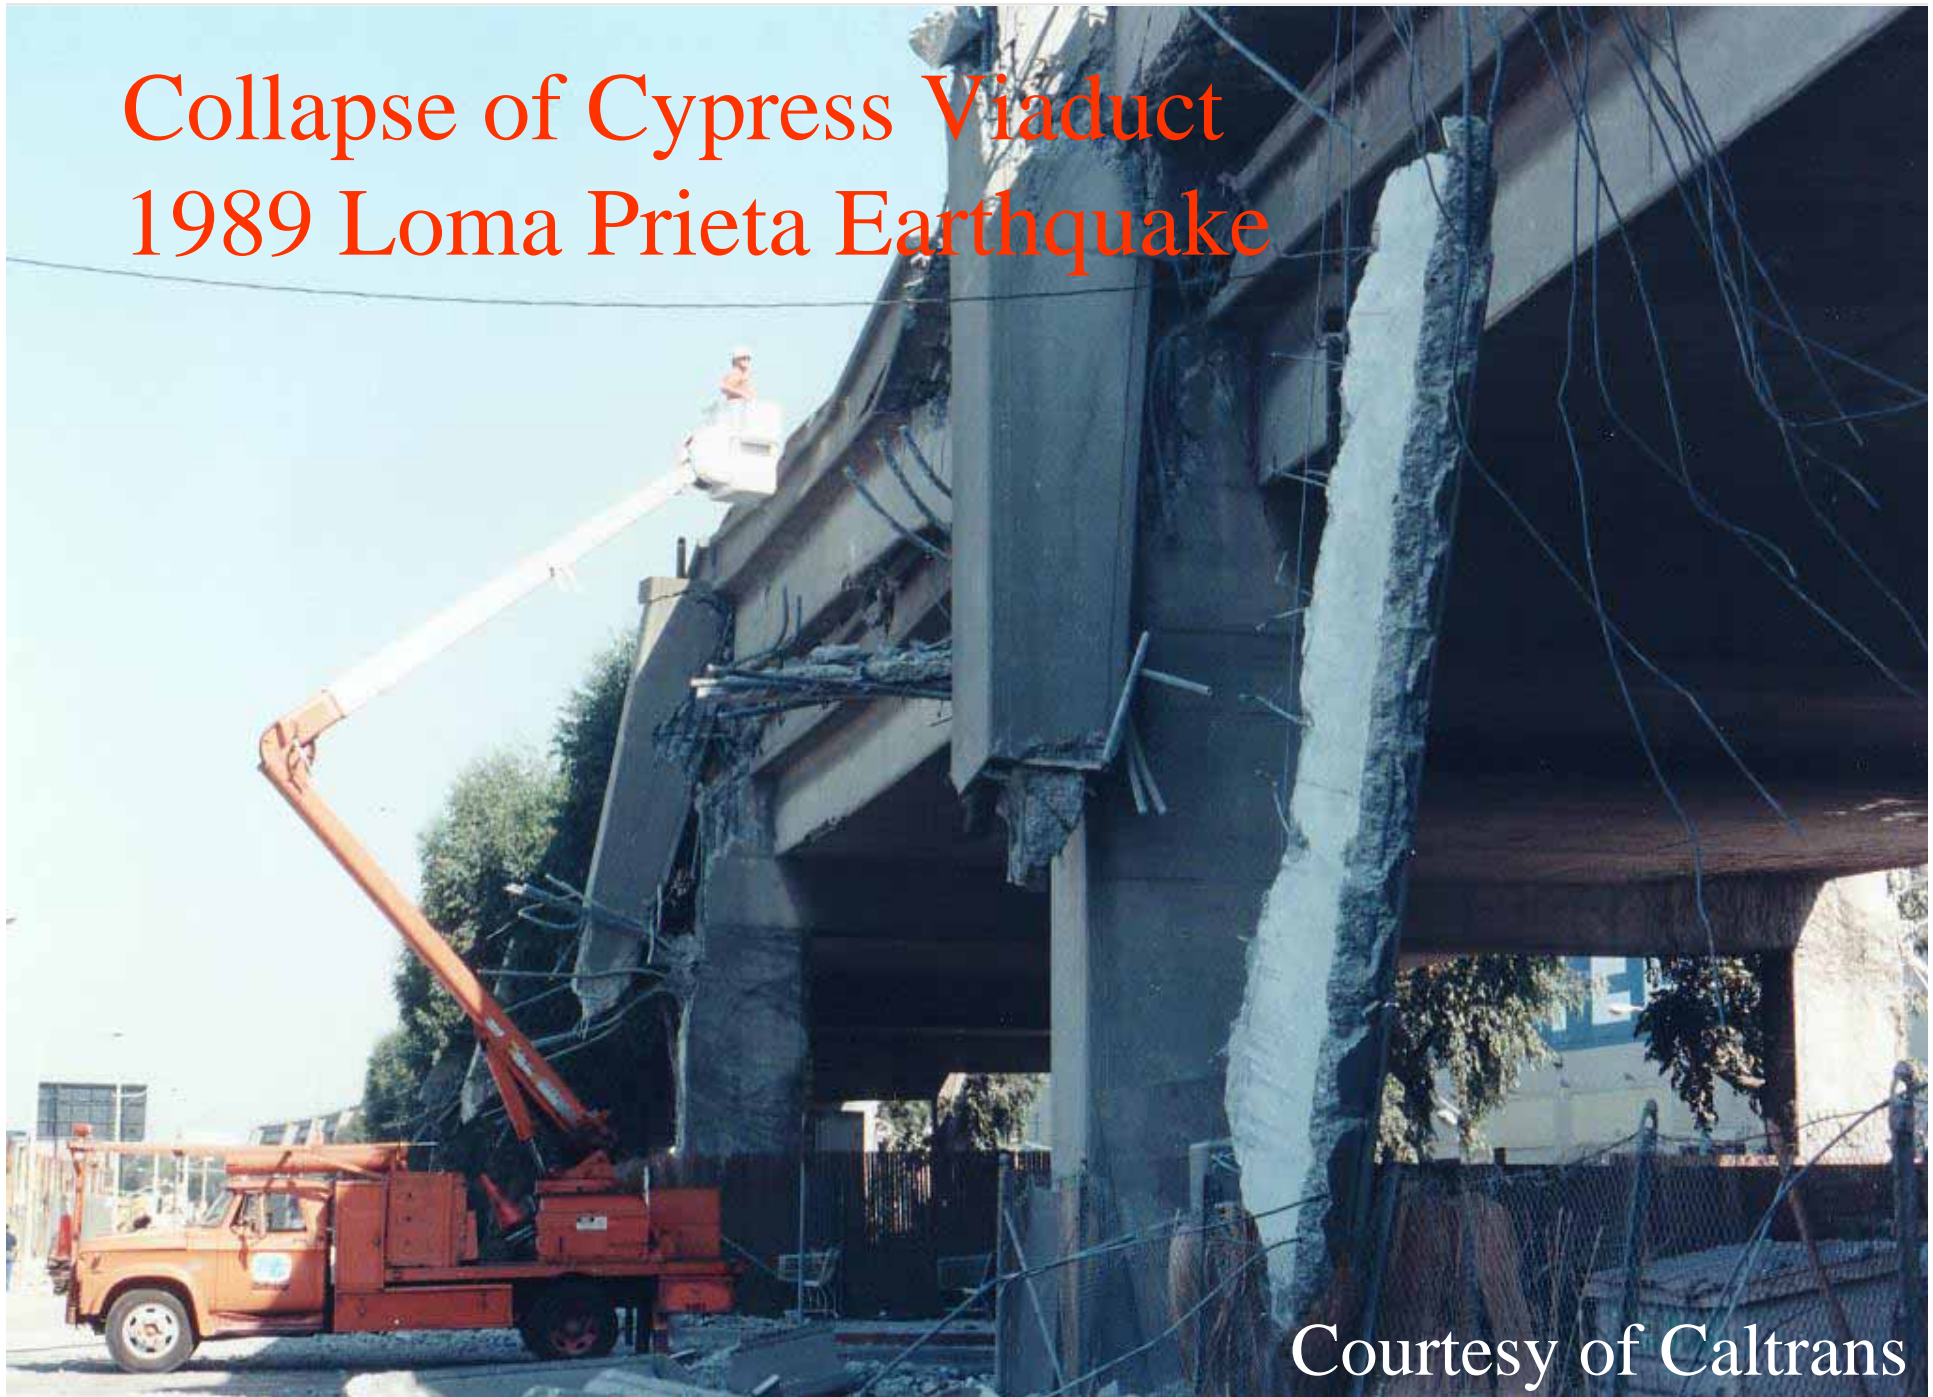
Collapse of Cypress Viaduct 1989 Loma Prieta Earthquake

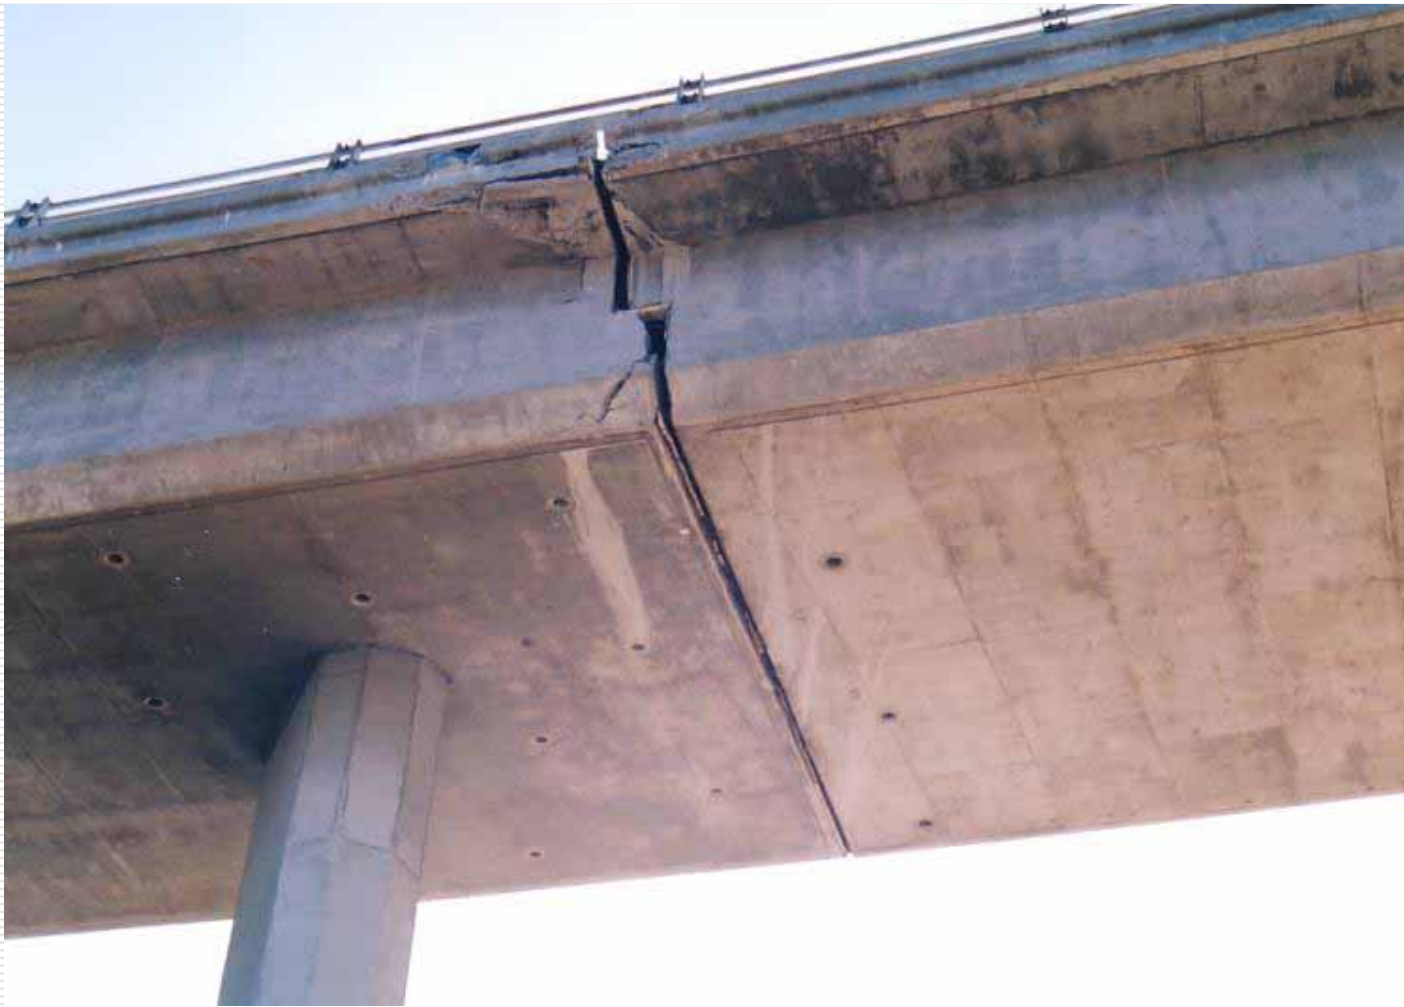
Pounding of Decks at Intermediate Hinge

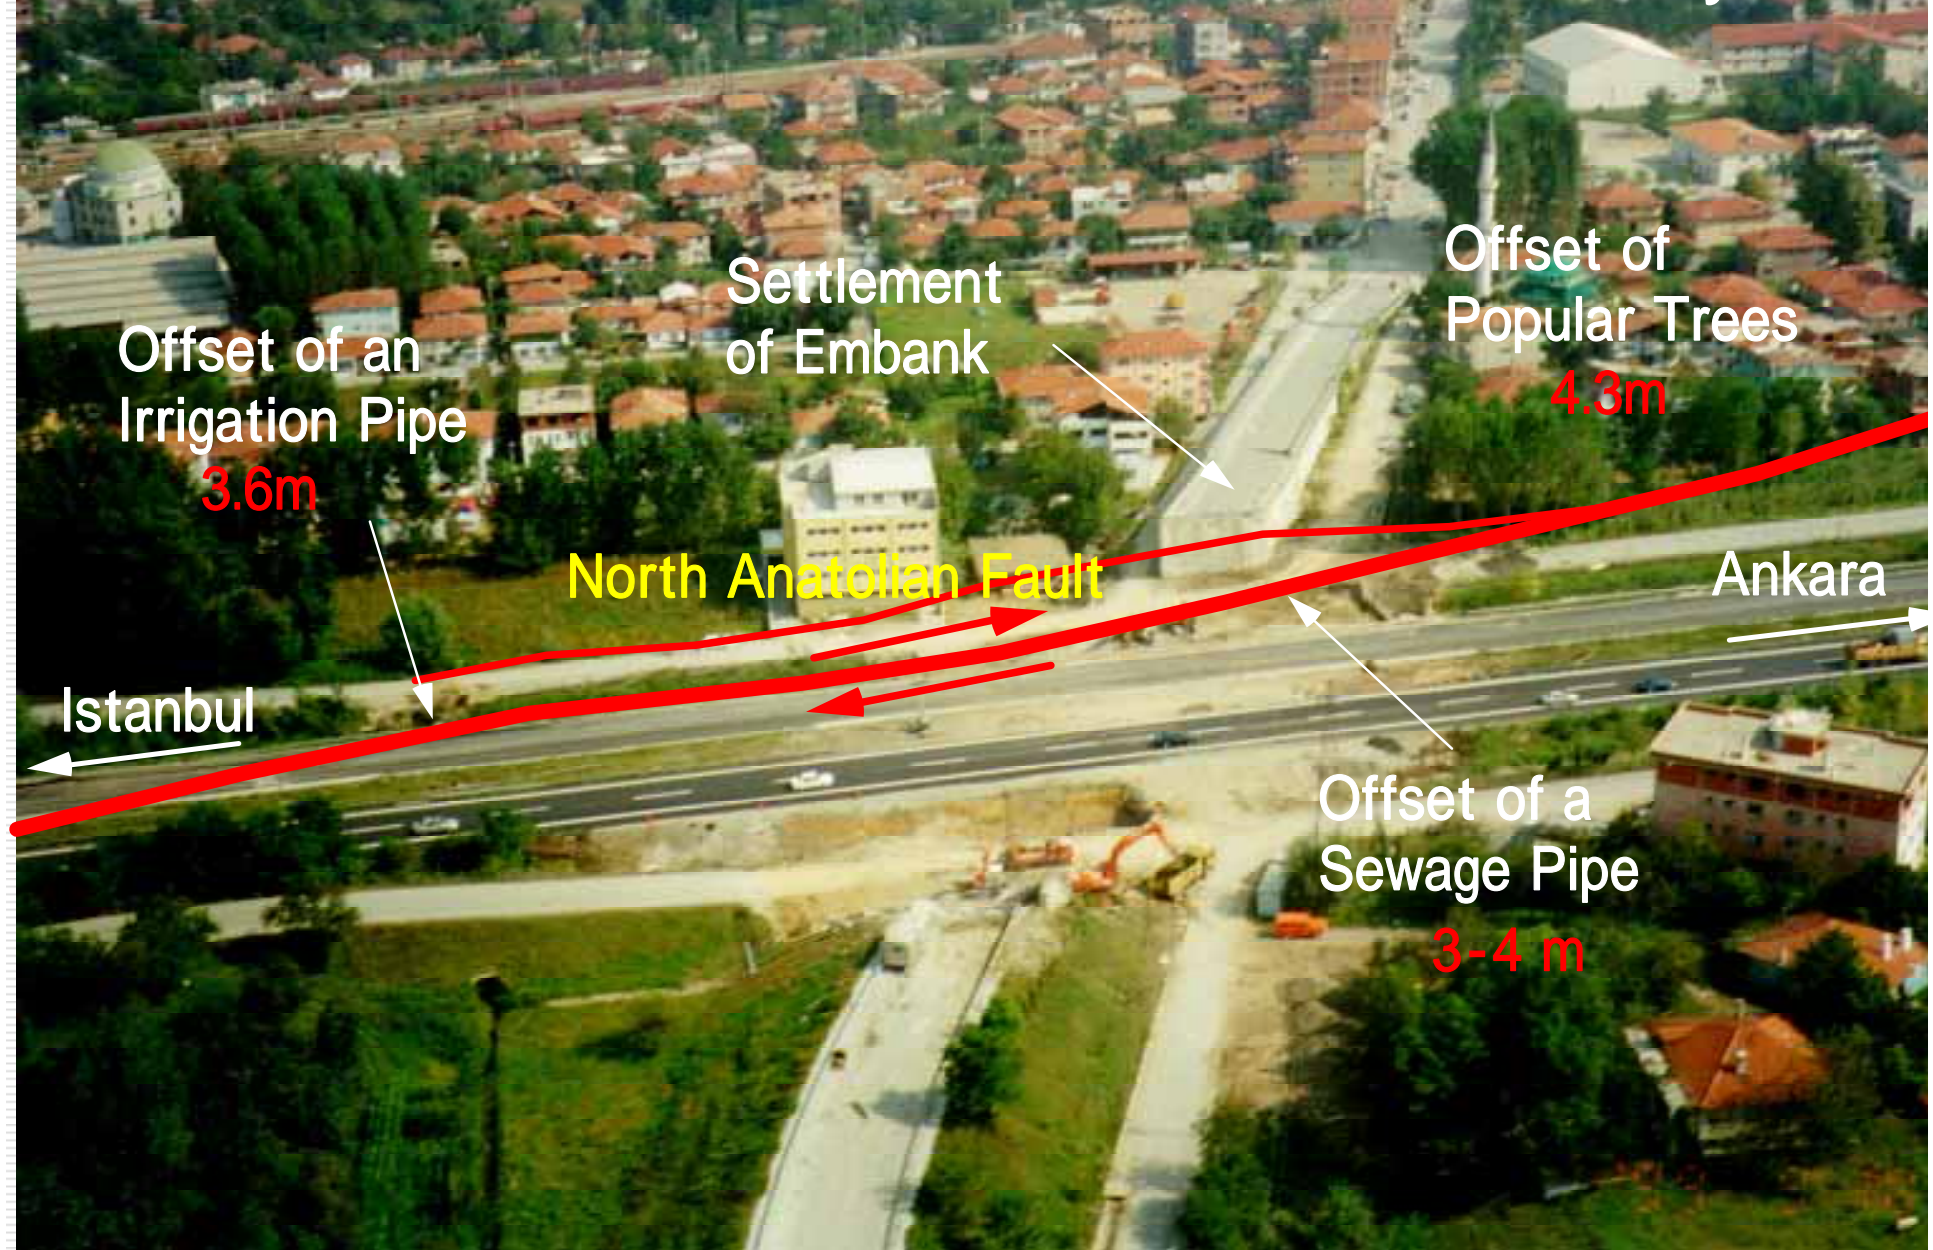
Evidences of Fault Dislocation around Arifye

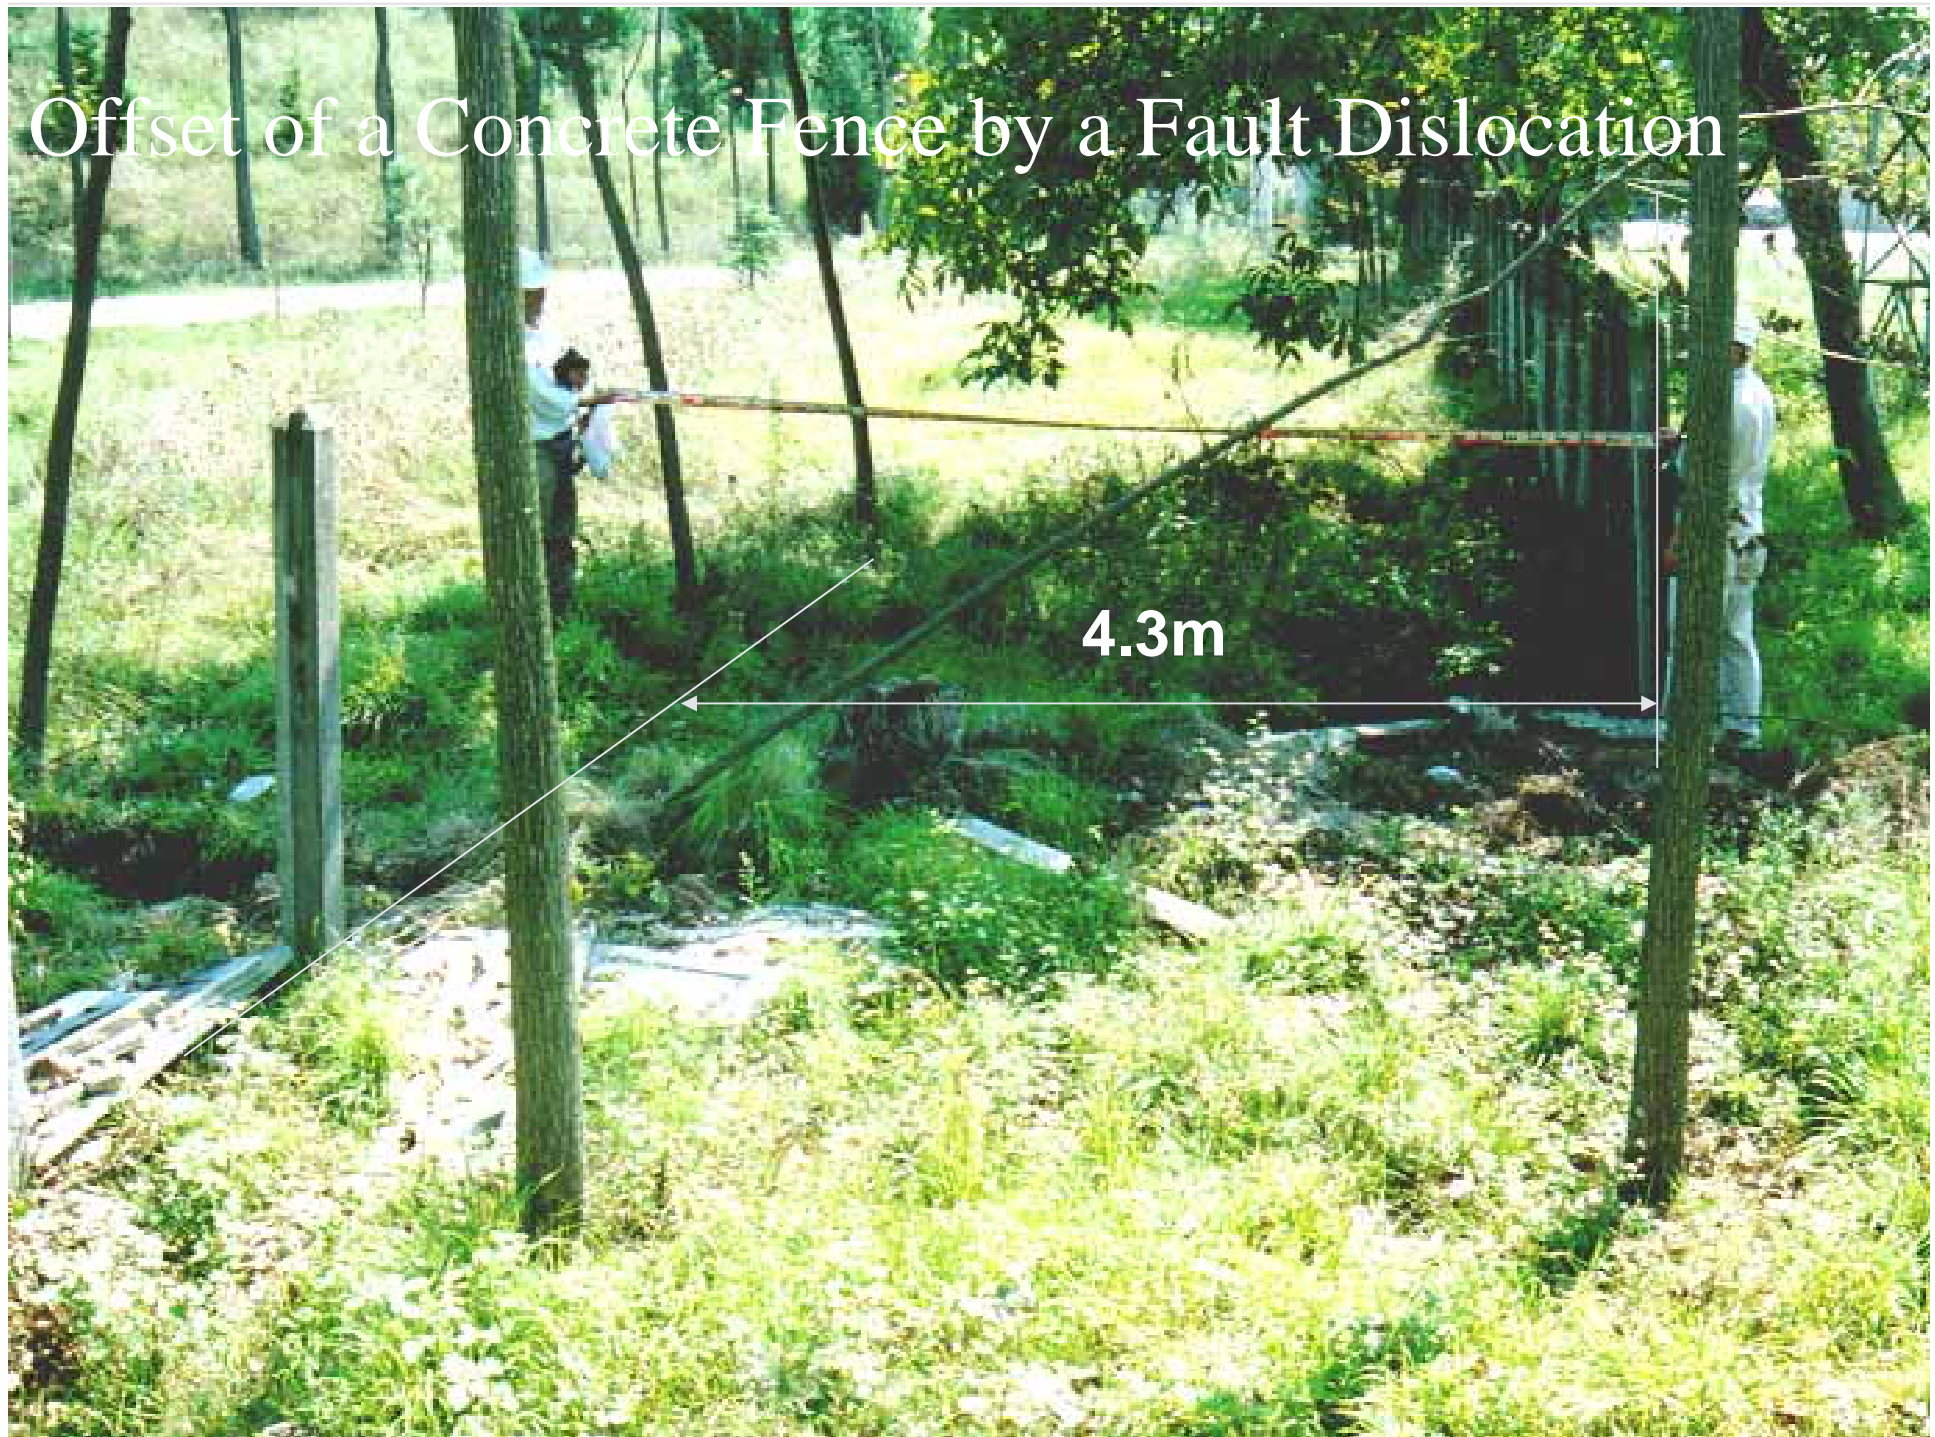
Offset of a Concrete Fence by a Fault Dislocation

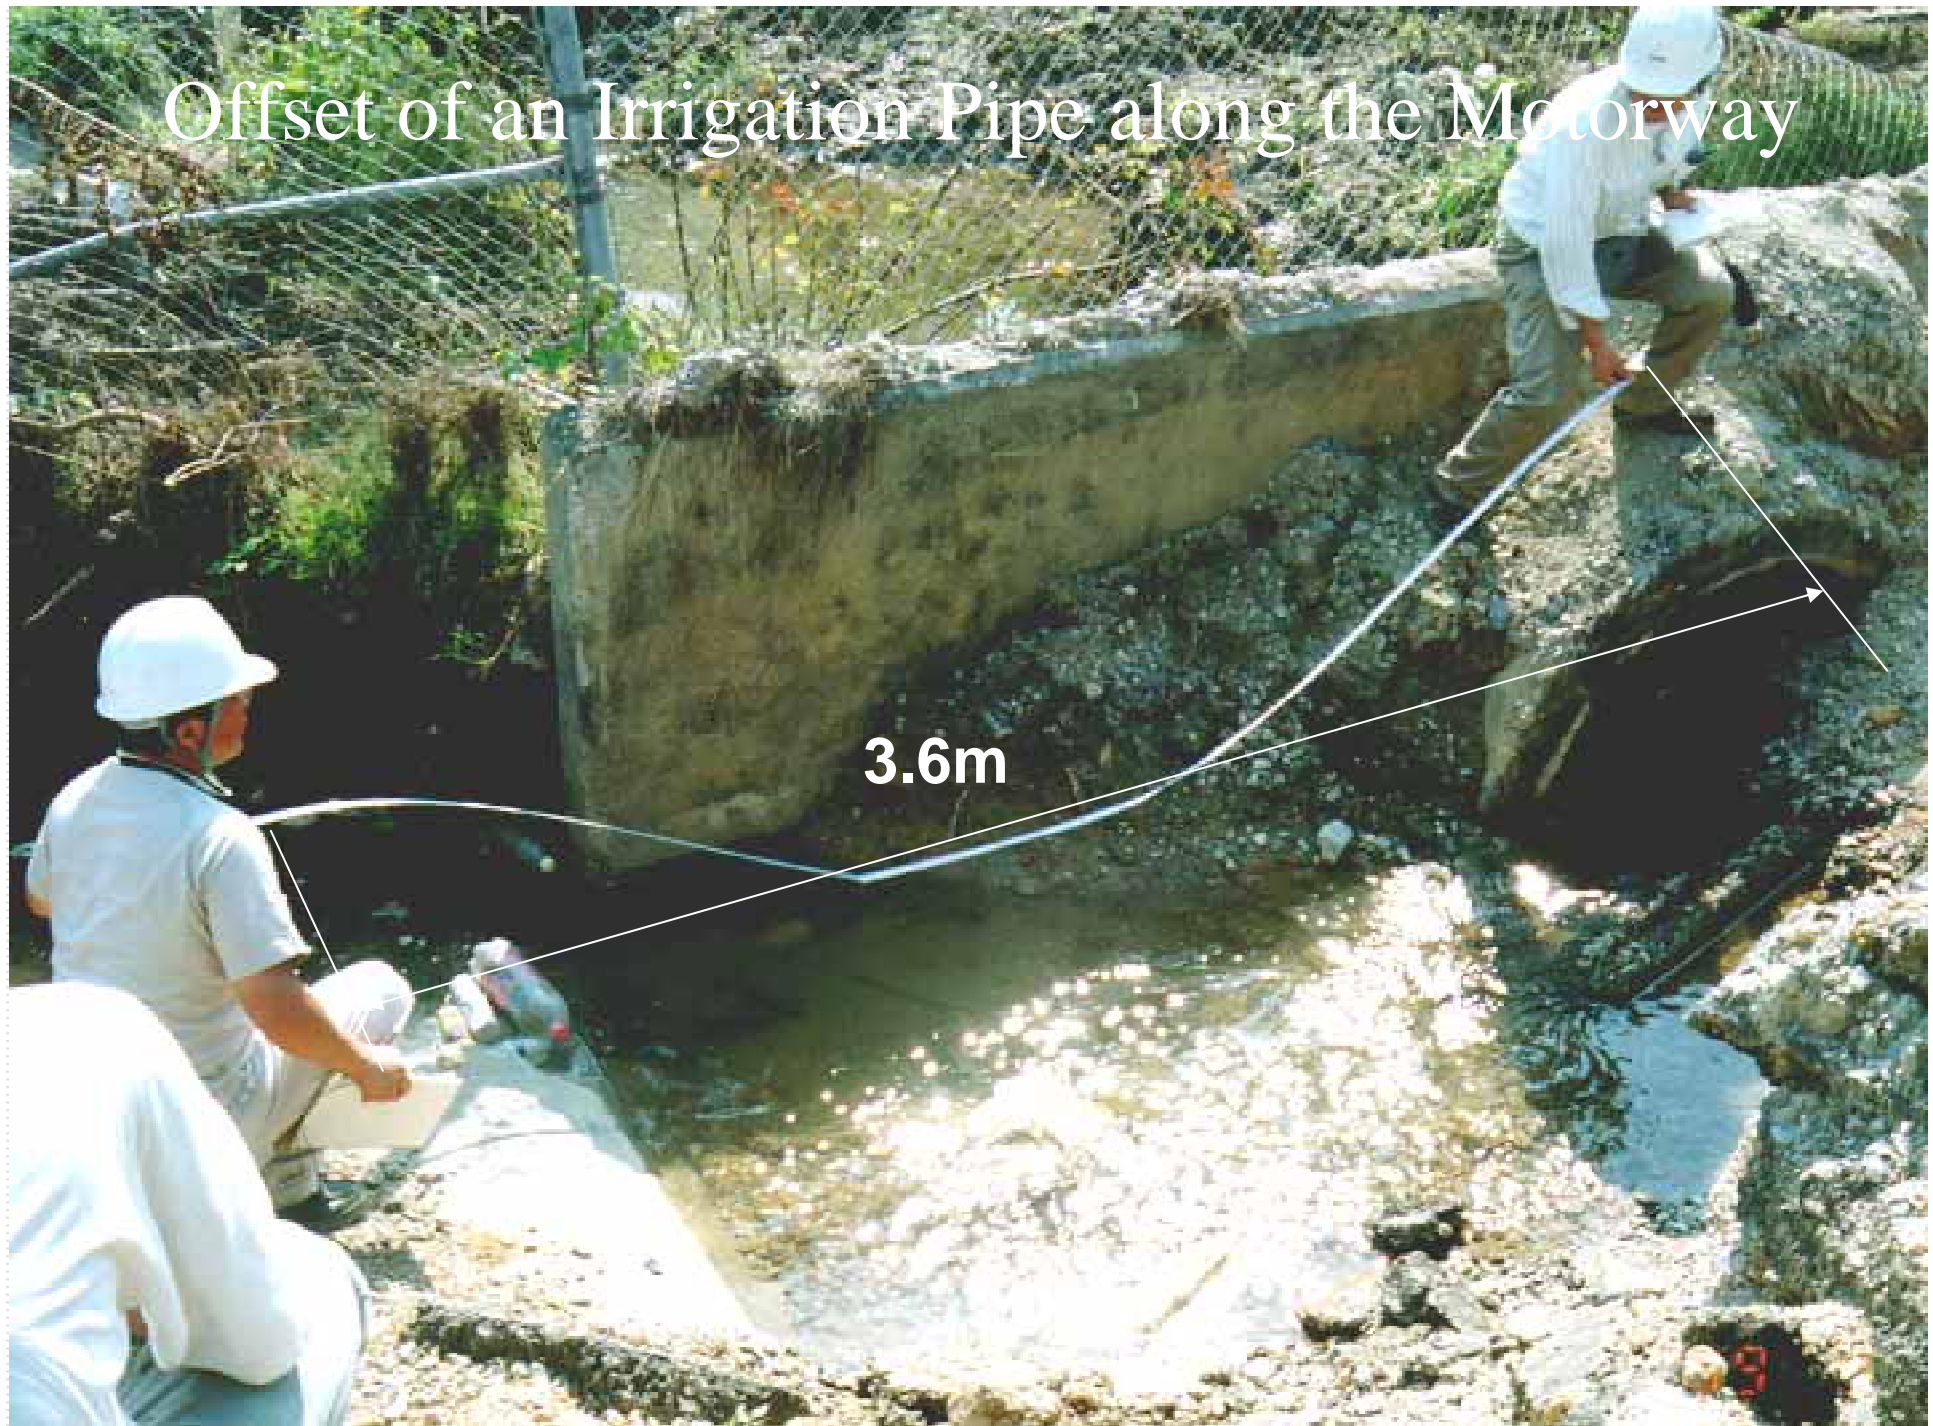
Offset of an Irrigation Pipe along the Motorway

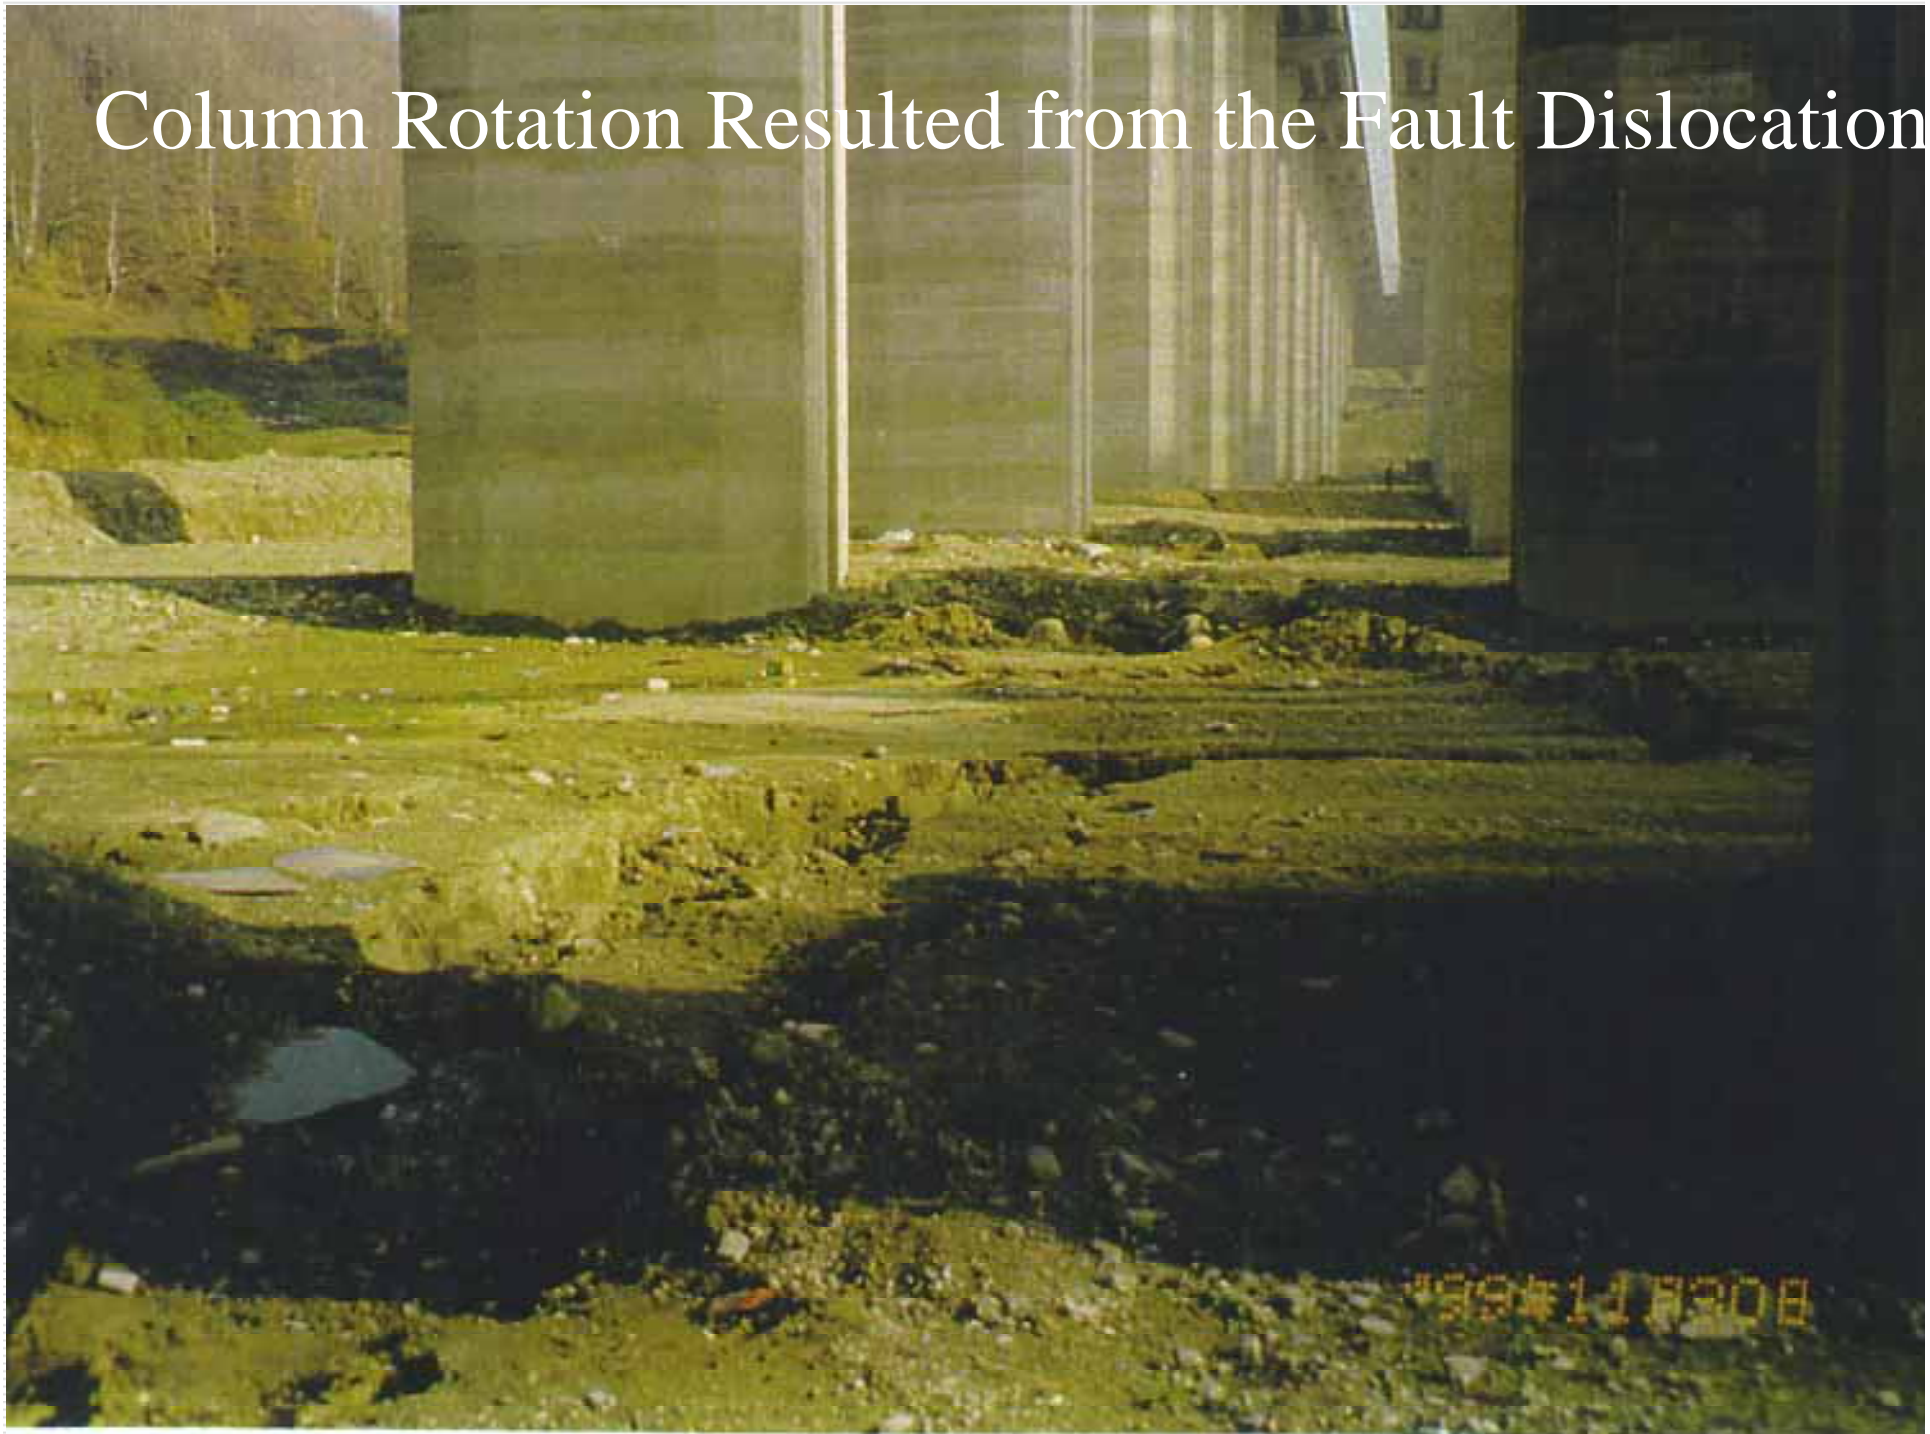
Column Rotation Resulted from the Fault Dislocation

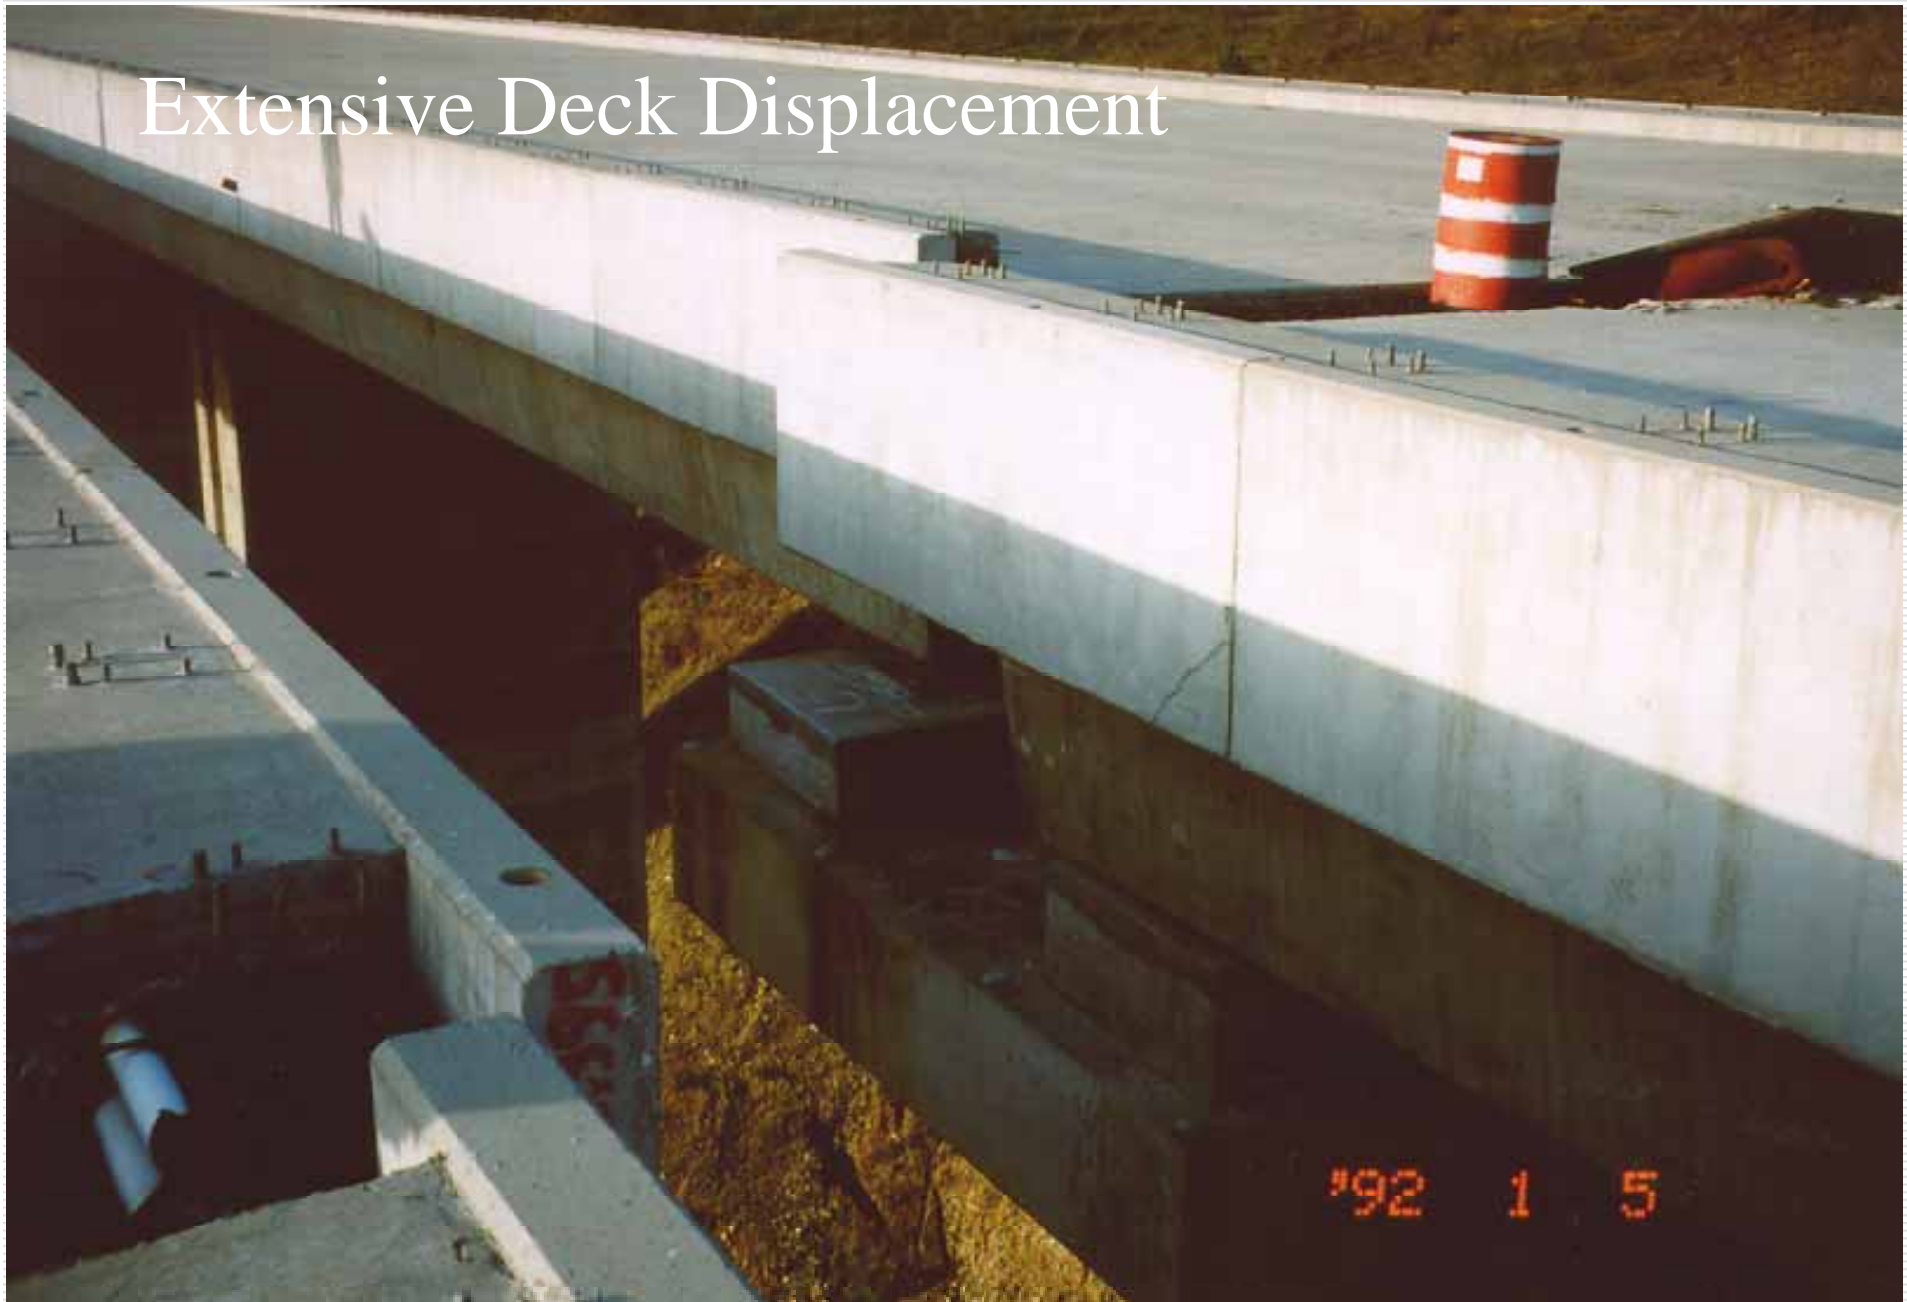
Extensive Deck Displacement
