2.3 Seismic Damage of Bridges in USA

2.4 Damage of Bridges Due to Fault Displacement

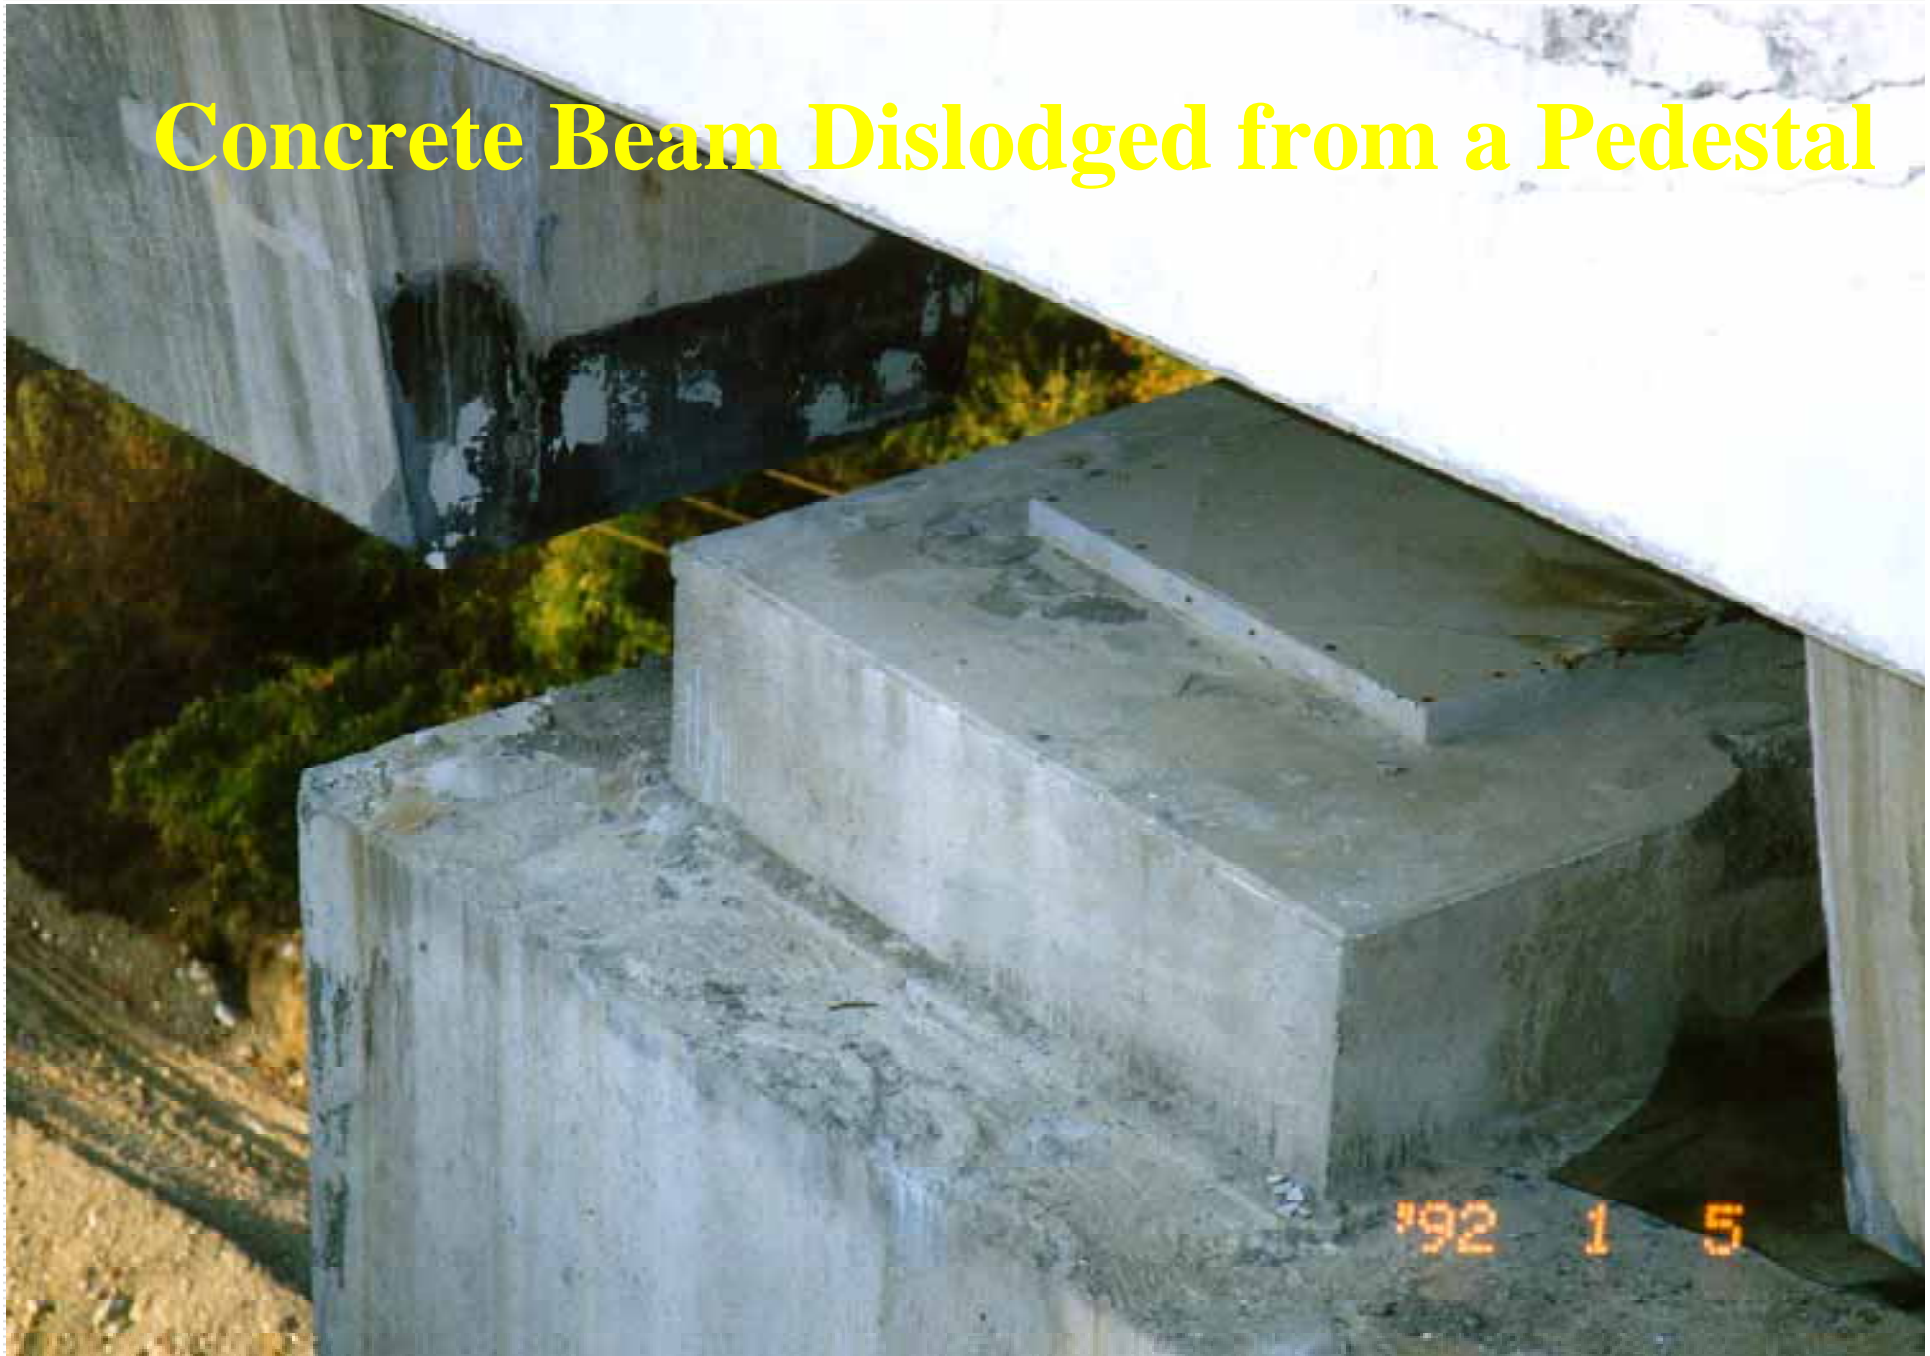
Concrete Beam Dislodged from a Pedestal

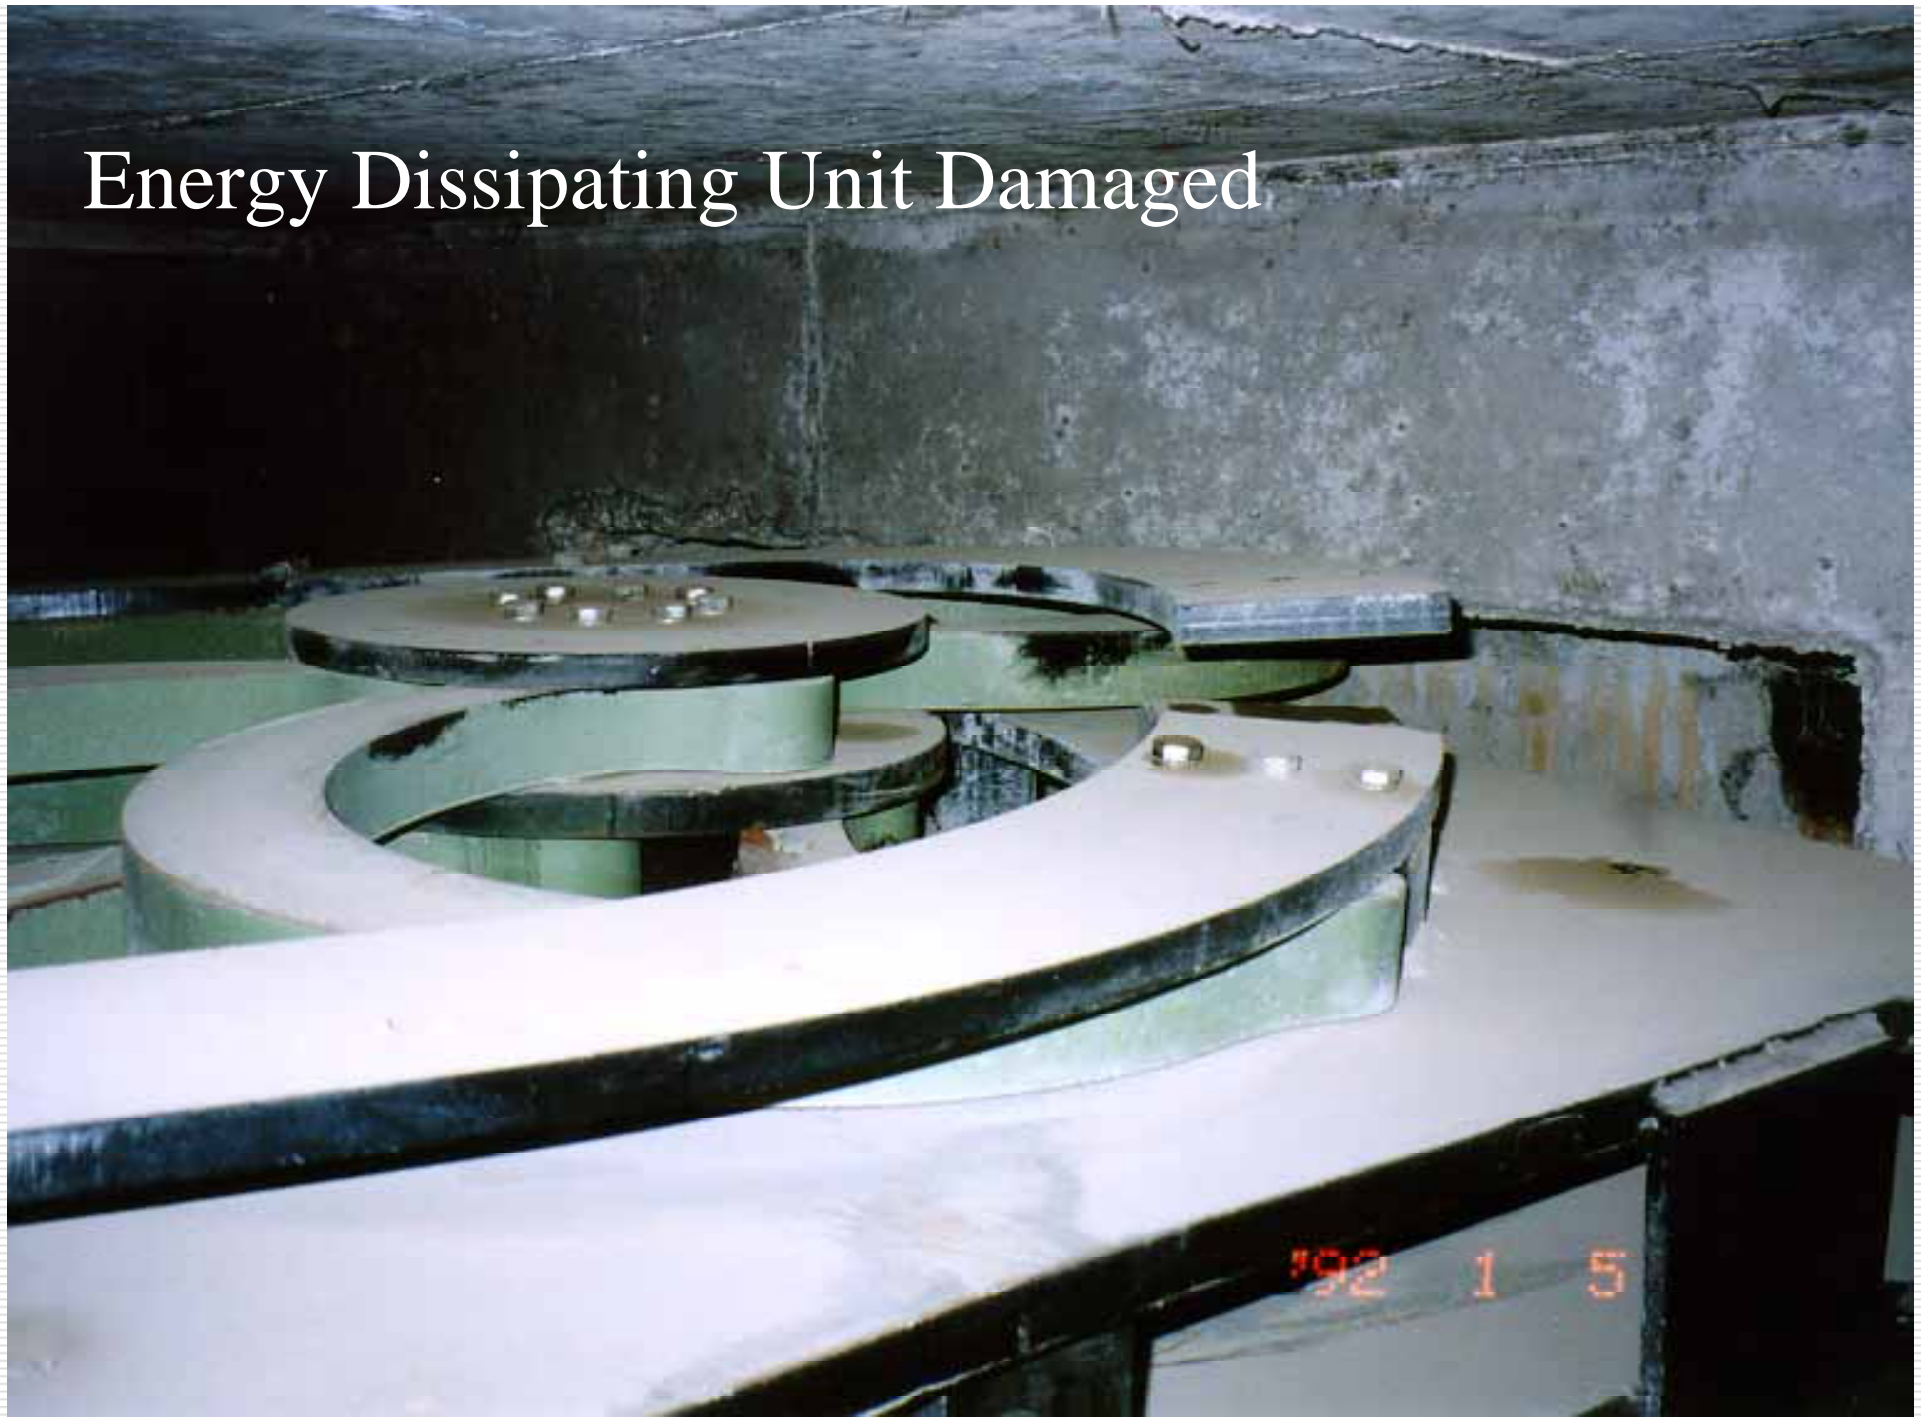
Energy Dissipating Unit Damaged

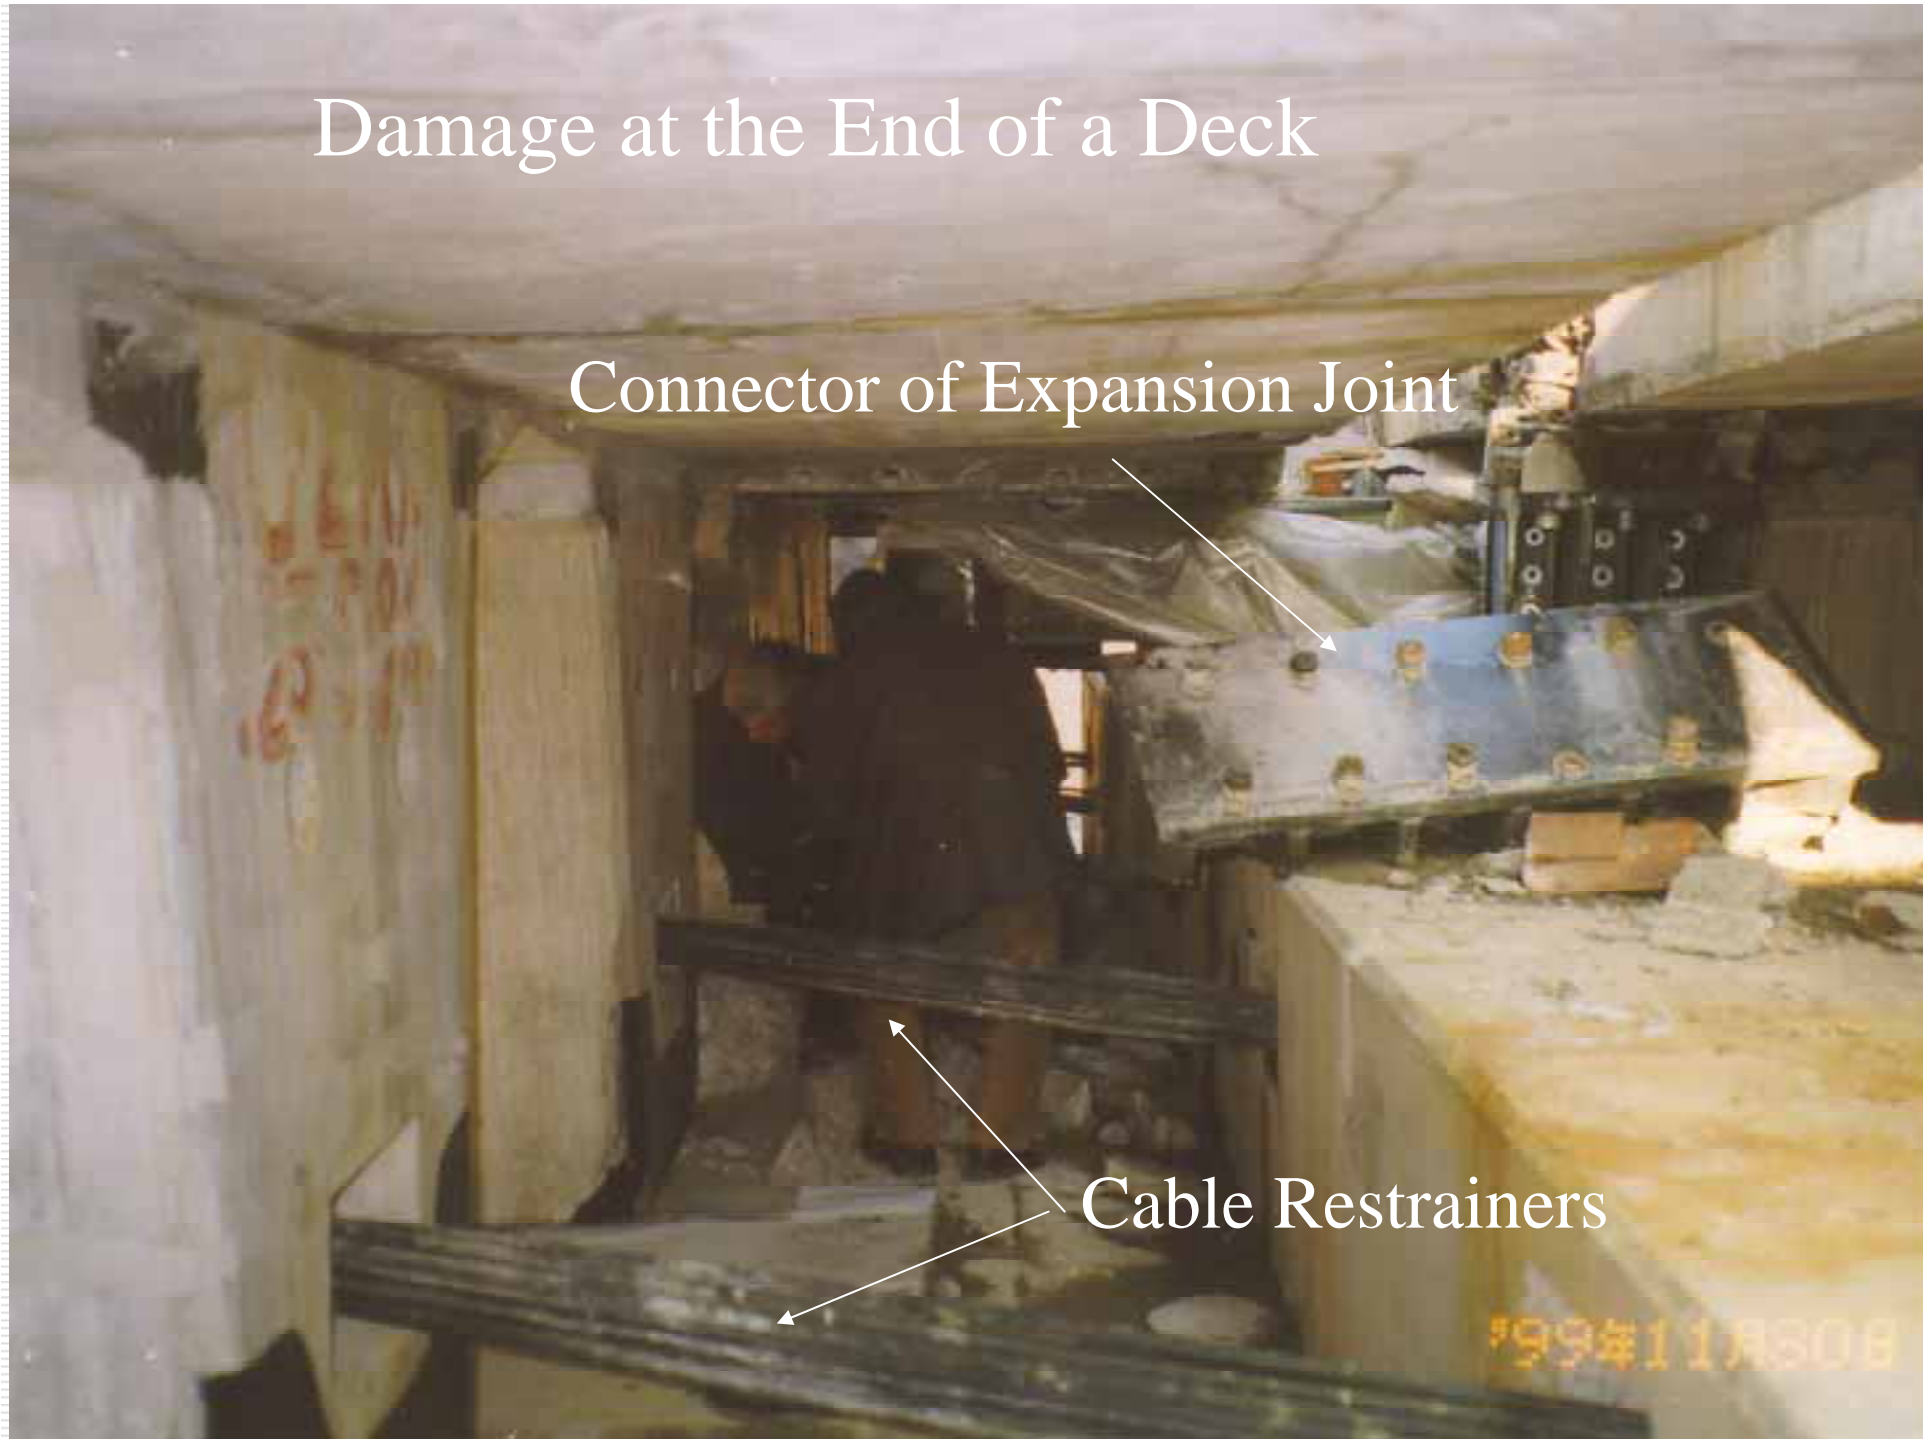
Damage at the End of a Deck

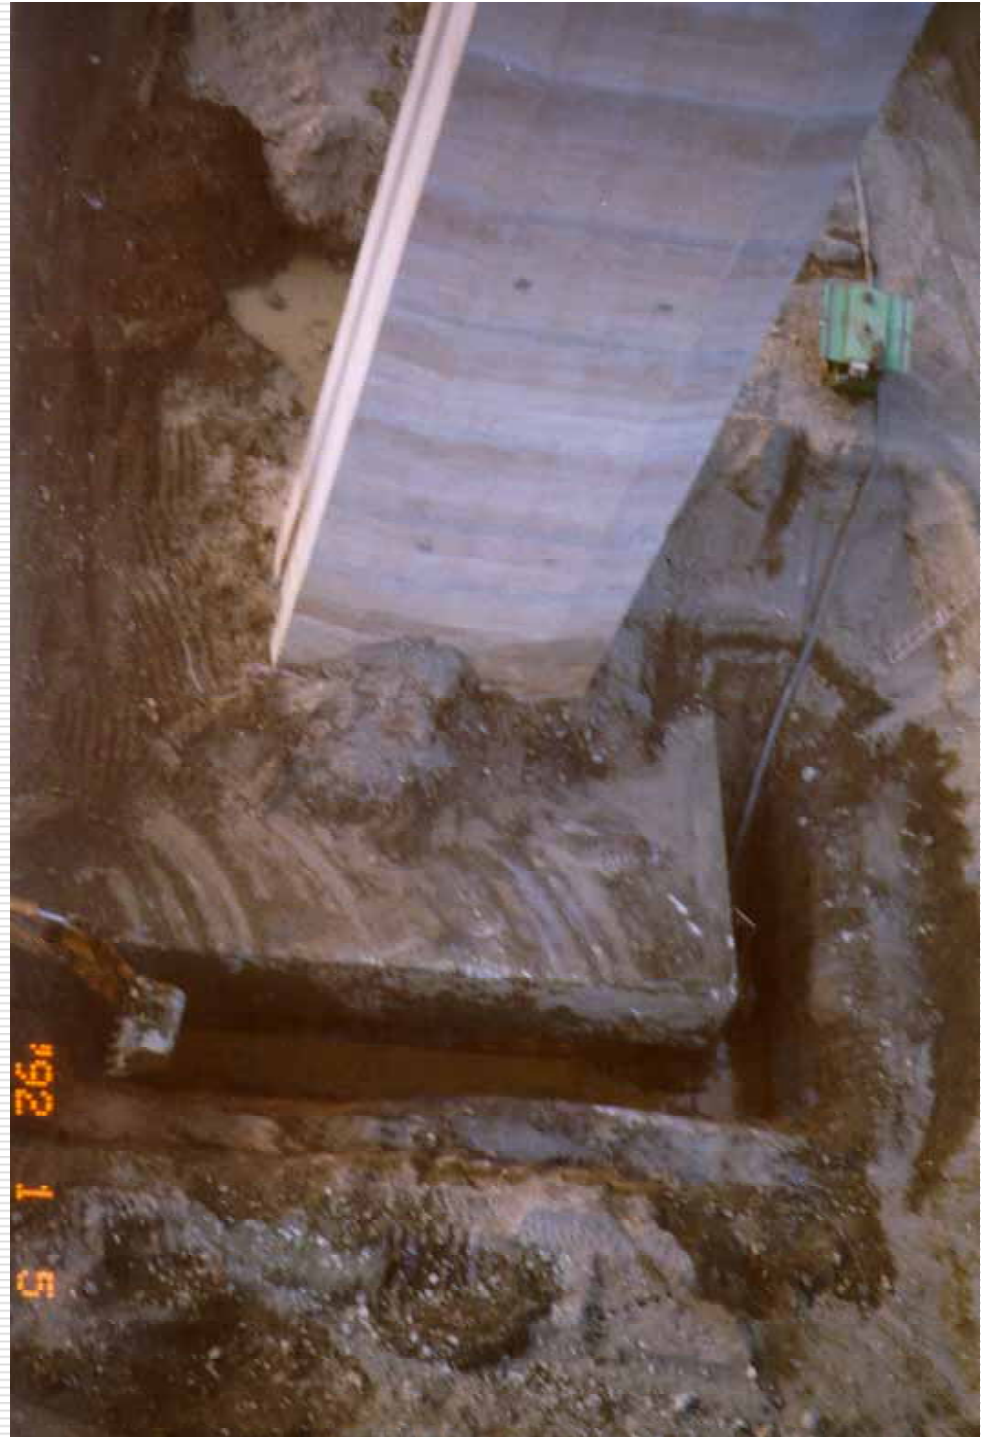
Pile Foundation Damaged by Fault Displacement

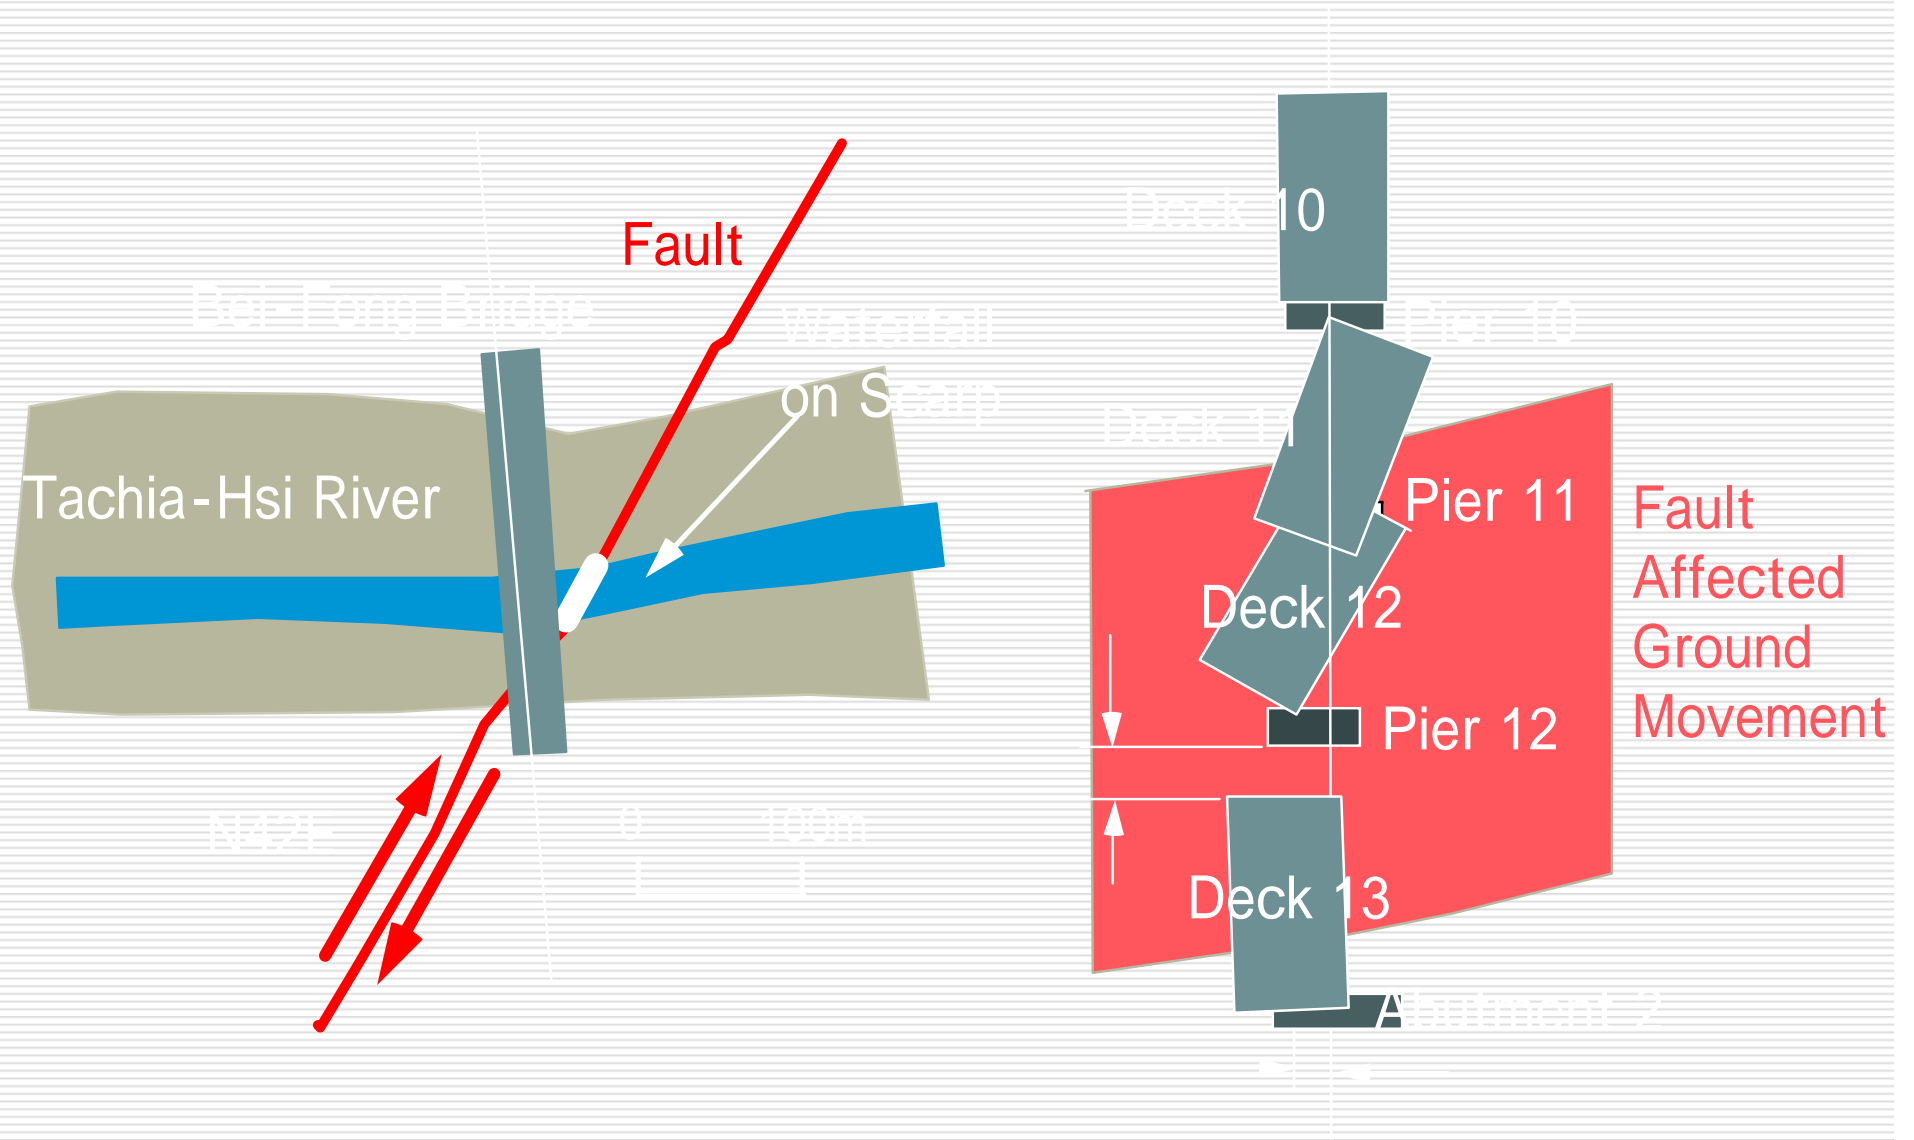
Fault Dislocation around Bei-Fong Bridge
