## 鋼構造物の設計 (7)

### 第3部: 鋼構造部材の設計

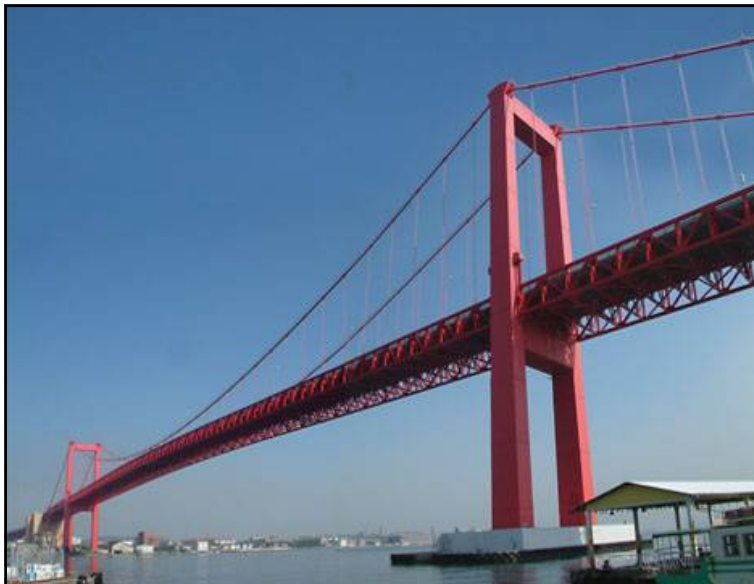
若戸大橋

北九州市 1962年

引張部材:ケーブル, ハンガー

支間367m

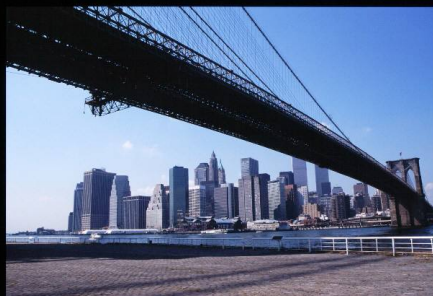
エアスピニング(AS)工法

Brooklyn橋

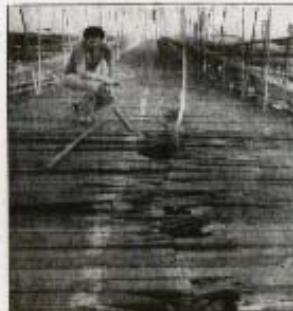
Newsman checks walkway holes after two cables broke.

NEW YORK (AP) — Pedestrians and bicyclists were turned away from the Brooklyn Bridge yesterday while engineers tried to determine whether corrosion from pigeon droppings caused two cables to break and fall, critically injuring one man.

The broken cables, 2.25 inches in diameter, were designed to keep the bridge from swaying in the wind and were not involved in holding up the bridge.

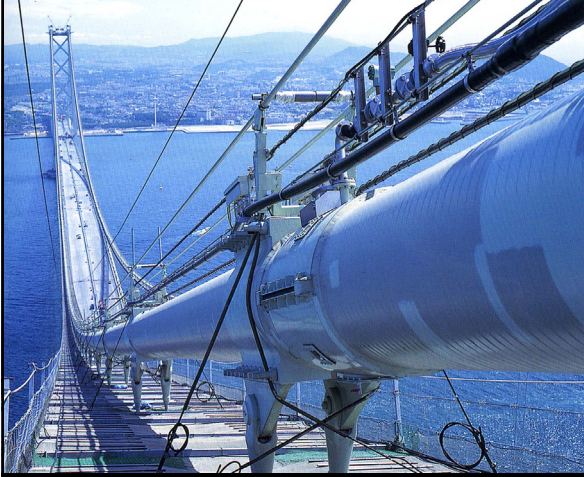
明石海峡大橋  
ケーブル空調装置
