6. Inspection, NDE

Research Works on NDE

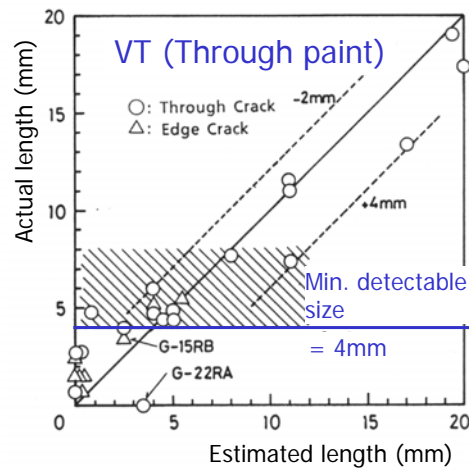
Inspection Results – VT (I)

Discontinuities of paint films are the sign of presence of cracks → Easy to detect

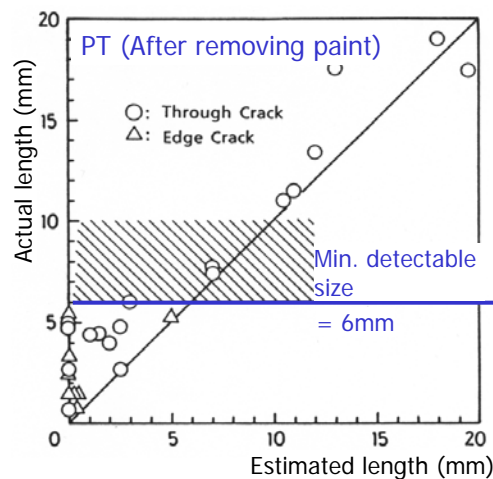
Inspection Results – PT (I)

Underestimate the length of cracks

Min. size = 6 mm

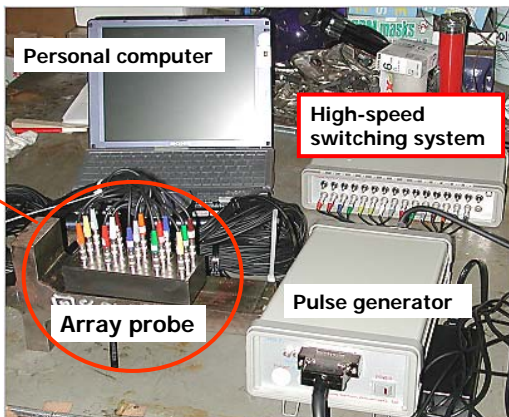
Ultrasonic Inspection System

A photograph showing the components of the Ultrasonic Inspection System. A personal computer is connected to a high-speed switching system, which is connected to an array probe. A pulse generator is also connected to the system. A red circle highlights the array probe, with a red line pointing to the word 'Selectable'.

Personal computer

High-speed switching system

Array probe

Pulse generator

- Compact and portable → appropriate for in-service inspection
- Very fast → All wave signals are recorded within 5 seconds
- All wave signal can be recorded at sampling frequency of 60 MHz, which is large enough for defect evaluation.
