Seismic Response Modification of Urban Infrastructure

(1) Damage Experience in the Past

Kazuhiko Kawashima
Department of Civil Engineering
Tokyo Institute of Technology
東京工業大学大学院理工学研究科土木工学専攻
川島一彦

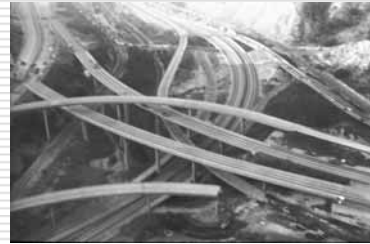
(3) 1971 San Fernando, Earthquake, USA

Collapse of 5/14 Overcrossing

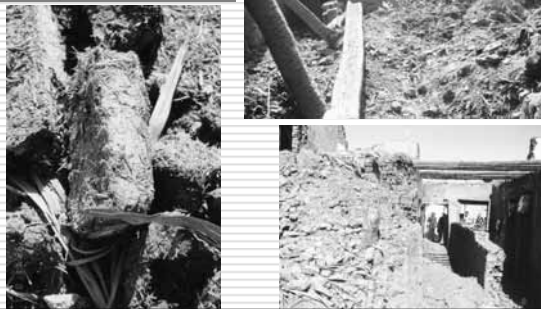
(6) 1992 Cairo, Egypt Earthquake (M5.4)

Adobe Construction
which always
resulted in extensive
damage worldwide

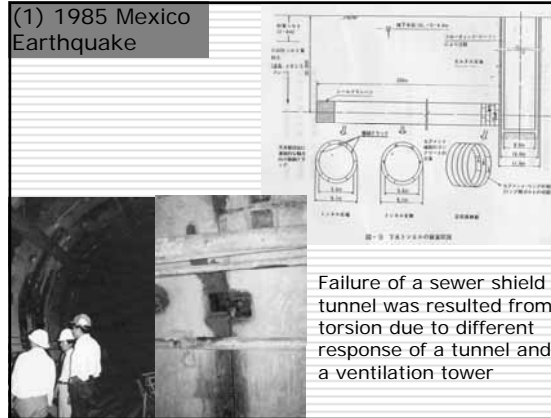
(1) 1985 Mexico Earthquake

Failure of a sewer shield tunnel was resulted from torsion due to different response of a tunnel and a ventilation tower

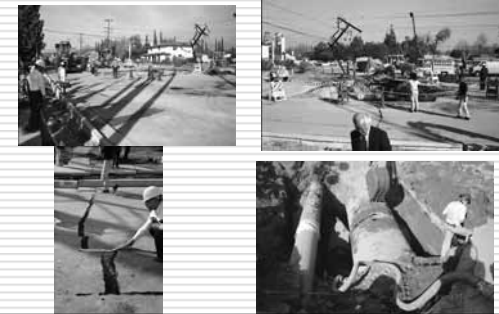
(2) 1994 Northridge Earthquake, USA

Failure of Water Pipes Resulting from Ground Motion Effects

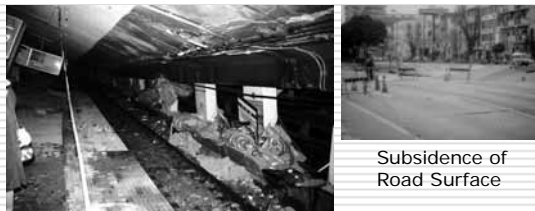
(3) 1995 Kobe Earthquake, Japan

Collapse of Daikai Subway Station

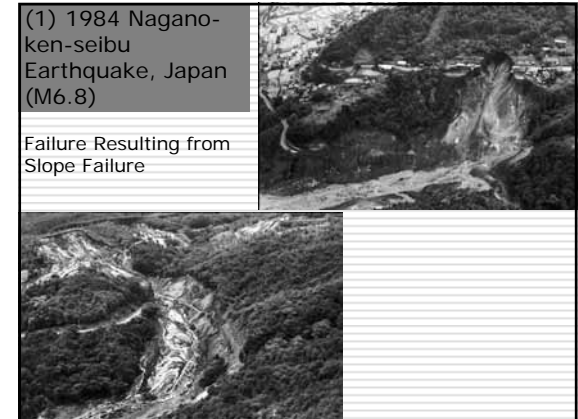
(1) 1984 Nagano-ken-seibu Earthquake, Japan (M6.8)

Failure Resulting from Slope Failure

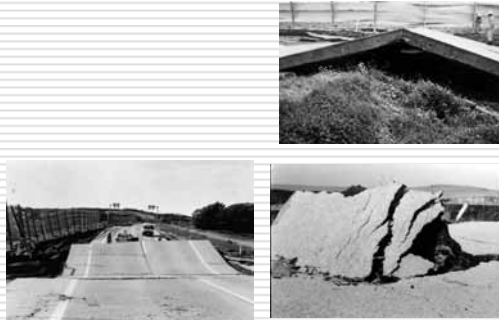
Failure of road pavement resulting from lateral spreading
1983 Nihon-kai-chubu, Japan, Earthquake
