Material related Issues

Fracture Control Design, #12

Chitoshi MIKI

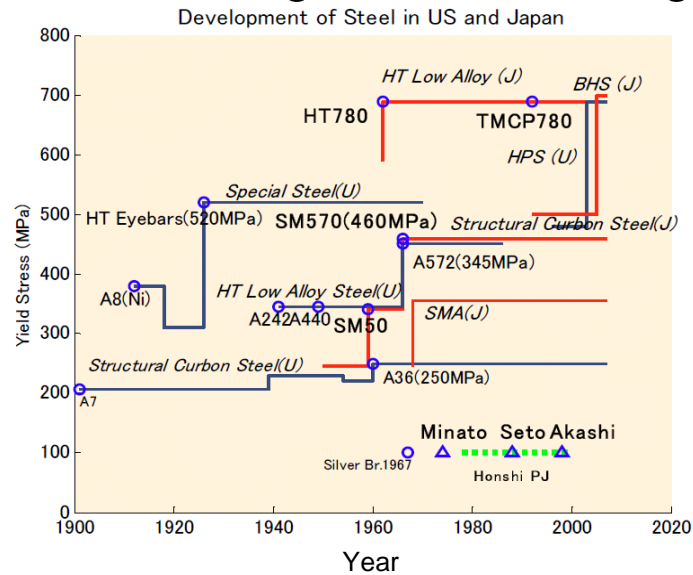
Historical change of steel strength

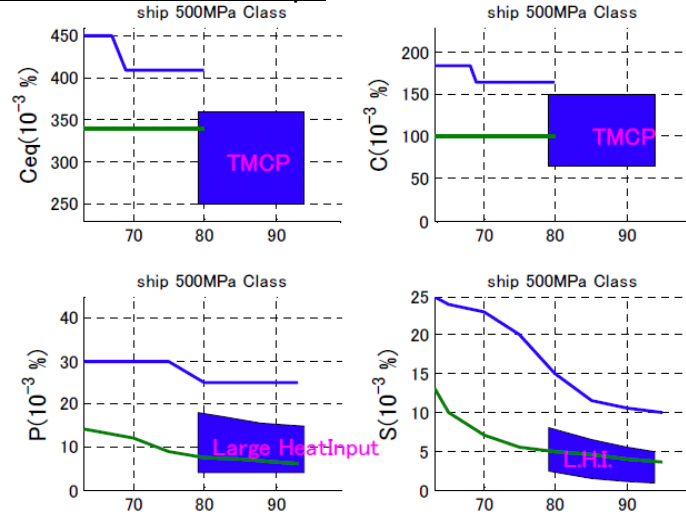
Chemical composition

500MPa class steels for ships

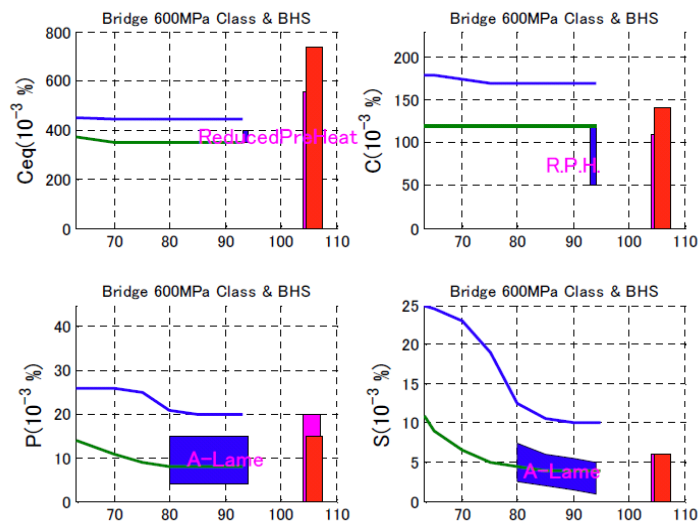
Chemical composition

600MPa class steels for bridges & BHS

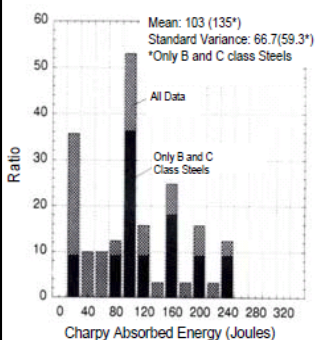
Charpy Absorbed Energy

JIS structural Steel 1970s

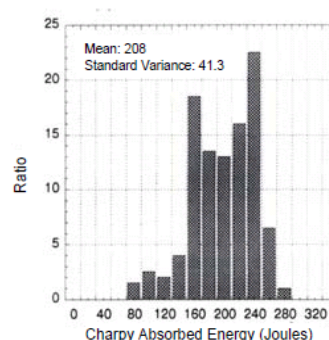
SM490YB 1990s

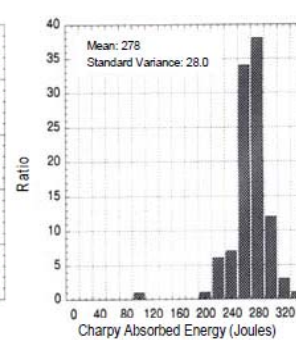
SM570Q 1990s

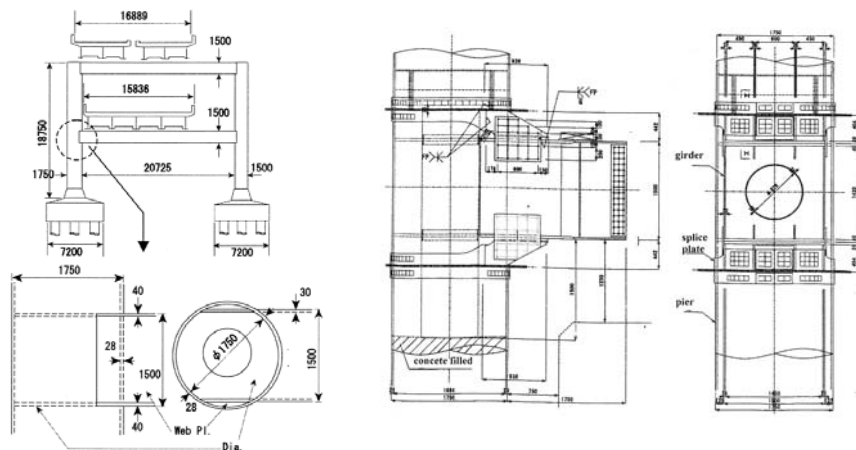
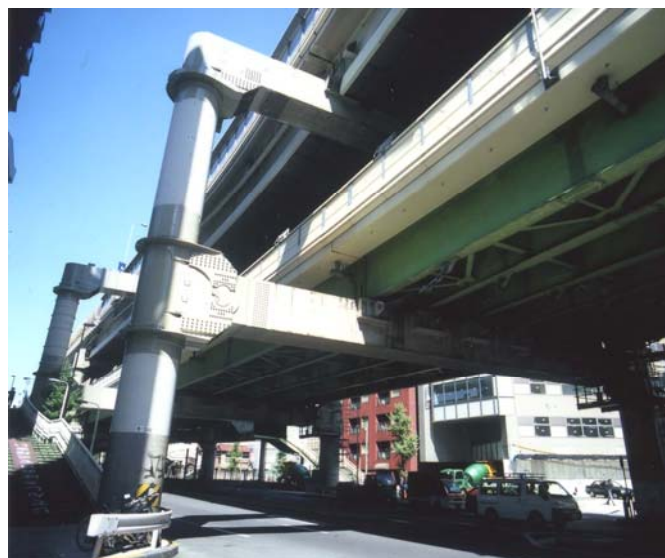
Lamellar Tearing

Old problem, but still important

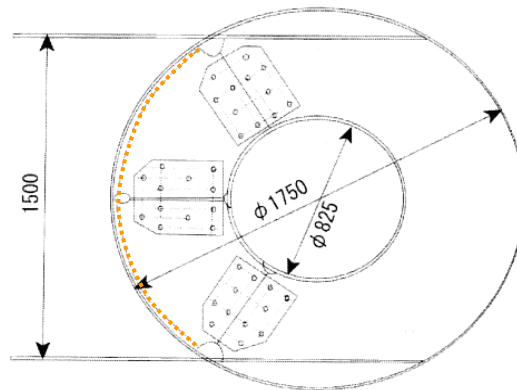
Repairing weld

Because of very low stress fluctuation

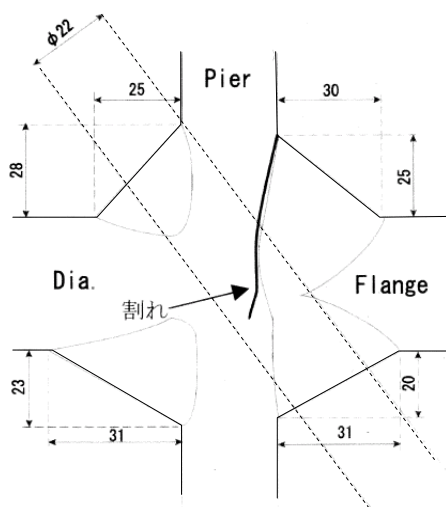
Lamellar tearing

UT results

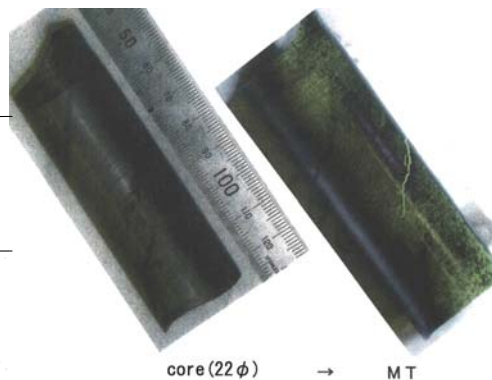
Coring

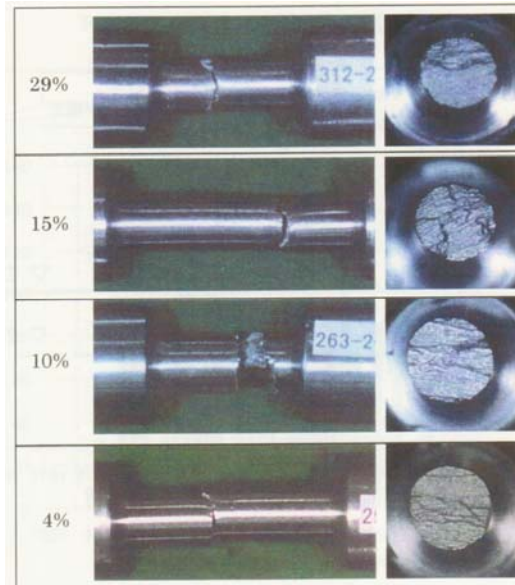
Test results

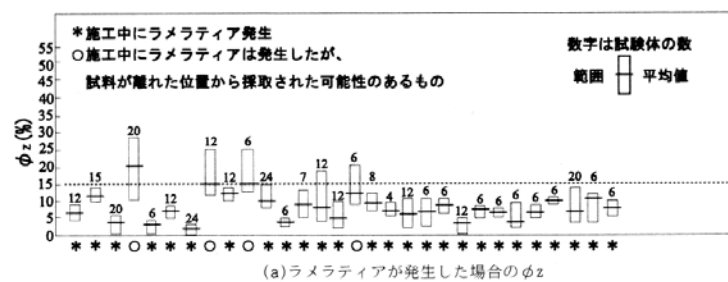
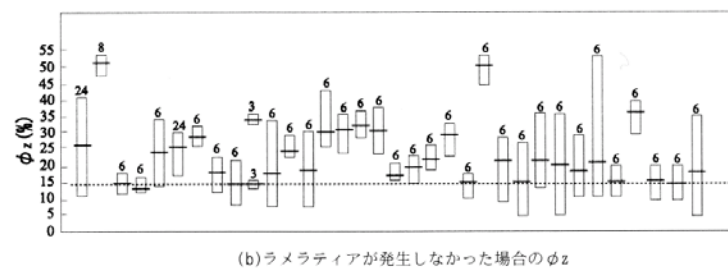
Occurrence of Lamellar Tearing and Φ_z

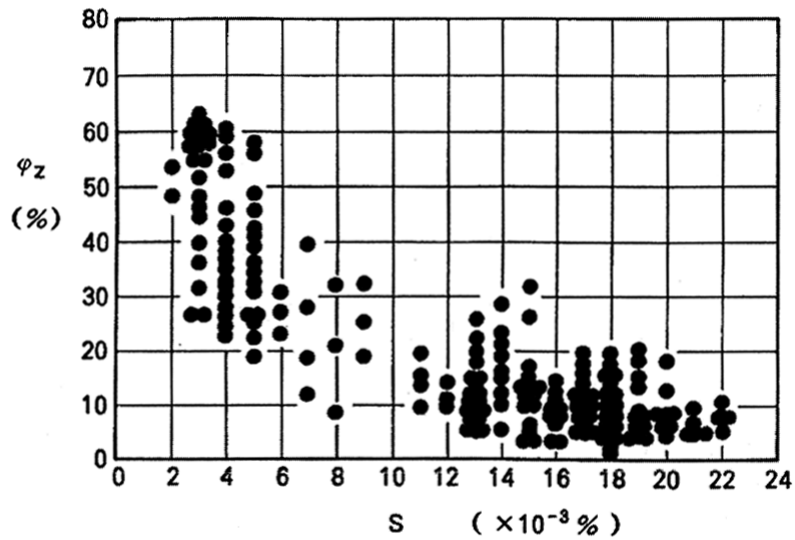
Content of Sulfur S and Φ_z

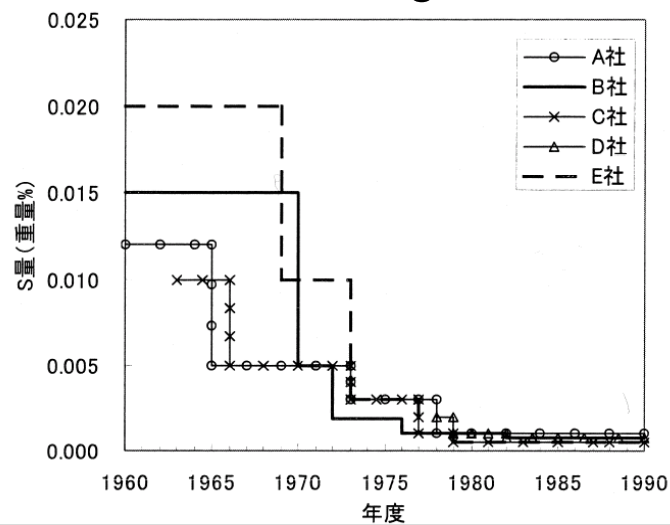
Capability of Removal of Sulfur in Steel Making Process

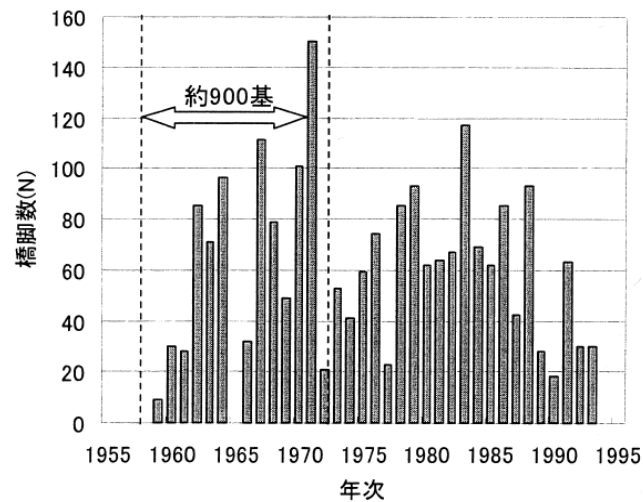
History of Steel Bent Construction in MEX

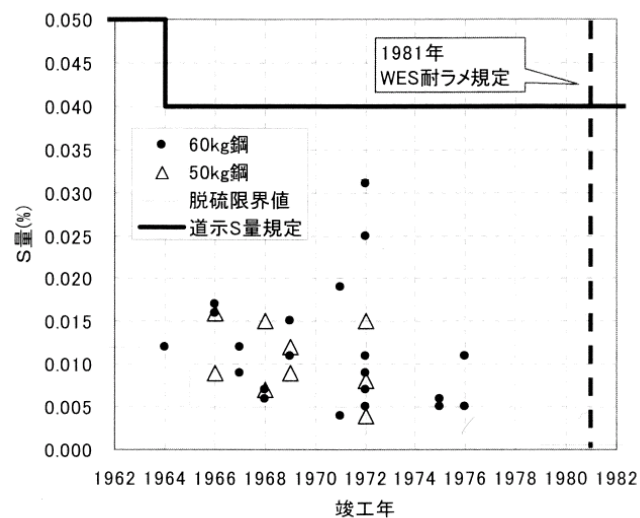
Results of z-direction tests for cores from piers Construction year and Sulfur Content

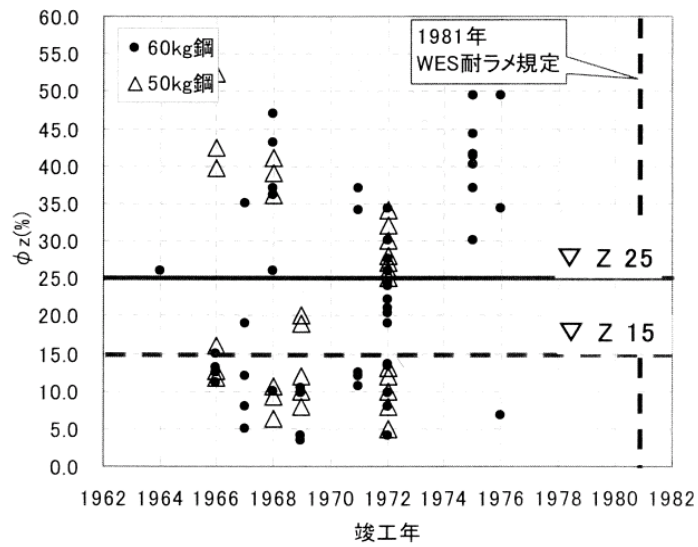
Construction year and Φ_Z

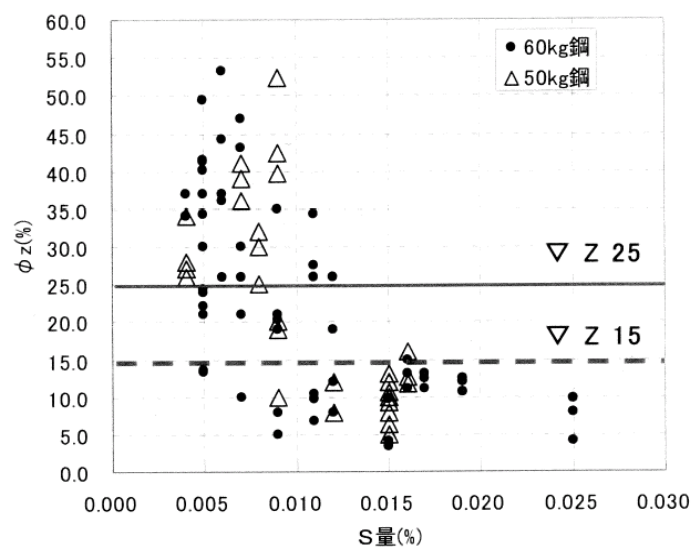
Sulfur content and Φ_Z
