Response Modification of Urban Infrastructure

(3) Chapter 2 Seismic Damage of Bridges
due to Ground Vibration (Part 2)

Kazuhiko Kawashima

Department of Civil Engineering

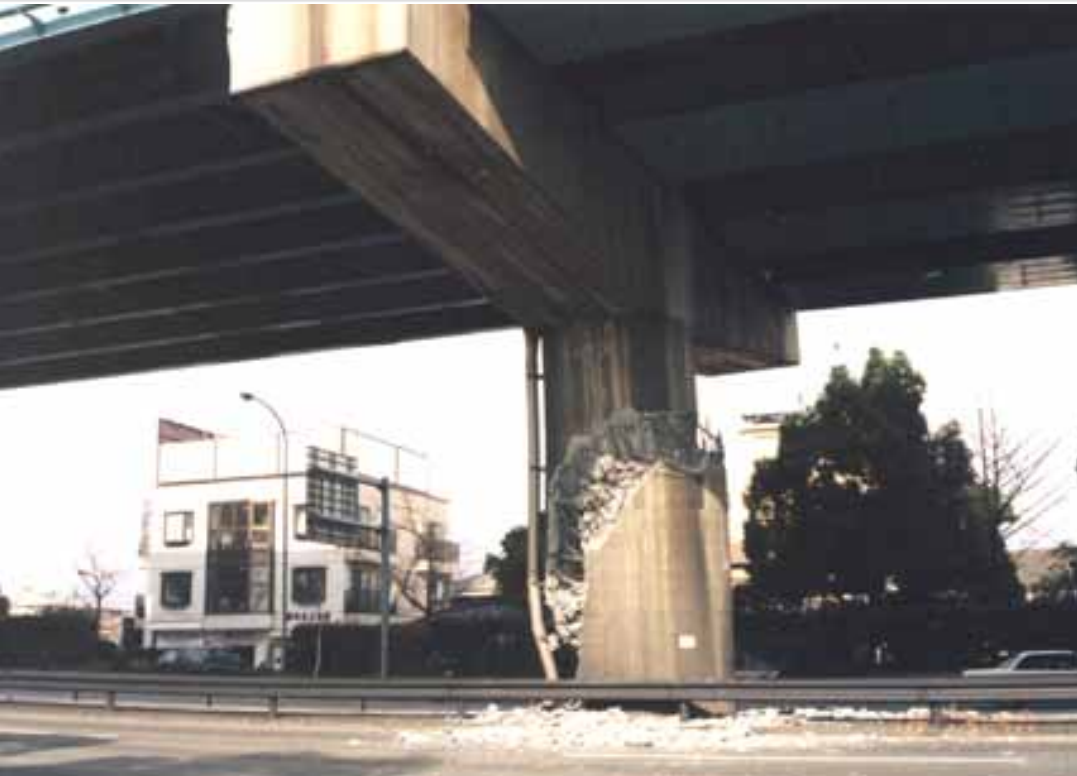
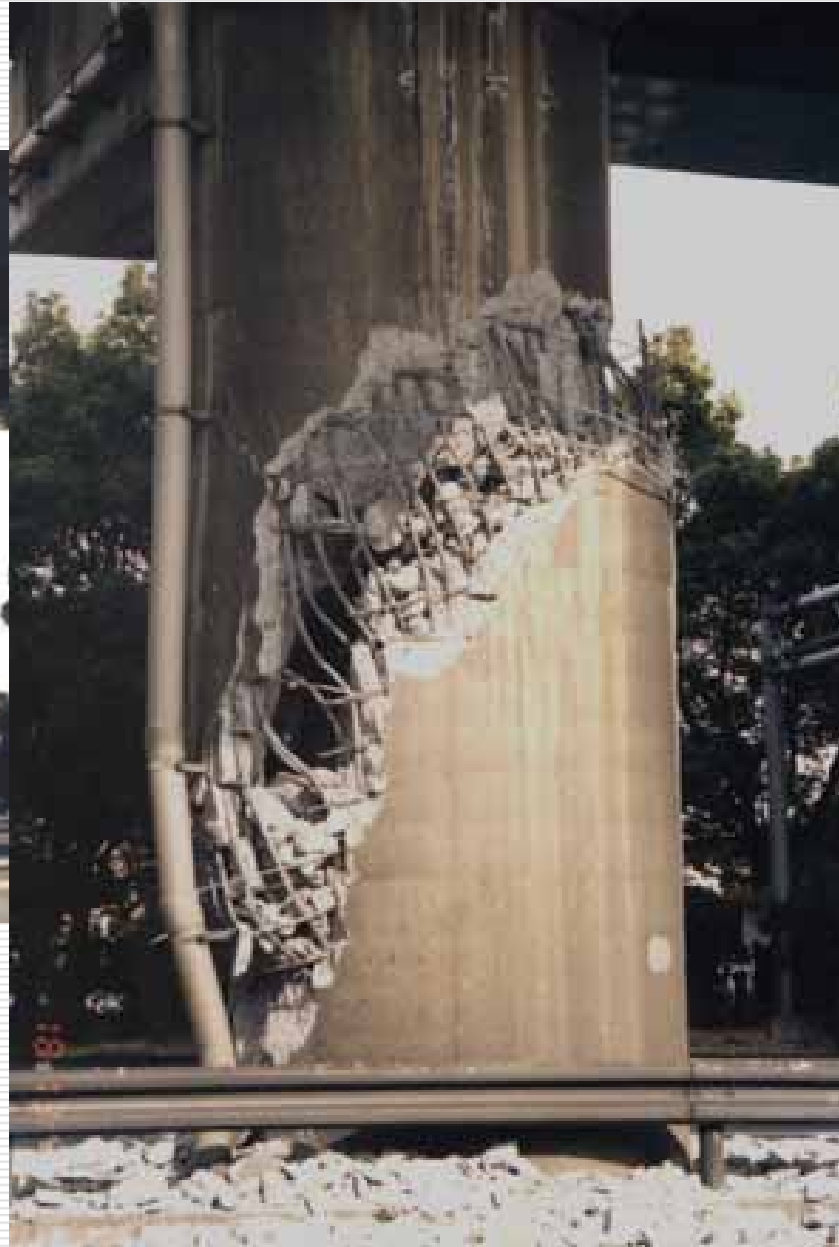
Shear Failure せん断破壊

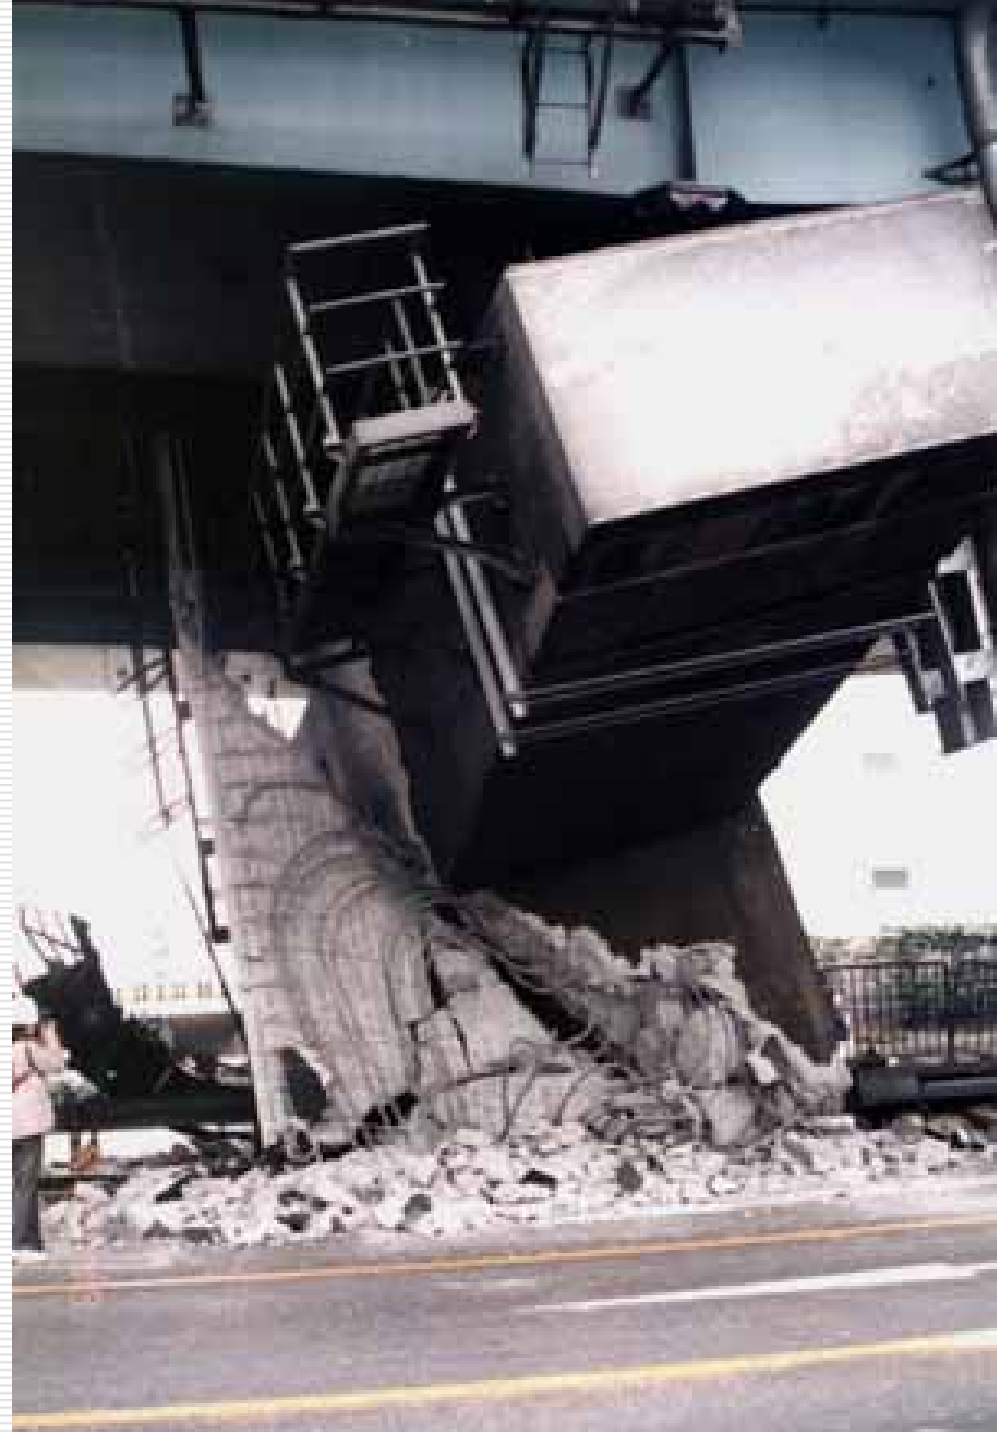
Shear Failure せん断破壊

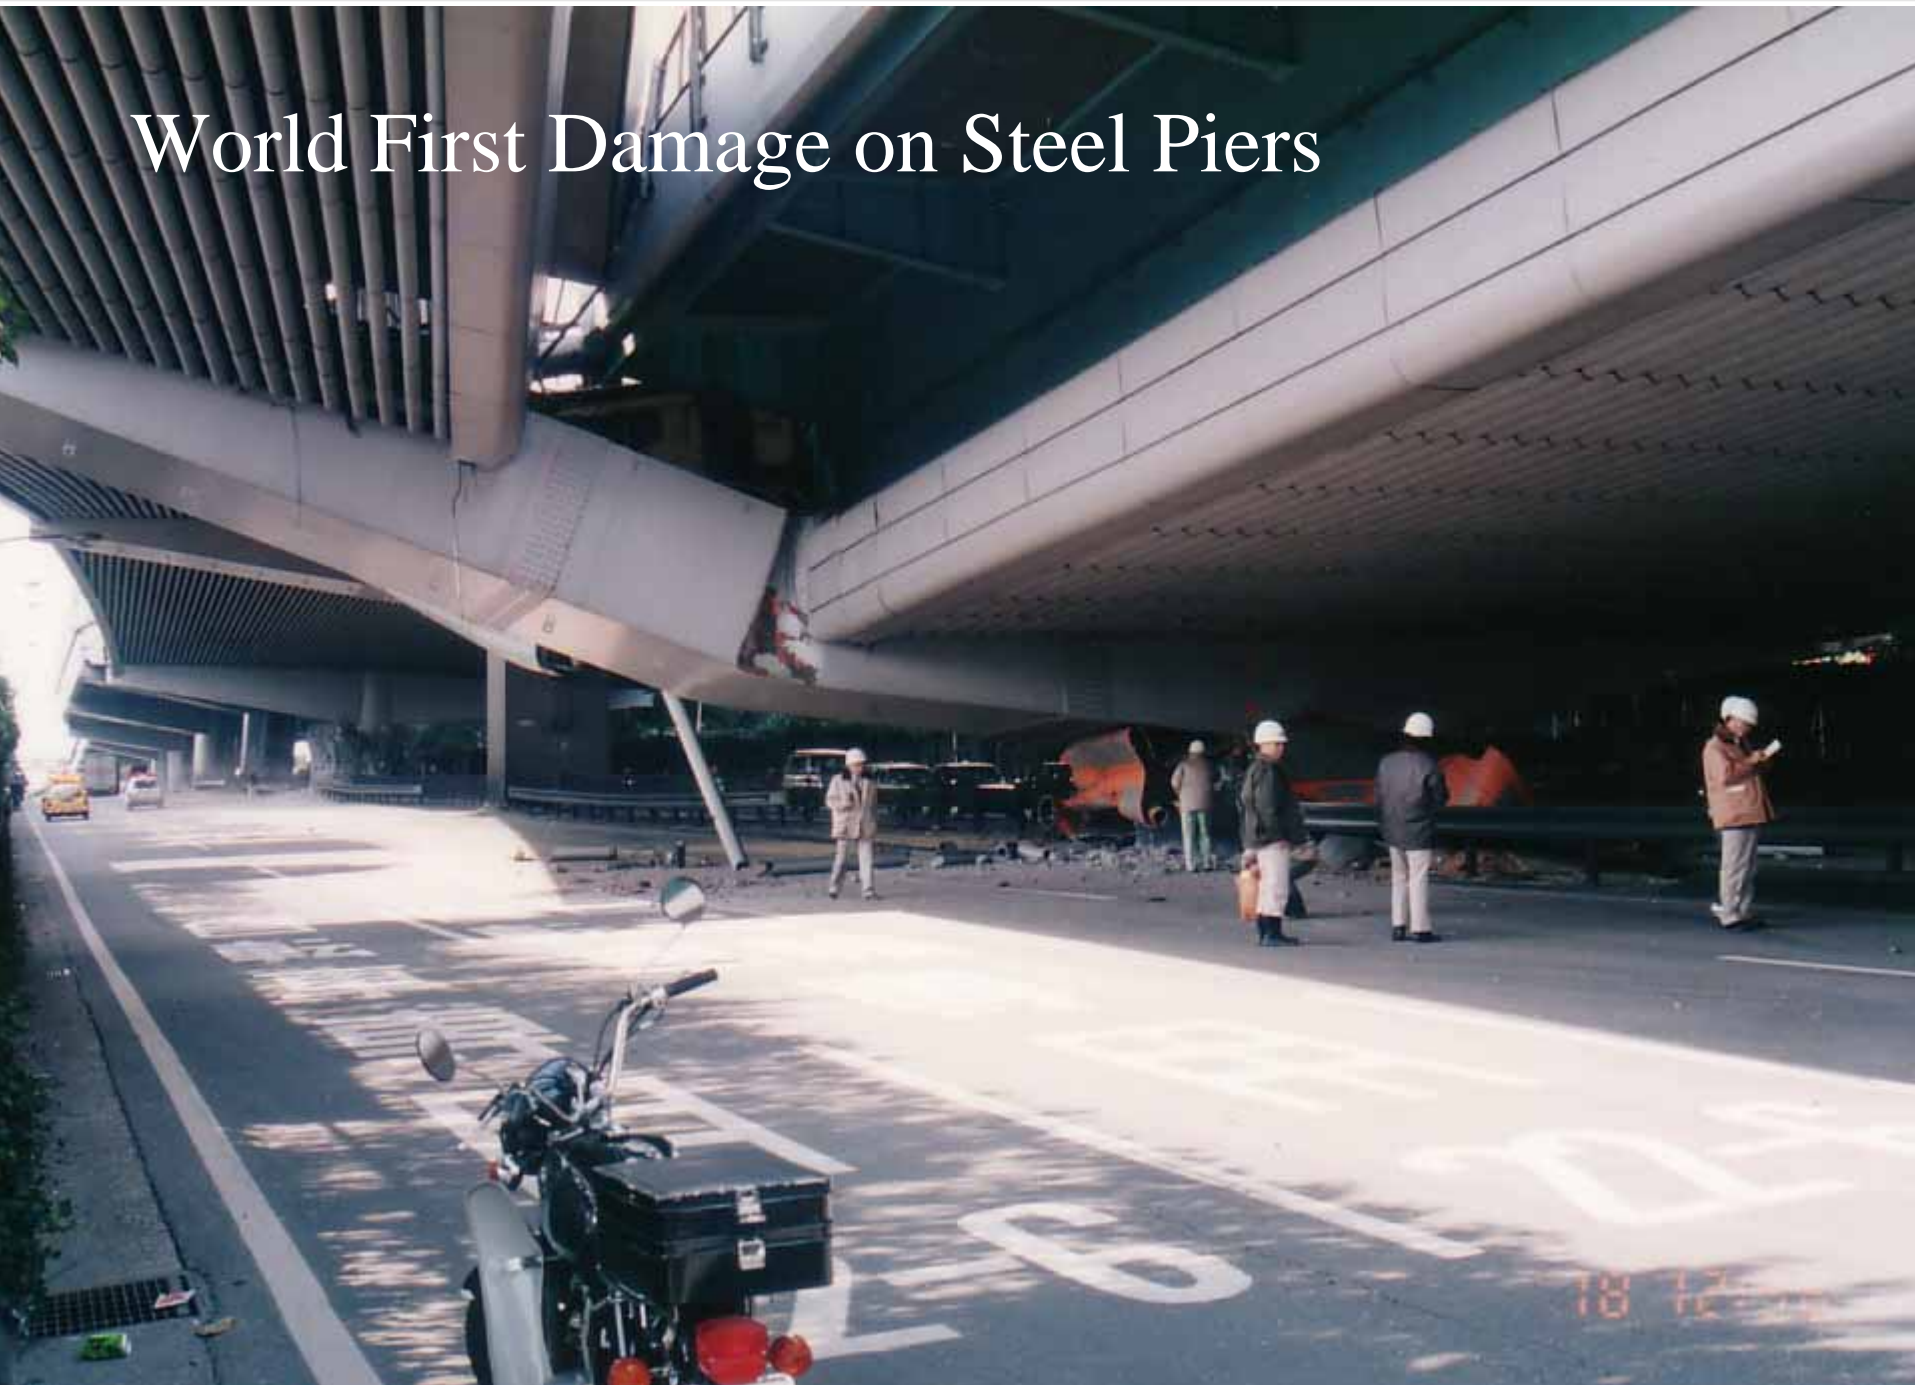
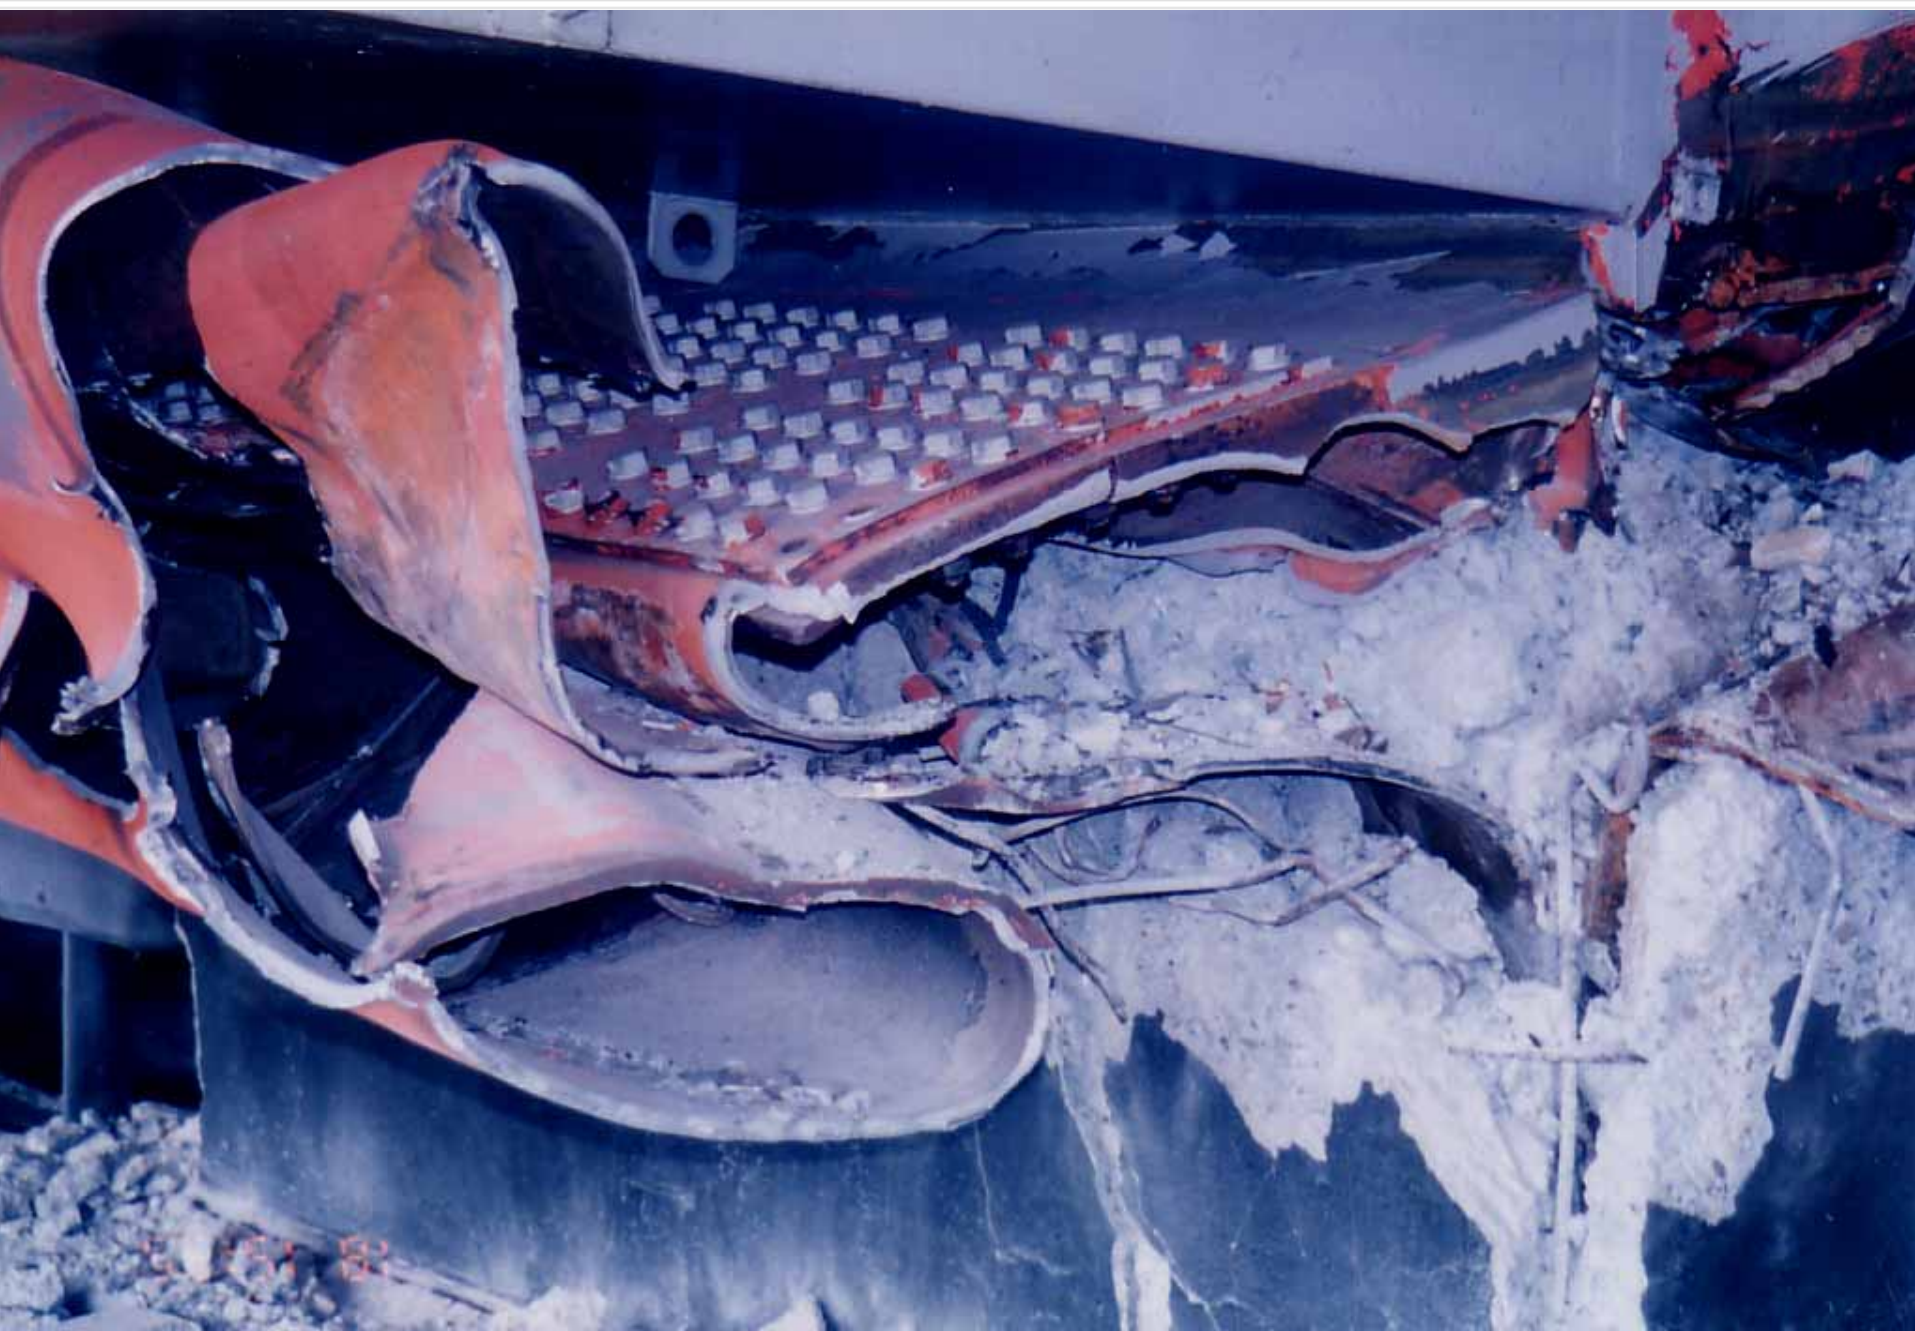
World First Damage on Steel Piers

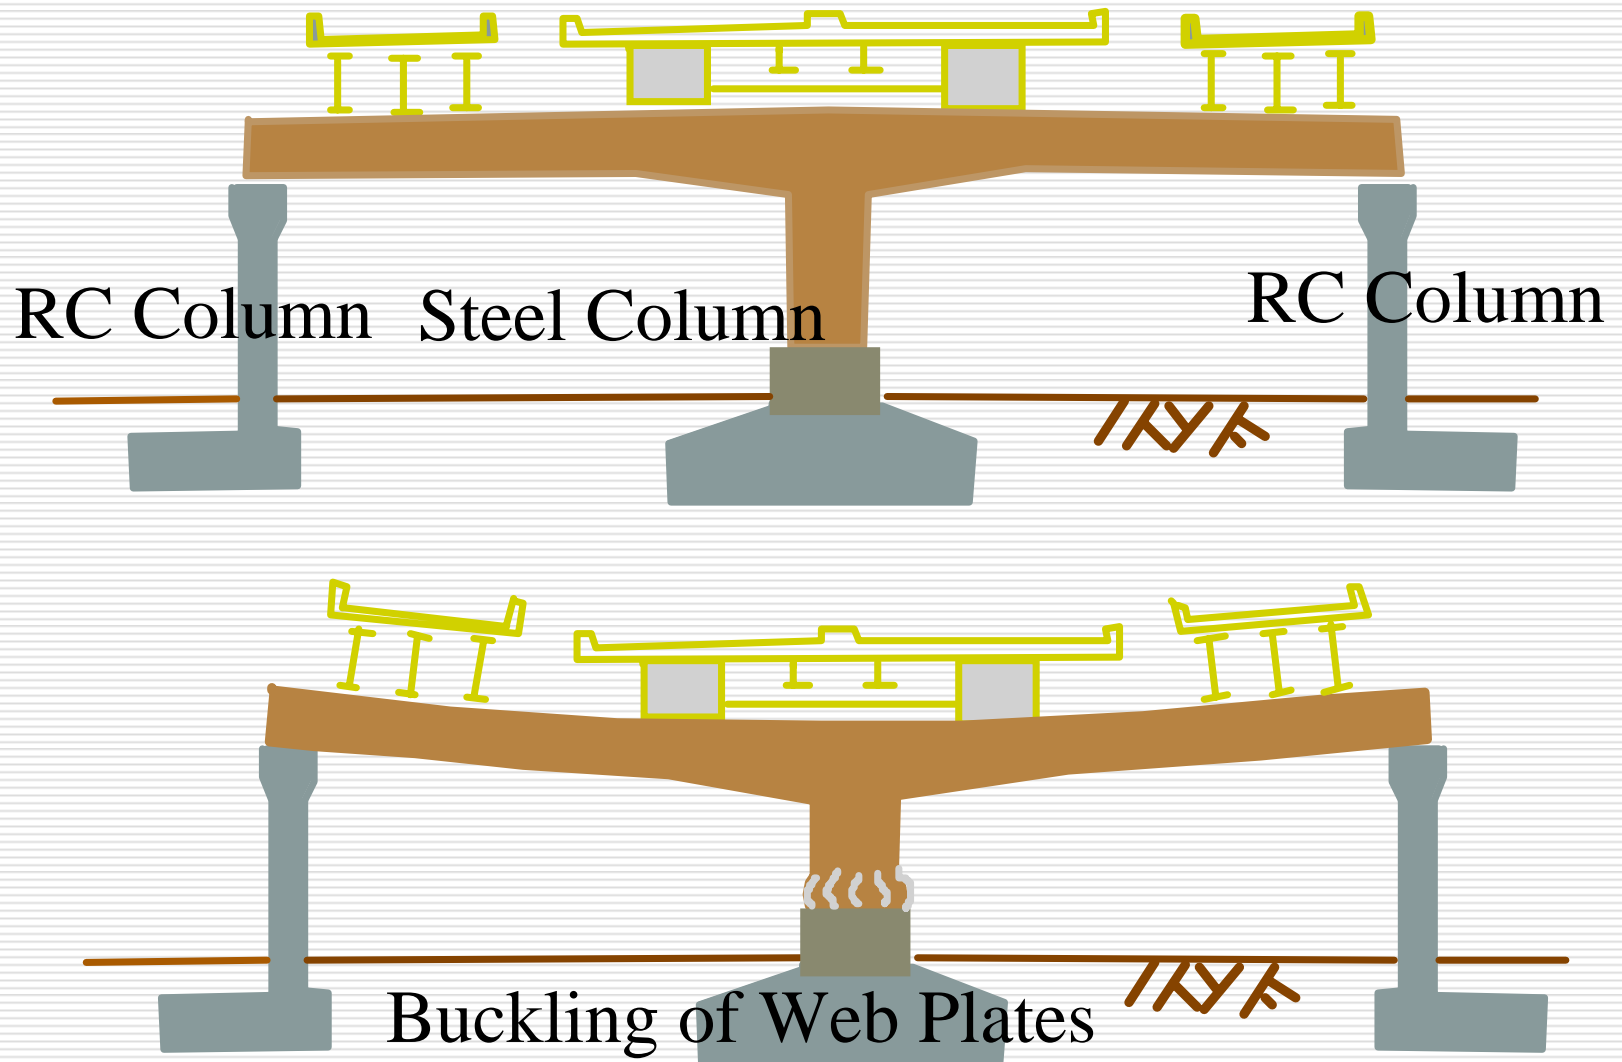
Progress of Failure of Steel Columns

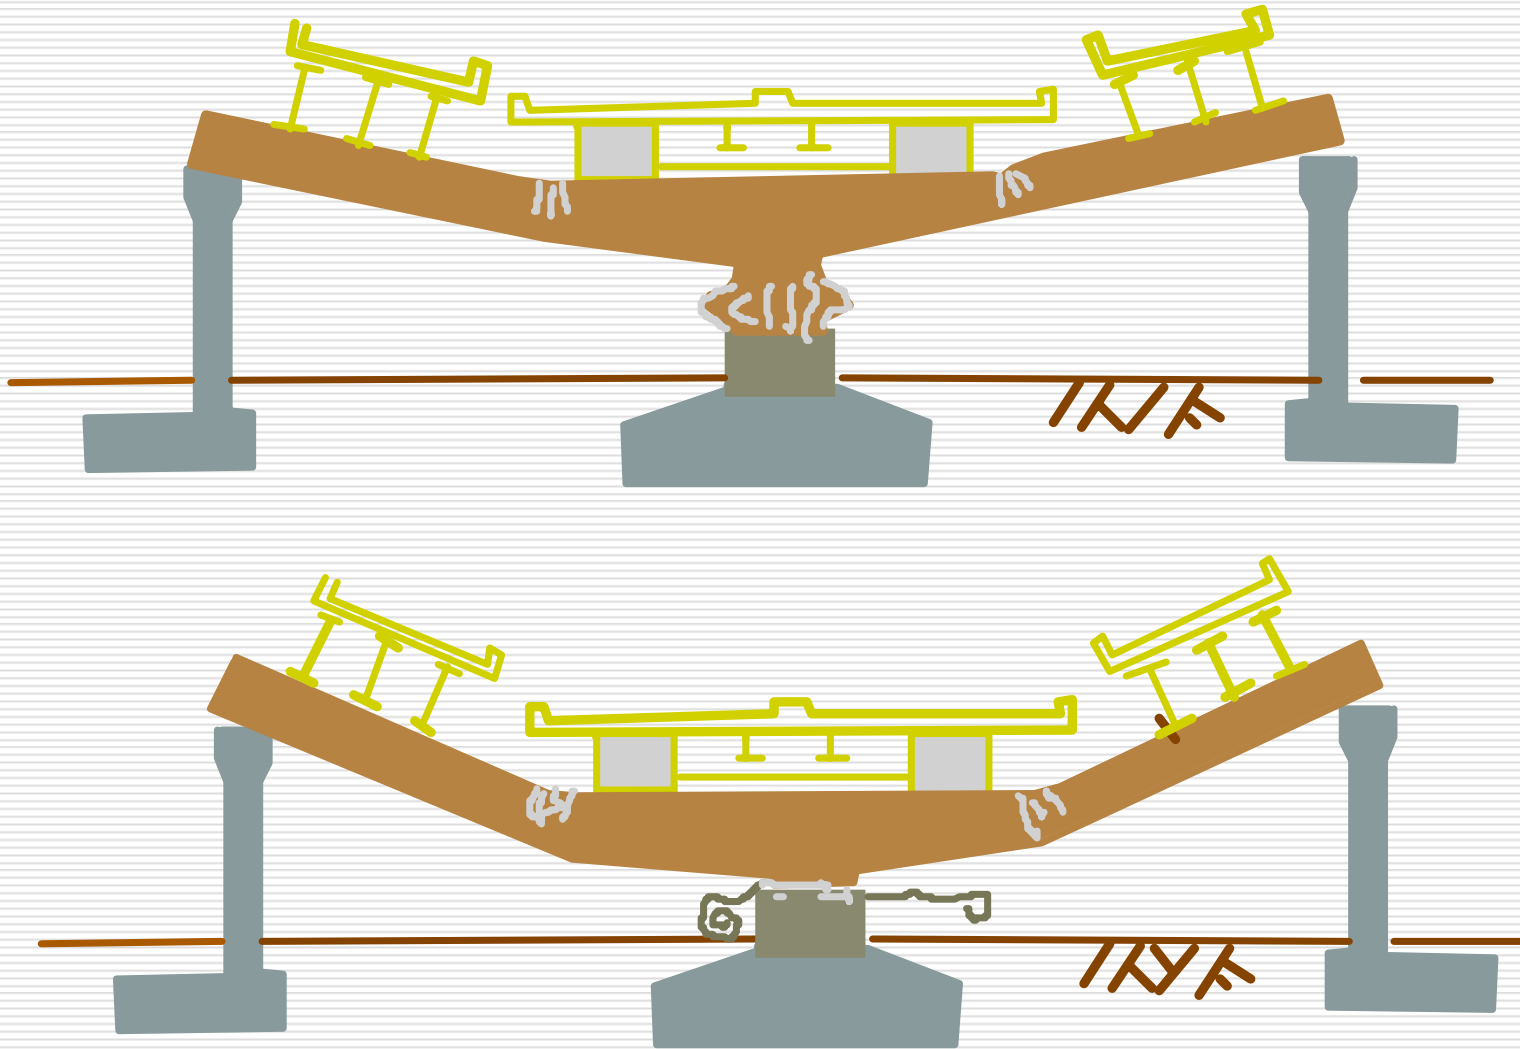
Progress of Failure of Steel Columns (continued)

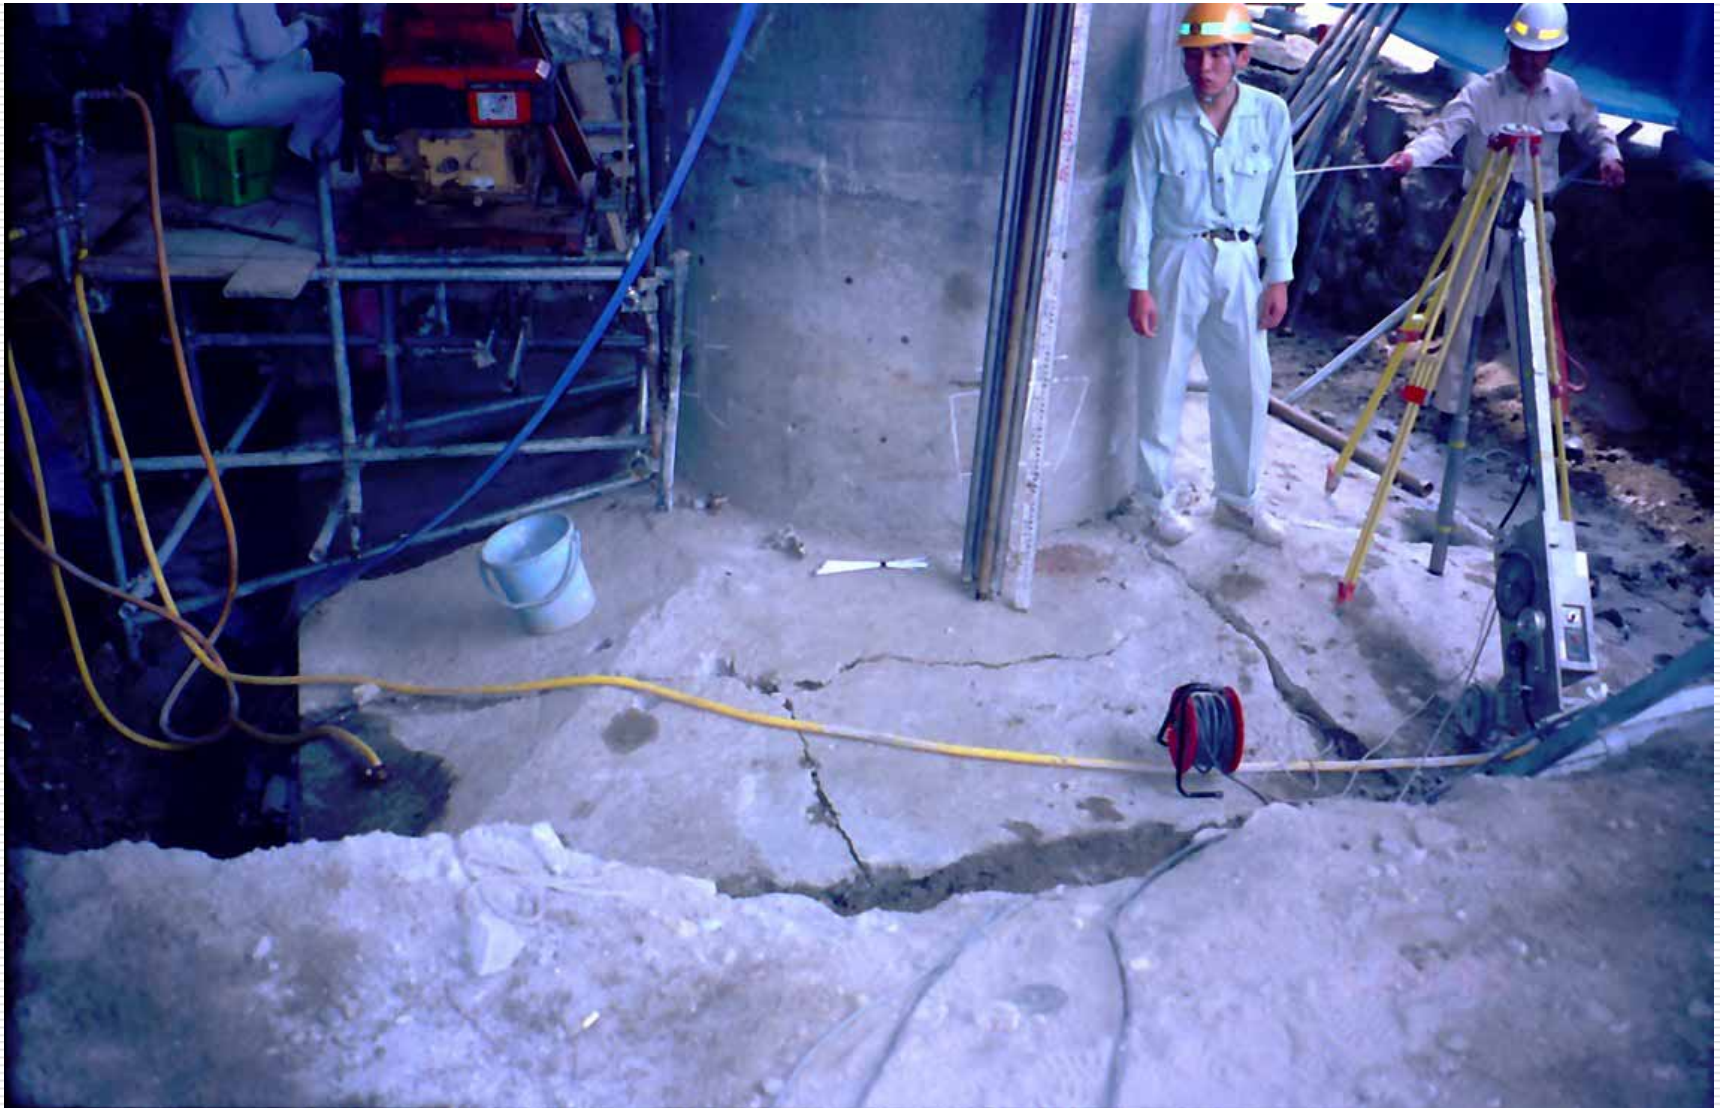
Damage of foundations was less, but not none

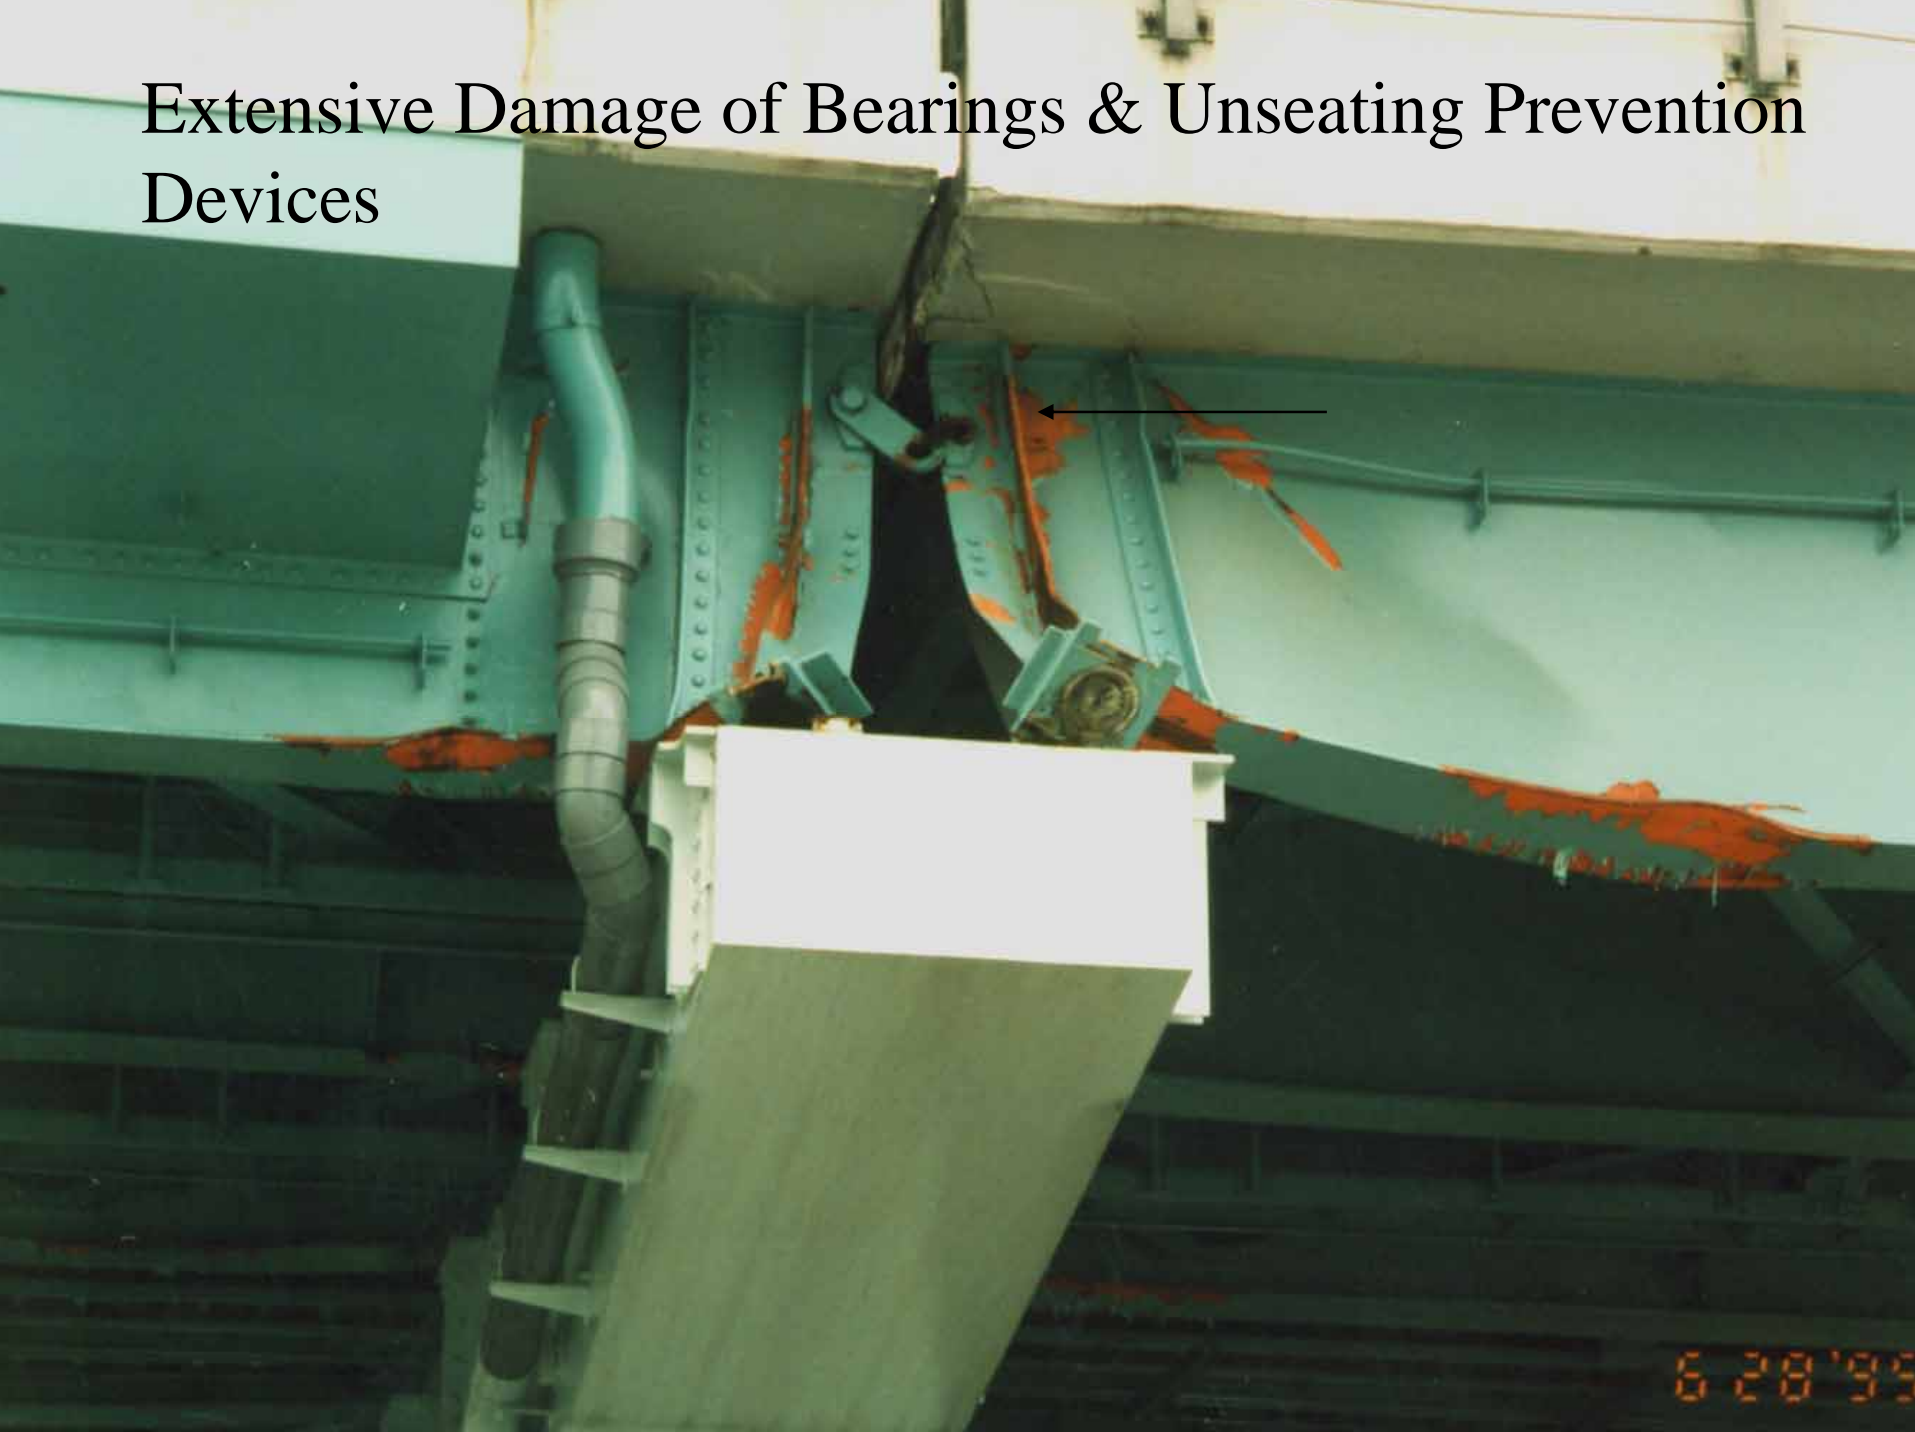
Extensive Damage of Bearings & Unseating Prevention Devices

- Damage of bearings (steel bearings) was an issue of discussion at every time when a damaging earthquake occurred.
- However there was always an argument that bearing a fuse to restrict extensive damage of the substructures. As a consequence, only minor upgrading was conducted to bearings.
- However it was so obvious after the 1995 Kobe earthquake that bearing was not a fuse for restricting damage of substructures, but it was one of the main factors resulting in the extensive damage.

- It was recommended in the 1995 & 1996 codes that elastomeric bearings (積層ゴム支承) including LRB (鉛プラグ入り積層ゴム支承) and HDR (高減衰積層ゴム支承) should be used.
- Steel bearings have the following deficiencies:
 - ✓ Insufficient strength and weak for shock
 - ✓ Structures with insufficient lateral and vertical capacity
 - ✓ Insufficient length of movement
- As a consequence, about 98% of the total bearing was steel bearing before 1995, but 90% is now elastomeric bearings.

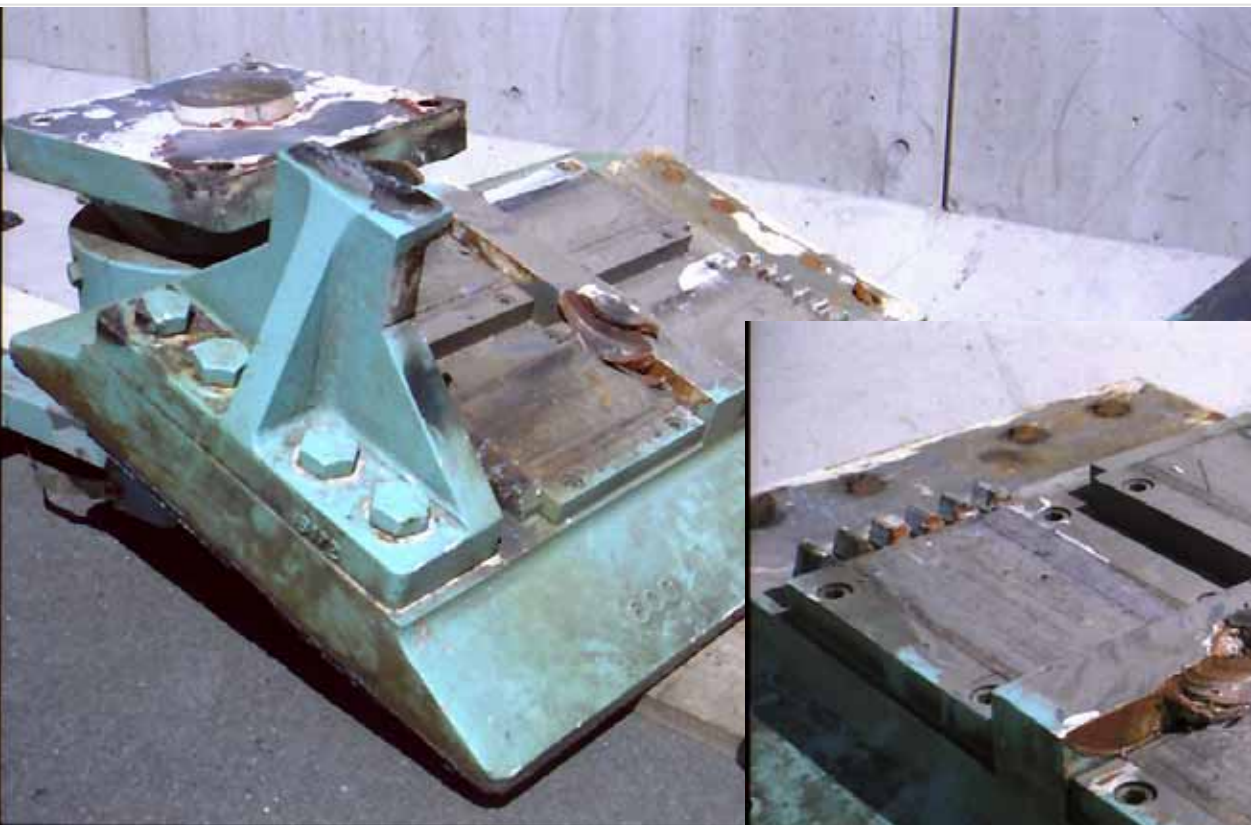
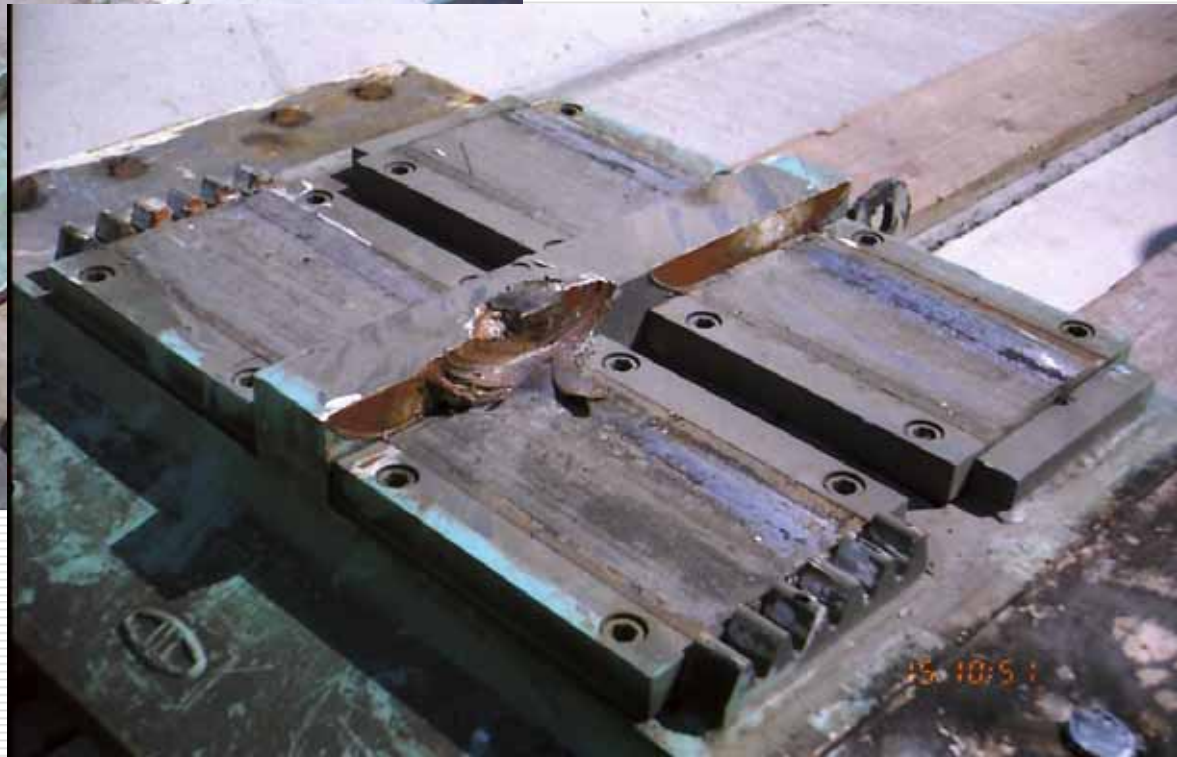
Vulnerable Steel Pin Bearings (Fixed bearings) & Roller Bearings (Movable Bearings) (ピン支承、ローラー支承)

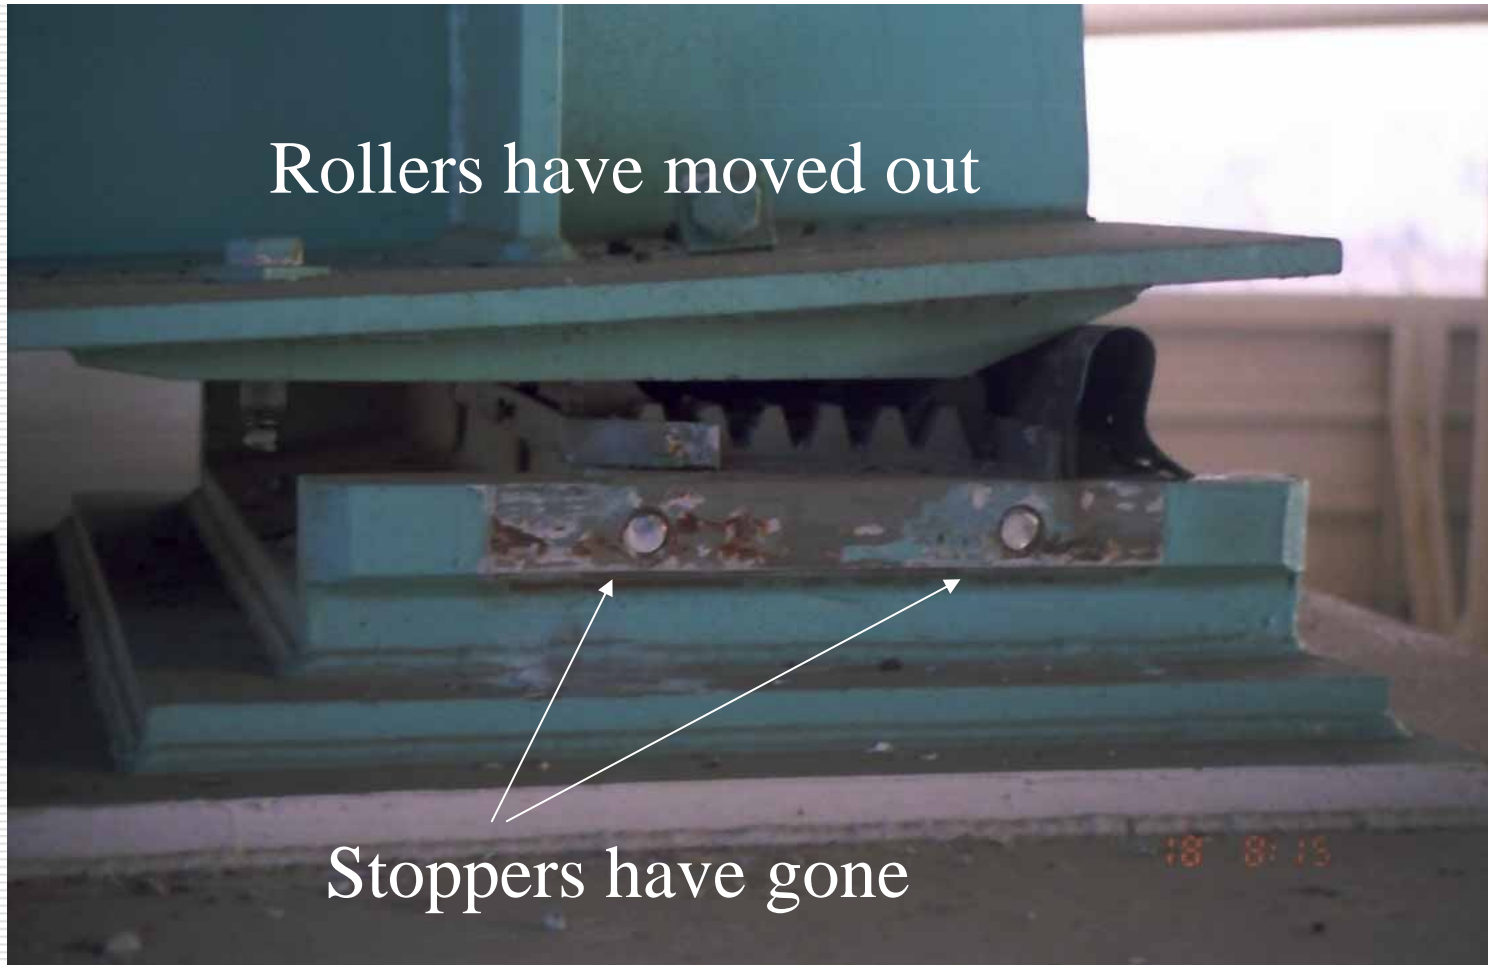
Vulnerable Steel Roller Bearings (Movable bearings) (ローラー支承、可動支承)
