Response Modification of Urban Infrastructure

(3) Chapter 2 Seismic Damage of Bridges
due to Ground Vibration (Part 2)

Kazuhiko Kawashima

Department of Civil Engineering

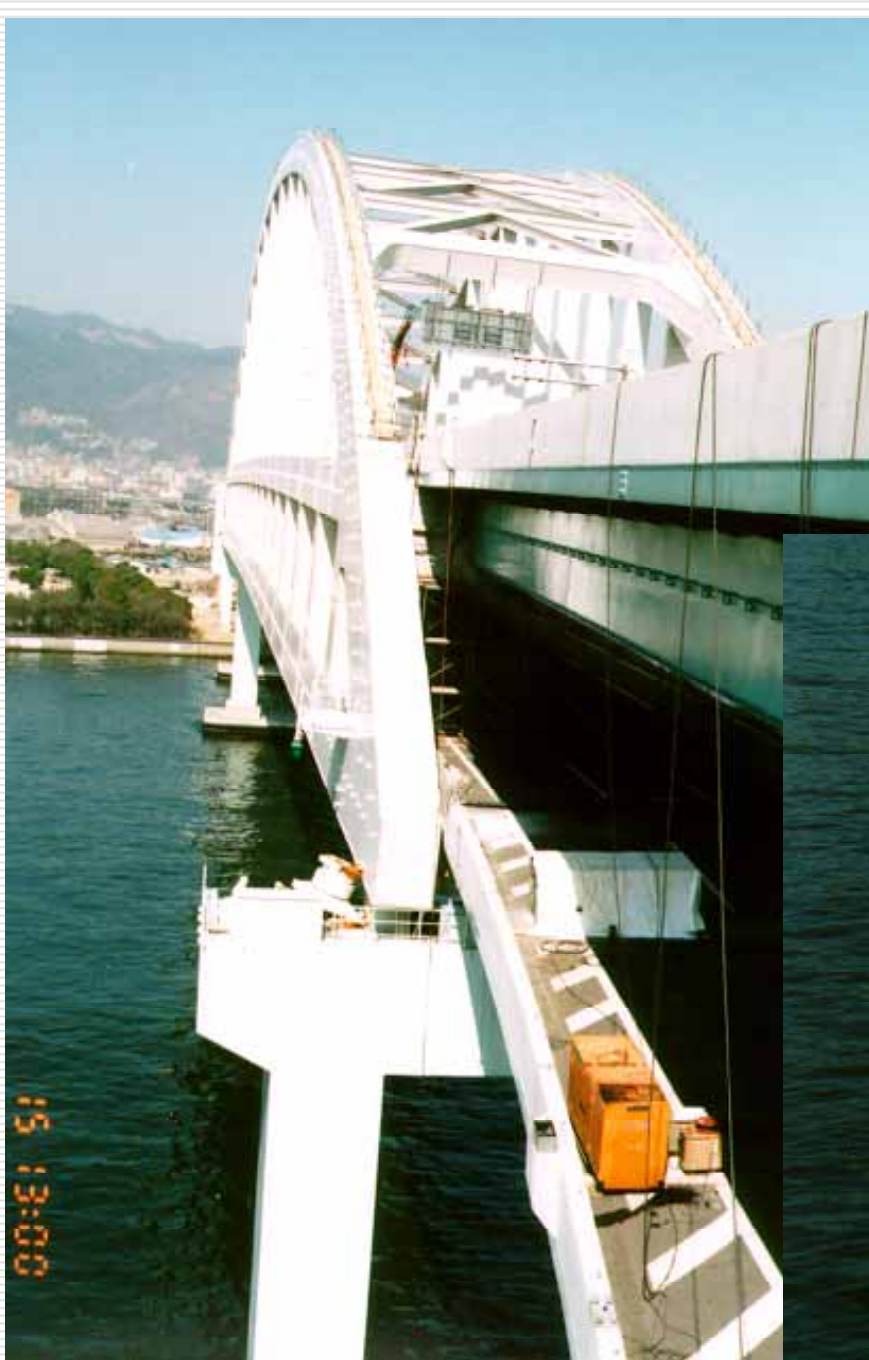
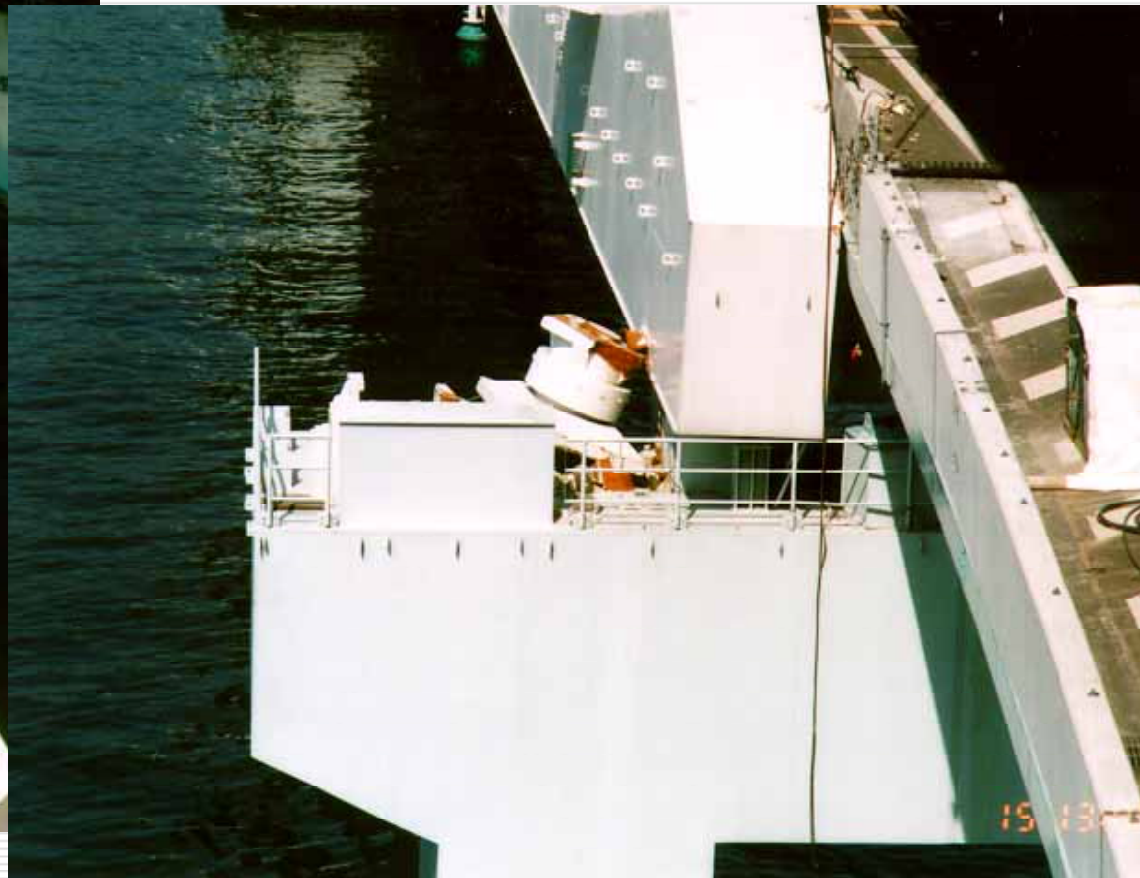
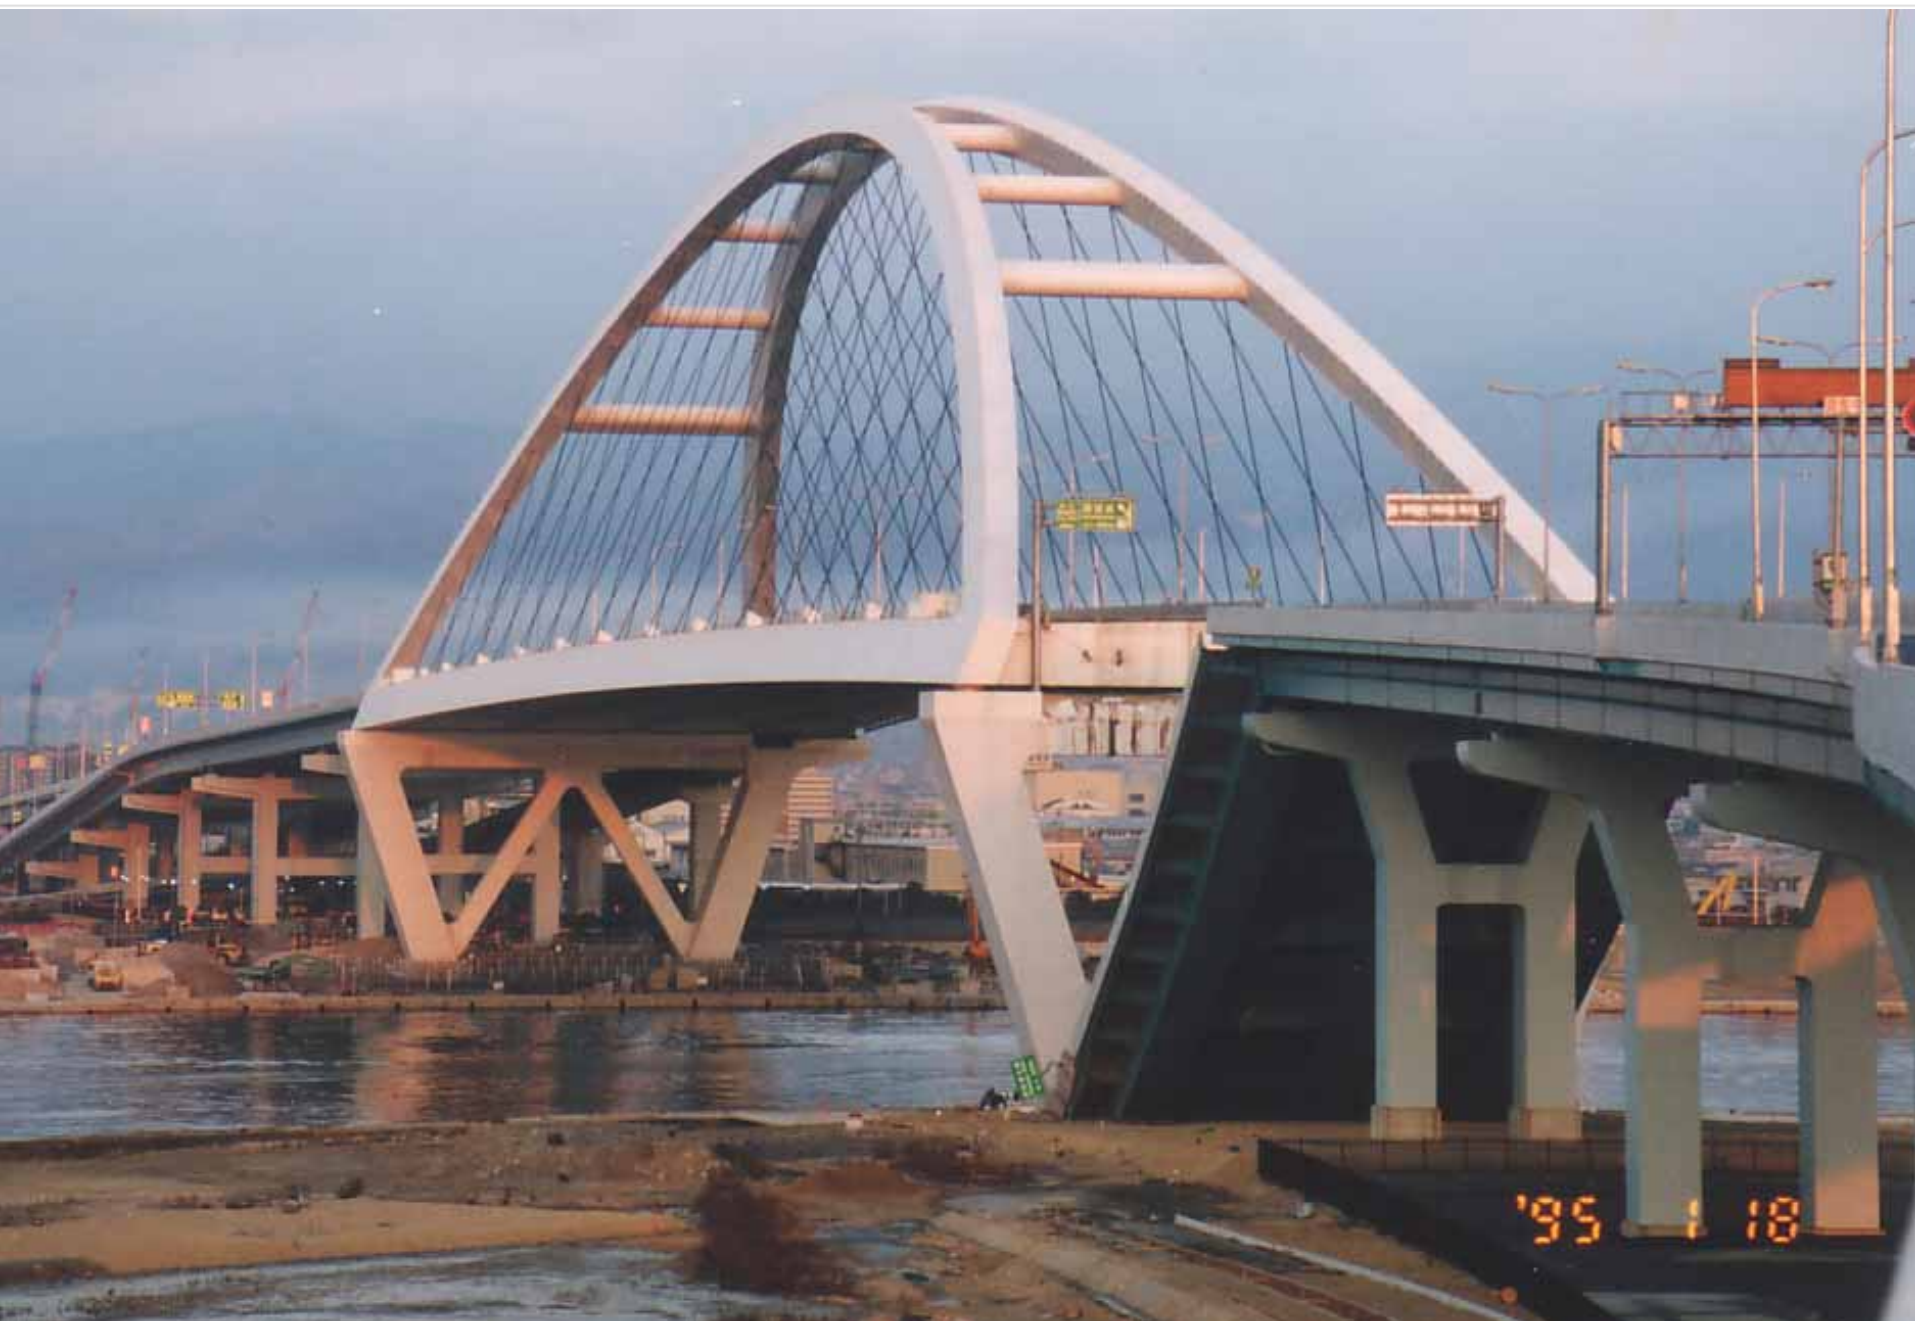
Failure of Steel Bearings

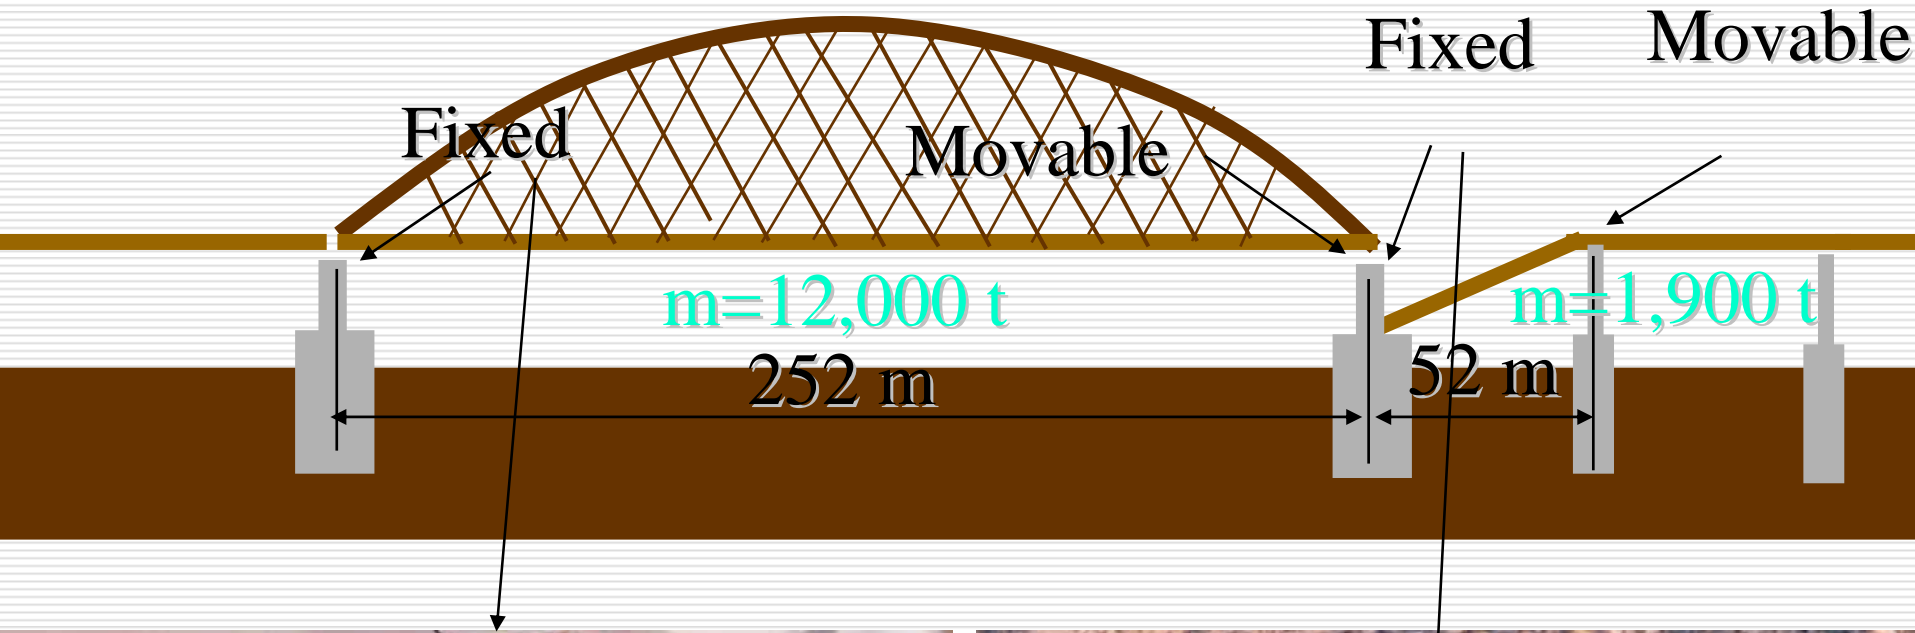
Collapse of an Approaching Span

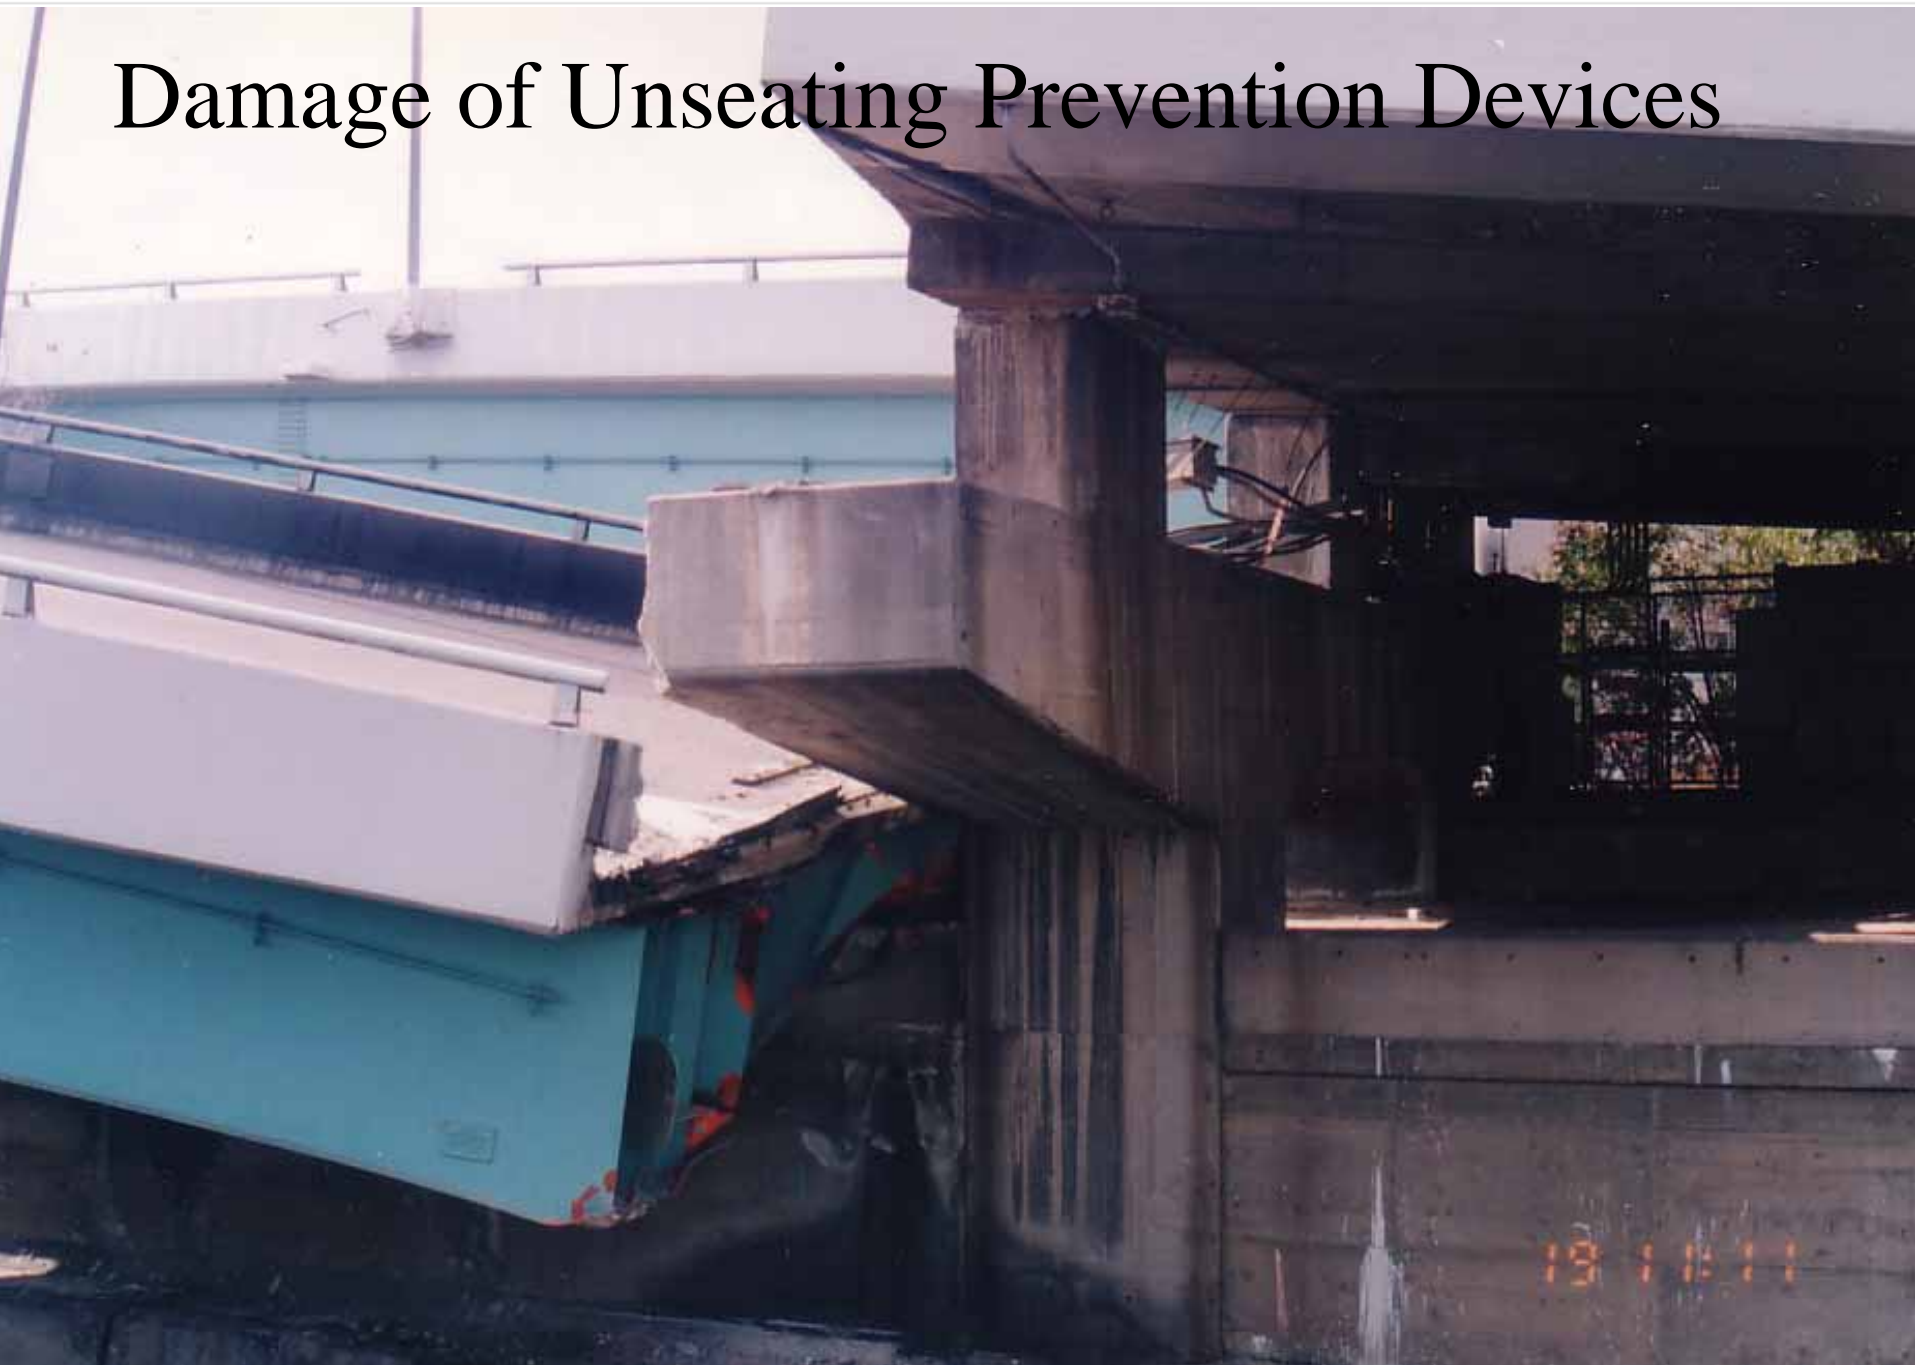
Damage of Unseating Prevention Devices

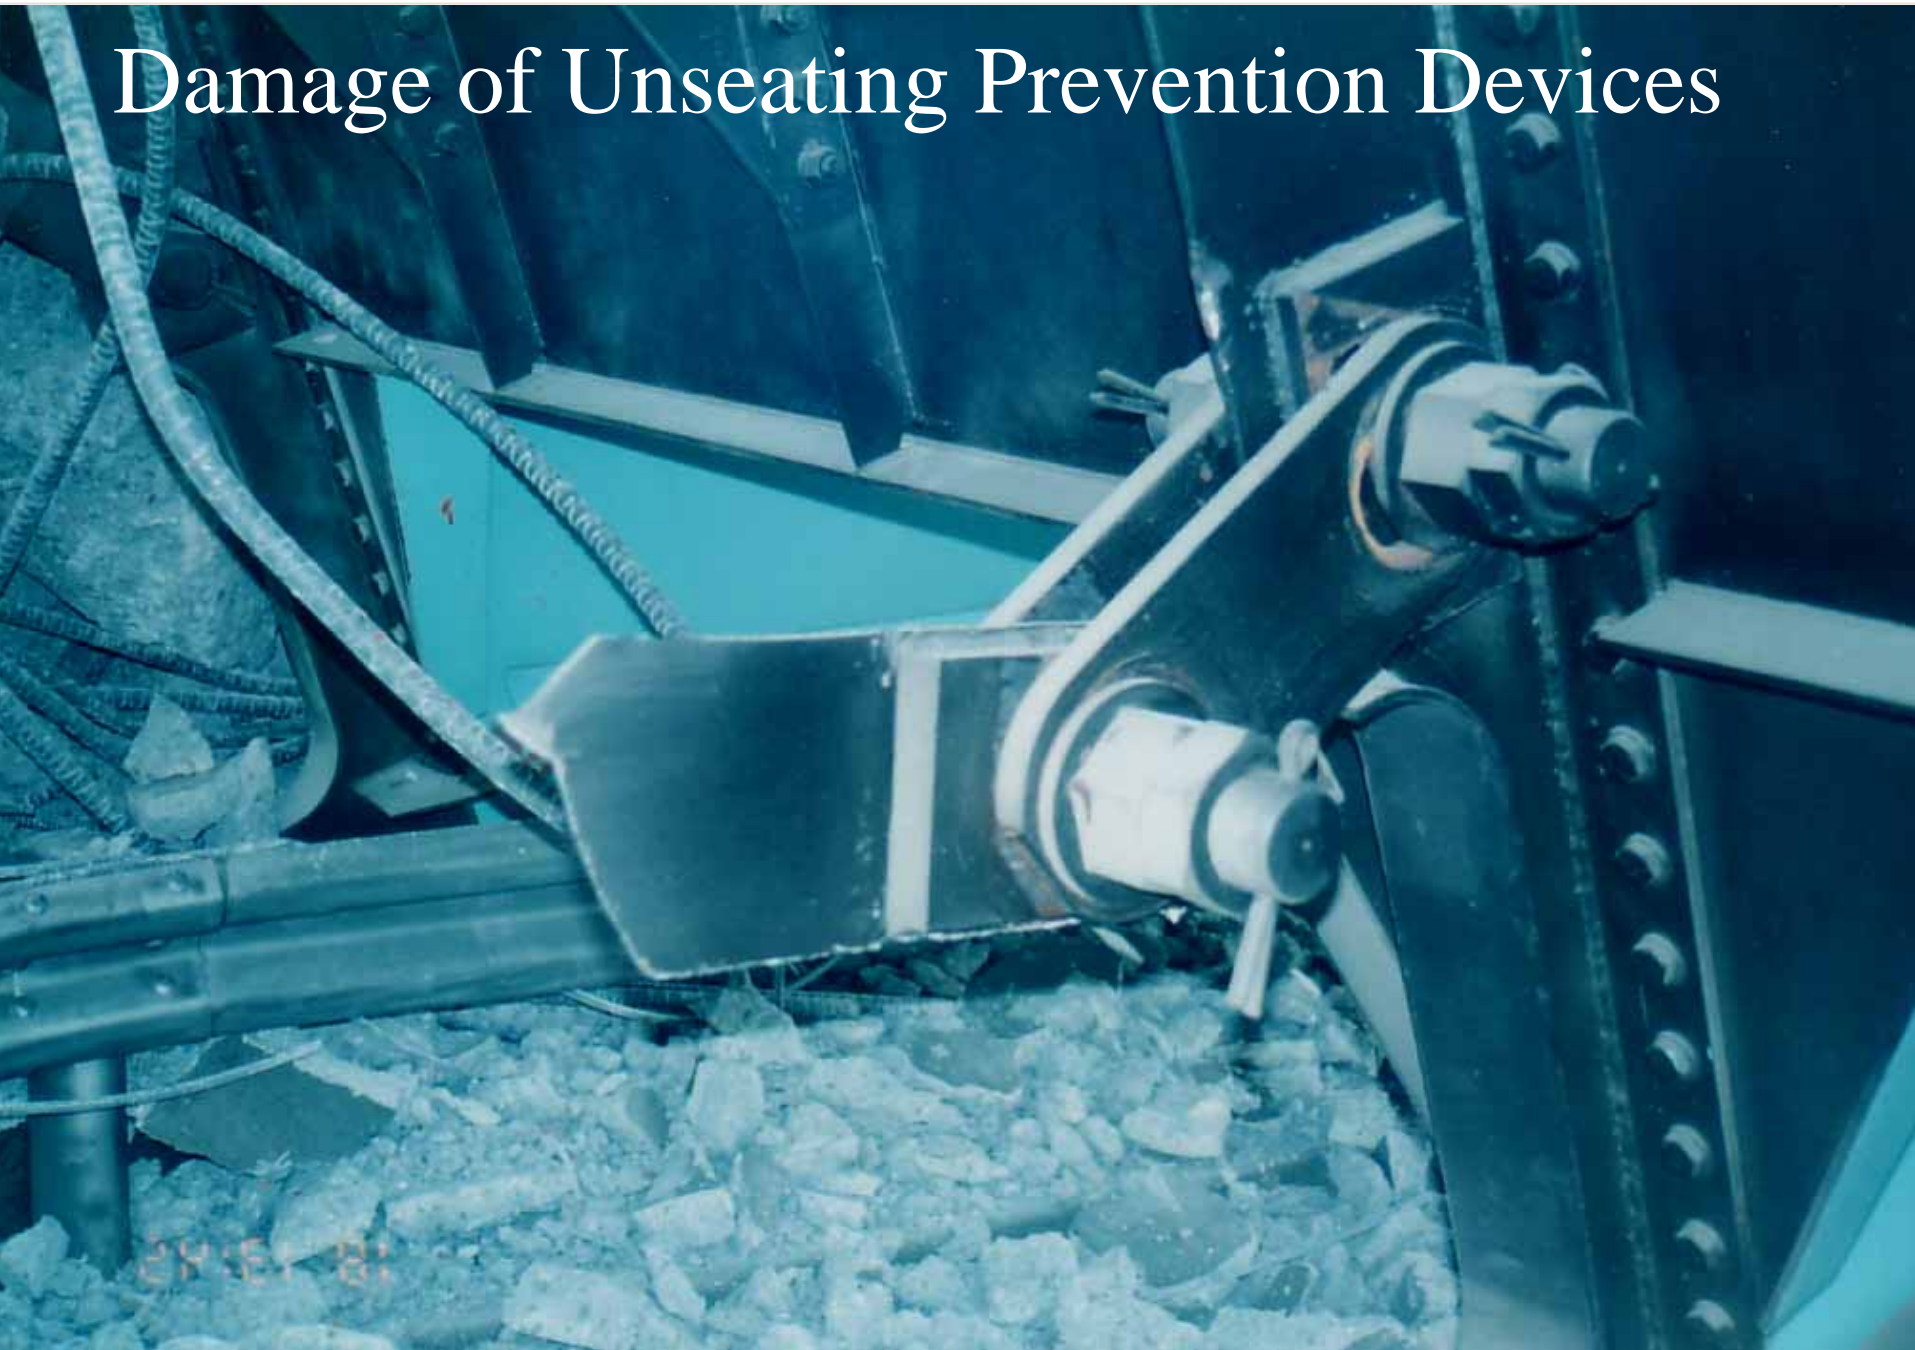
Damage of Unseating Prevention Devices

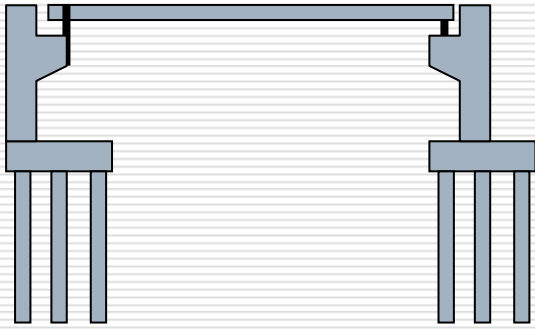
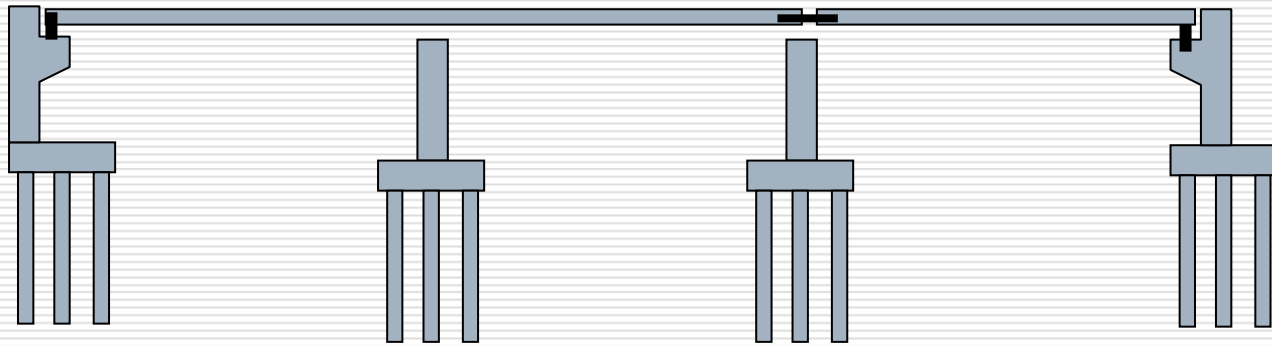
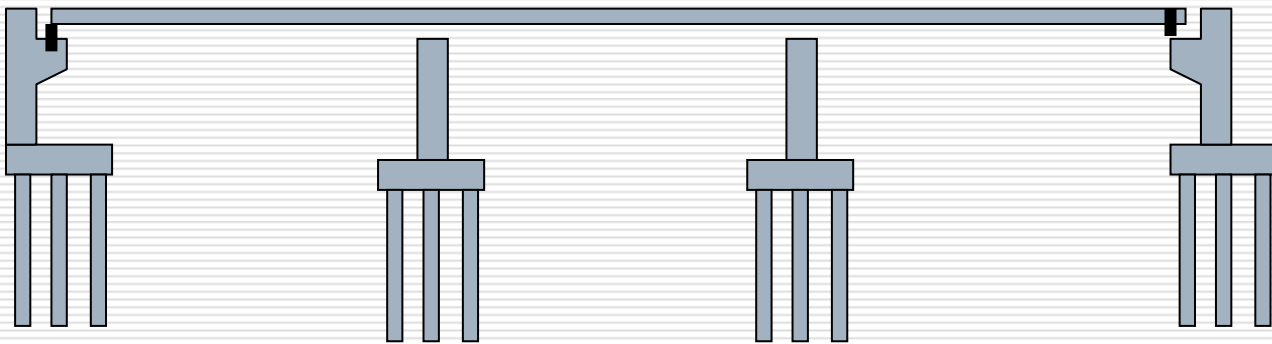
- Provide sufficient seat support length SE
- Device connecting a girder to a substructure
- Device connecting adjacent girders

Design Force of Unseating Prevention Devices was Increased after the 1995 Kobe Earthquake

- k_h was increased from 0.2 to 1.0 after the 1995 Kobe earthquake.
- However this is an emergency measures. There are many unknowns, so there needs more thorough research on the force demand of unseating prevention devices.

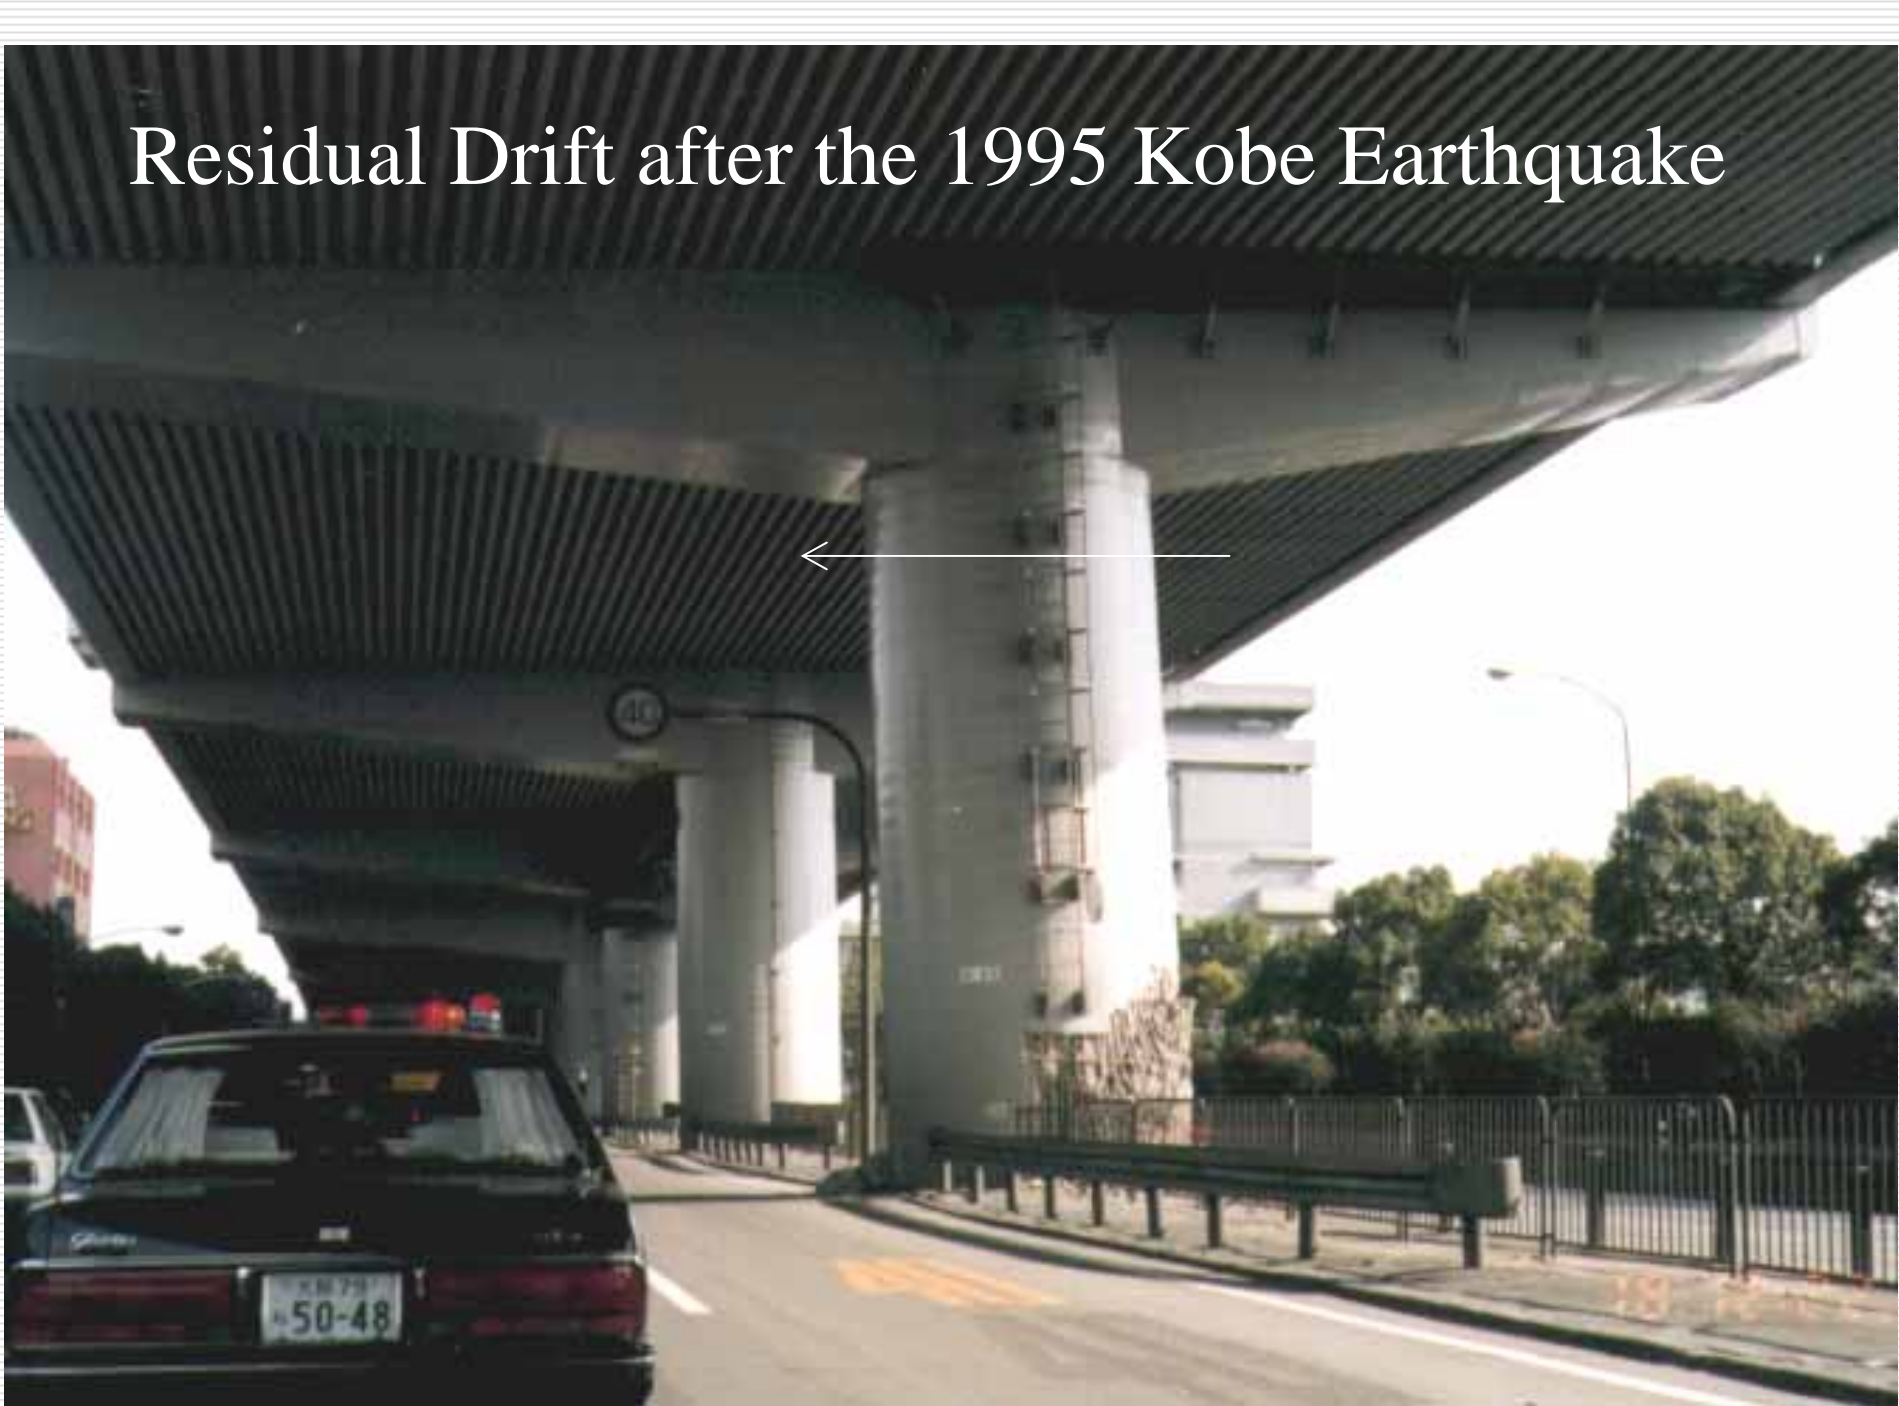
Residual Drift after the 1995 Kobe Earthquake

- A new provision was introduced for limiting residual tilt of columns after the 1995 Kobe earthquake. This was the first provision for the residual tilt.
- Residual displacement response spectra were used to formulate the provision as:

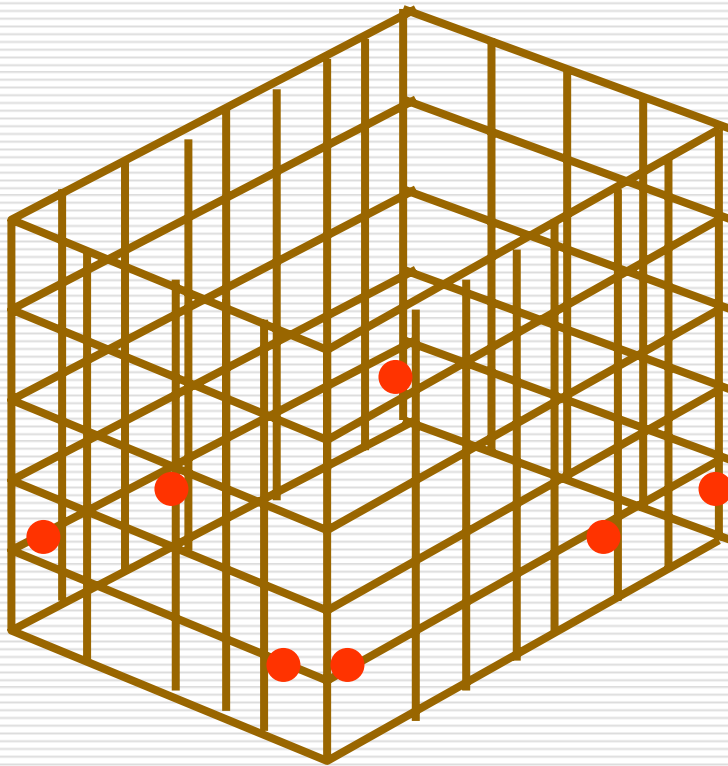
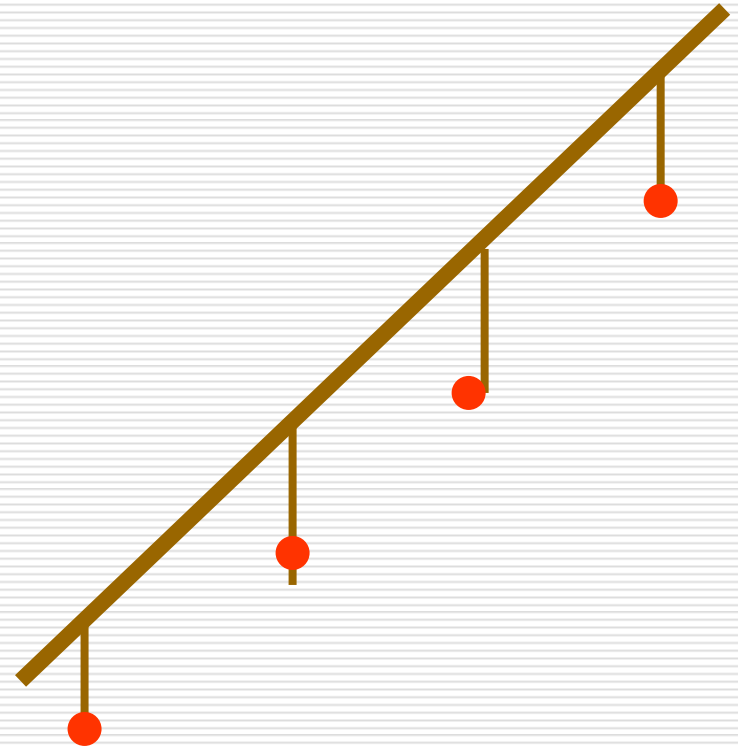
Much Less Static Indeterminacy in Bridges than Buildings

Plastic Hinges

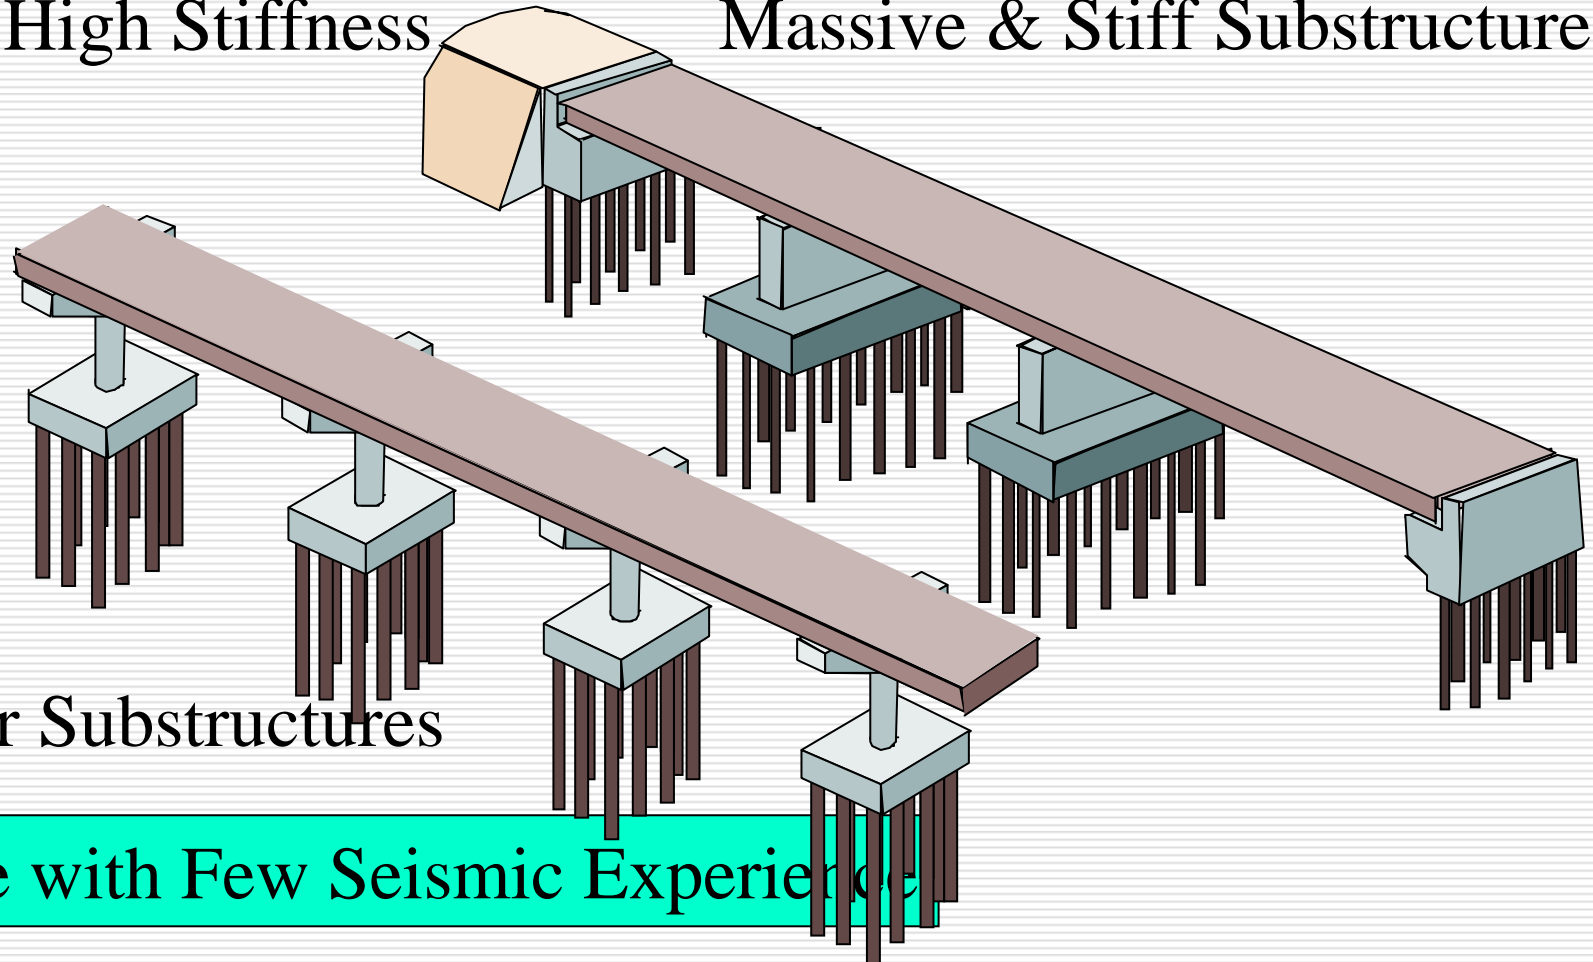
Bridges with Sufficient Past Seismic Experience

Abutment with High Stiffness

Massive & Stiff Substructures

Slender Substructures

Bridge with Few Seismic Experience

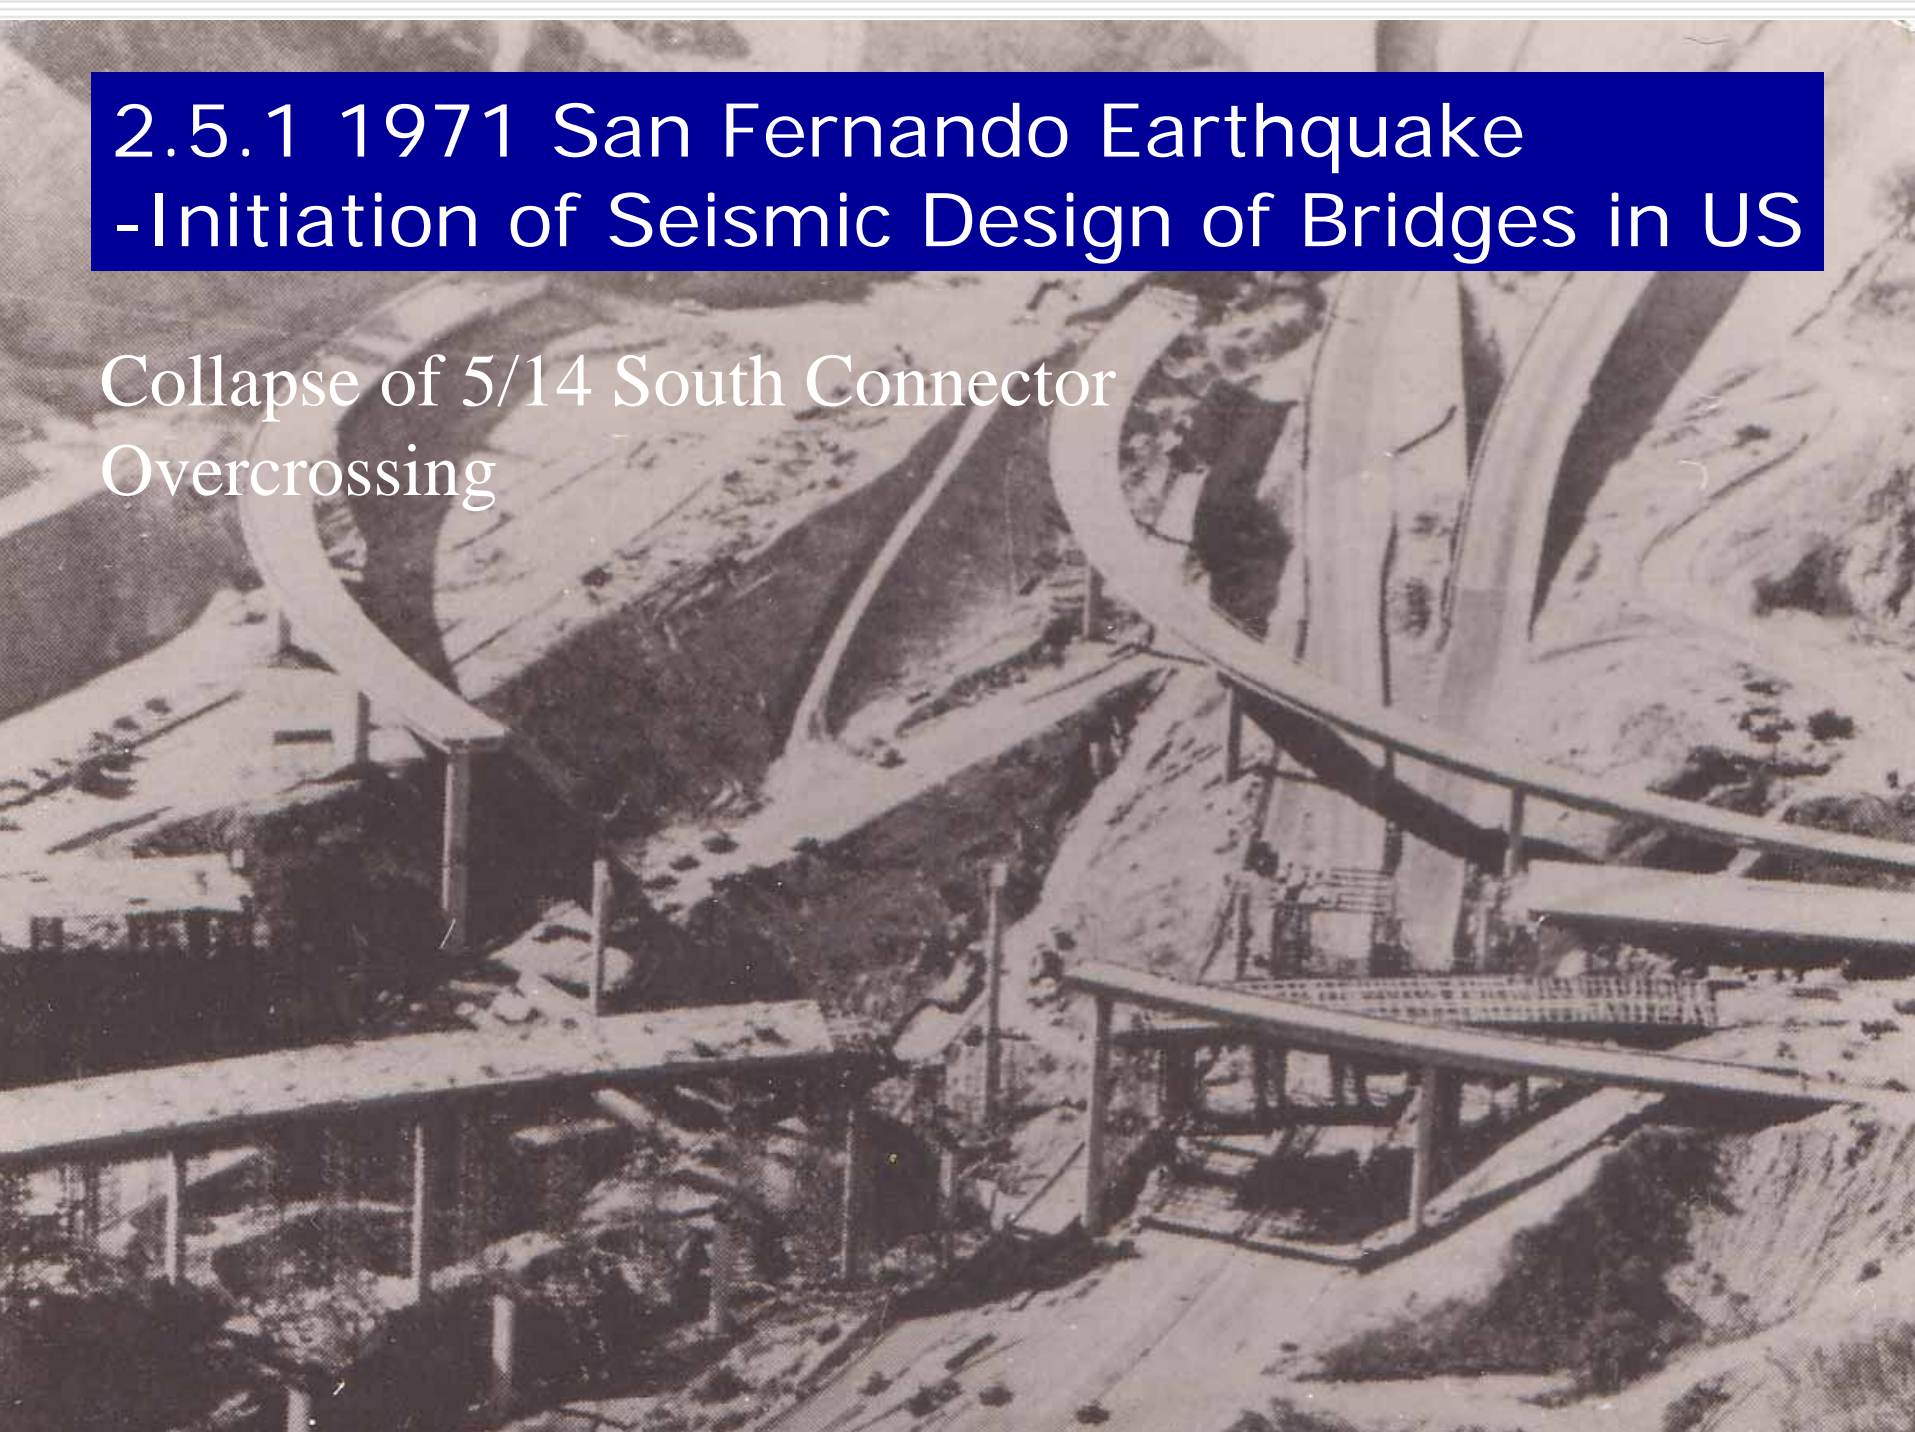
Collapse of 5/14 South Connector
Overcrossing

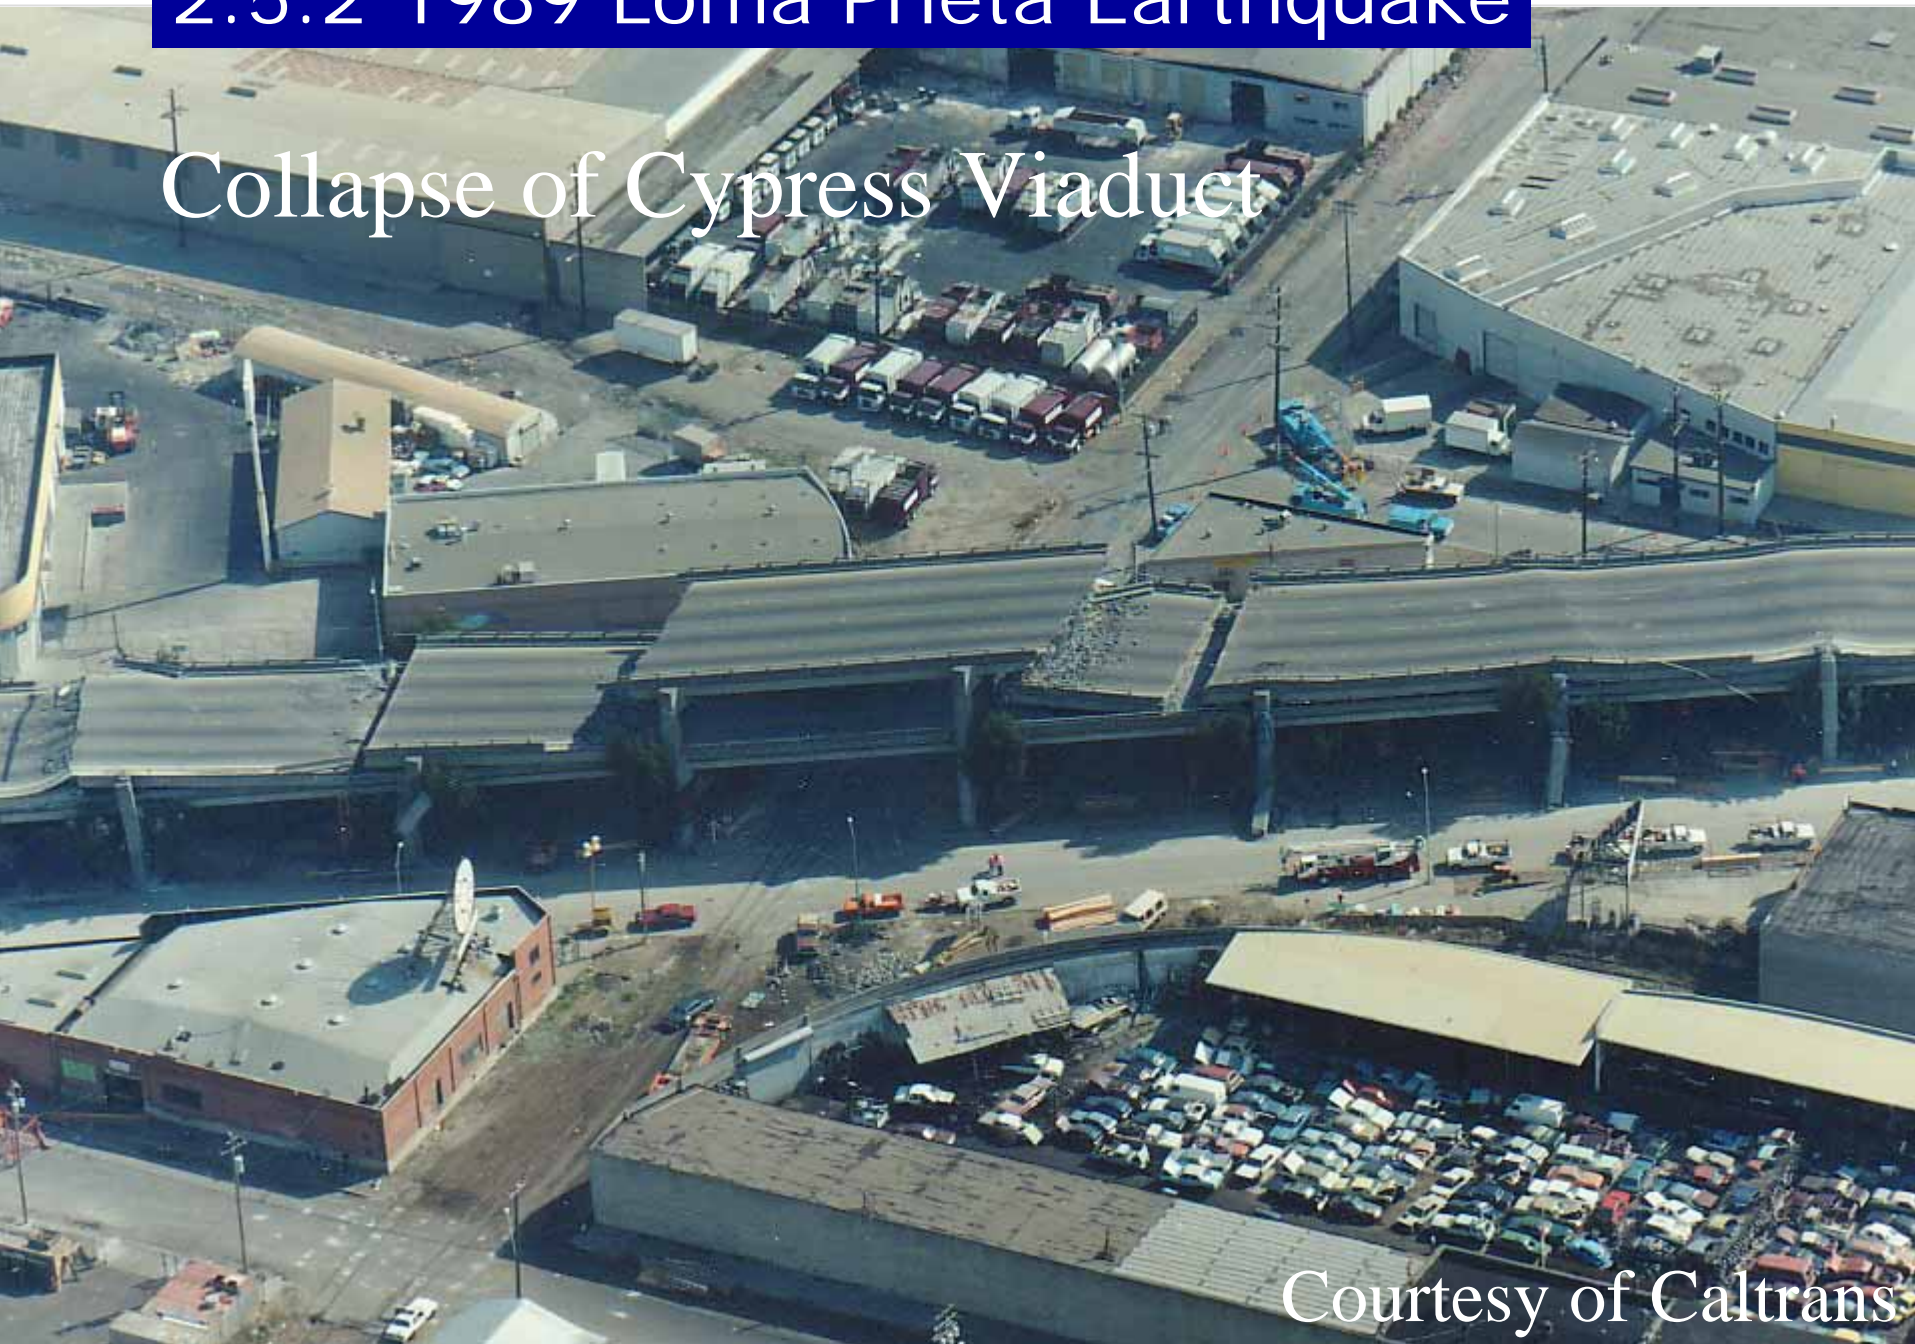
Collapse of Cypress Viaduct
