Response Modification of Urban Infrastructure

(3) Chapter 2 Seismic Damage of Bridges
due to Ground Vibration (Part 2)

Kazuhiko Kawashima

Department of Civil Engineering

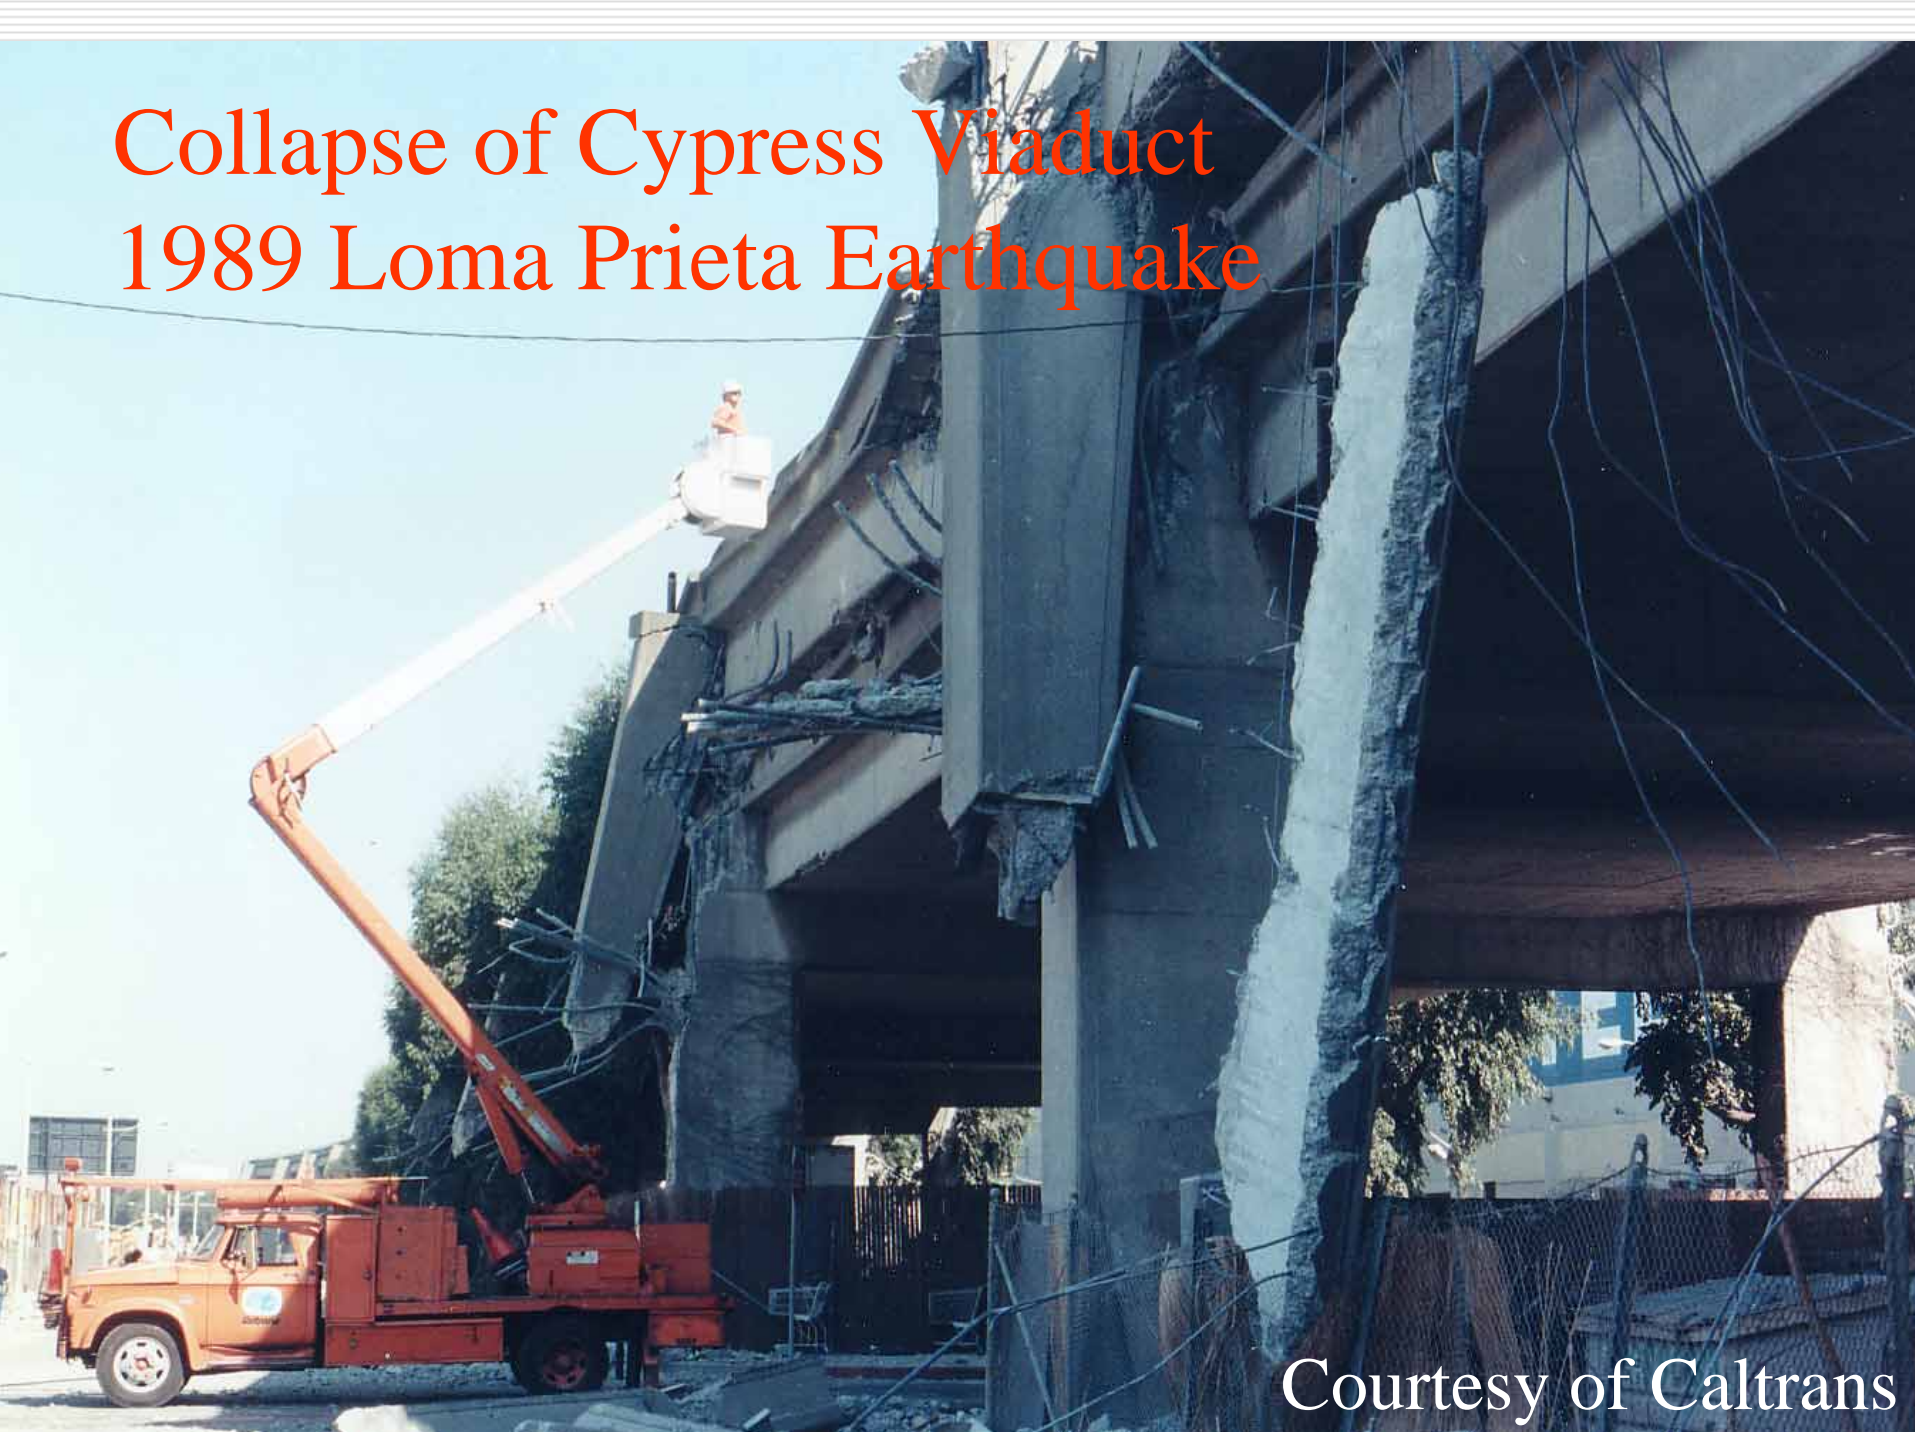
Collapse of Cypress Viaduct 1989 Loma Prieta Earthquake

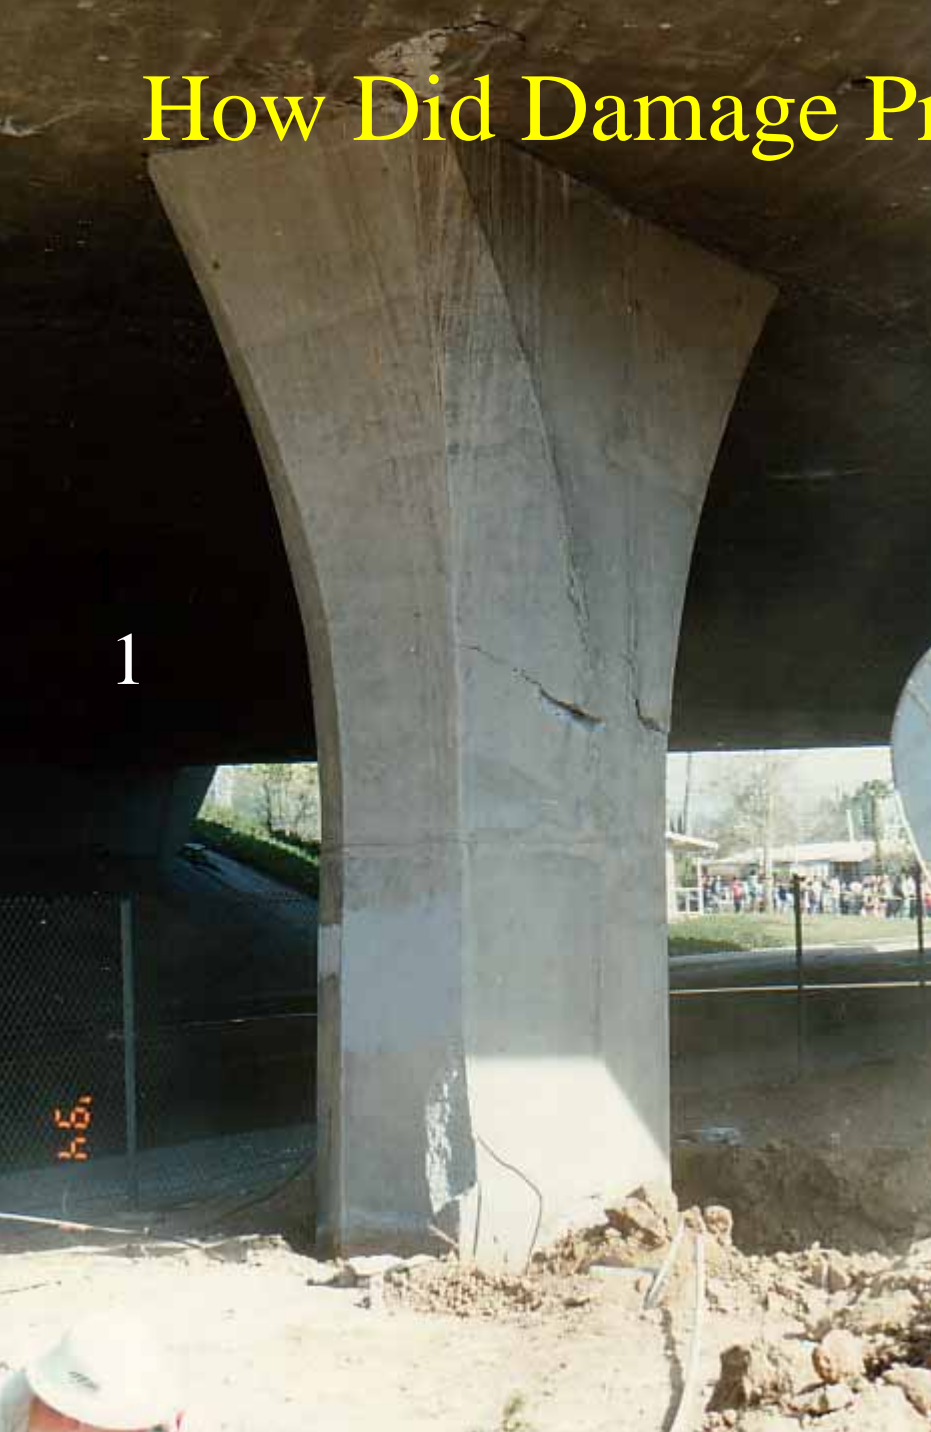
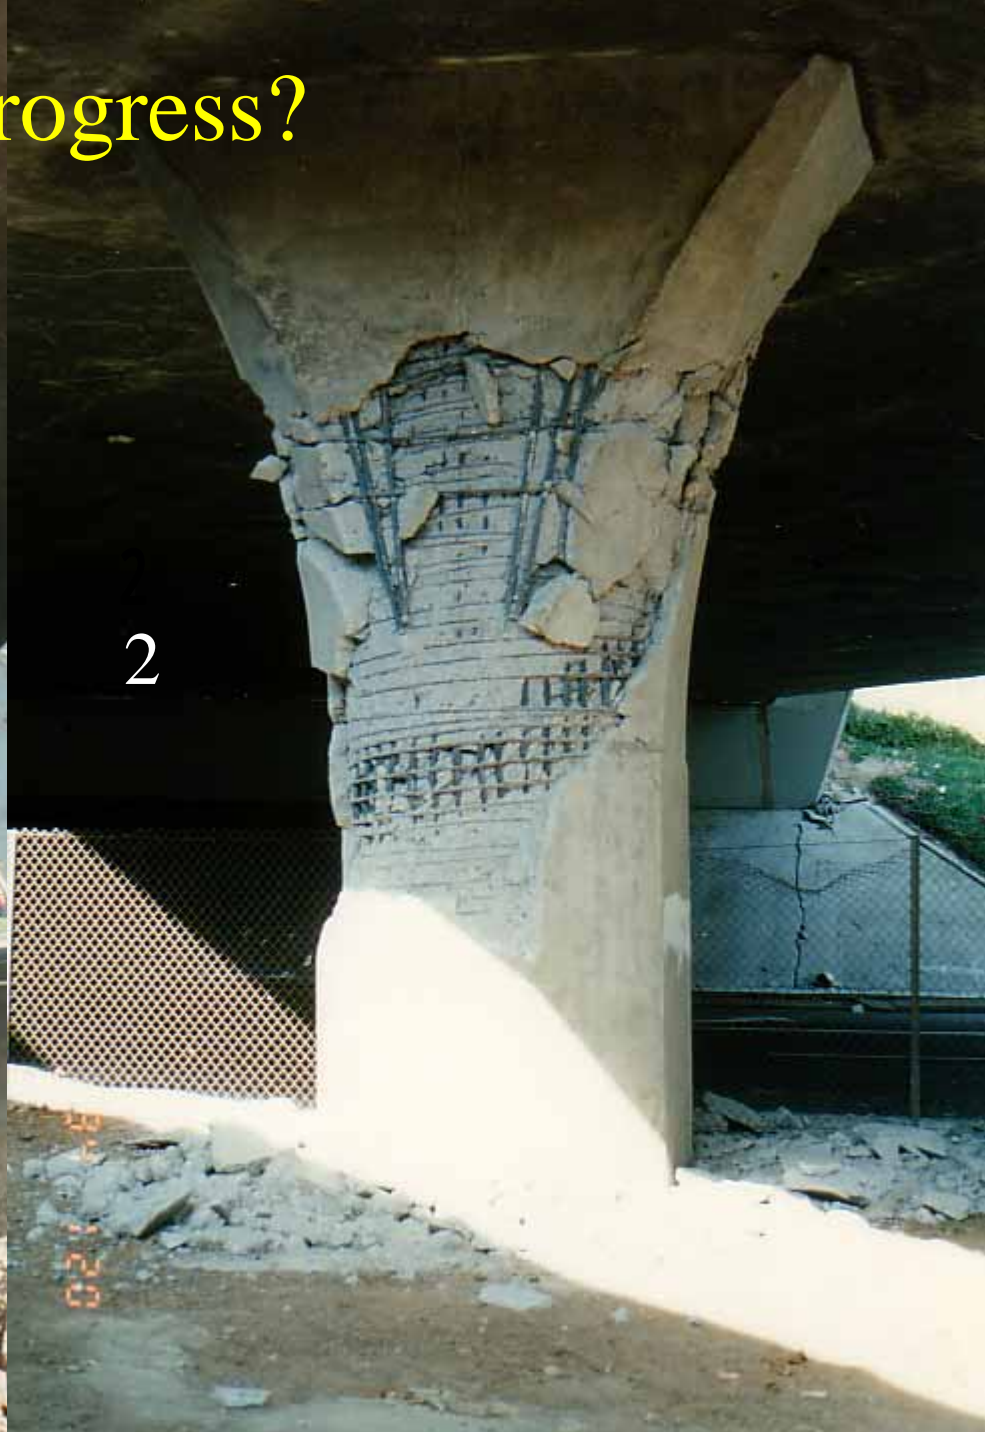
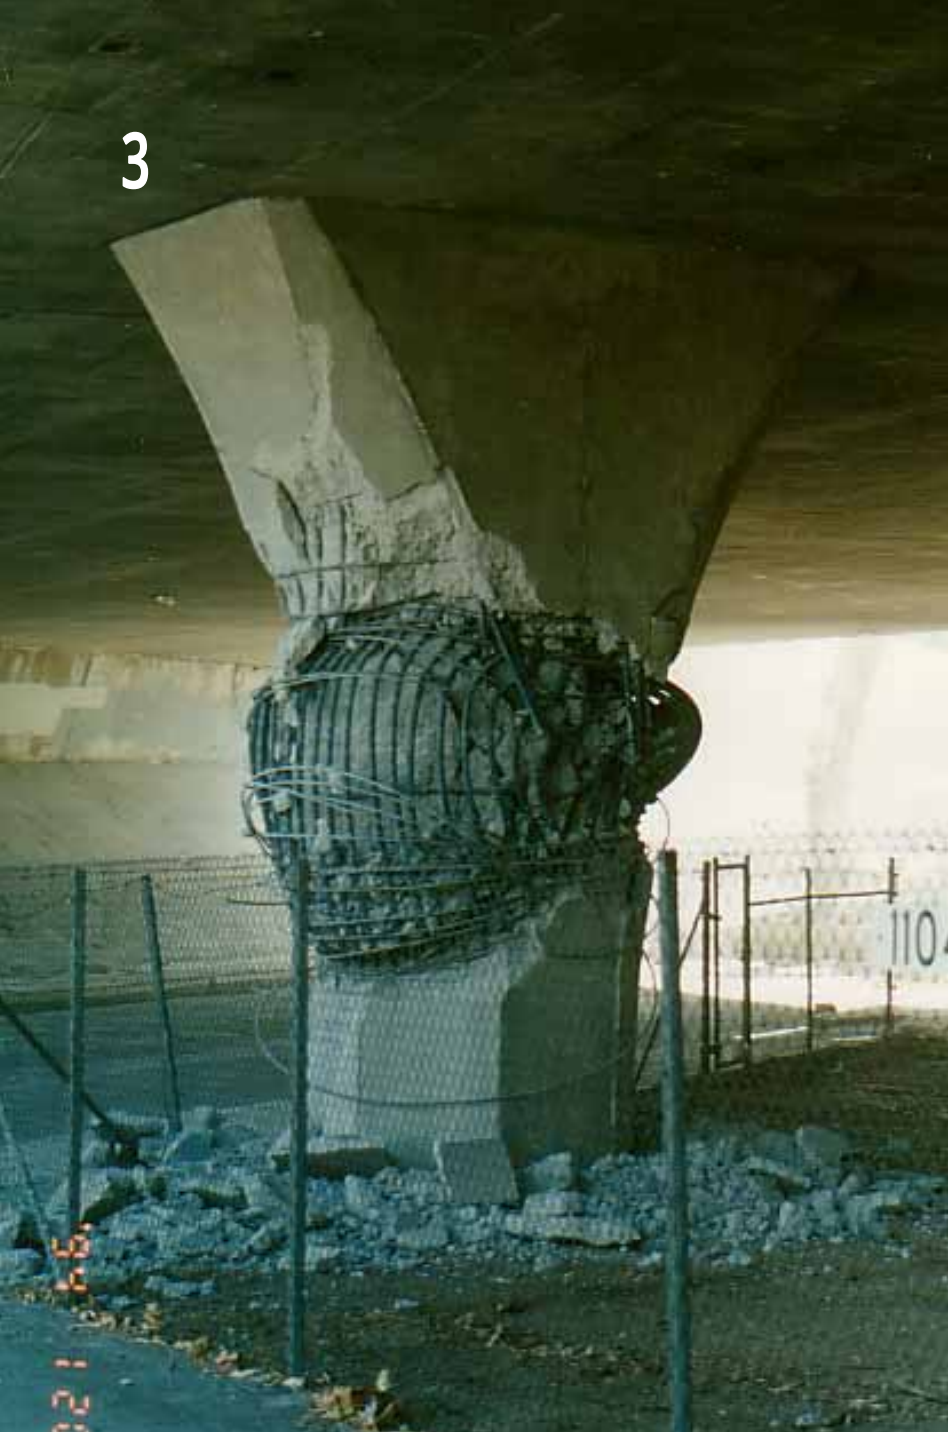
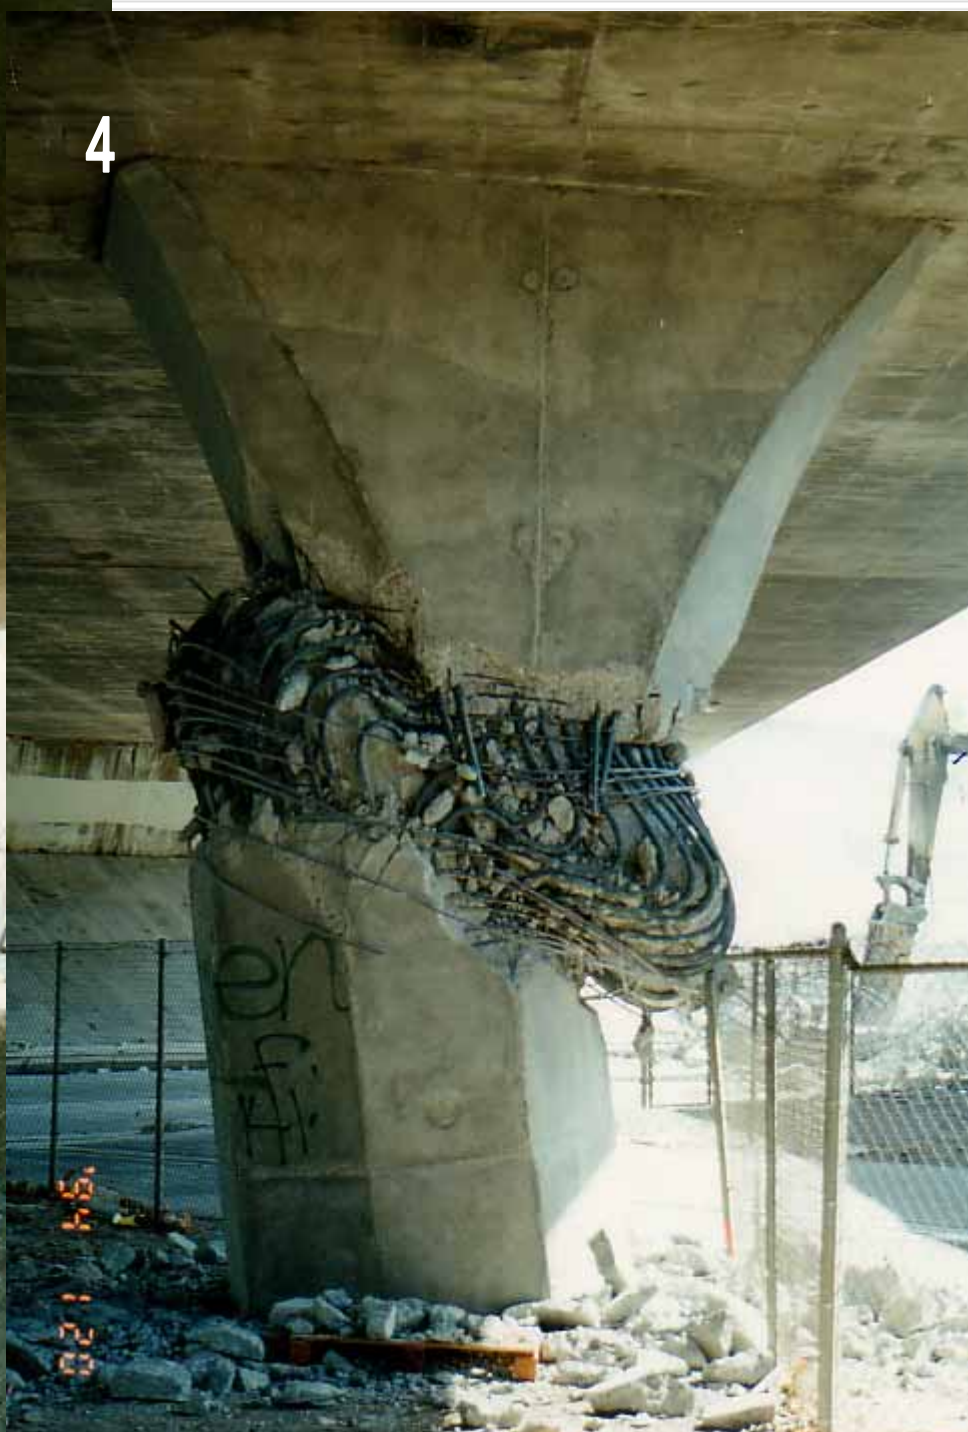
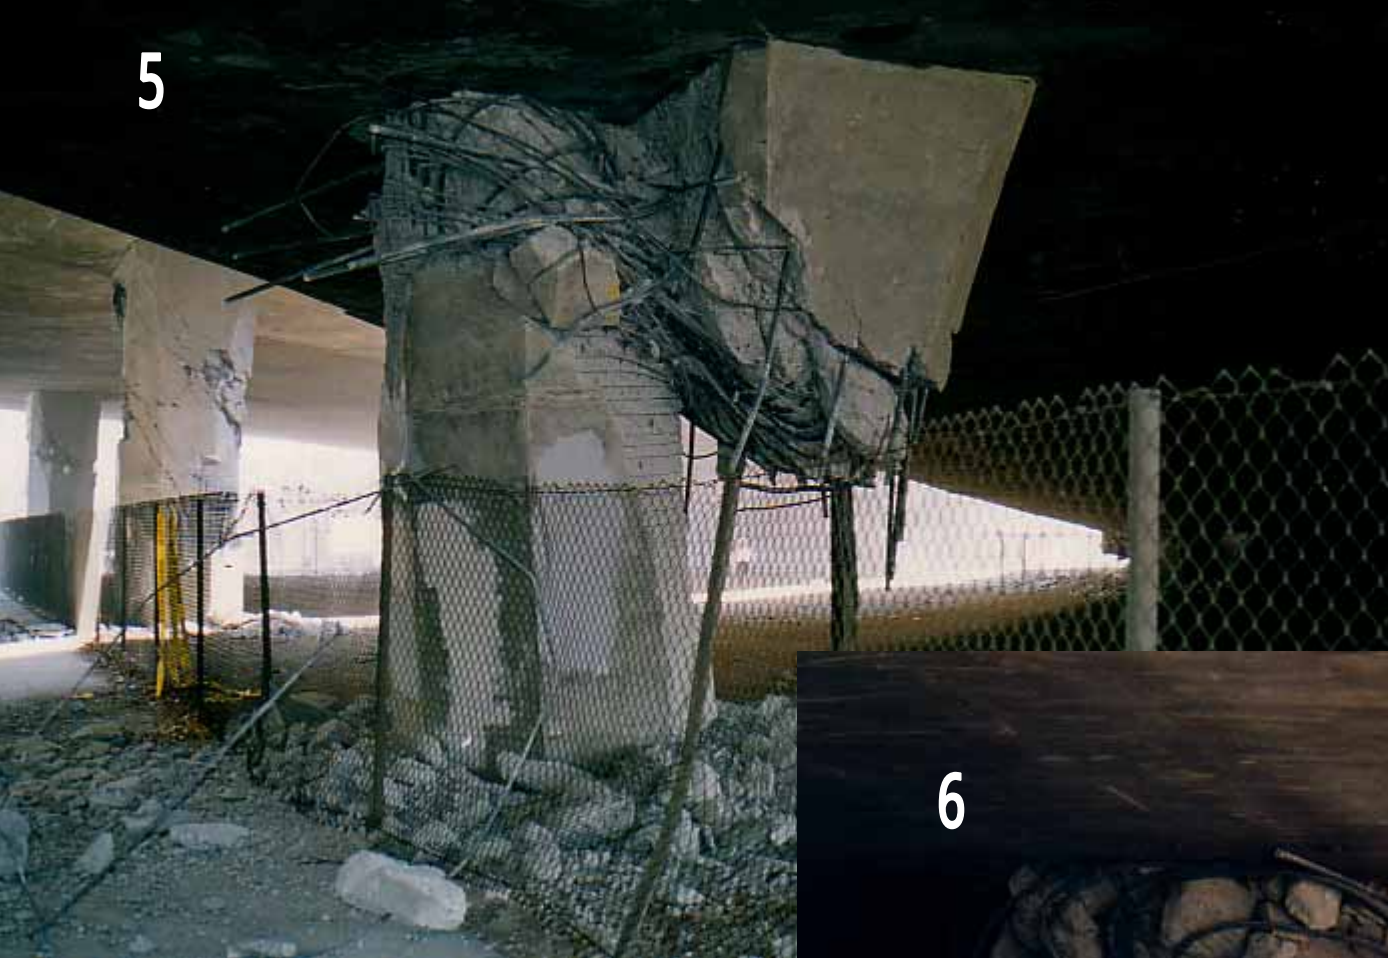
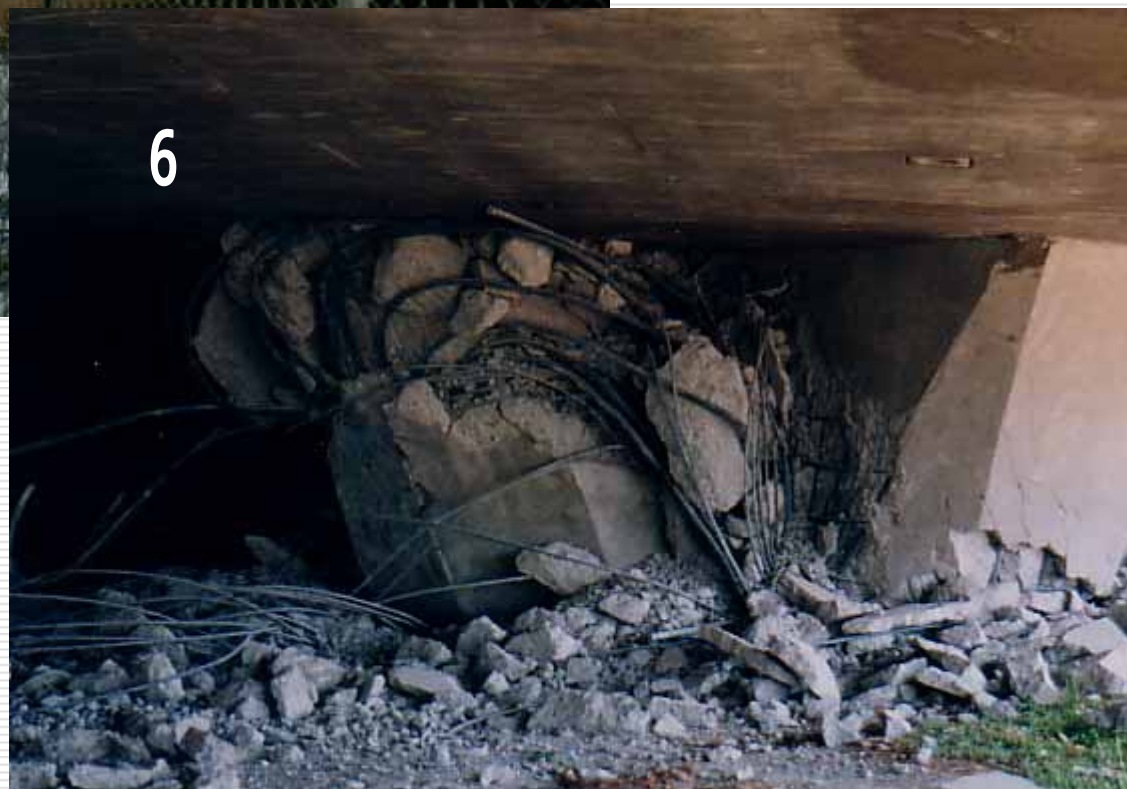
How Did Damage Progress?

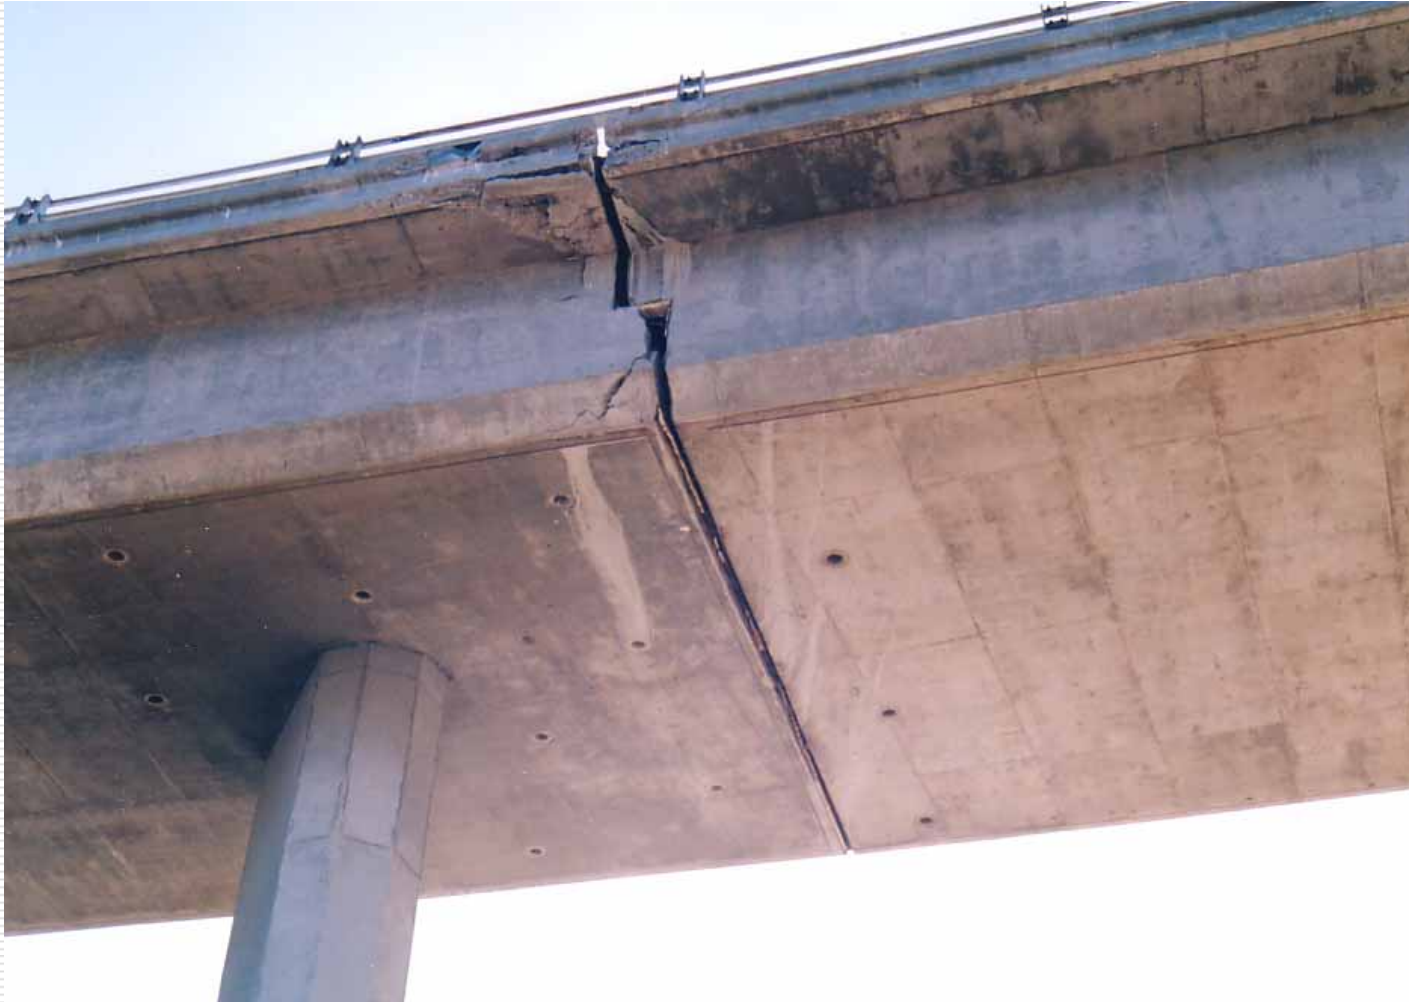
Pounding of Decks at Intermediate Hinge

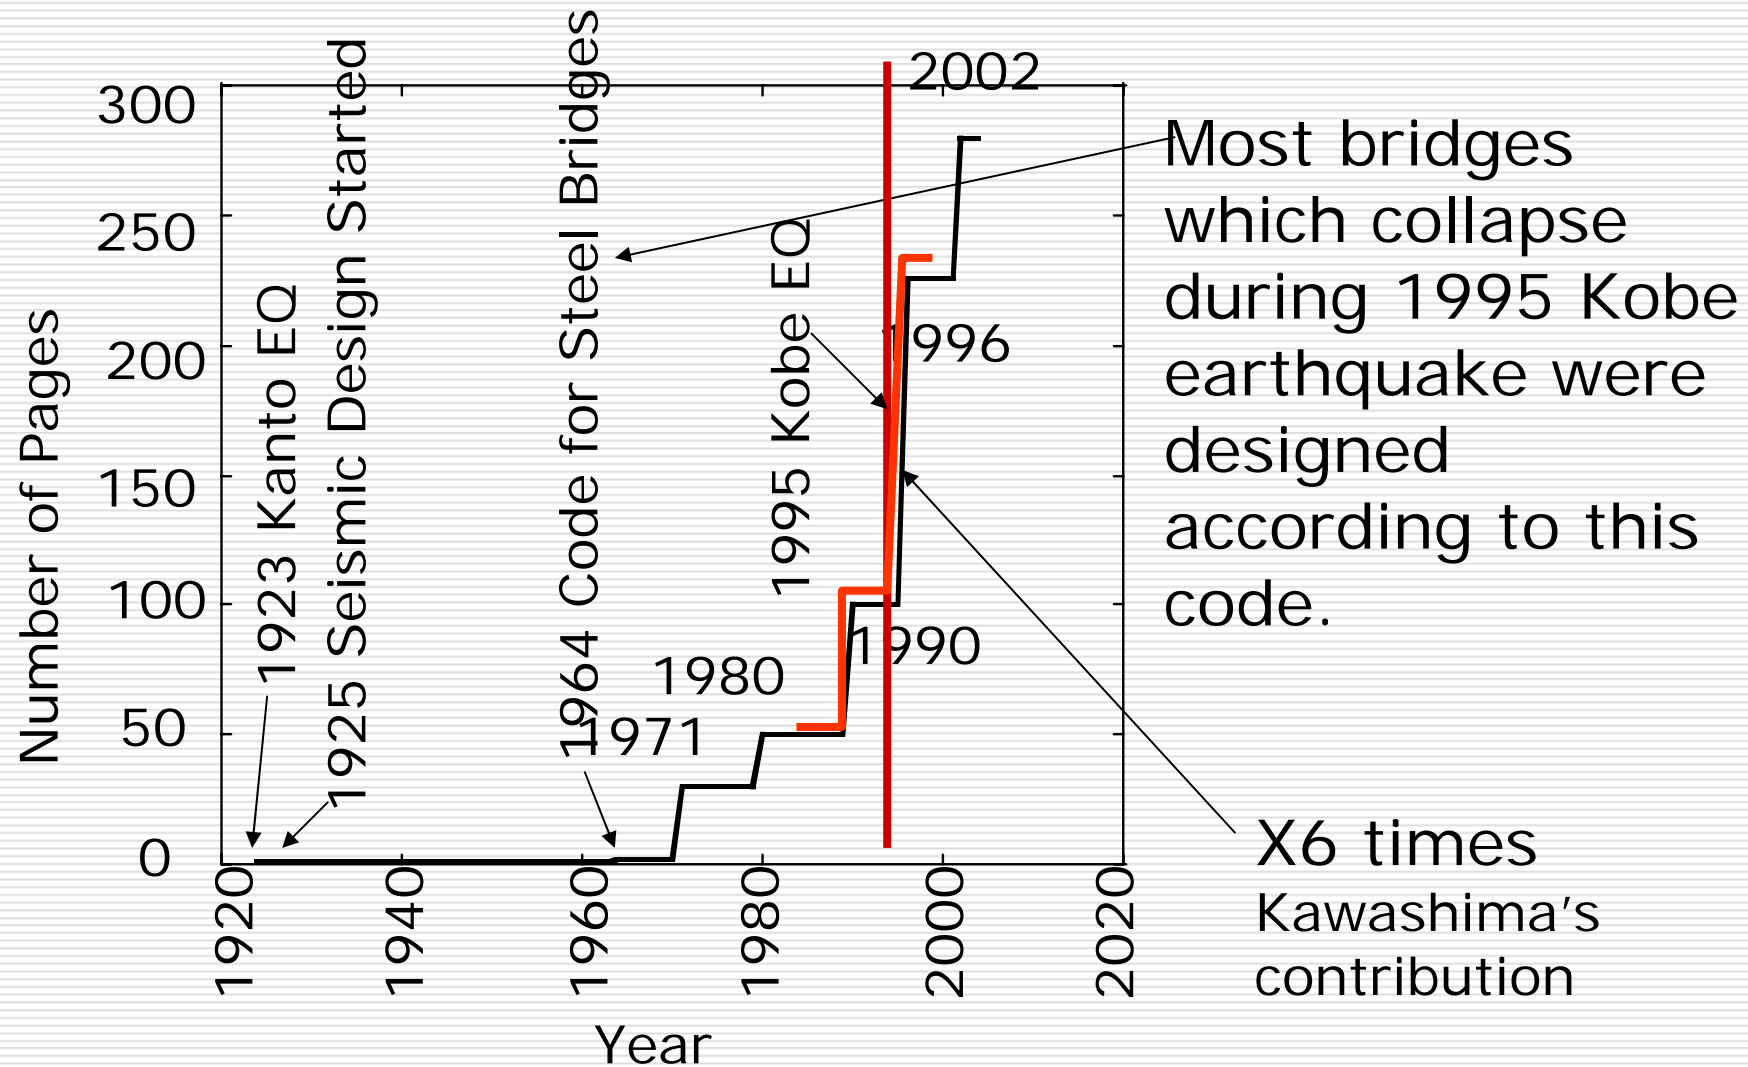
Number of Pages related to Seismic Design of Bridges in Japan
