Bridge engineering learned from failures -fatigue and fracture control-

C. Miki Tokyo Institute of Technology, Tokyo, Japan

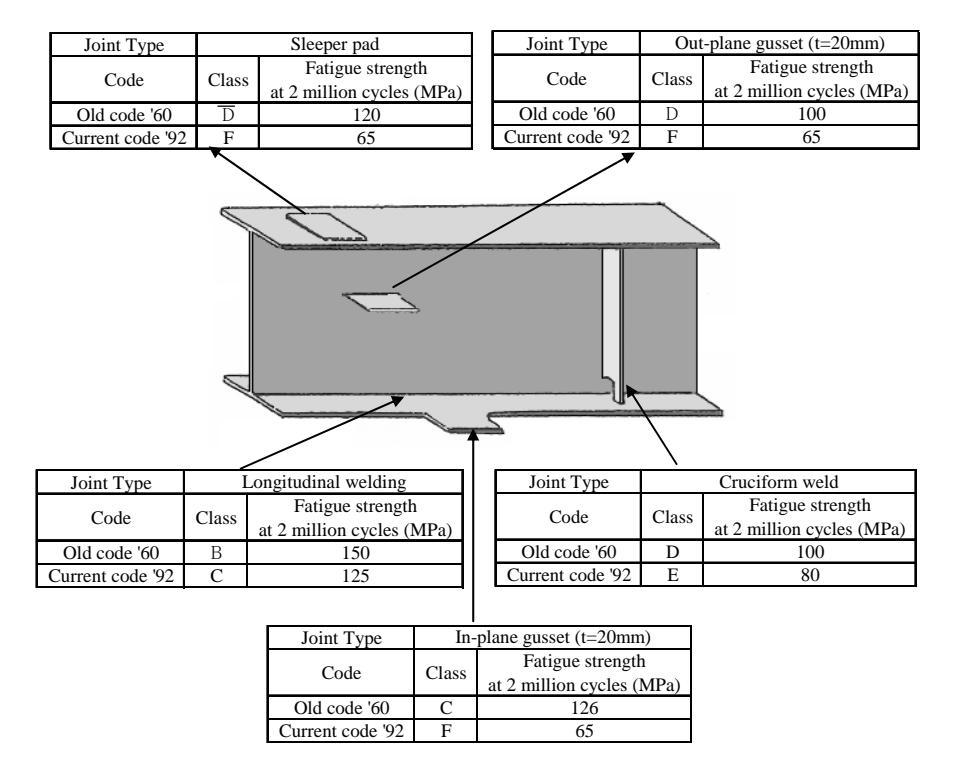
Figure 3 Change of allowable fatigue stresses from '60 code to '92 code

As often occurs with old structures, the allowable stresses used in fatigue design on subsequent review being found to have been inappropriate. Figure 3 shows a comparison of the allowable fatigue design stresses of typical joints in steel railway bridges in 1960 and at present in Japan. Since 1970s, fatigue tests on full-scale and large models have been carried out in U.S. and Japan. The results of these tests revealed the strong size effects of fatigue strengths, the results of large size models were very low compared with existing results of joint specimens. According to these facts, allowable fatigue stresses were reconsidered and made the present values.

According to this fact, comprehensive fatigue damage prevention works had been performed for all of steel bridges, total number of girders is 1511 and total length is 27km, in the Tokaido Shinkansen (the bullet train system). In order to assess fatigue damage, stress measurements under service conditions were performed in many bridges covering all types of bridges. These
