### Fatigue Cases and Retrofit Works in Steel Bridges

#### Causes of fatigue damage

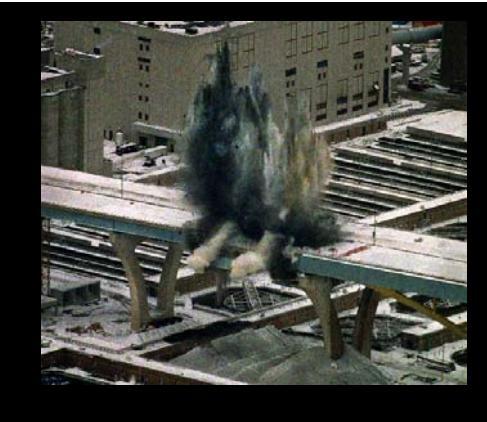
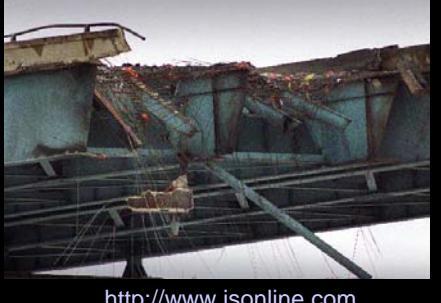
# Hoan Bridge

Two of the bridge's three support beams had failed and the deck was sagging approximately four feet. The Hoan was immediately closed in both directions with no injury or loss of life while engineers then rushed to the scene to examine the situation and begin mulling over potential solutions. The affected span did not collapse, though, as the third and final support beam kept it from failing, although one source notes "the final girder sustained considerable stress damage until the bridge span was felled two weeks later."

on December 28, 2000, the buckled portion of the bridge was removed without incident.

the southbound lanes were reopened on February 17, 2001 with one lane of traffic in each direction.

on October 11, 2001, Governor Scott McCallum was the first to drive over the newly-repaired northbound lanes at 10:00 am, officially re-opening the bridge to traffic, although only two lanes in each direction were initially available. All six lanes were cleared and made available on November 1, 2001, officially completing the repair work in less than eleven months.

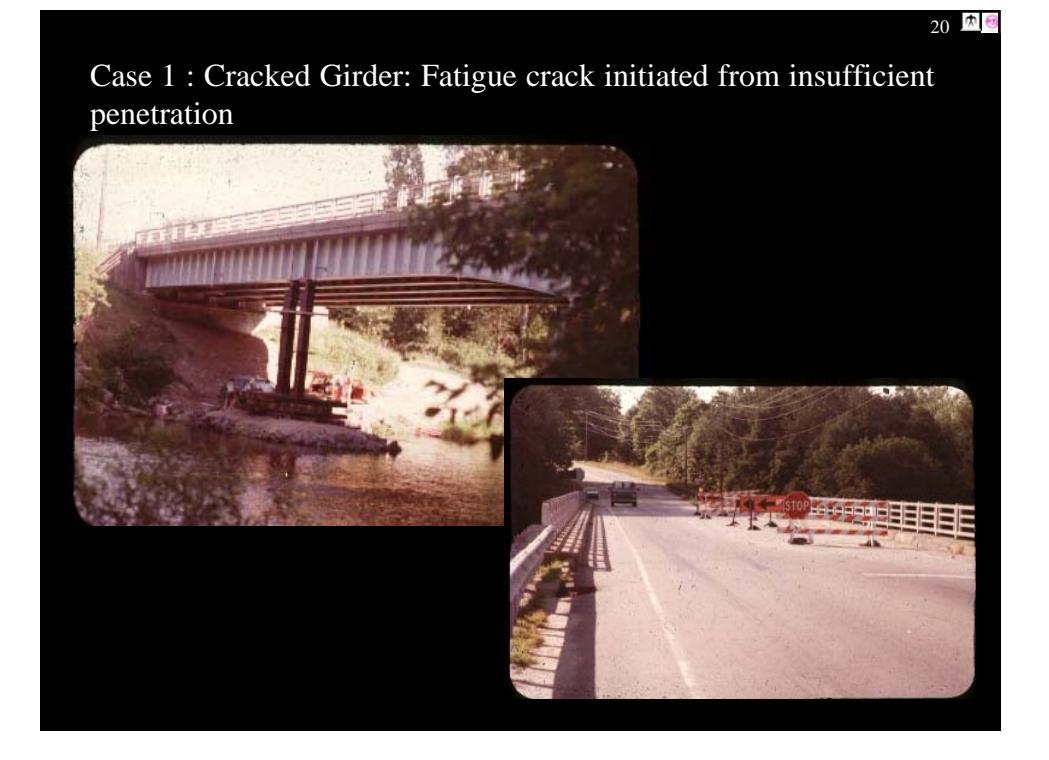
- two spans continuous girder(45.7 + 45.7m), constructed in 1949. This cracking accident was found in 1981.

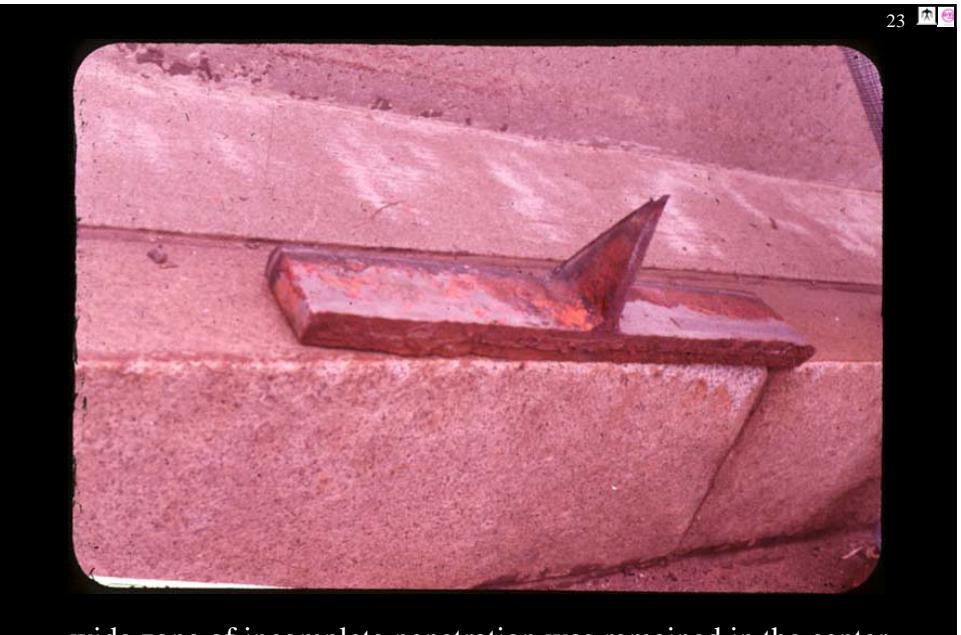
wide zone of incomplete penetration was remained in the center part of joints.

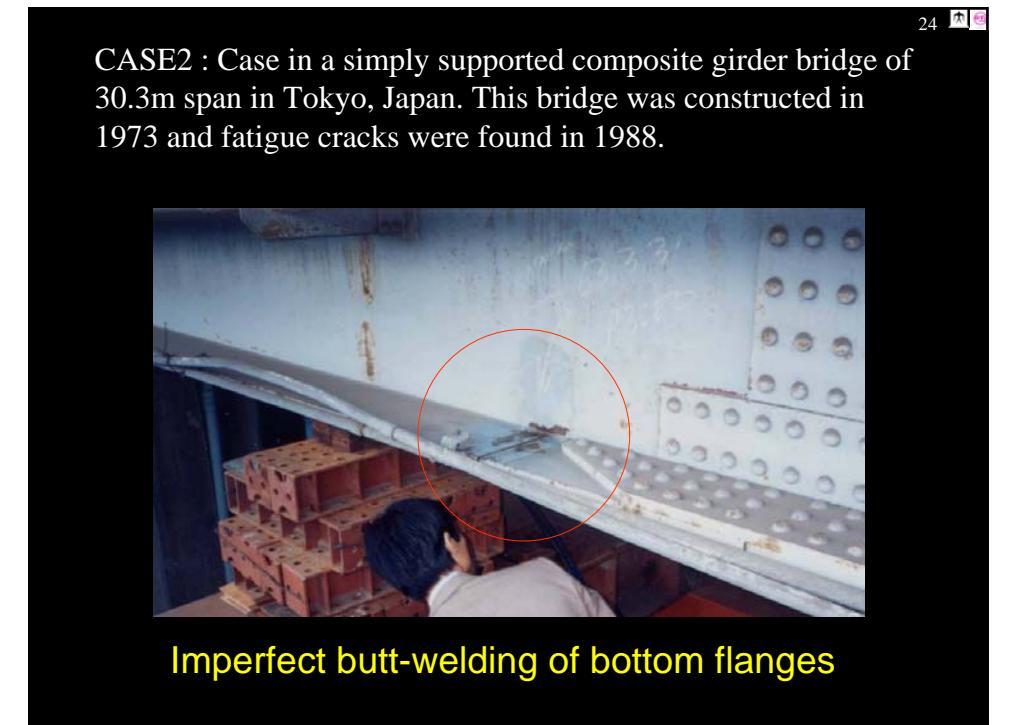
• Cracks are arrested in fillet welds between the flange plate and the web plate due to large plastic deformation of weld metal.

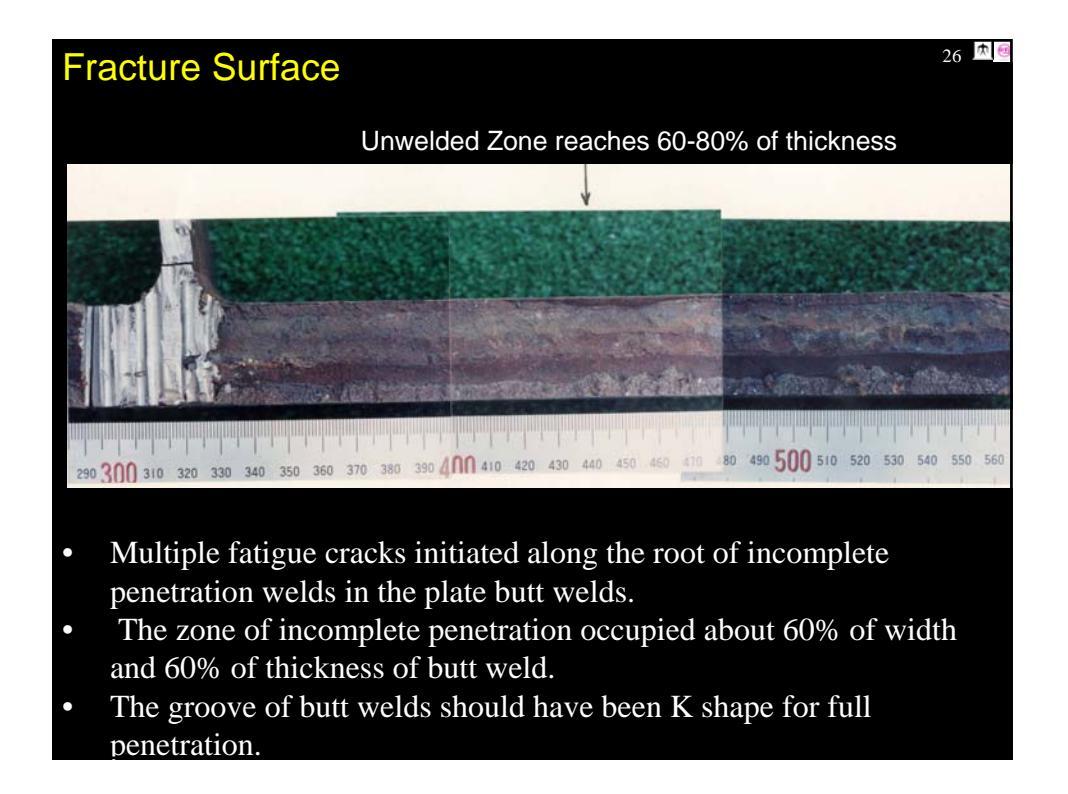
• Weld defects of incomplete penetration were discovered in 45 joints out of 388 joints.

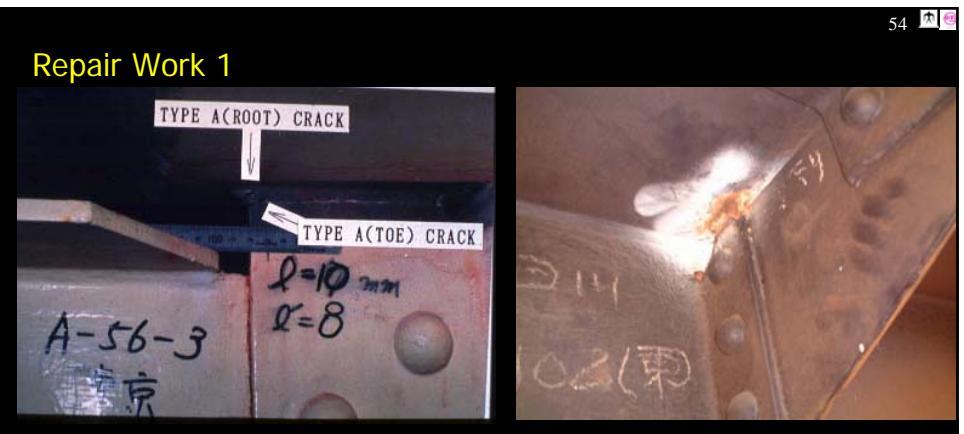
#### 3-3 Fatigue cracks at the cross bracing connection details

large forces are produced in cross bracing from

- Difference in deflection between main girders caused by vehicle loads
- forced deformation of the upper flanges of plate girders by deflection of the concrete deck in a direction perpendicular to the bridge axis.

- 1. For small cracks : re-welding the crack is done by TIG dressing
- 2. small size fillet weld (possibility of crack from root) : after fillet welding on top of the crack, the toe is finished by TIG or grinding
- 3. When a crack is large : the crack is removed by gouging, fullpenetration welding is performed, with toe finishing done by TIG or grinding.

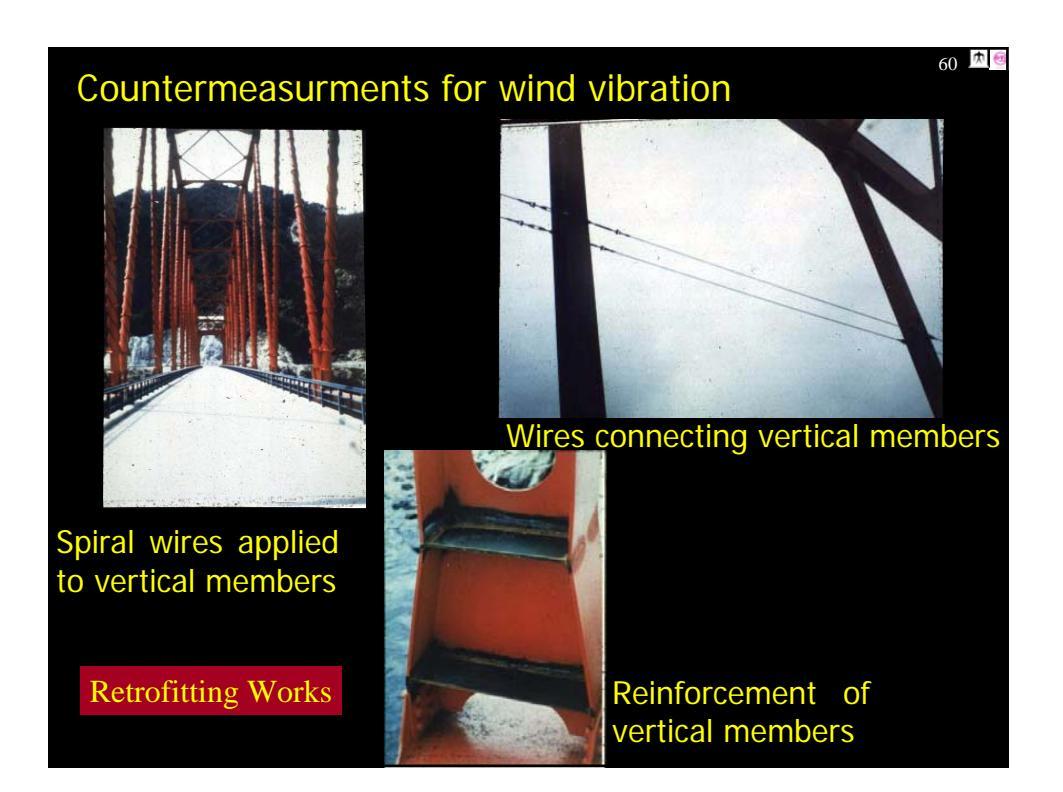
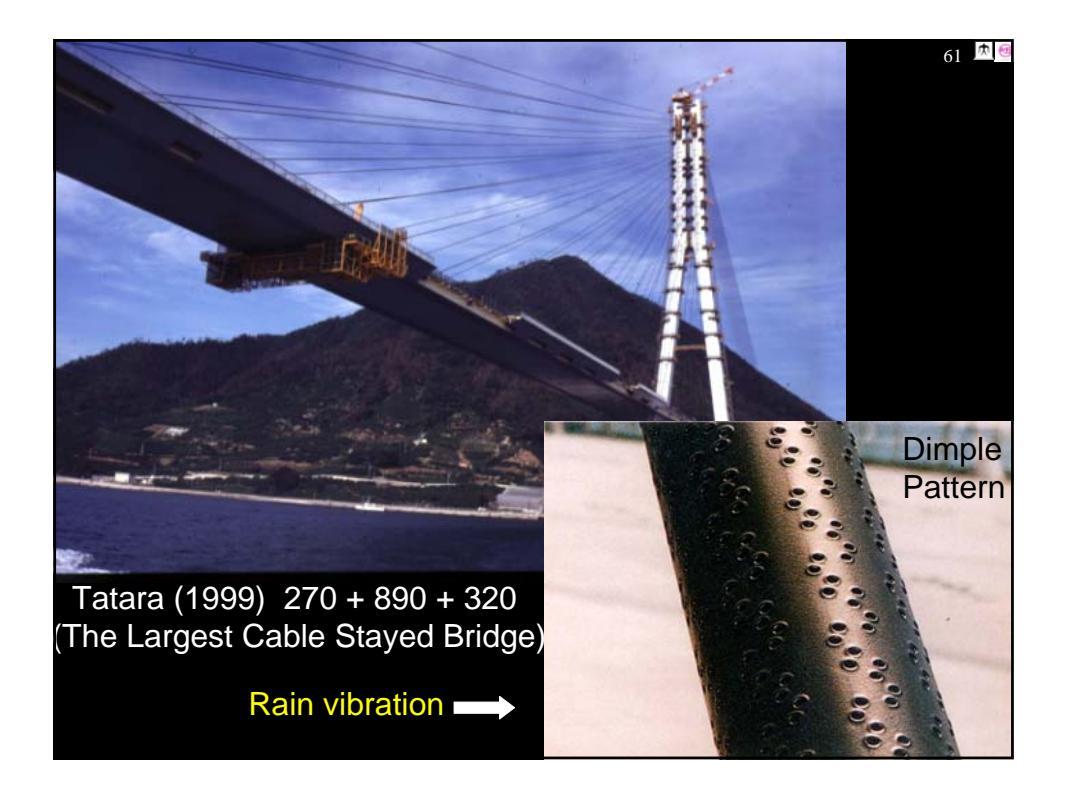
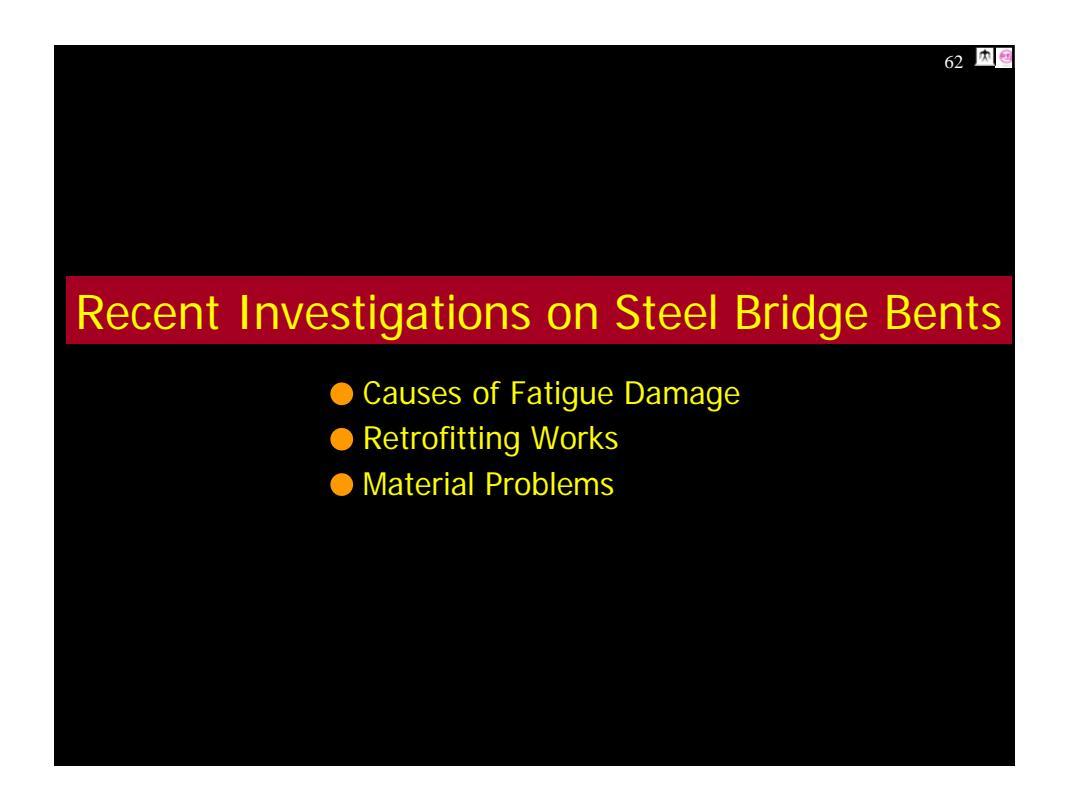
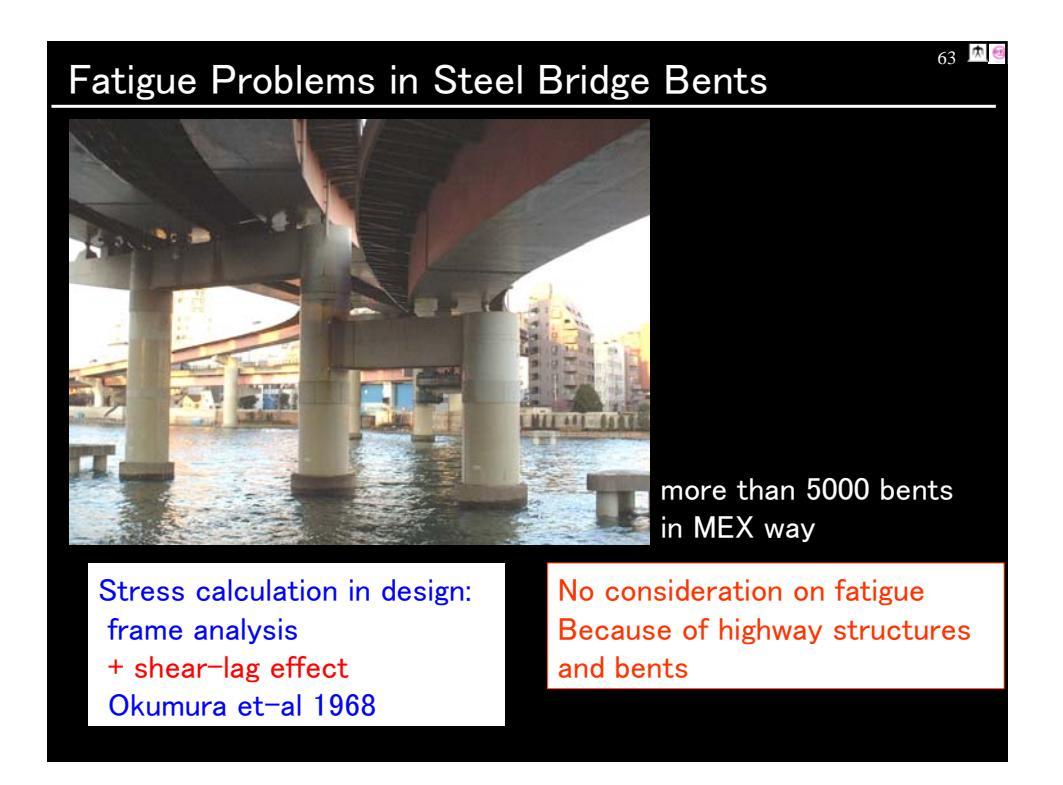
M Bridge

- Karman vortex shedding may cause fatigue damage in bridge members.
- fatigue cracks cut the connection plates between the main girder and the vertical suspension members.

The End of Vertical Member In Ranger Type Bridge

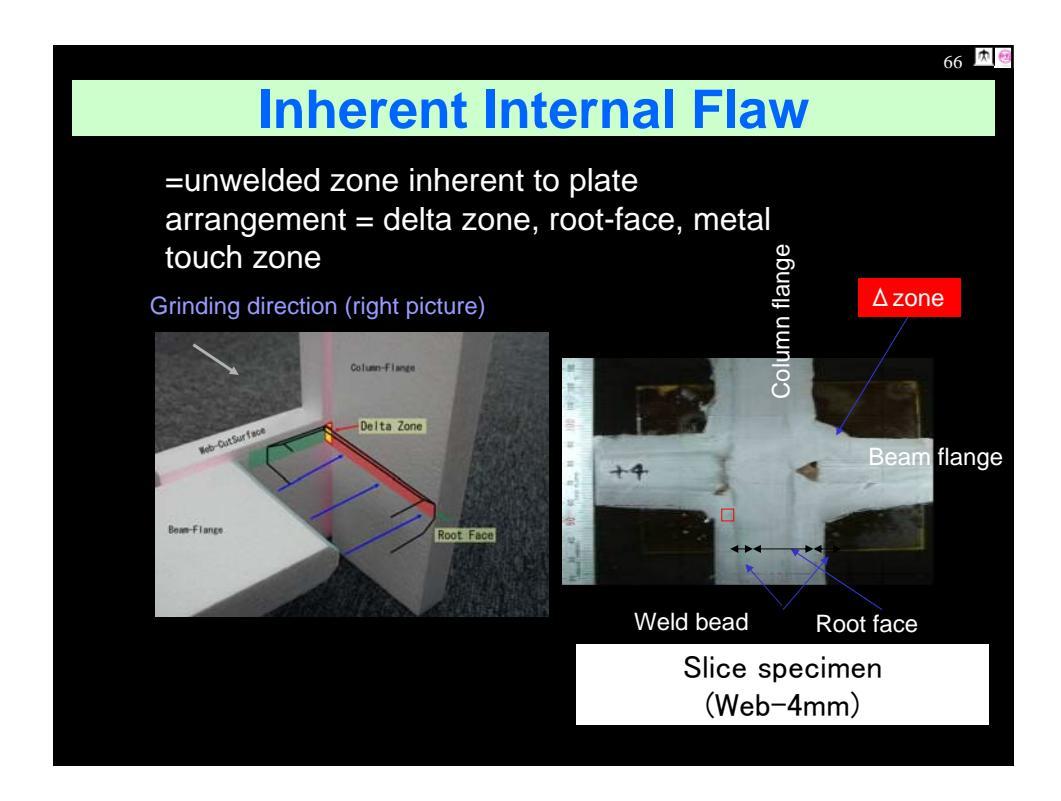
# Fatigue crack in beam-column connection of steel pier

- Cracks come out from inside of weld metal.
- From unwelded zone, Lack of fusion, weld crack, or other weld defects

- Intersection of weld line
   →high restraint stress, weld
   flaw (blow hole,slag
   inclusion, weld crack)
- 2. Stress concentration (Geometry, shear lag, bead, notch)
- 3. Inherent Internal Flaw
