3. SEISMIC DAMAGE IN THE PAST EARTHQUAKES

3.1 Loma Prieta and Northridge, USA, Earthquakes

3.2 Pre-Kobe and Kobe, Japan, Earthquakes

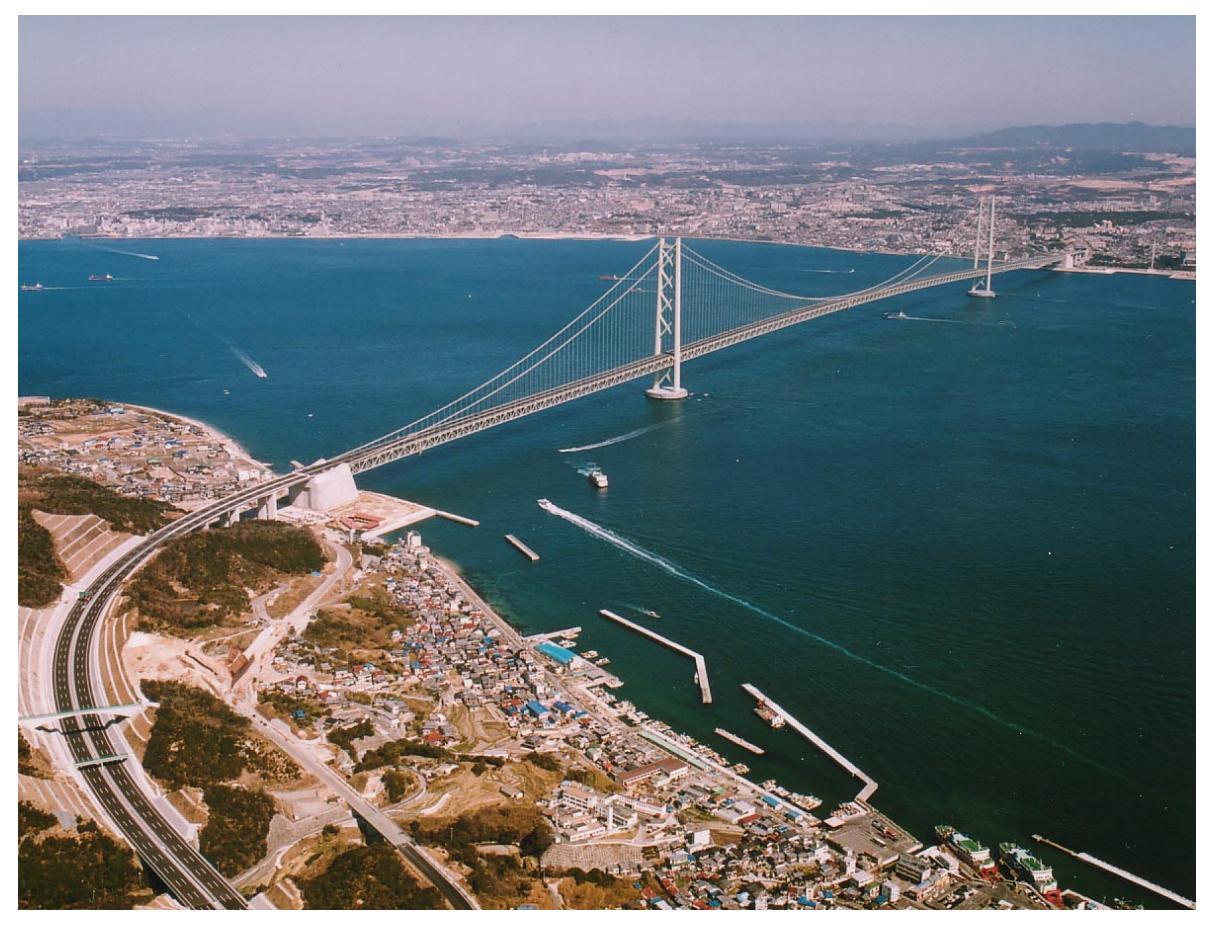
The world-longest Akashi Straight Bridge (refer to Photo 3.10) was under construction when the earthquake occurred. Two abutments and two main towers were already completed, and cables hanged a part of the superstructure. The fault crossed the bridge between two tower foundations (P2 and P3). This resulted in the permanent movements and rotations of the anchorage and tower foundations as shown in Fig. 3.4 (Saeki et al 1997, Yasuda et al 2000). P3 tower foundation and A4 anchorage were dislocated 1.3m and 1.4m, respectively, relative to 1A anchorage and P2 tower foundation. This increased the center-span length from 1990m to 1990.84m, and the total bridge length from 3910m to 3911.09. Survey after the earthquake revealed that there was not any damage in the structures except the permanent movements. The superstructure was erected by slightly changing the length.

Photo 3.10 Akashi Straight Bridge

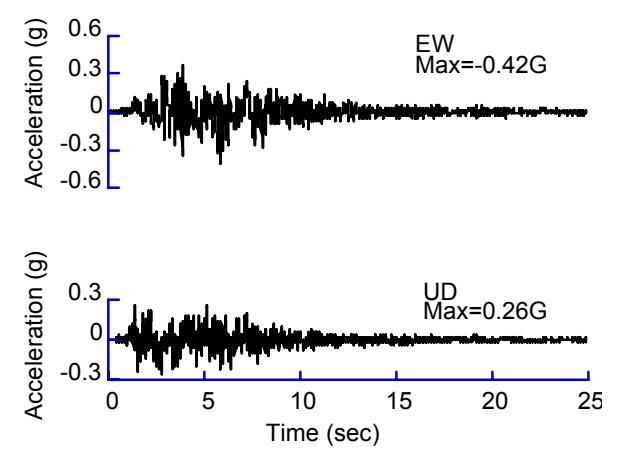
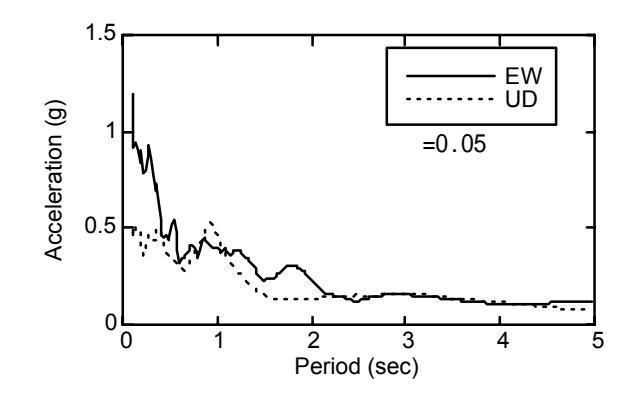
Fig. 3.5 shows the ground accelerations recorded at Sakarya, Adapazeri (Bogazici University 1999). The peak acceleration of fault parallel component was 4.07m/s². The fault normal acceleration was not recorded.

Fig. 3.5 Ground Motions Recorded at Sakarya, Adapazeri

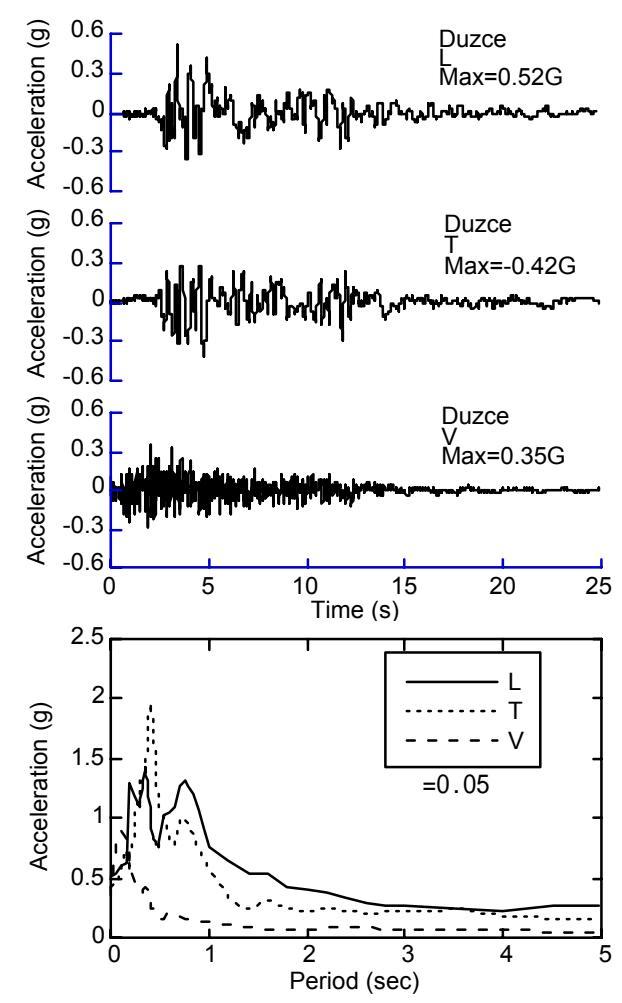
A part of the Istanbul-Ankara Motorway at Bolu suffered extensive damage in the Duzce Earthquake with moment magnitude M_w =7.2, November 12, 1999. Fig. 3.7 shows the ground accelerations recorded at Duzce. Long period pulses are included in the records. Response acceleration of 0.05 damping ratio was 1.3 g at 0.8 second in the L-component.

Fig. 3.7 Accelerations and Response Spectra at Duzce, 1999 Duzce Earthquake

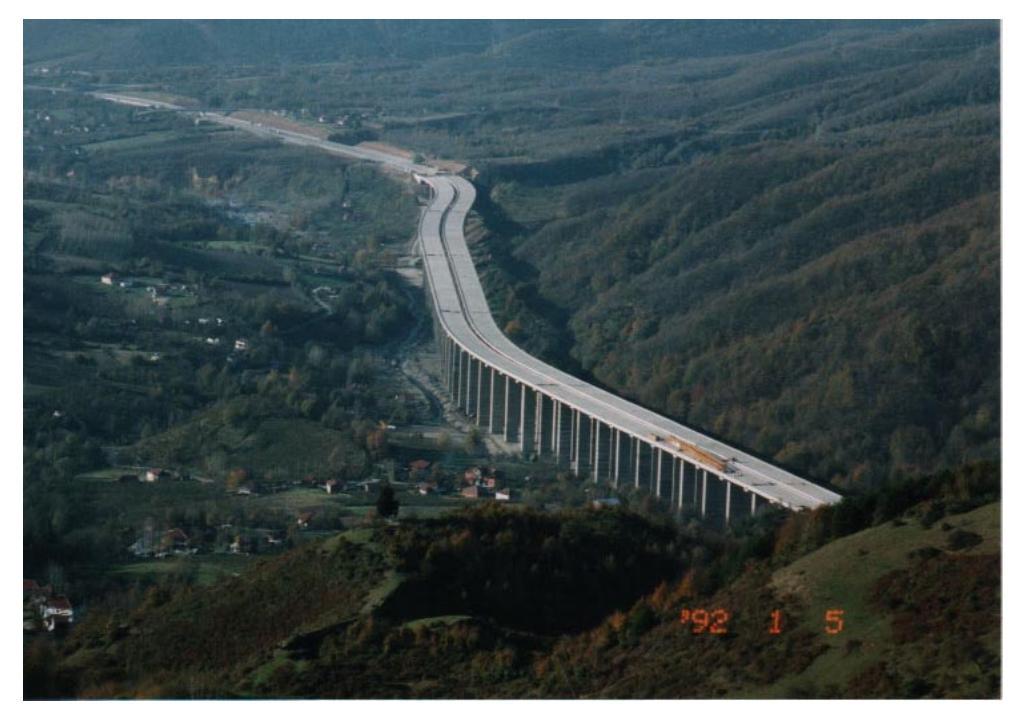
The Bolu Viaduct consisted of a 2313m long 59 span westbound deck and a 2273 m long 58 span eastbound deck as shown in Photo 3.17. Averaged span length was 40m. Superstructure consisted of 7 prestressed concrete U-beams. Although the U-beams were simply supported, the concrete deck was continuous for 10 spans. Hence, the Viaduct behaved as 10 span continuous bridges.

Photo 3.17 Bolu Viaduct

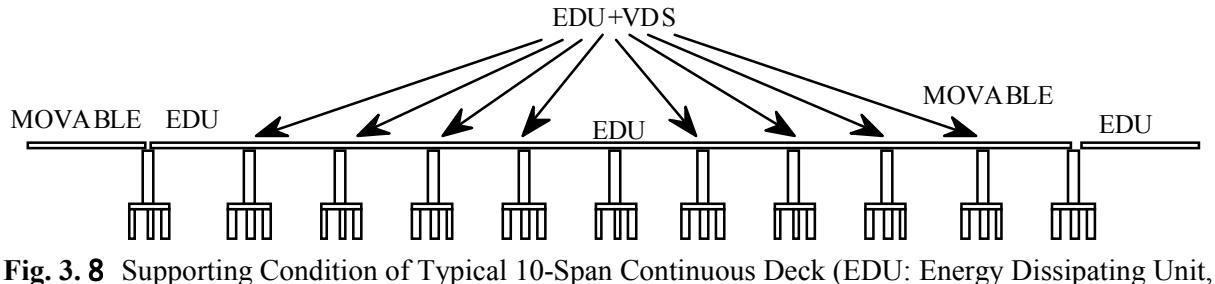
A unique supporting system was adopted in the Bolu Viaduct (Yilmaz 2000, Tiras and Sahiss 2001, Ghasemi et al 2000, Kawashima and Shoji 2000). A deck was supported by pot bearings that allowed multi-directional sliding. A mechanical energy-dissipating unit consisting of 8 C-shaped mild steel damping elements (EDU in Fig. 3.8) was provided at 10 columns, except one of the two deck ends. They achieved energy dissipation for multi-directional movements of the decks. Except at one of the two deck ends and the mid-column, a viscous damper stopper (VDS in Fig. 3.8) was provided, which connected to the energy-dissipating unit in series. The viscous damper stoppers allowed the deck to displace freely in longitudinal direction resulting from creep, shrinkage and thermal effects. Under seismic loading, the viscous damper stopper is locked so that the energy dissipating units dissipate energy.

VDS: Viscous Damper Stopper, Movable: Sliding Pot Bearings)

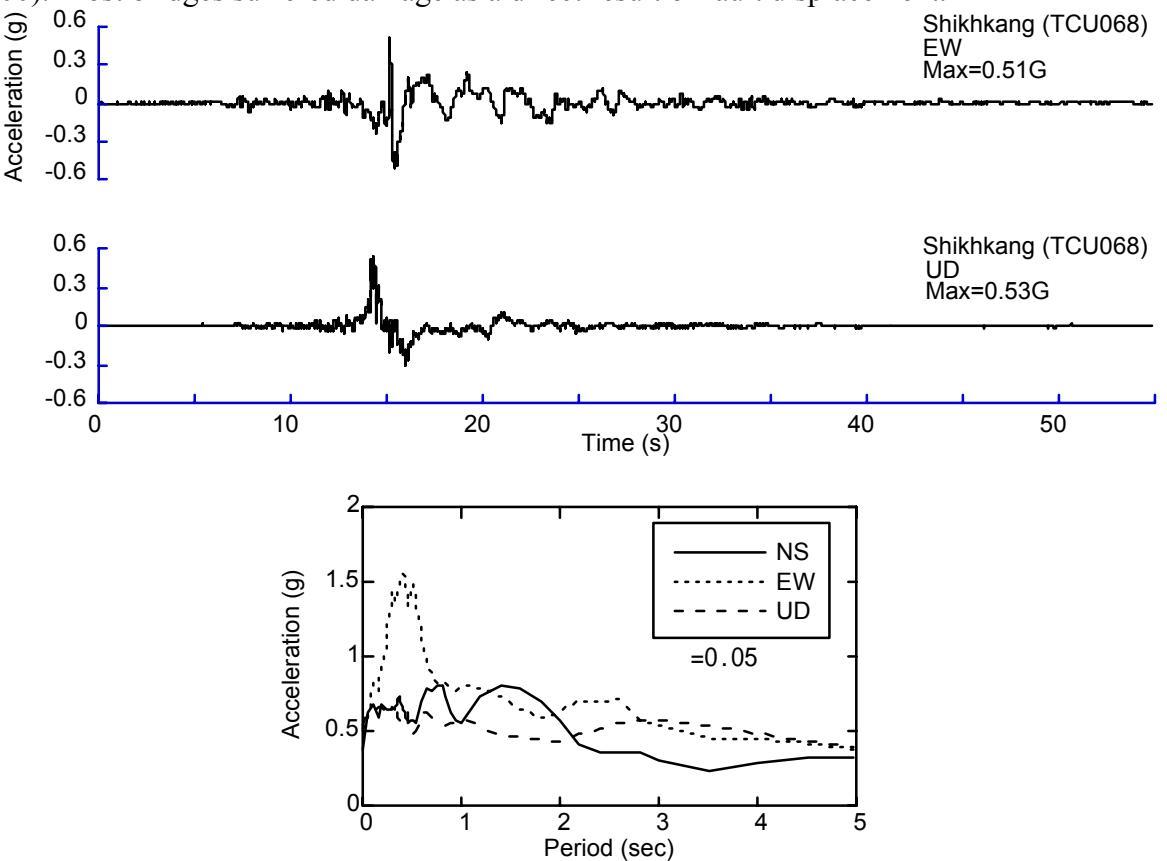
Fig. 3.9 shows the ground acceleration recorded at Shikhkang (TCU068) and response

acceleration of 0.05 damping ratio, respectively (Lee et al 1999). Long pulses are included in the ground accelerations. In particular, EW component has a single pulse with peak acceleration of 4.9 m/s². Response acceleration of 0.05 damping ratio is about 1.5g at 0.5 second.

Fig.3.9 Accelerations and Response Accelerations with 0.05 Damping Ratio, Shikhkang (TCU068), Chi-Chi Earthquake (Lee et al 1999)
