(1) Seismic Damage of Urban Infrastructures in Past Earthquakes

Kazuhiko Kawashima
Department of Civil Engineering
Tokyo Institute of Technology

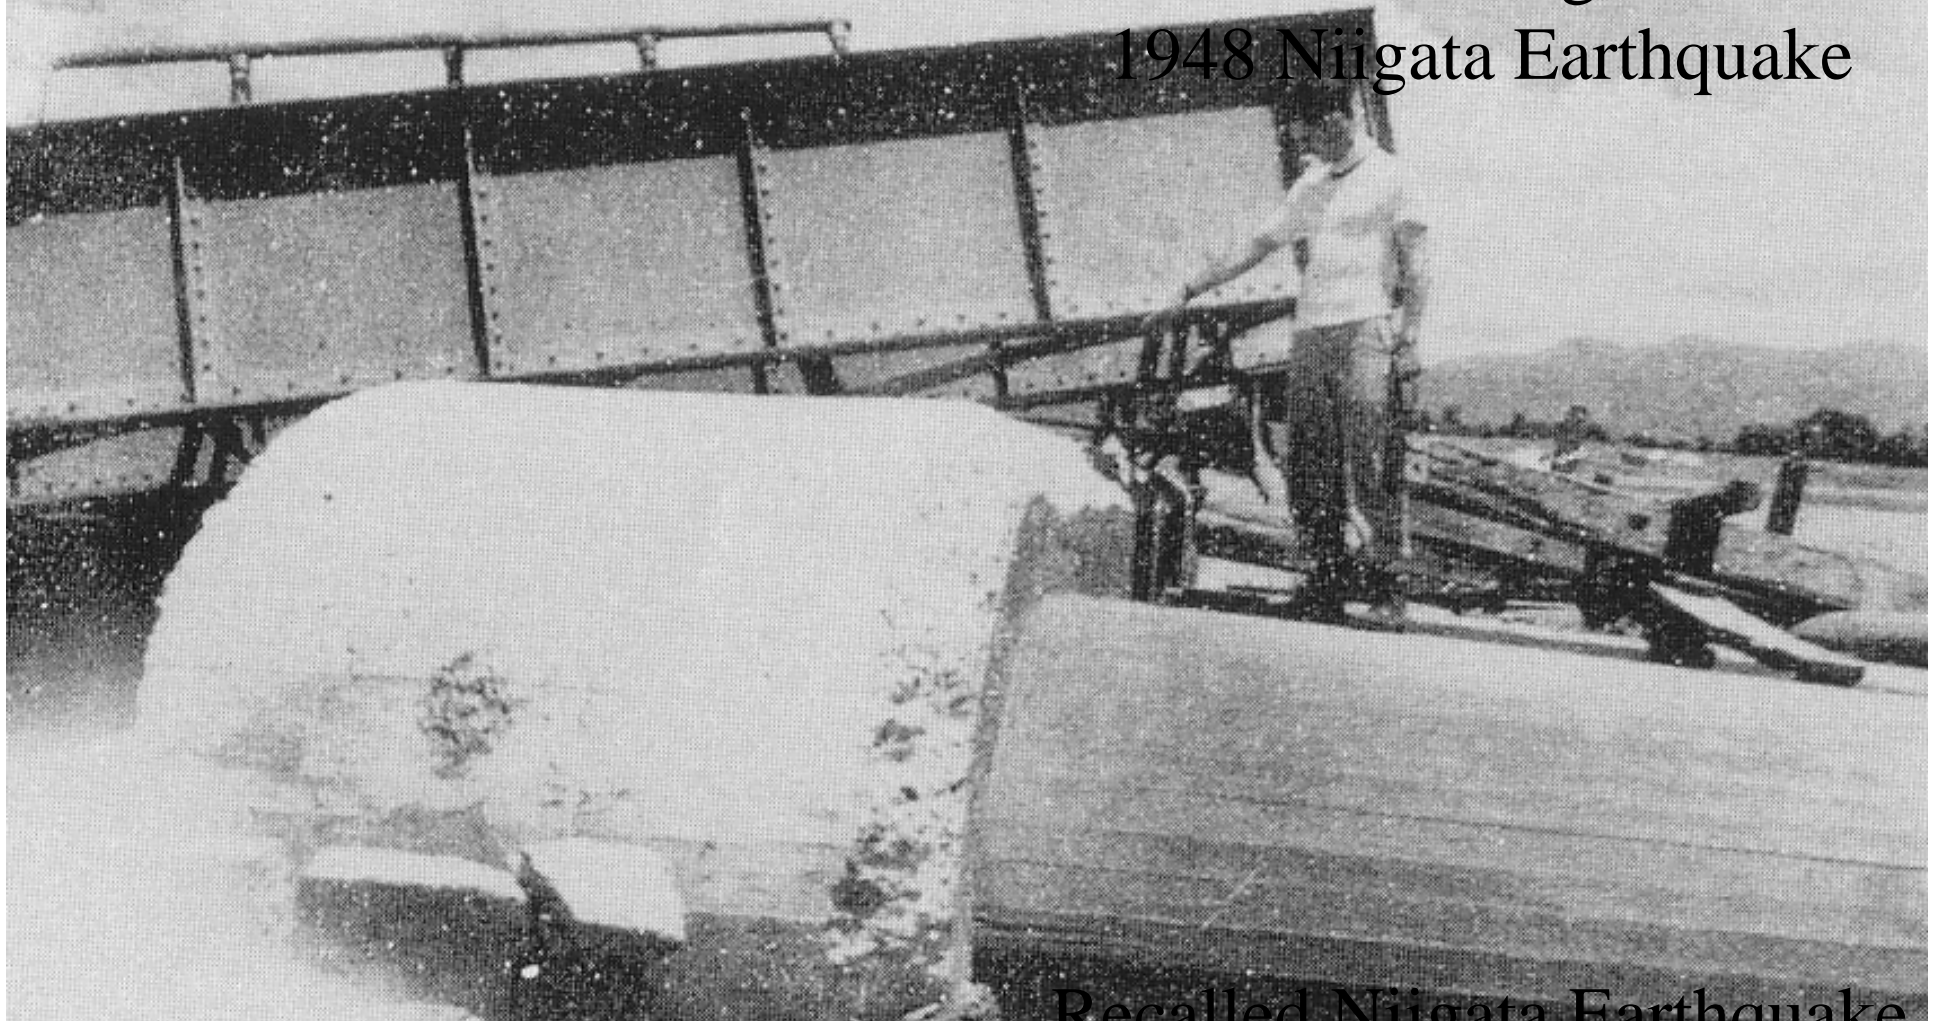
Nakazuno Bridge
1948 Niigata Earthquake

Failure of Foundations Resulted in Collapse of the Bridge

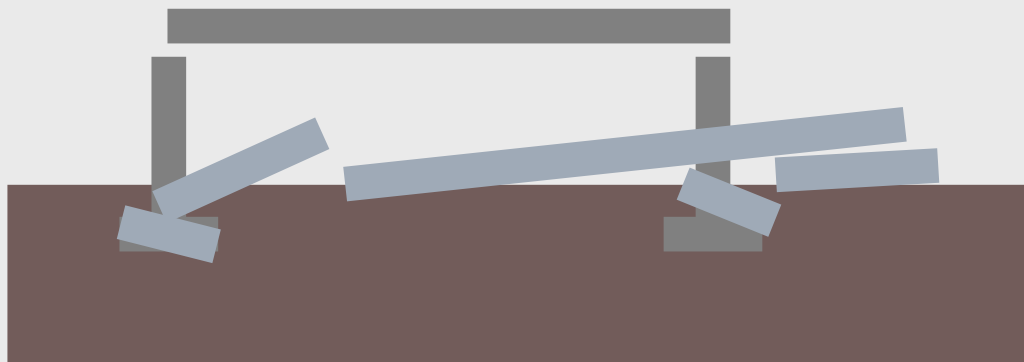
Tilting, Overturning and
Settlement of Foundations

Collapse

As a consequence of the extensive damage in the 1923 Kanto earthquake, seismic design was initiated in 1925

- Elastic static seismic design using 0.2-0.3 seismic coefficients based on the allowable stress design approach
- Construction of massive & rigid piers with large sections started

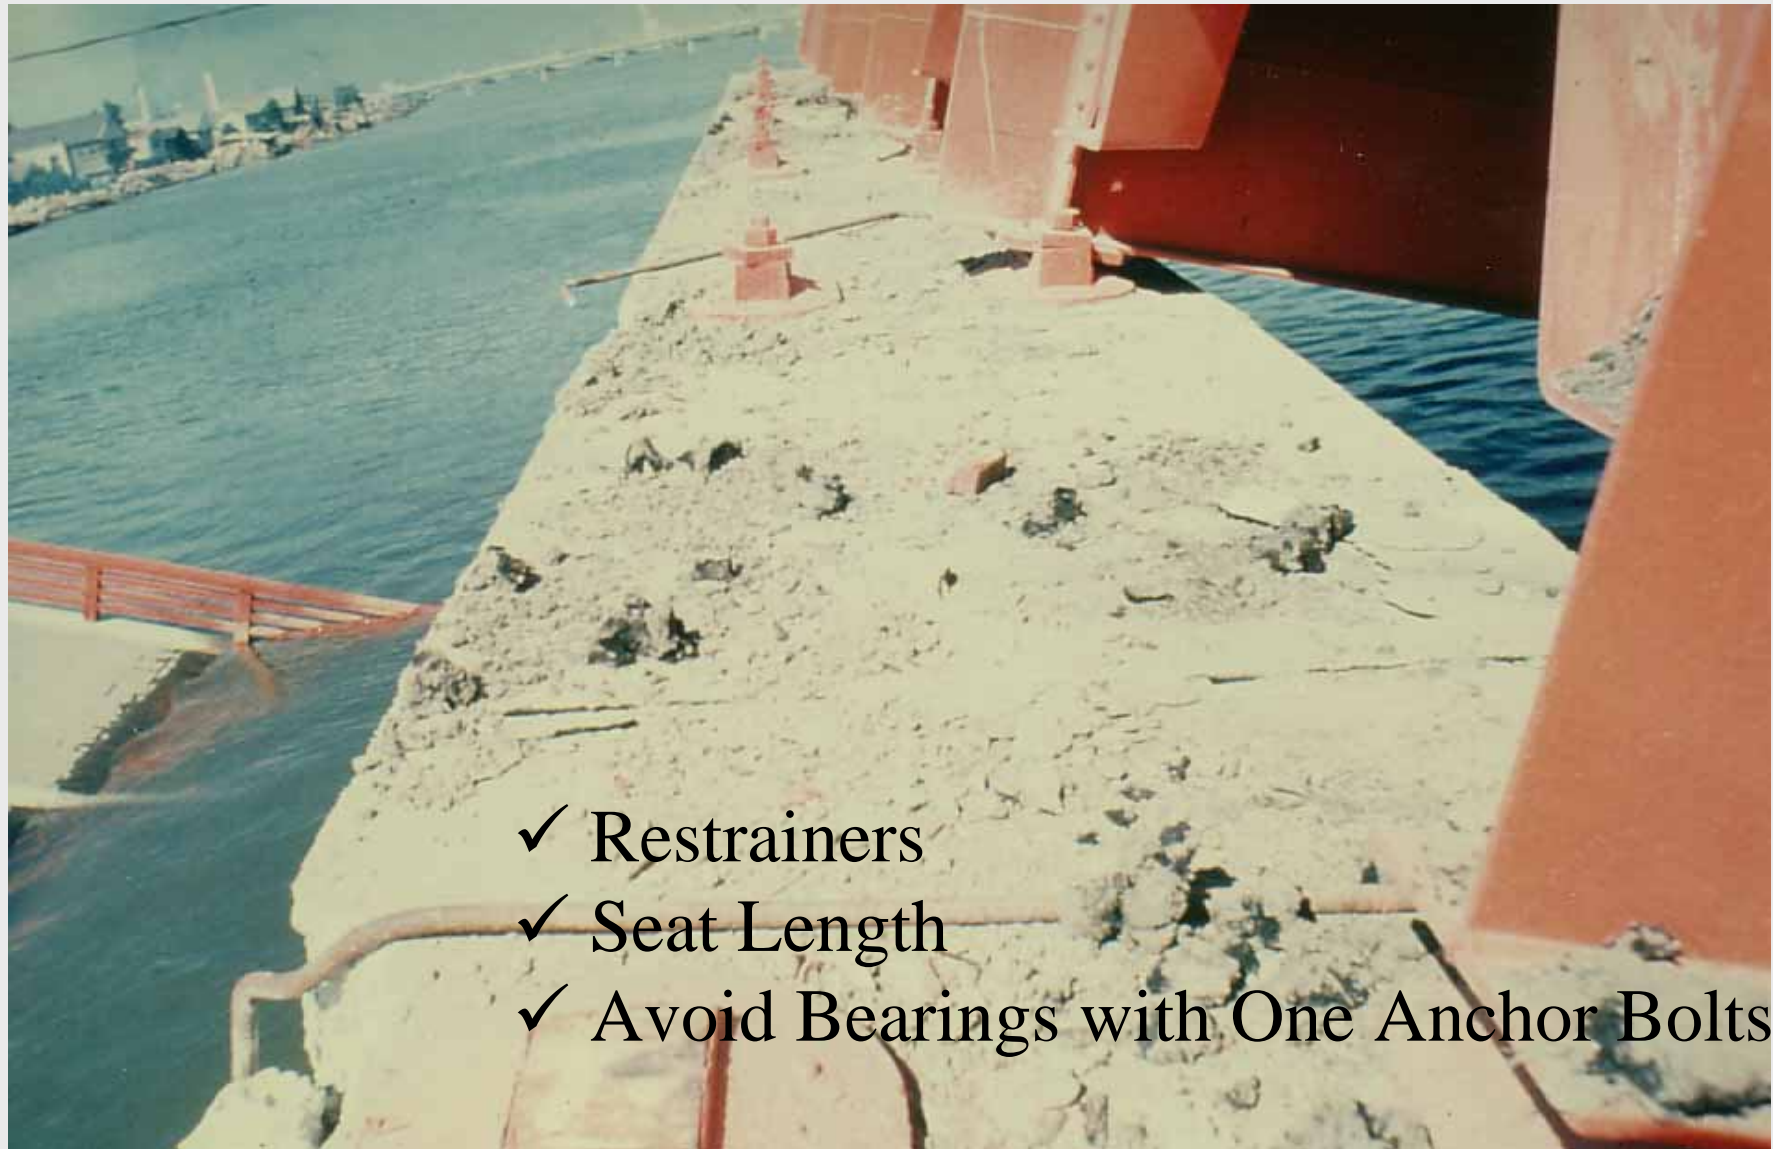
This damage resulted in the first development of unseating prevention devices

- ✓ Restainers
- ✓ Seat Length
- ✓ Avoid Bearings with One Anchor Bolts

Unseating Prevention Devices

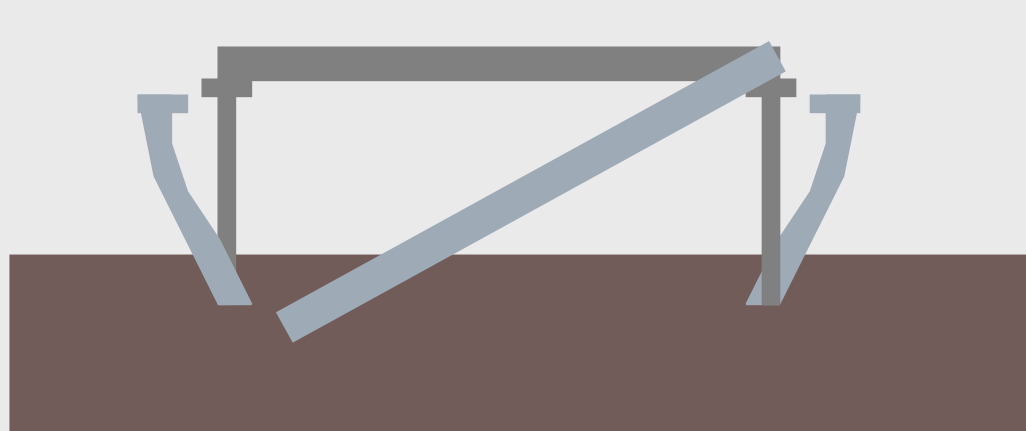
- Consideration to soil liquefaction and unseating prevention devices were not included in seismic design practice prior to 1964
- Excessive relative displacement of decks resulted from soil liquefaction

↓
Collapse

1971 Guide Specifications on Seismic Design of Highway Bridges

- Modified seismic coefficient method which incorporated natural period, soil condition and importance dependence of the seismic coefficient was introduced
- Evaluation of vulnerability for liquefaction was first included
- Unseating prevention devices were first included

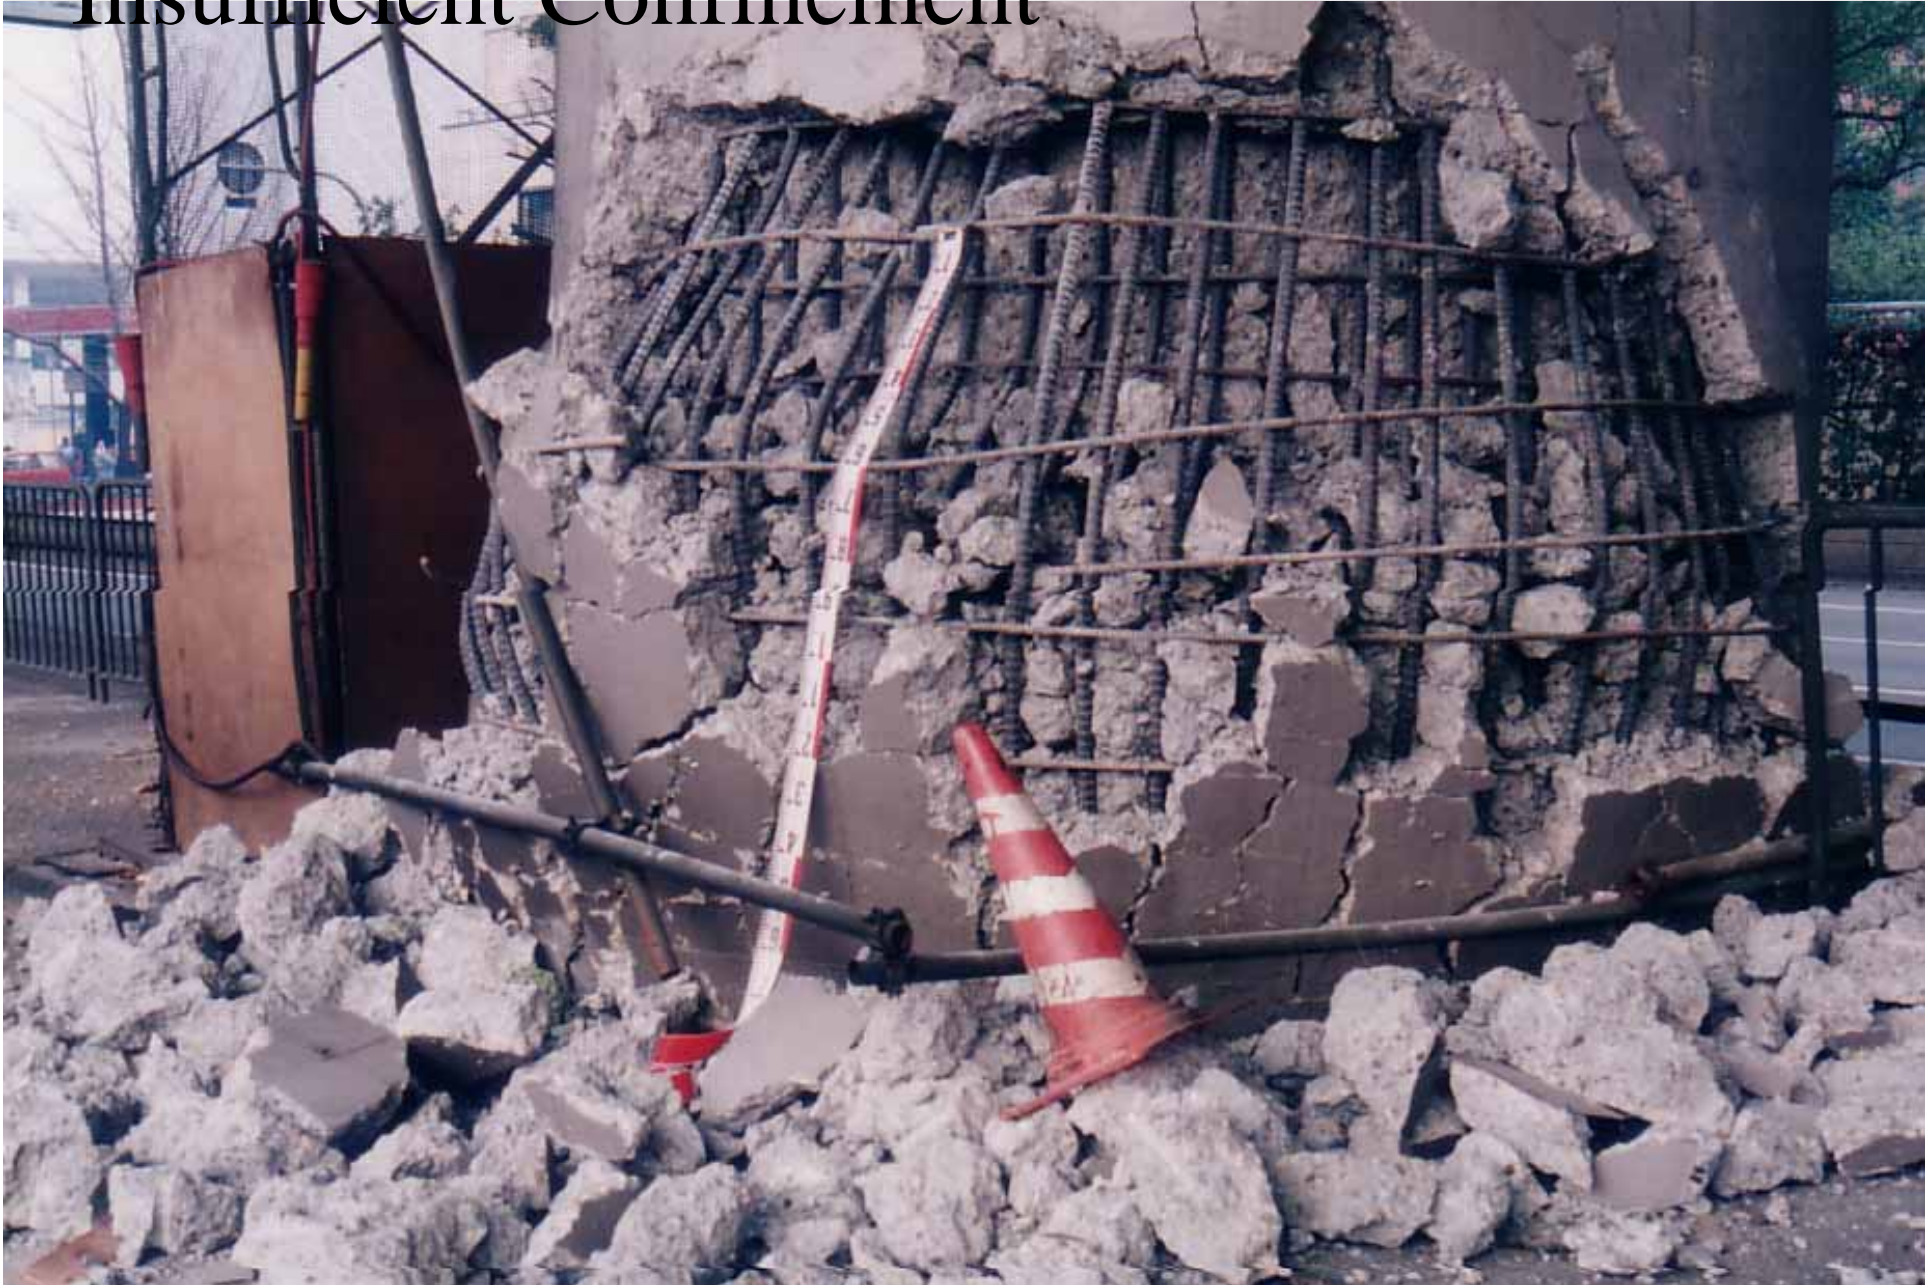
Insufficient Confinement

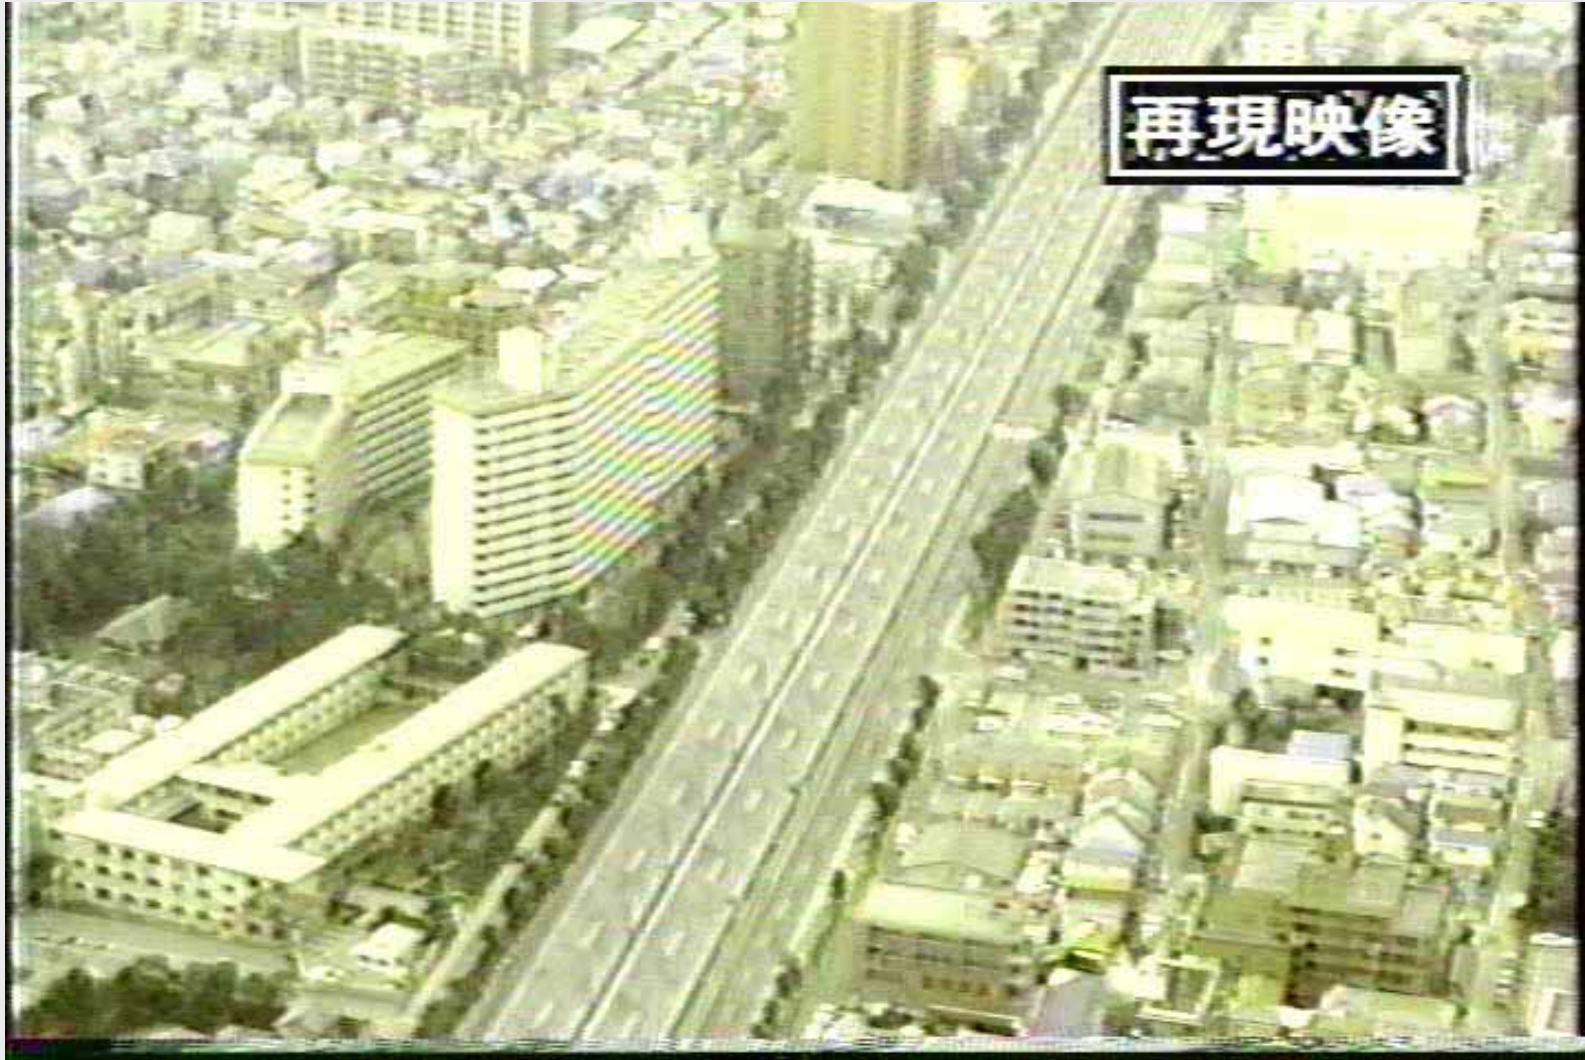
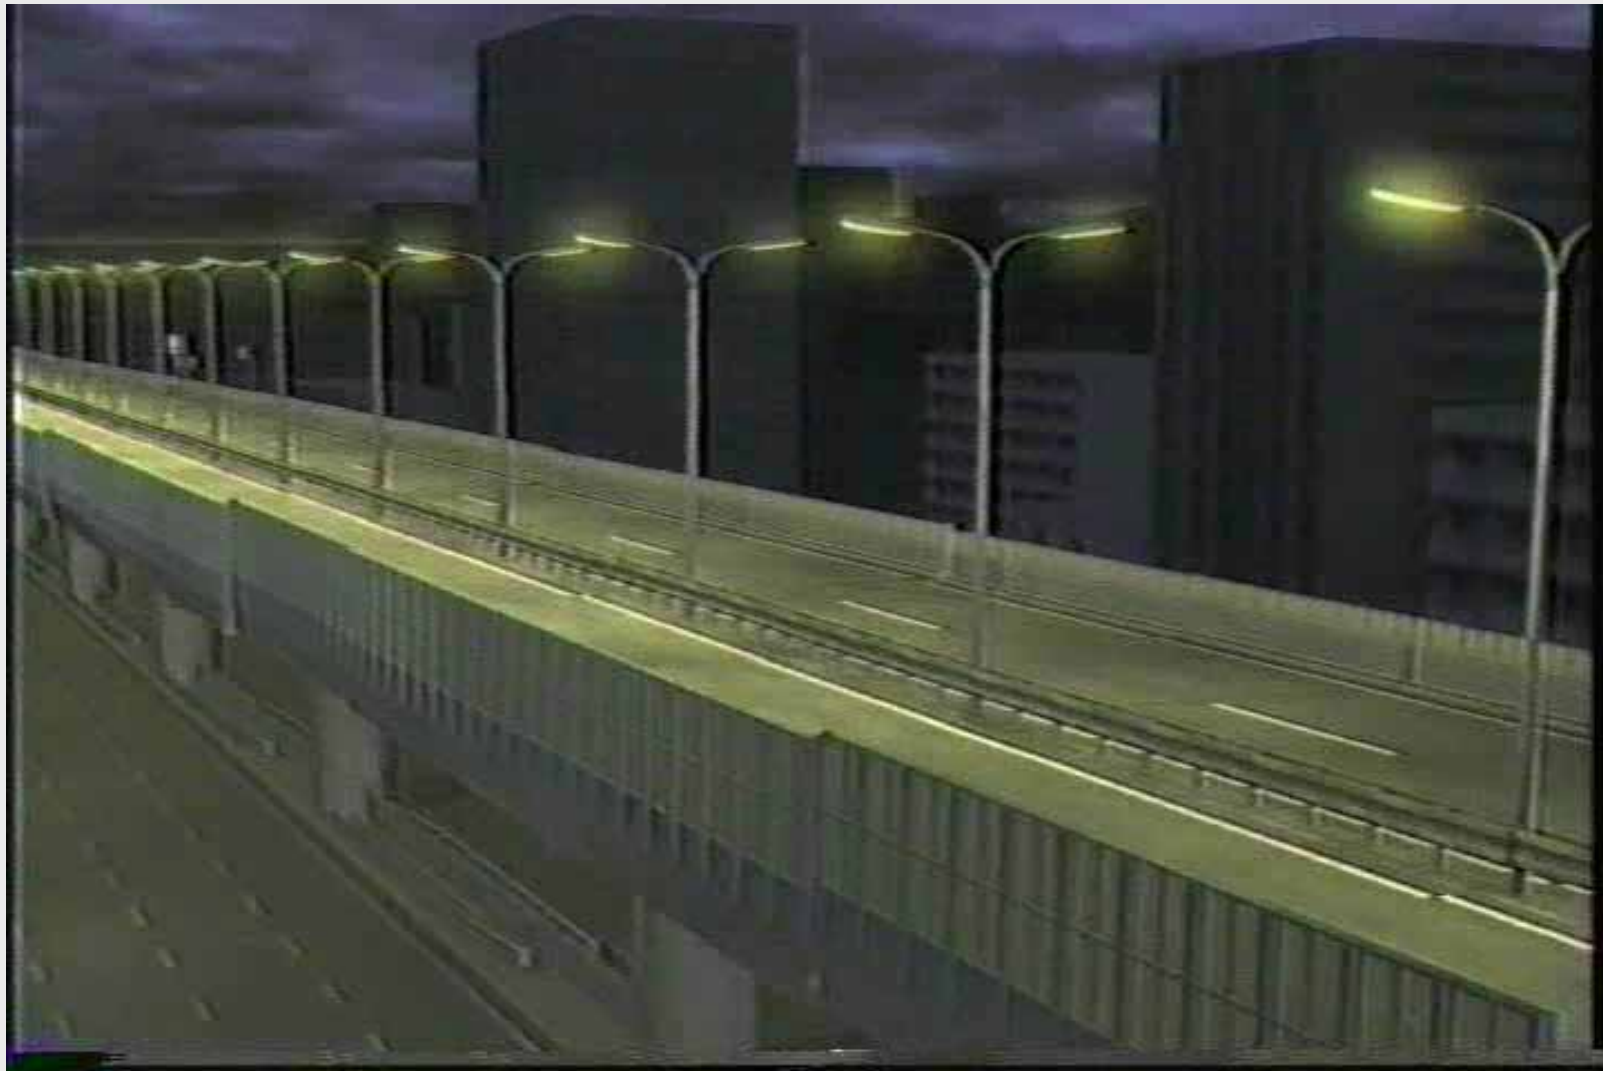
The most extensive damage occurred at a 18-span viaduct. This bridge collapsed due to failure of RC columns resulted from the premature shear failure.

Collapse of a 18-span viaduct in the 1995 Kobe Earthquake

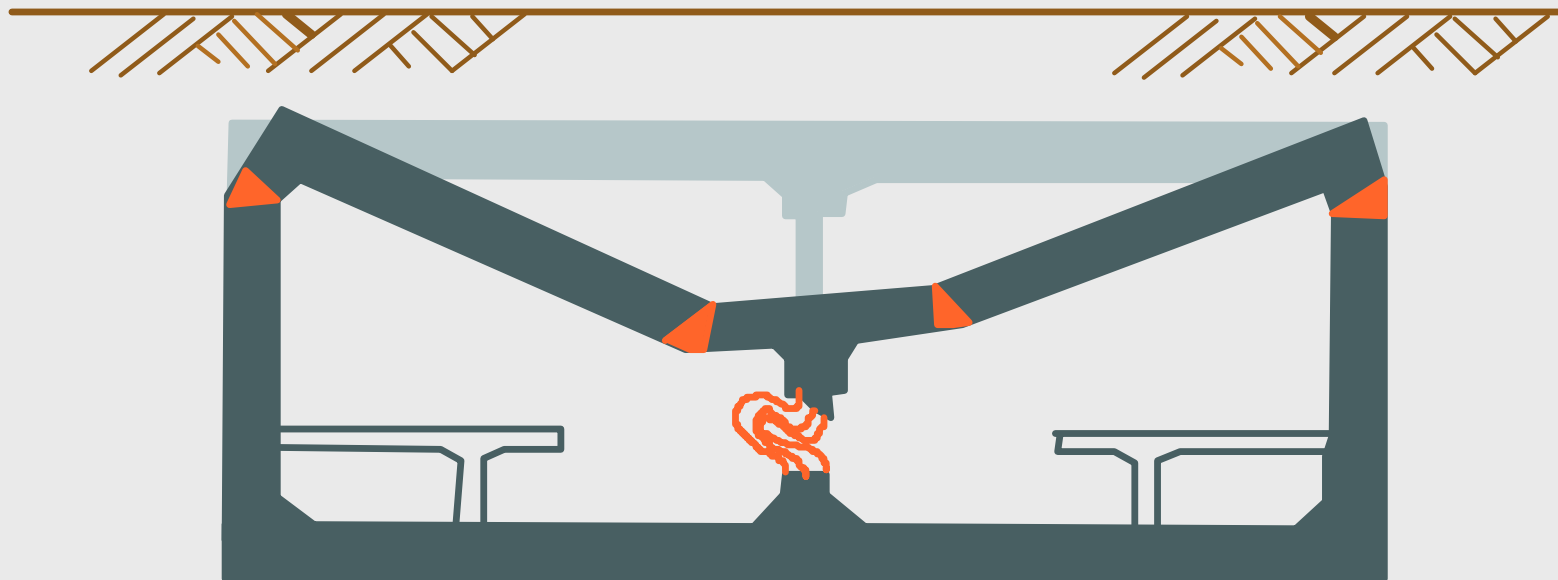
Failure Mechanism of Subway Station

Failure of Subway Station
