## Response Modification of Urban Infrastructure 都市施設の免震設計

(2) Chapter 2 Seismic Damage of Bridges due to Ground Vibration (Part 1)
 (2)2章 地震動による橋梁の地震被害 (Part 1)

Kazuhiko Kawashima Department of Civil Engineering Tokyo institute of Technology 東京工業大学大学院理工学研究科土木工学専攻 川島一彦

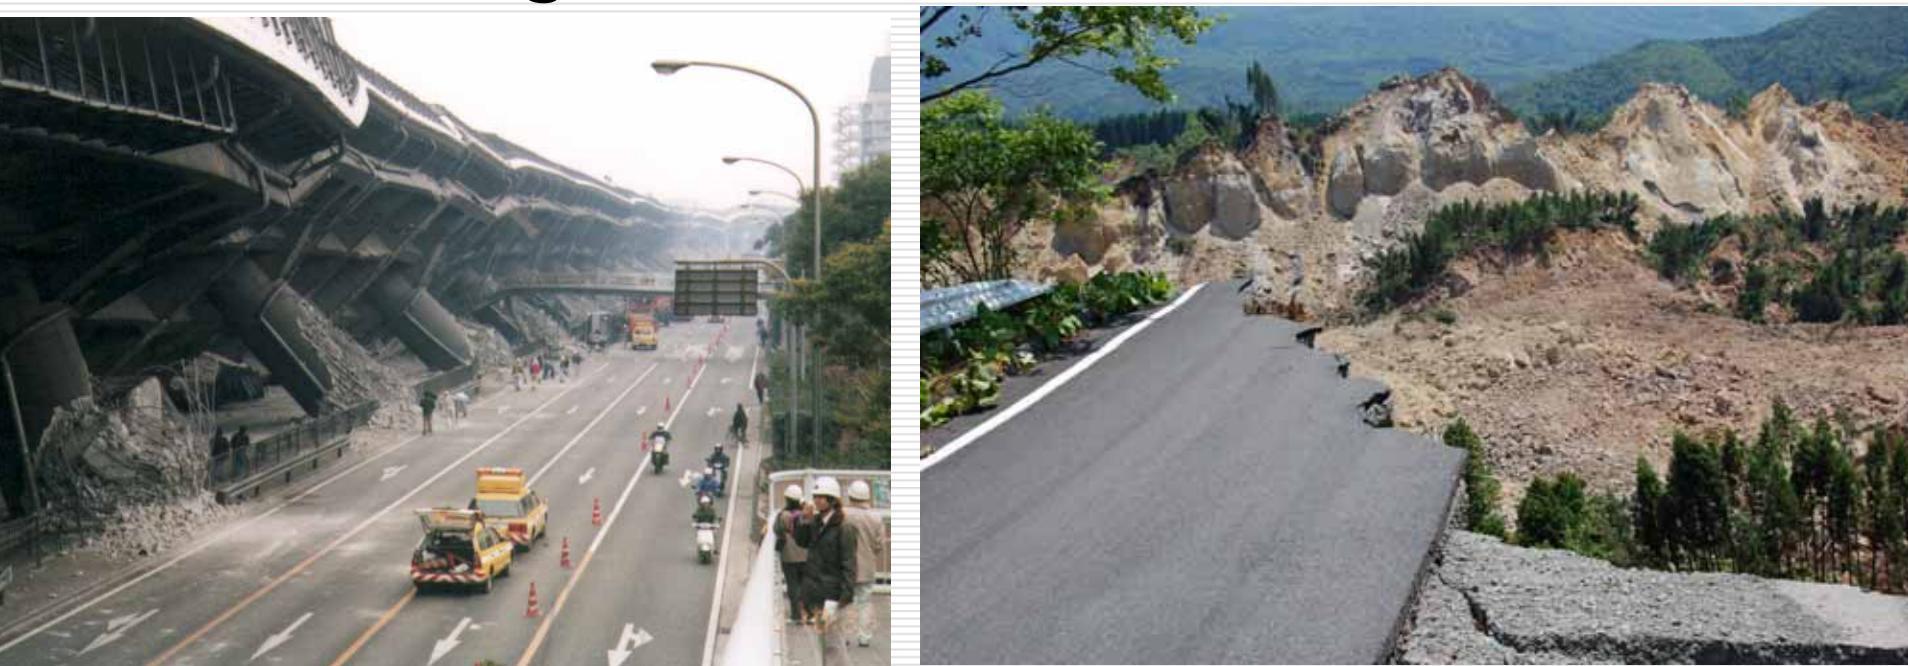
#### Large Slope Failure

1995 Kobe Earthquake, Japan

2008 Iwate-Miyagi Earthquake, Japan 2.2 Why Is Mitigation of Seismic Damage Difficult?
Japanese Experience of Mitigating of Seismic Damage of Bridges どうして地震被害は簡単に減らないのか?
一日本における橋梁の耐震設計の歴史 2.2.1 Stage I: Damage which occurred at the days when the seismic effect was not considered or poorly considered in design

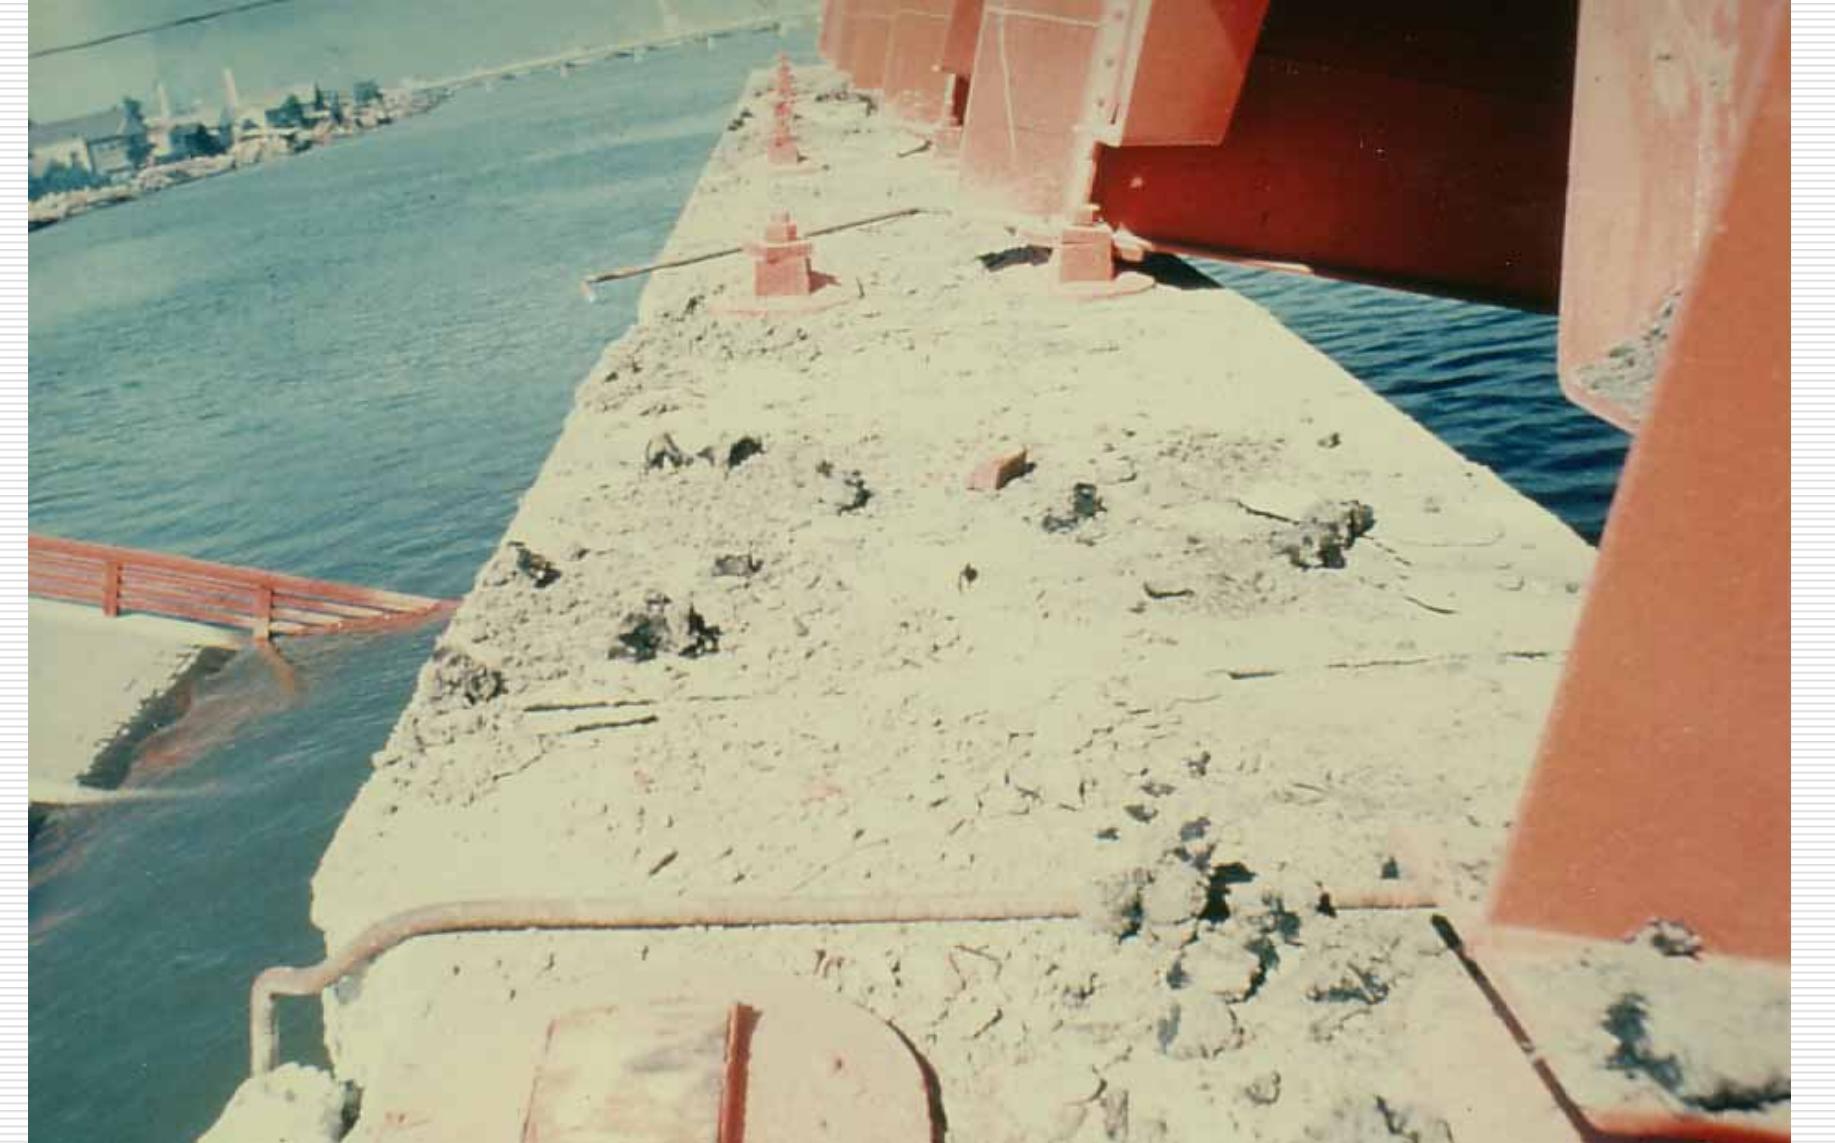
The experience of Niigata earthquake resulted in the first development of unseating prevention devices (落橋防止構造)
