Seismic Design of Urban Infrastructures

Chapter 2 Seismic Damage of Bridges in Past Earthquakes

Kazuhiko Kawashima Tokyo Institute of Technology

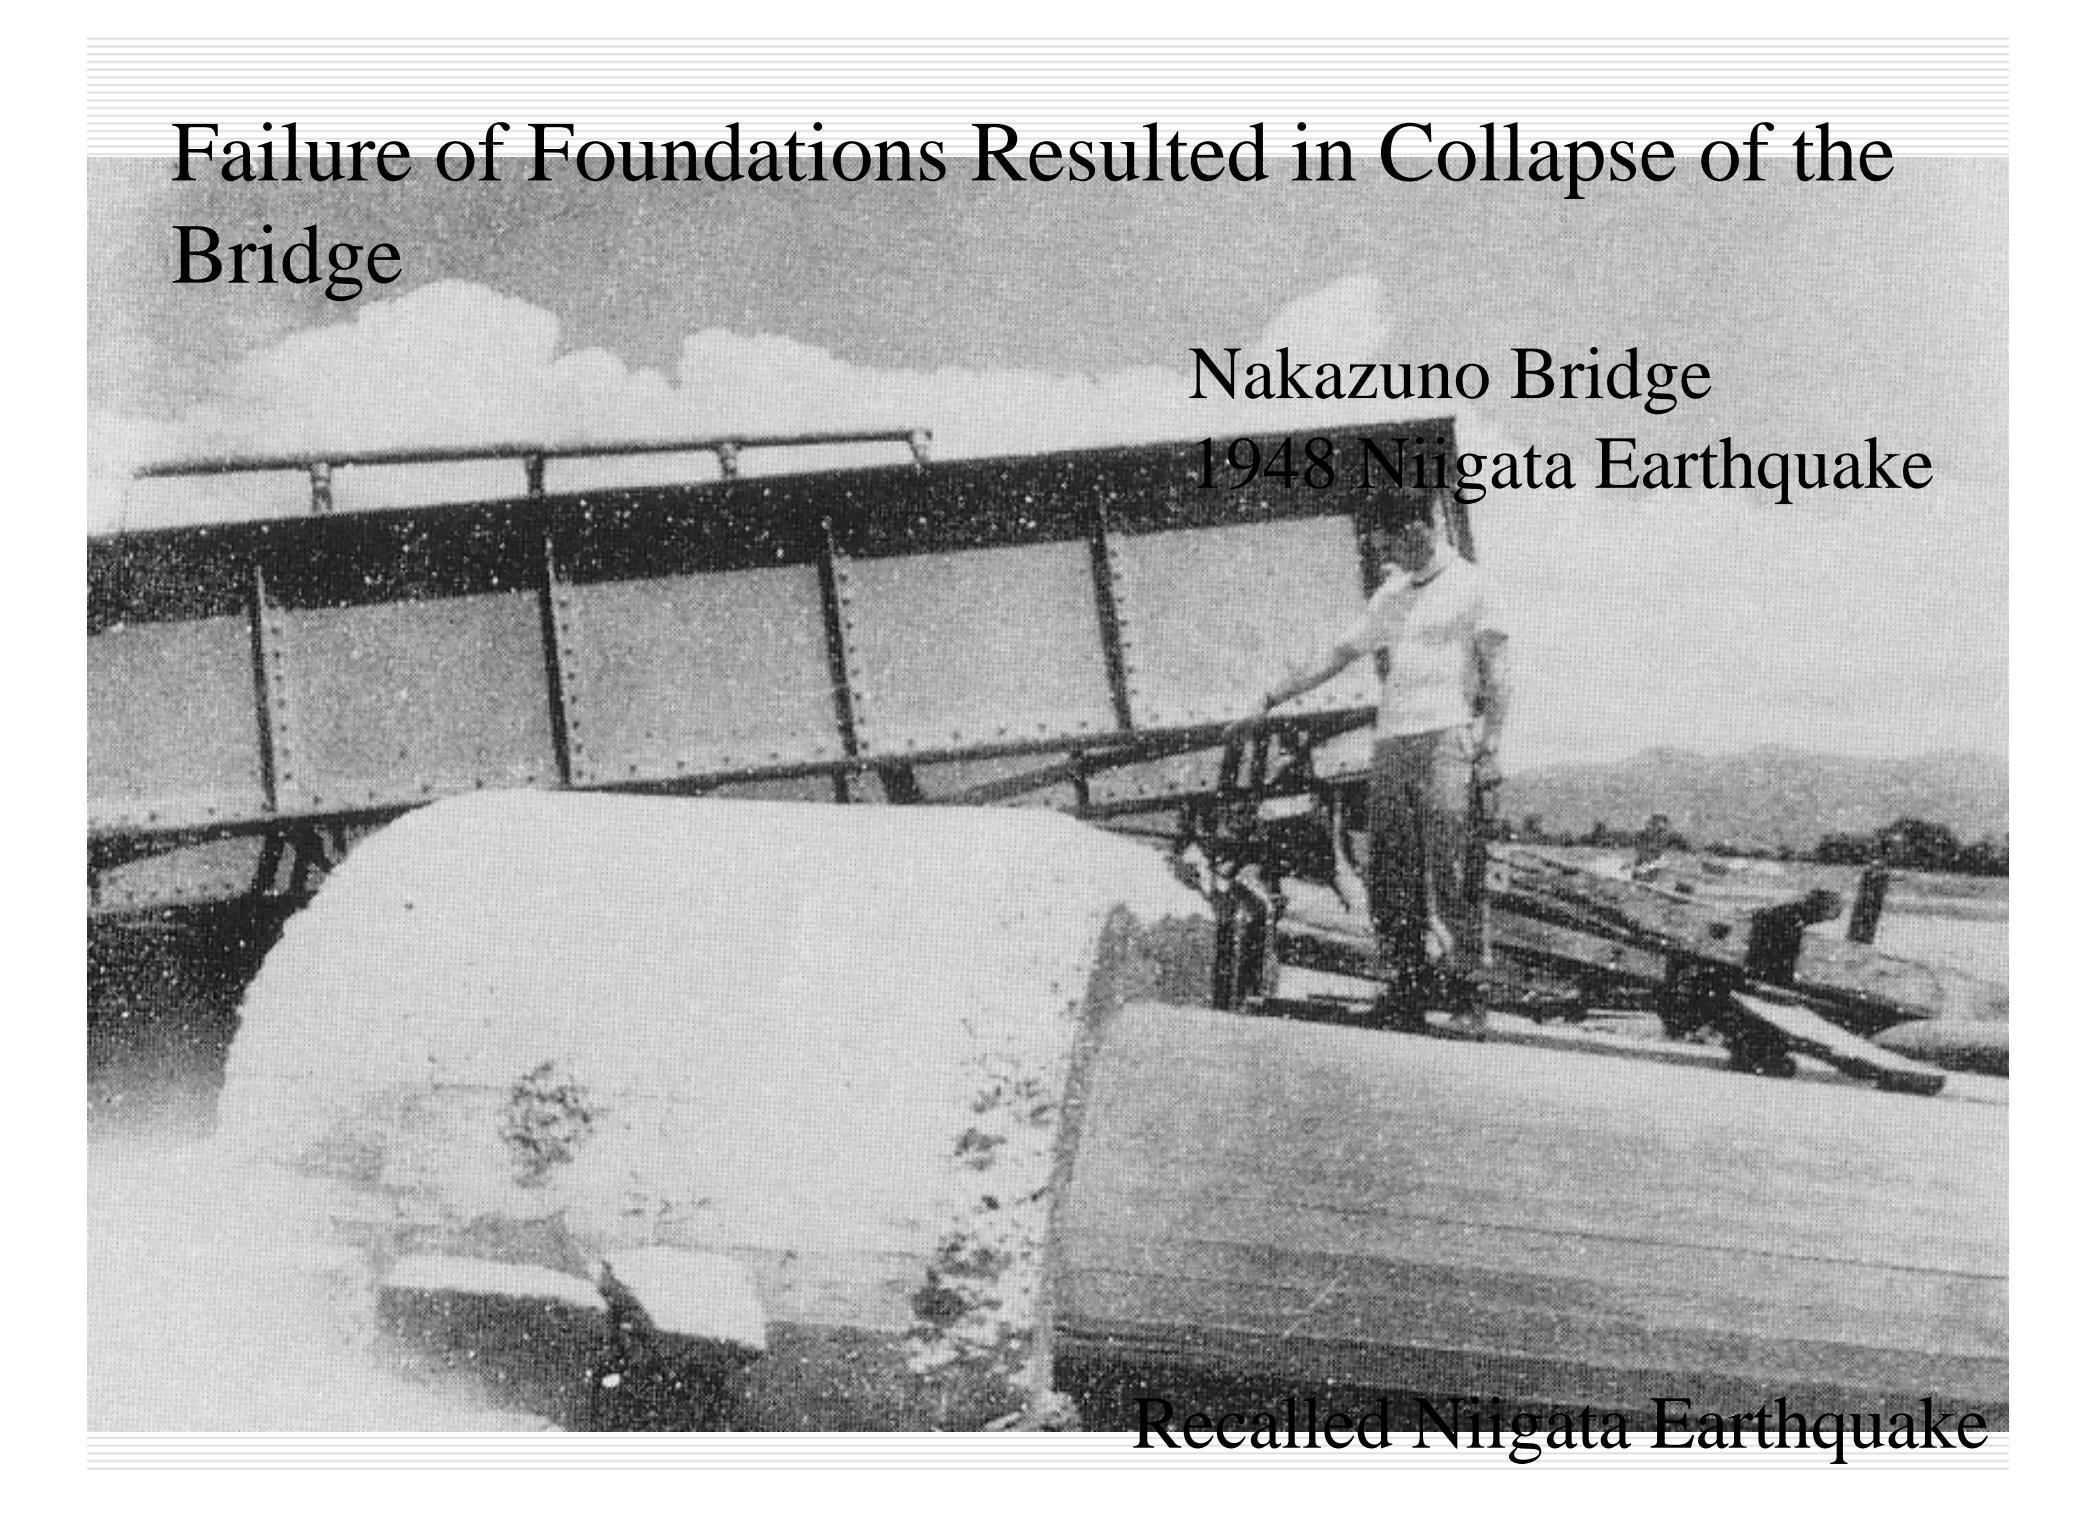
Collapse of Nakazuno Bridge 1948 Fukui Earthquake

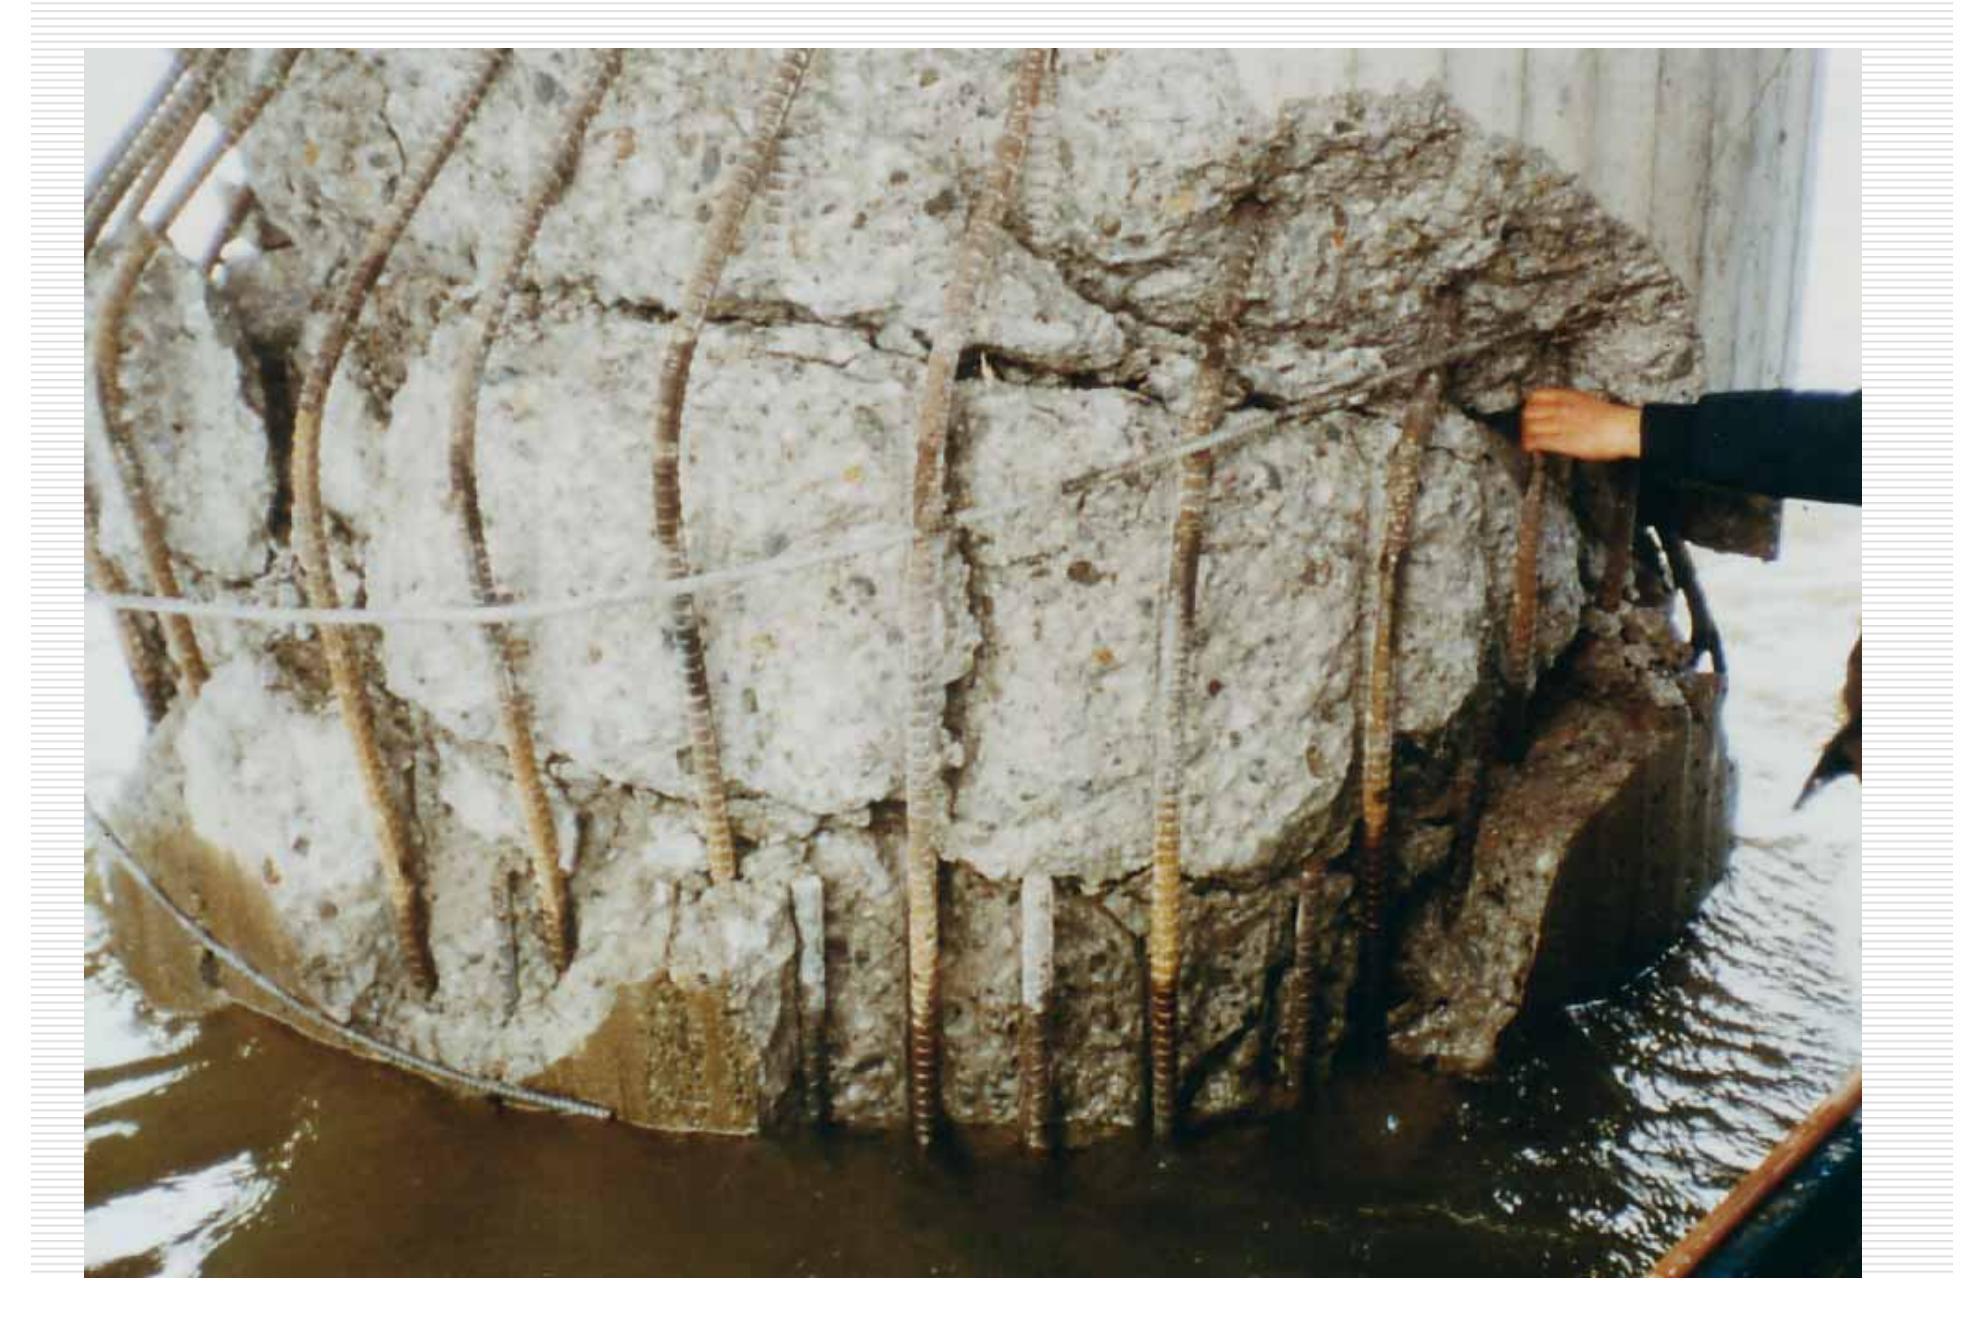
Shizunai Bridge

Premature Shear Failure of RC Piers

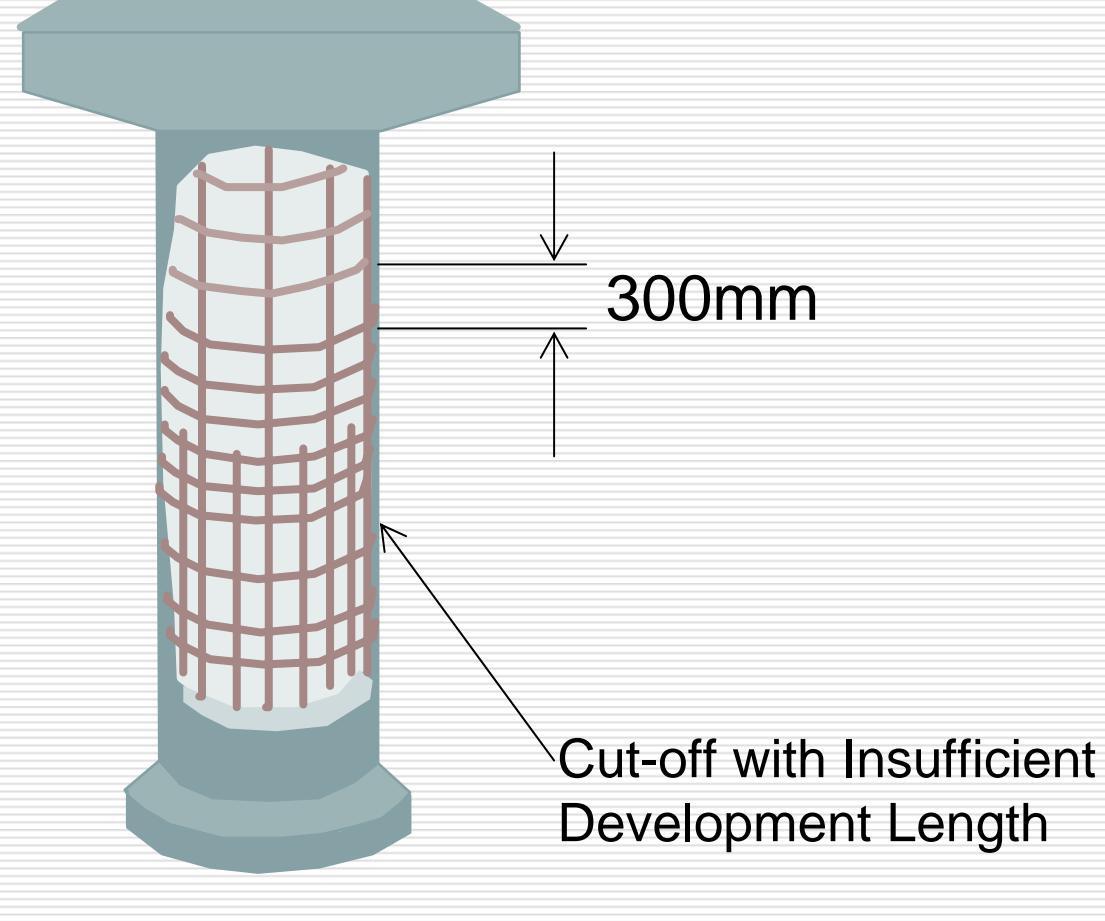
Premature Shear Failure of Reinforced Concrete Piers Resulting from Insufficient Development Length

Common Design Practice prior to 1985

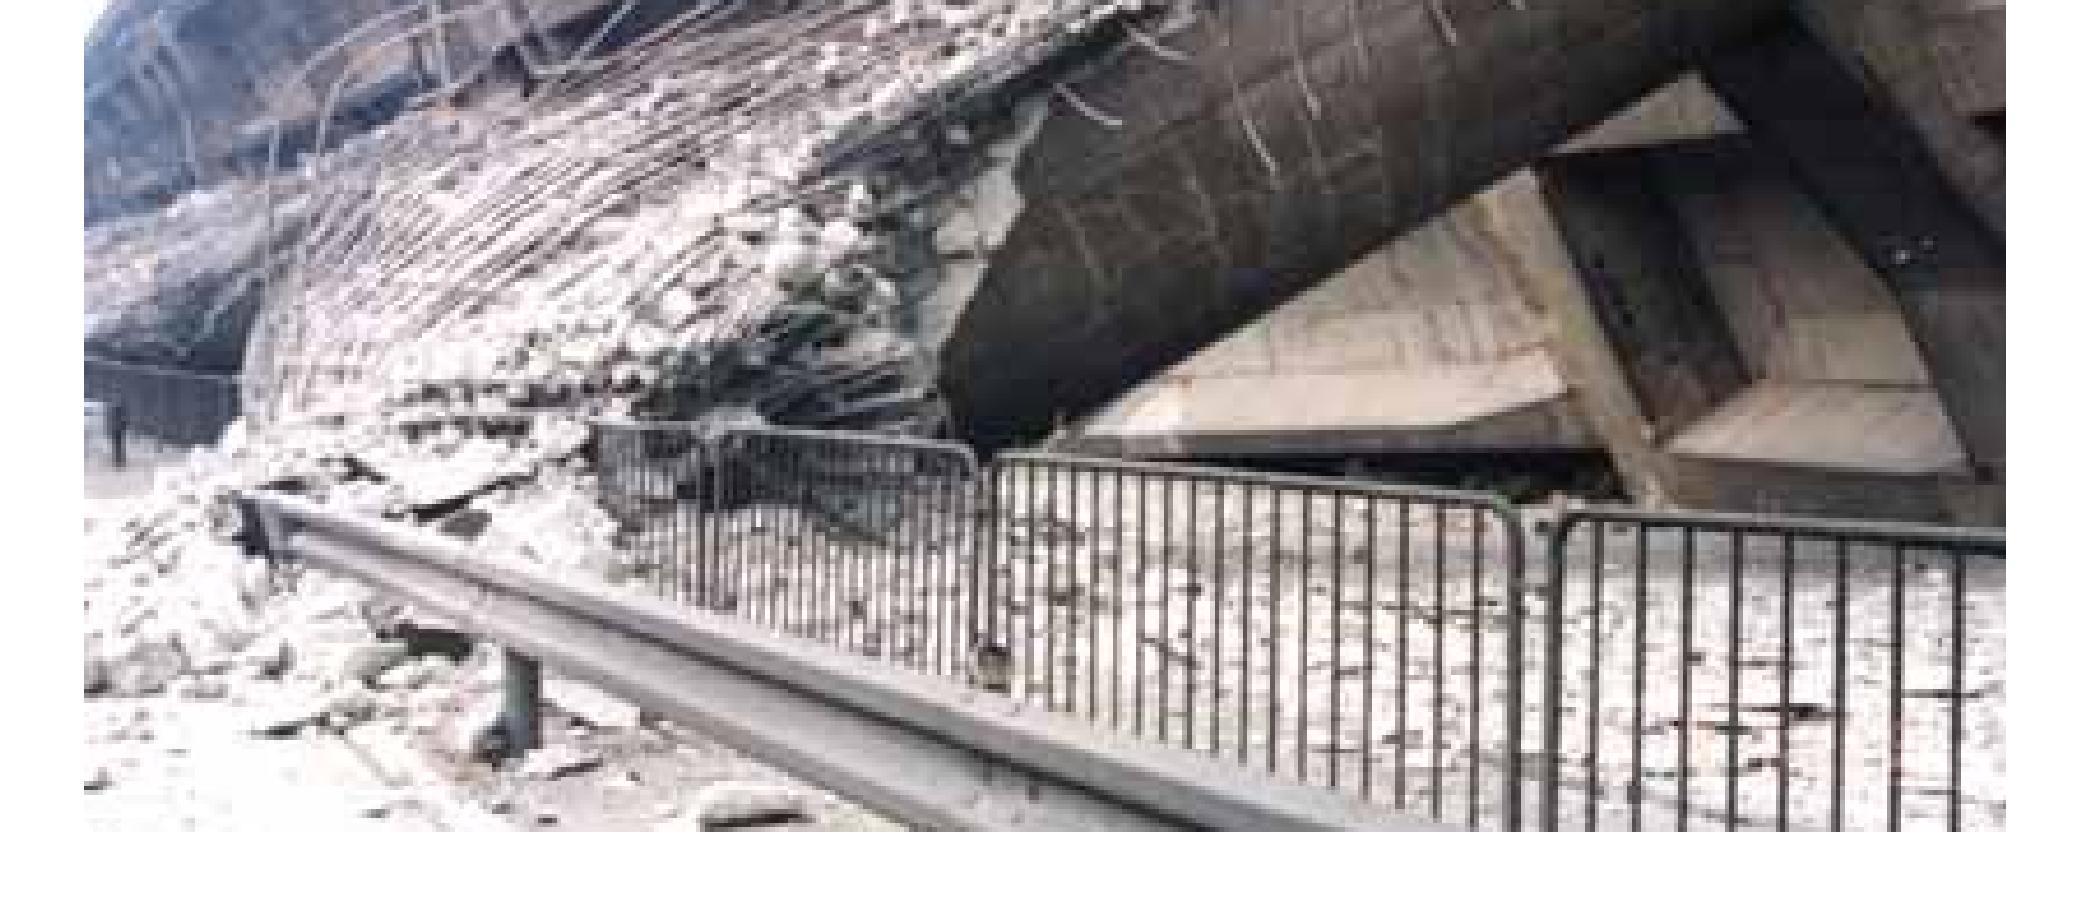
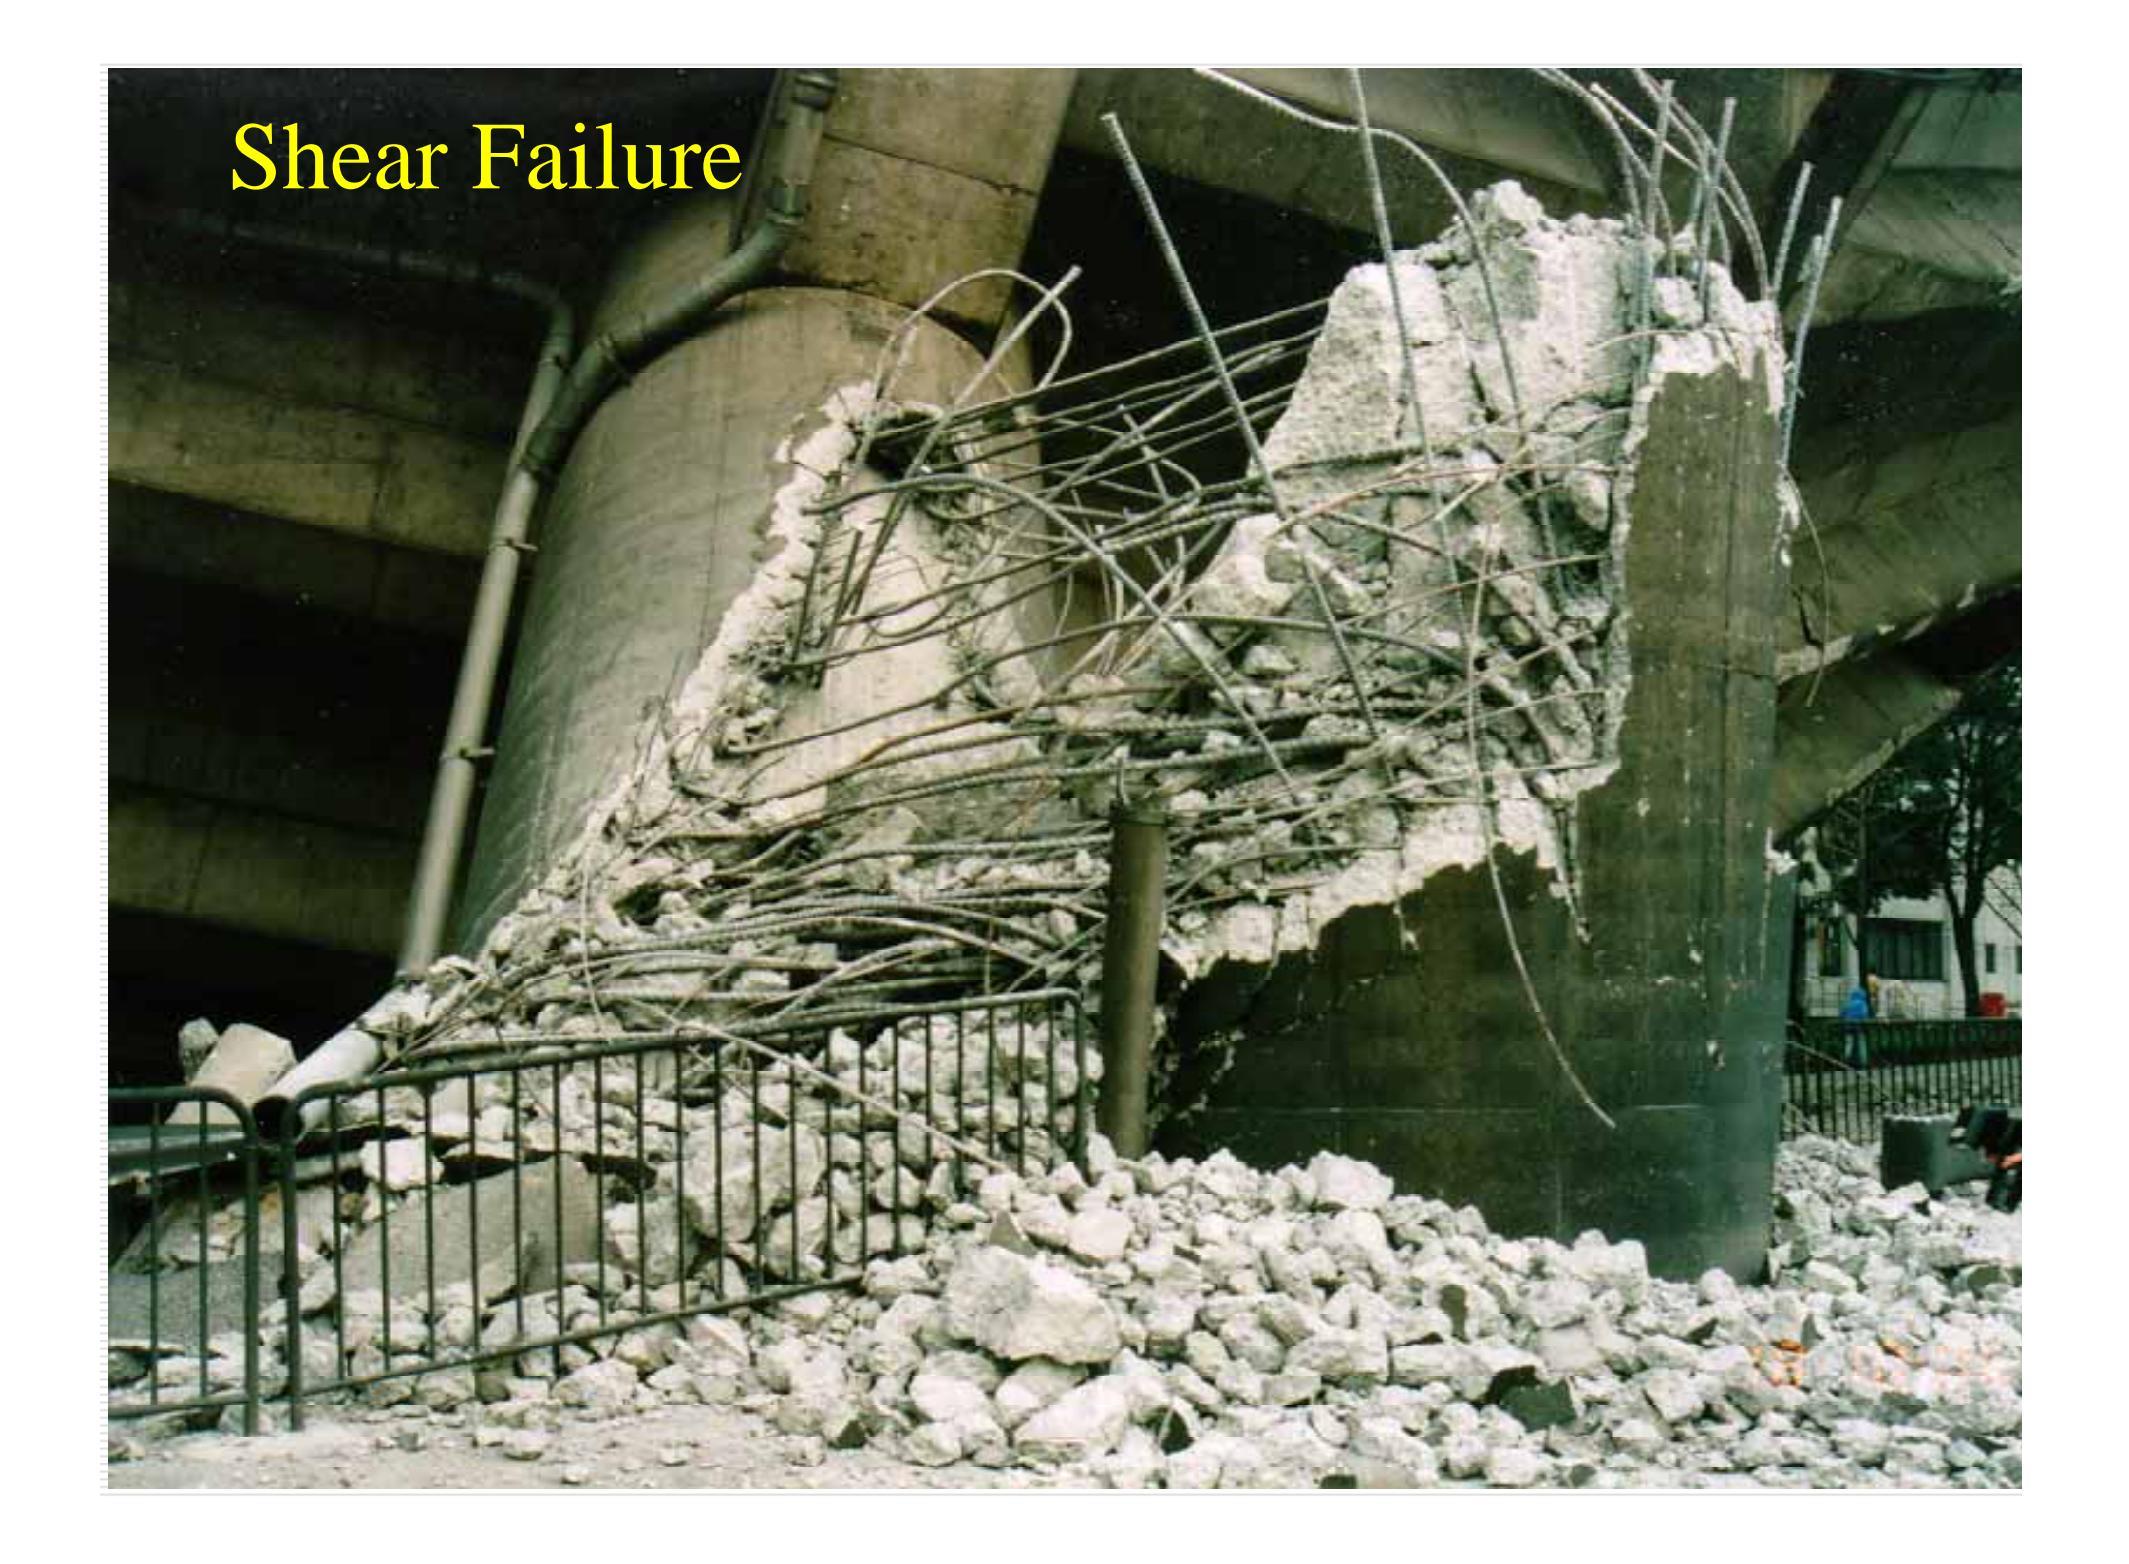
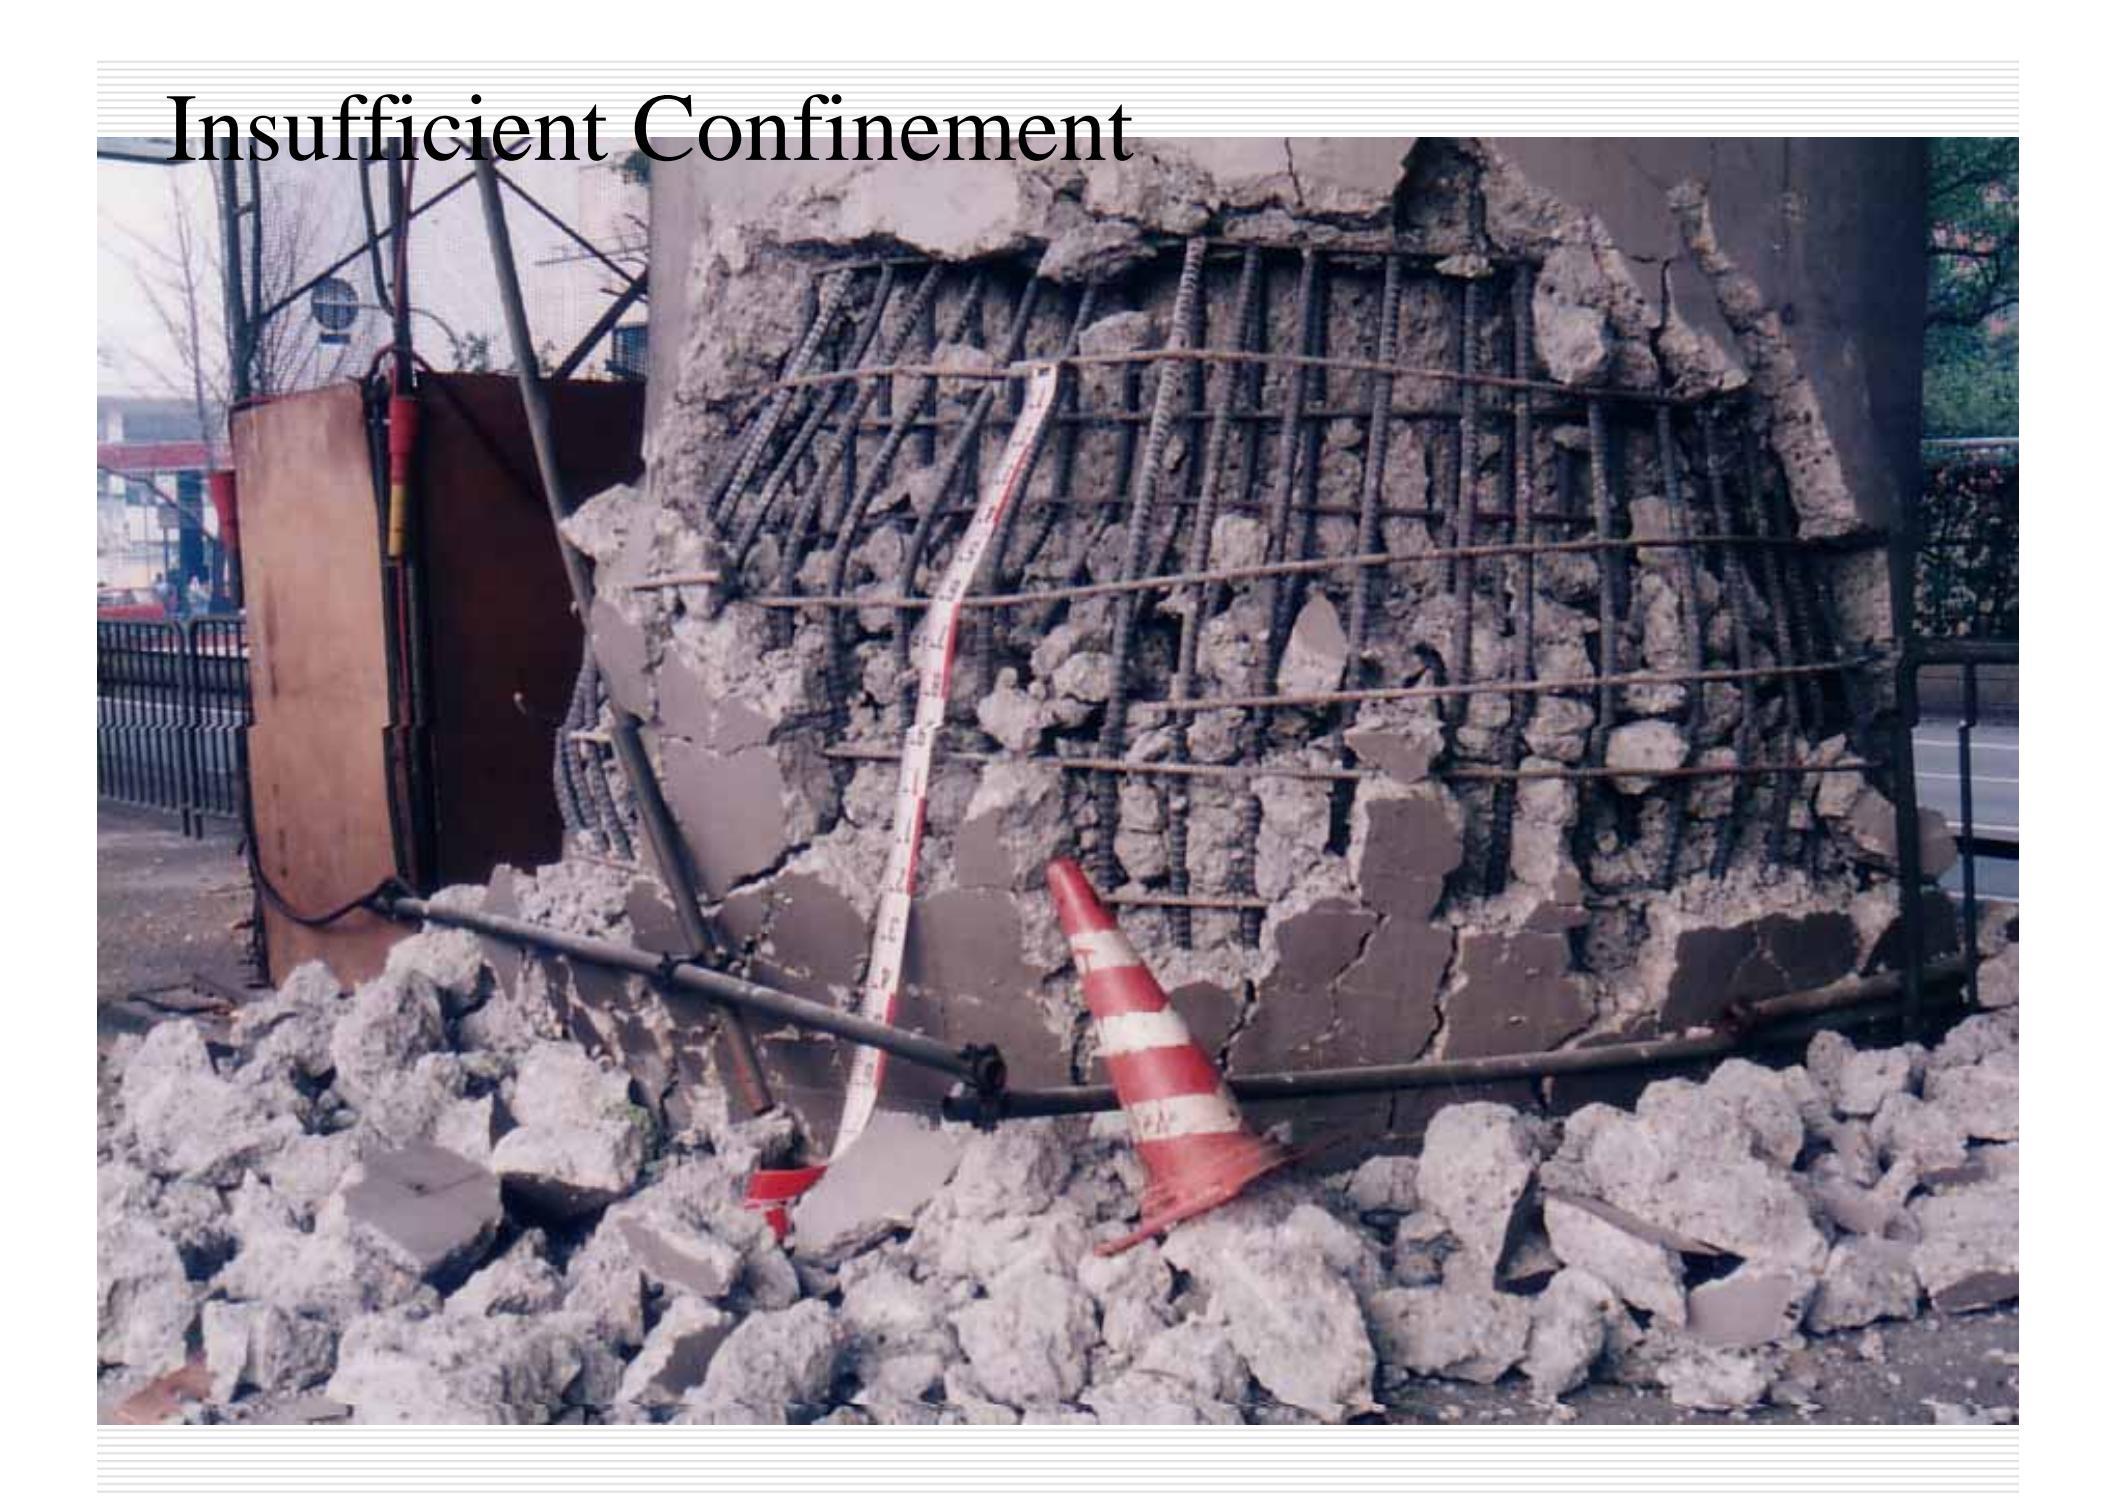
2.2.1 The most extensive damage occurred at a 18-span viaduct. This bridge collapsed due to failure of RC columns resulted from the premature shear failure. Collapse of 18-Span Fuka Hanshin Expressway 1995 Kobe Earthquake

Premature Shear Failure of RC Columns Resulted from Insufficient Development Length

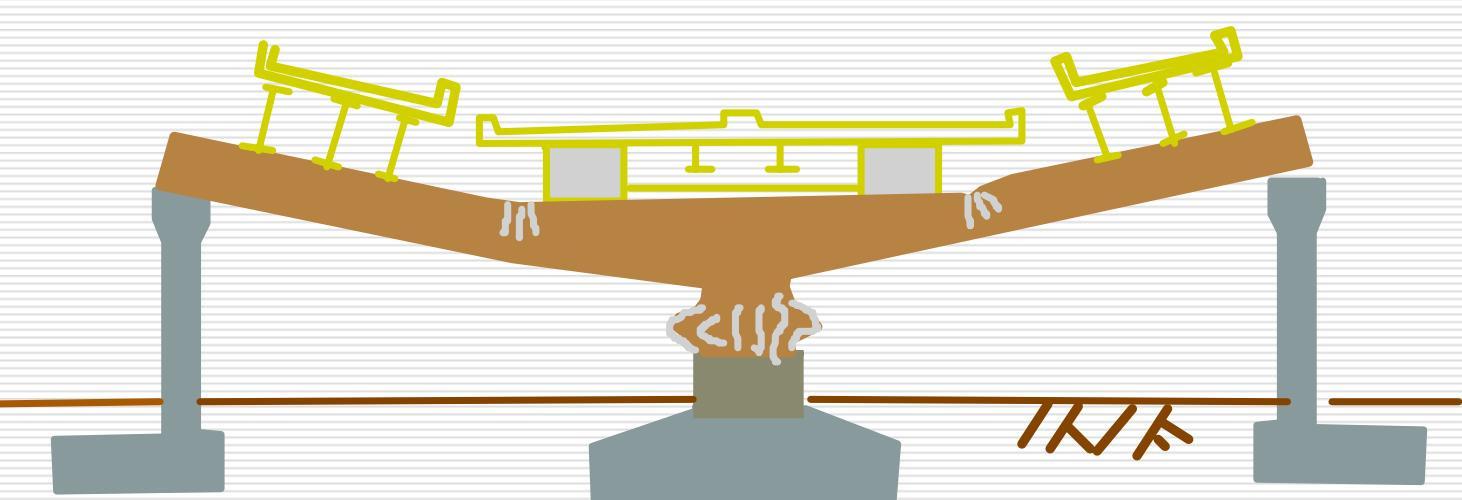
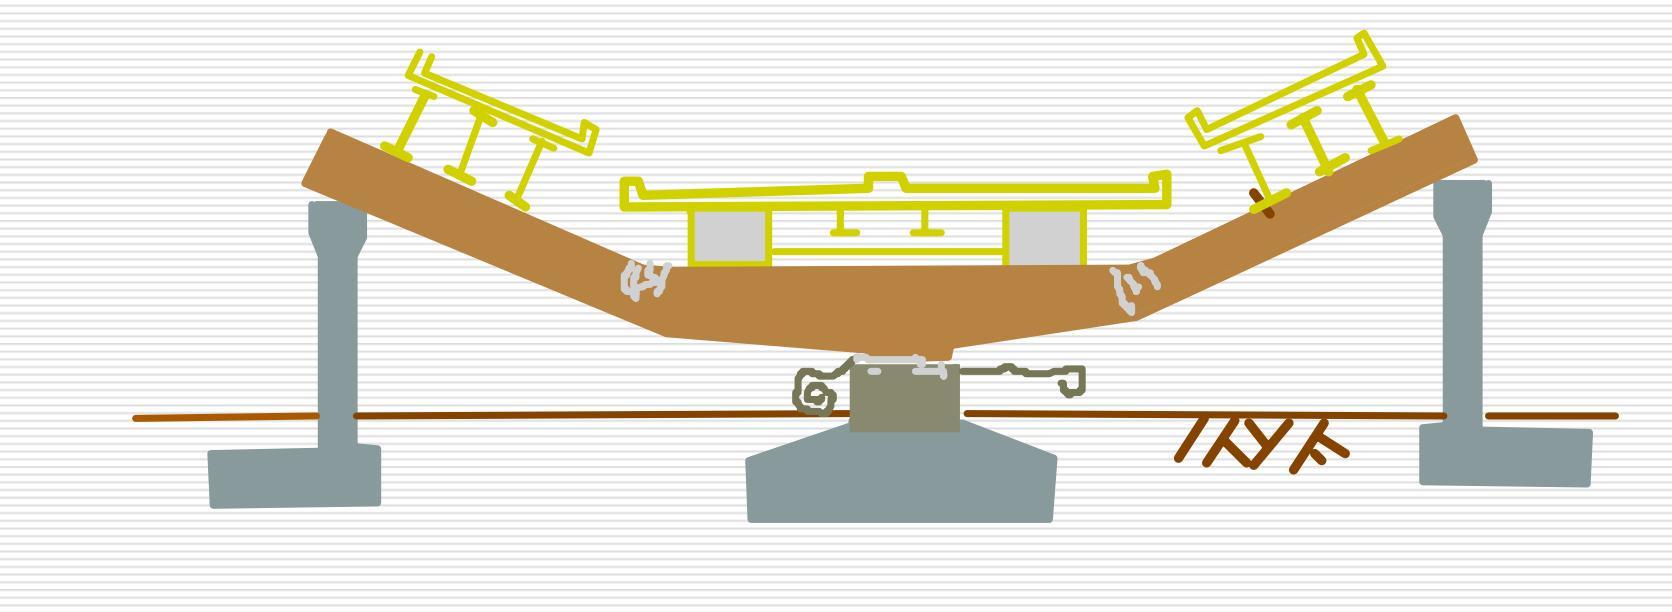
Progress of Failure of Steel Columns (continued)
