Seismic Design of Urban Infrastructures

Chapter 2 Seismic Damage of Bridges in Past Earthquakes

Kazuhiko Kawashima Tokyo Institute of Technology

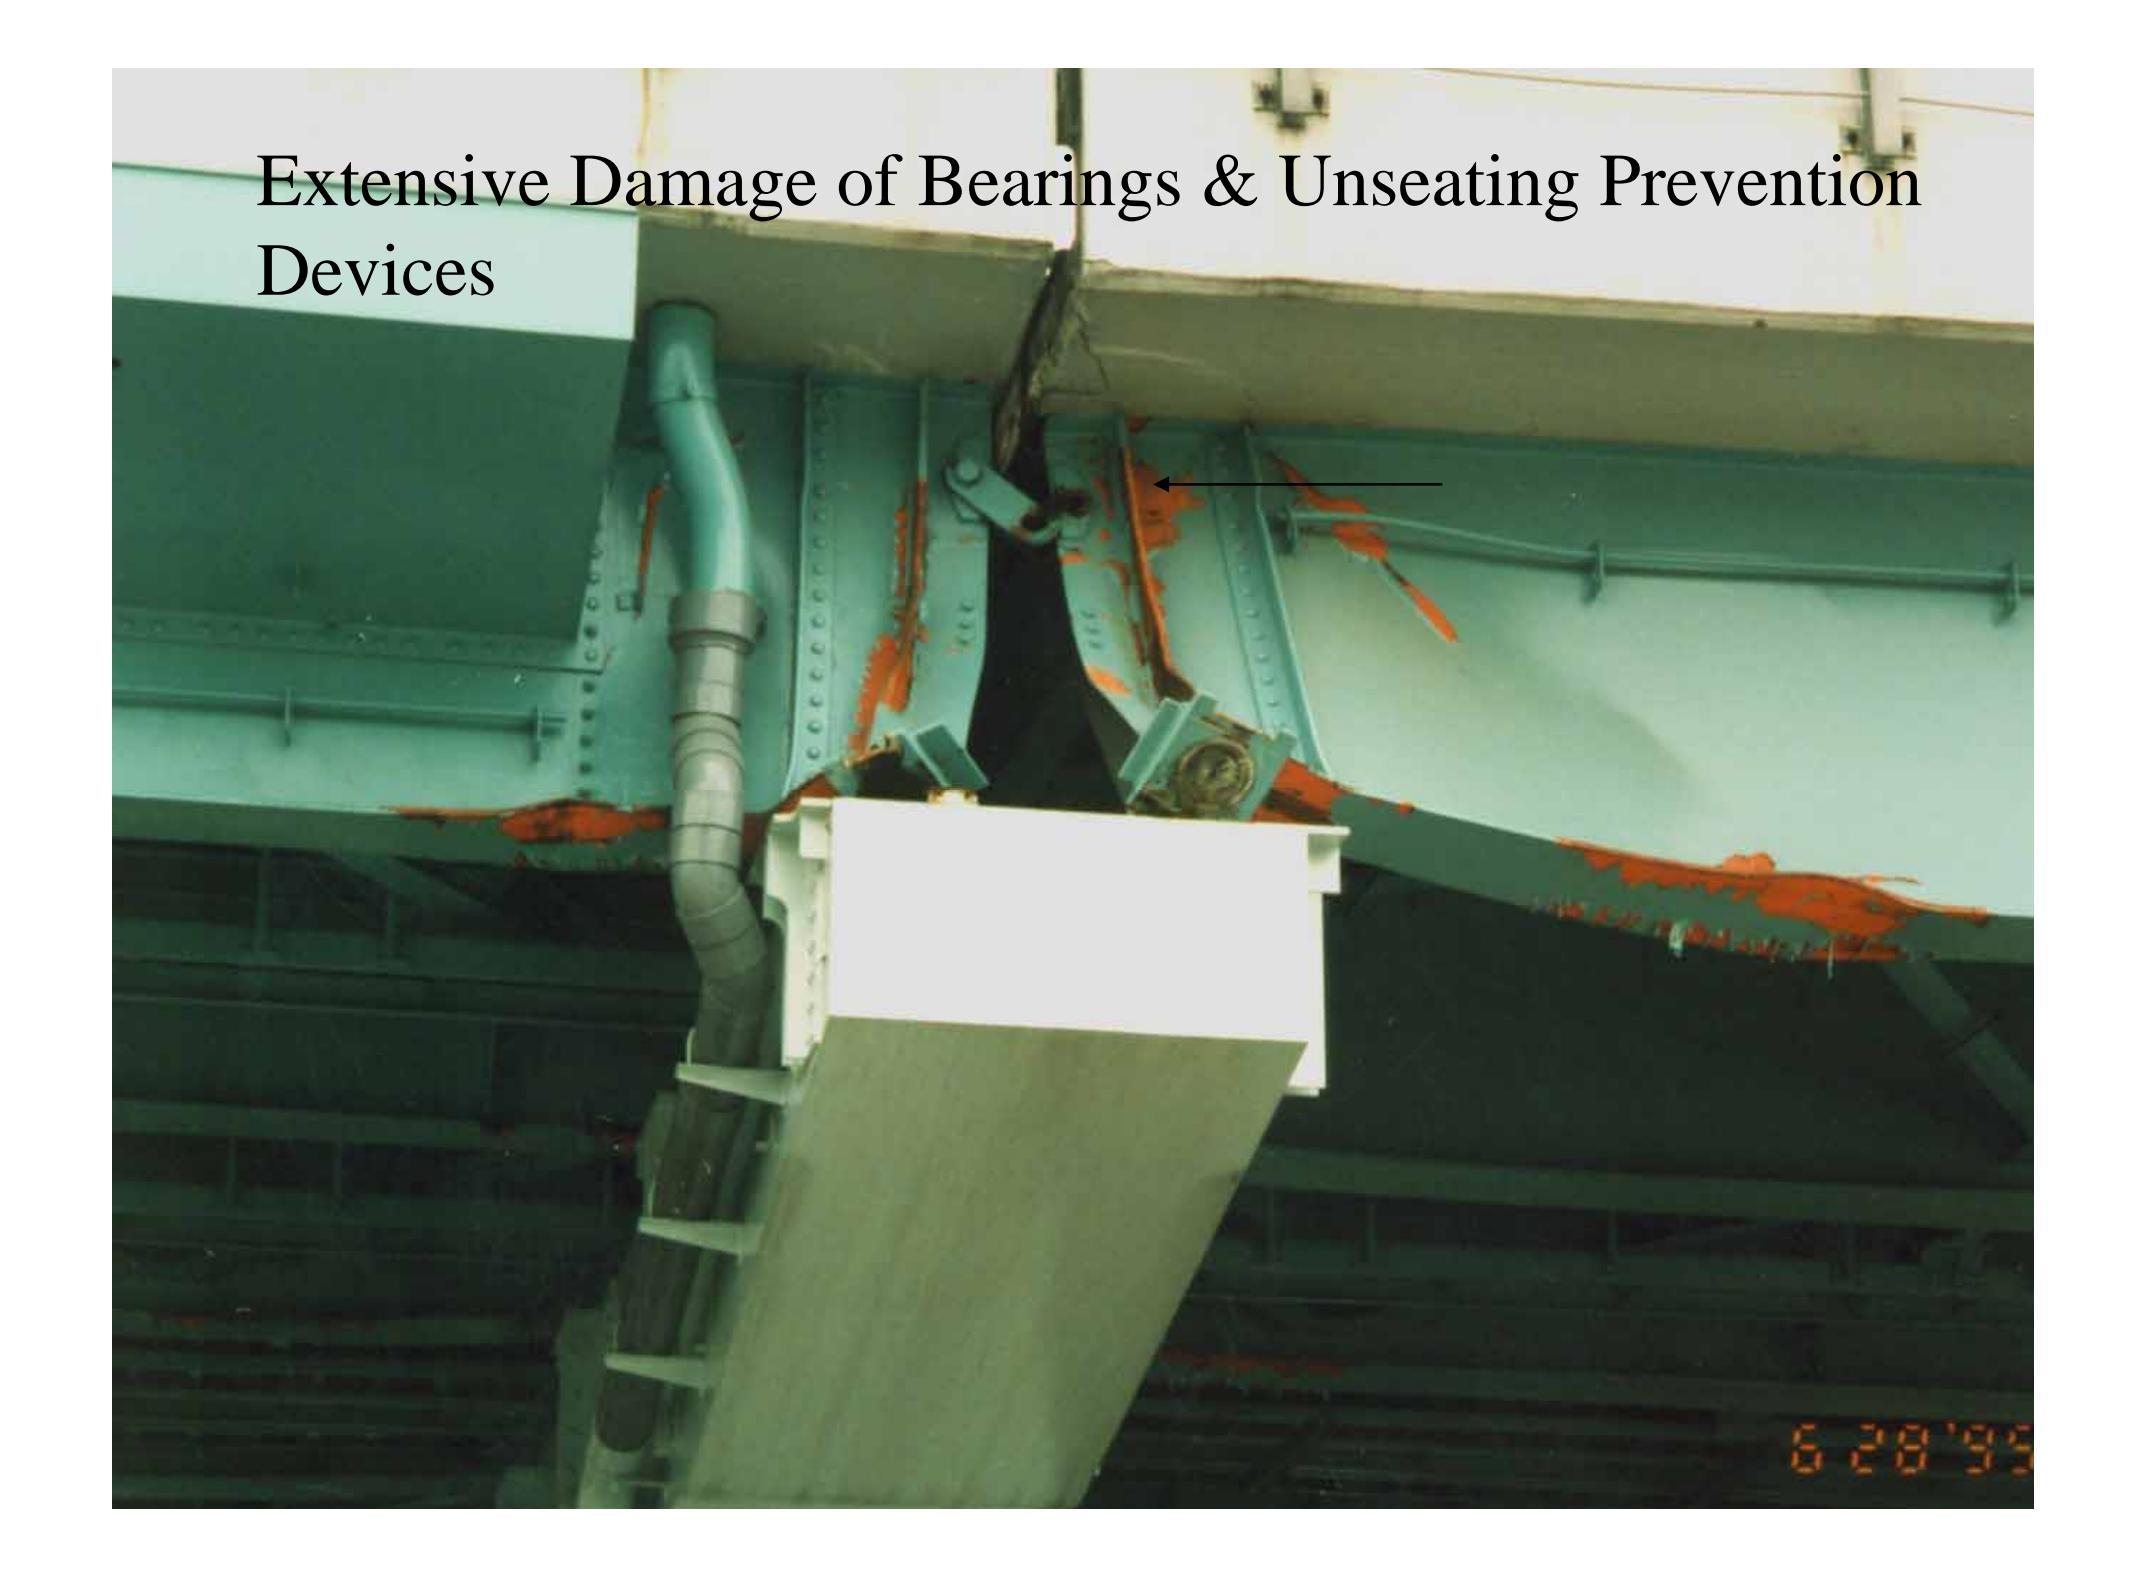
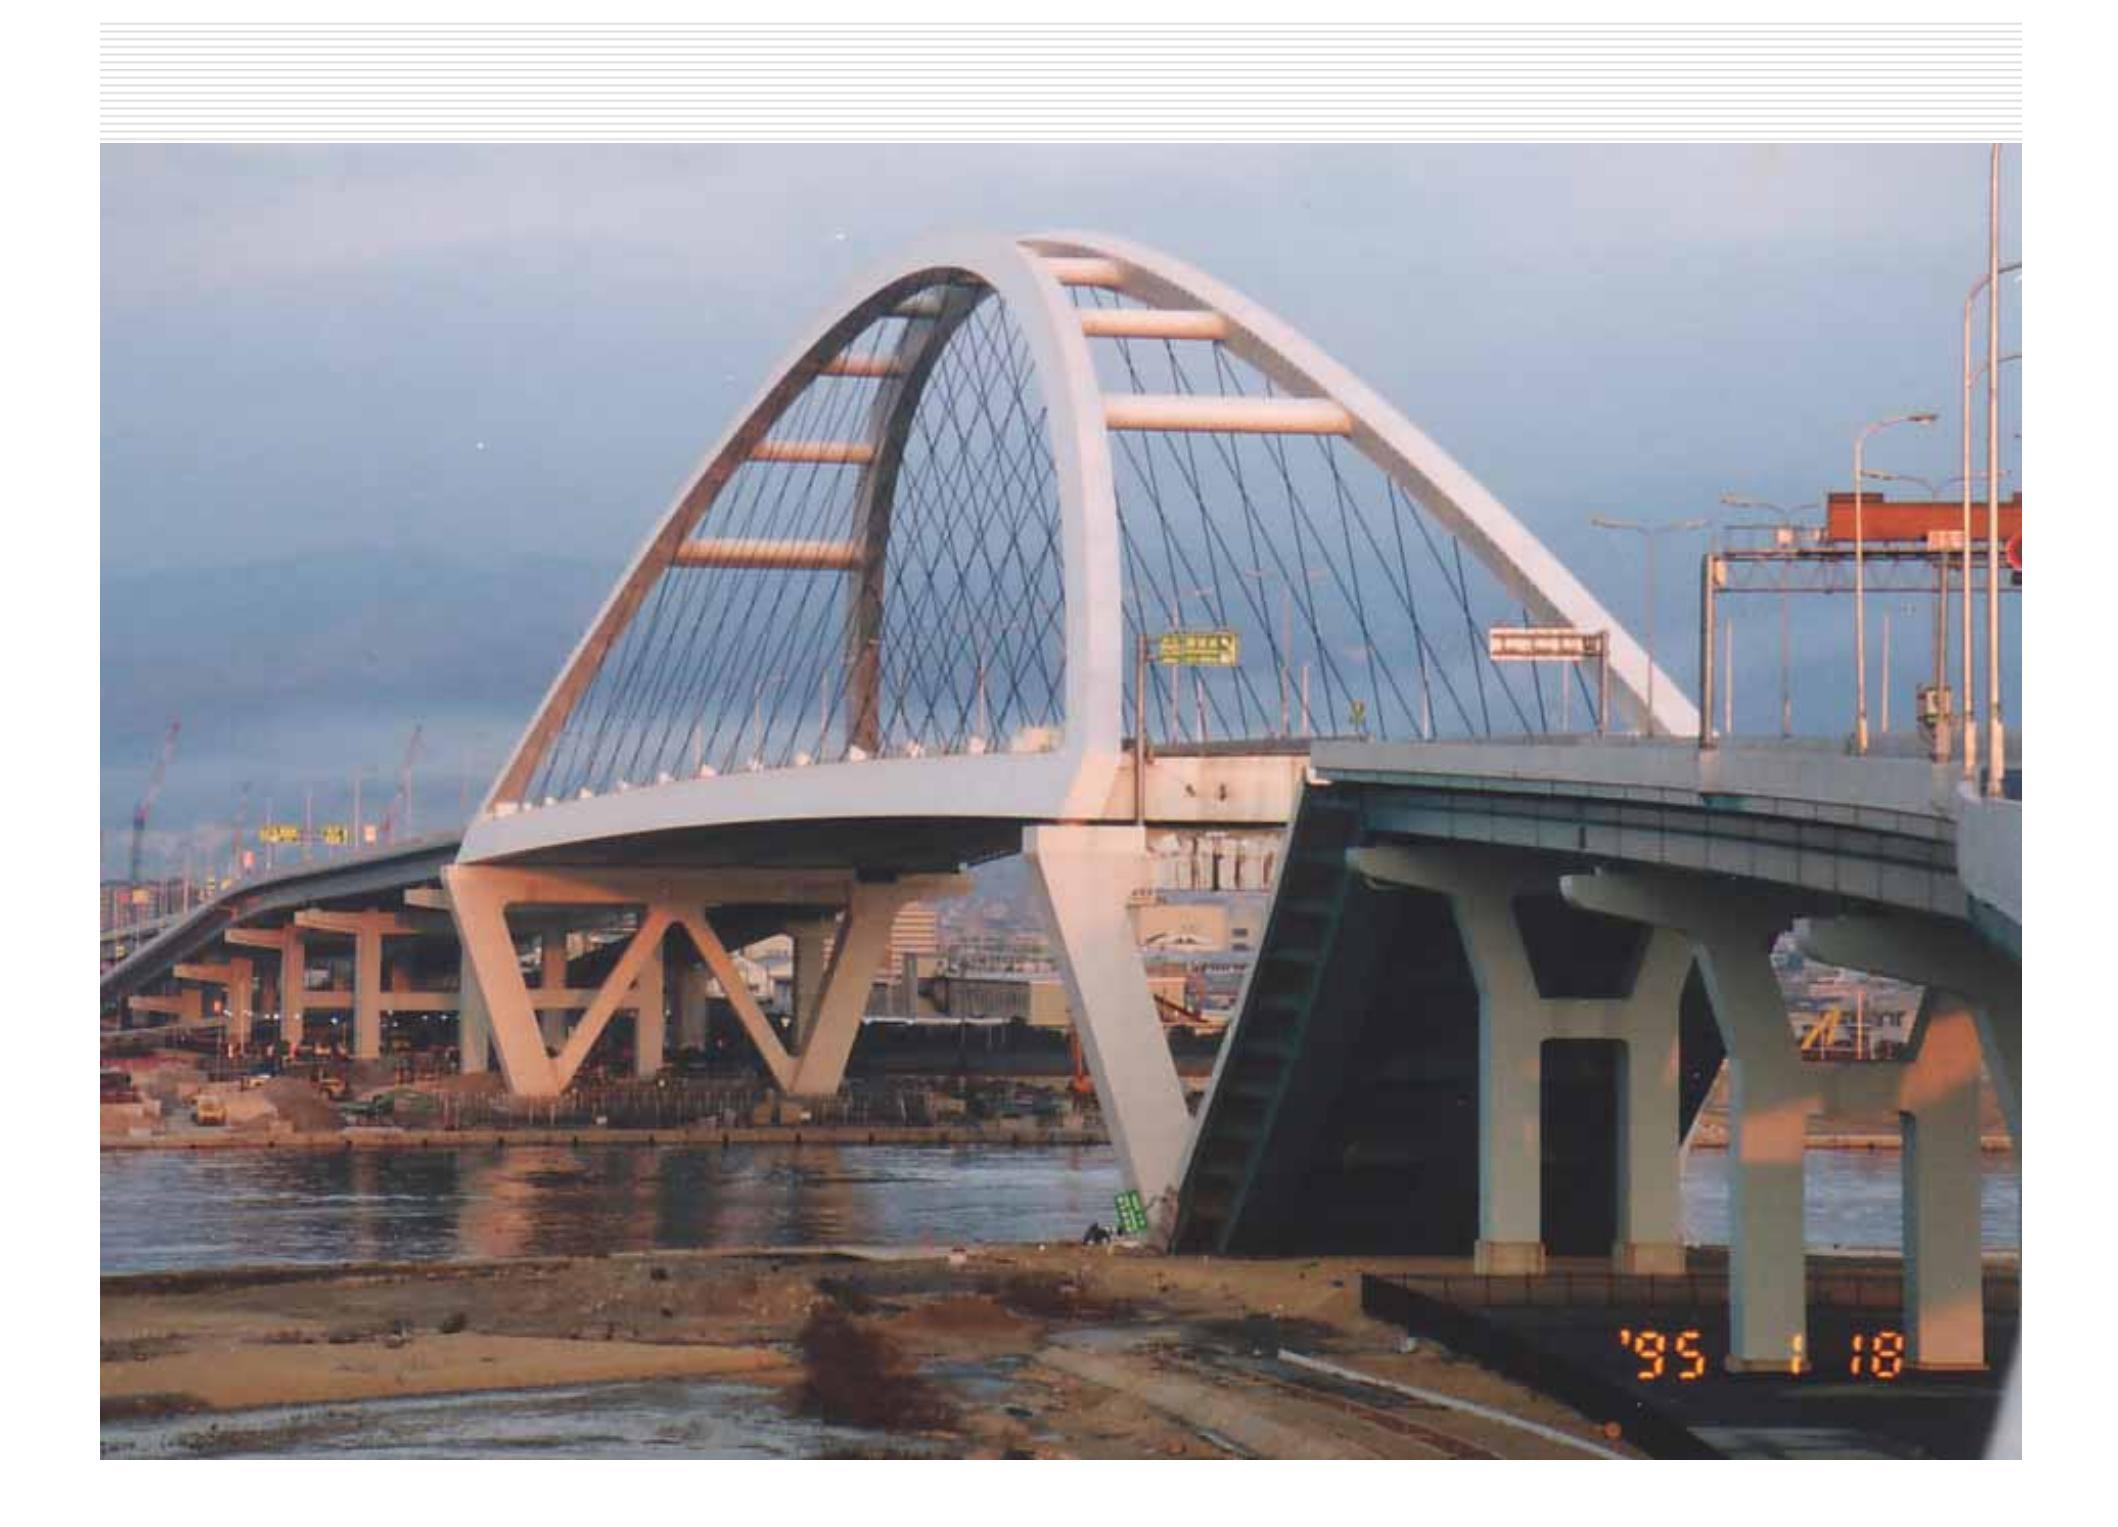
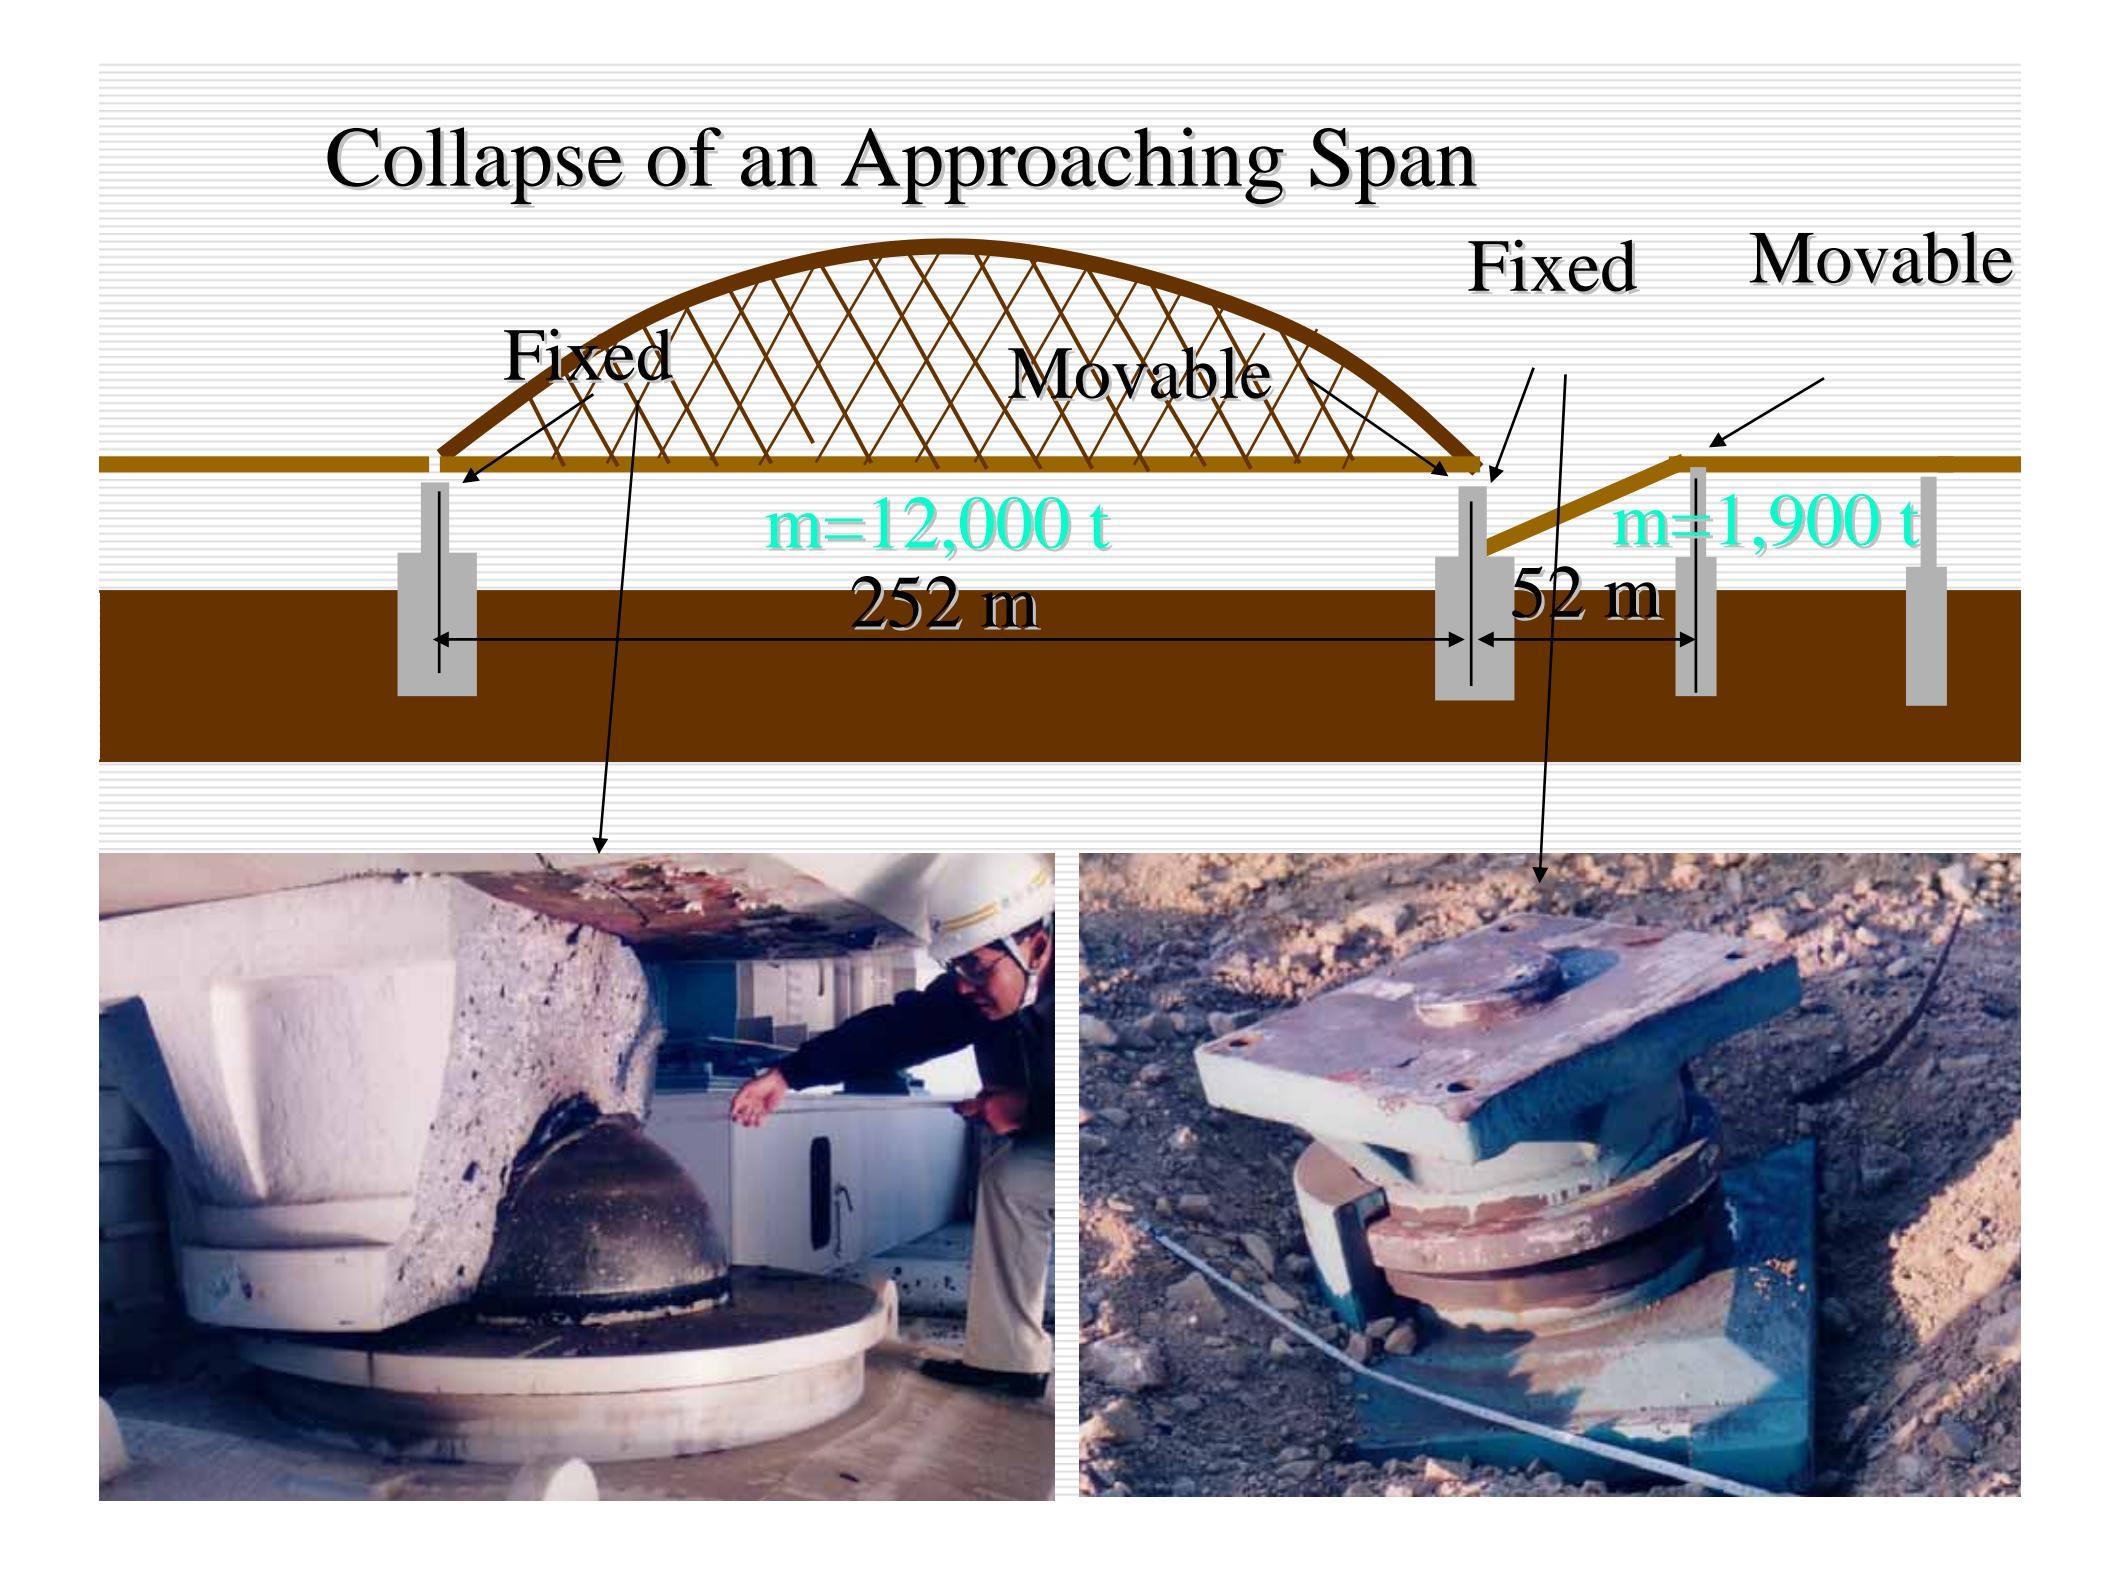
2.2.5 Extensive Damage of Bearings

•Damage of bearings (steel bearings) was an issue of discussion at every time when a damaging earthquake occurred.

•However there was always an argument that bearing damage was a fuse to restrict extensive damage at the substructures. As a consequence, only minor upgrading had been adopted for design of bearings.

•However it was so obvious that bearing damage was not a fuse for restricting damage of substructures, but it was one of the main causes of the extensive damage in the 1995 Kobe earthquake.

- •It was recommended in the 1995 & 1996 codes that elastomeric bearings including LRB and HDR should be used.
- •Steel bearings have the following deficiencies:
 - \checkmark Insufficient strength and weak for shock
 - ✓ Structures with insufficient lateral and vertical capacity
 - ✓ Insufficient lengnth of movement
